HISTORIC LANDMARK COMMISSION STAFF REPORT

534 N Wall Street Window Replacement Minor Alteration

PLNHLC2015-00168
Meeting Date: May 14, 2015

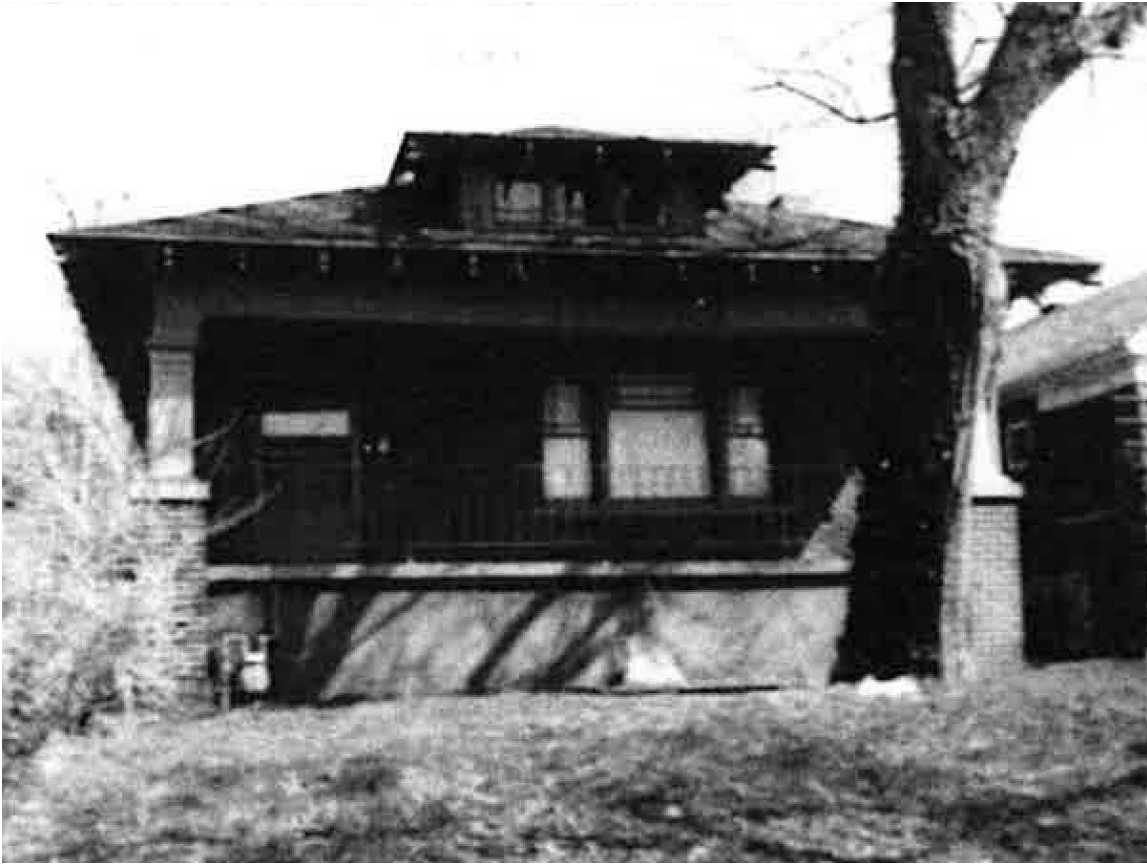
Historic

Front Facade

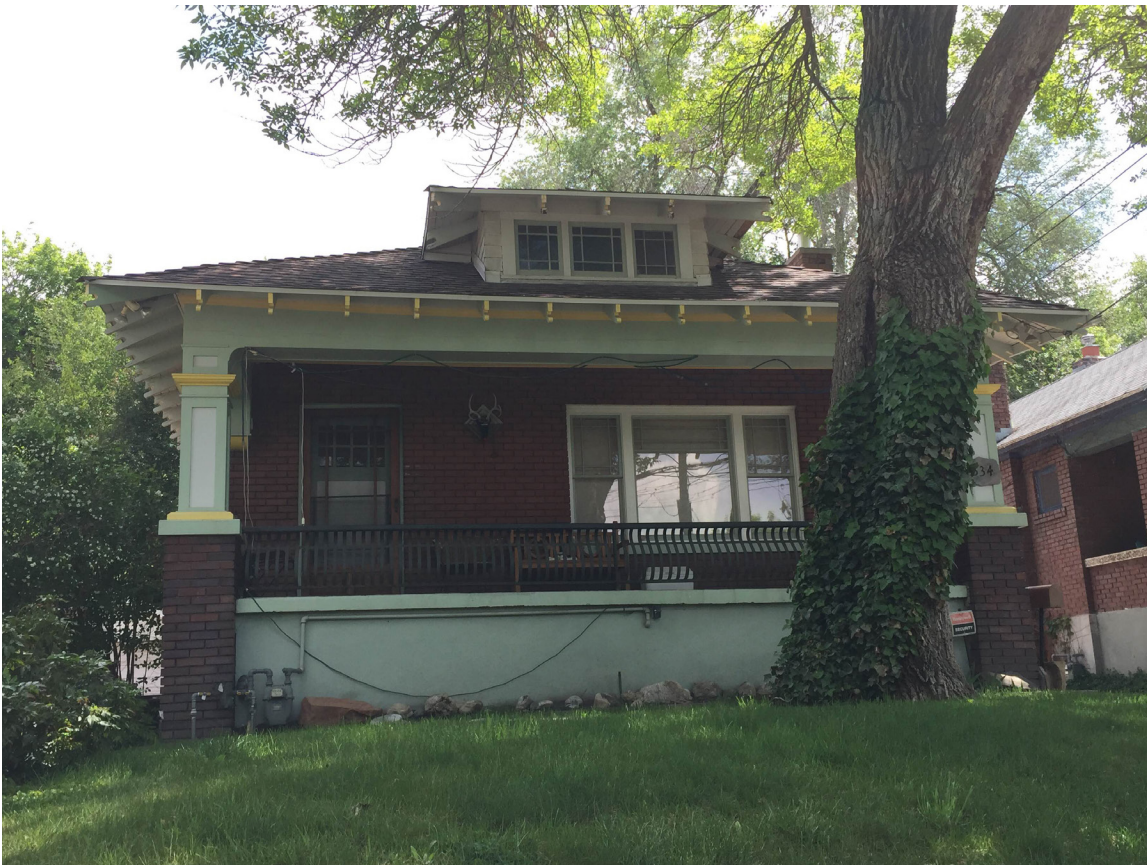
Present Day

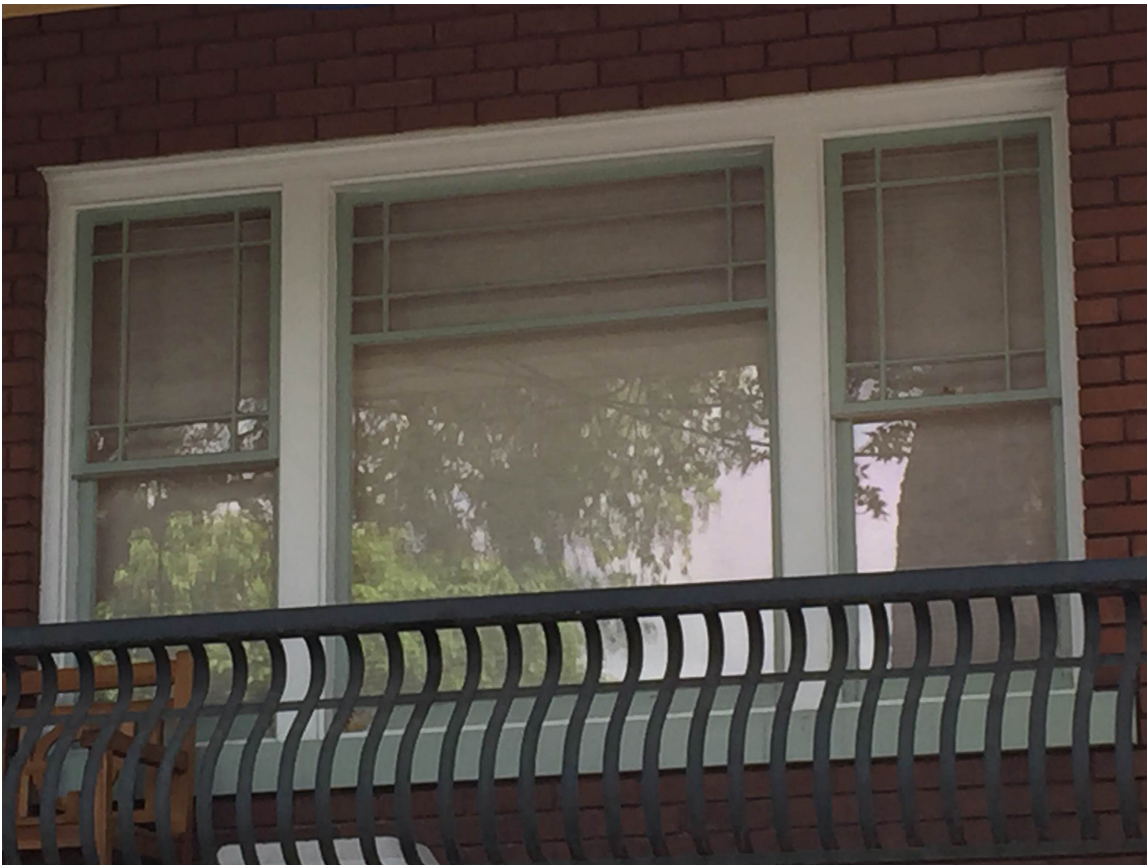
Window from Sidewalk

Analysis: In connection with the currently issued Certificate of Appropriateness concerning windows on the subject property, a member of planning staff visited the applicant's home to examine the windows. As of this examination, the front windows were in good condition, such that, with only minimal intervention, they will provide many more years of service.

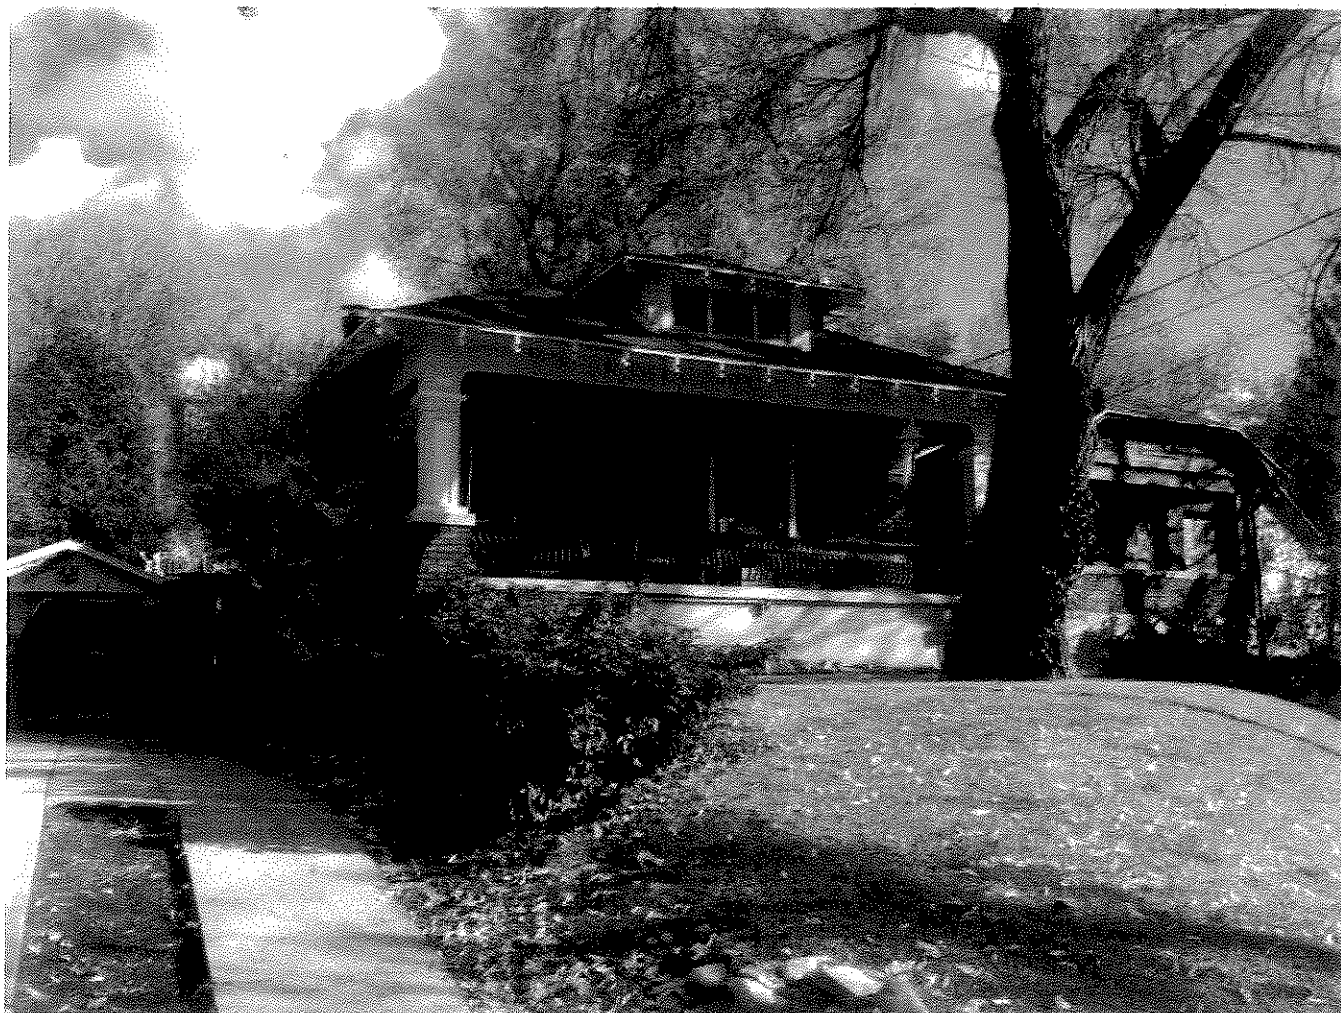
The windows labeled 9,10,11 are those we would like to build exterior wood frame storms for.

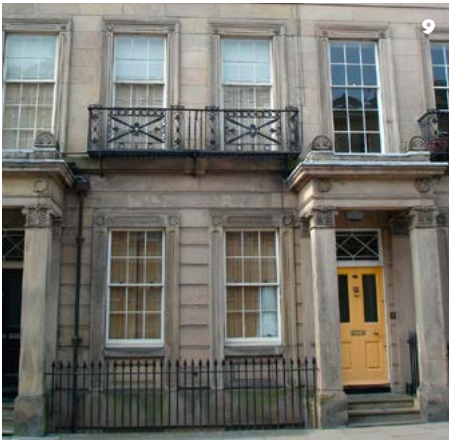
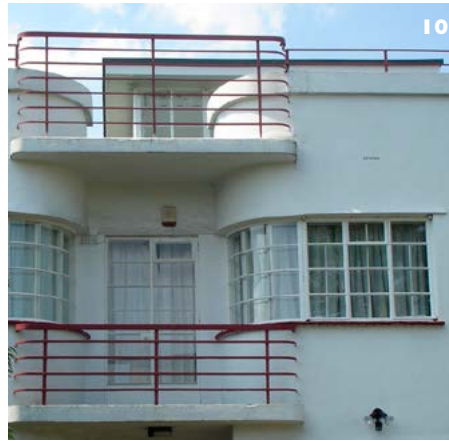
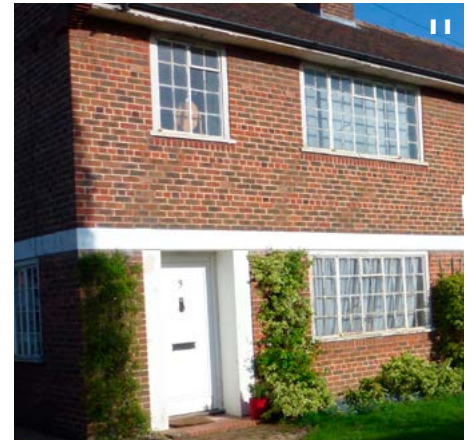
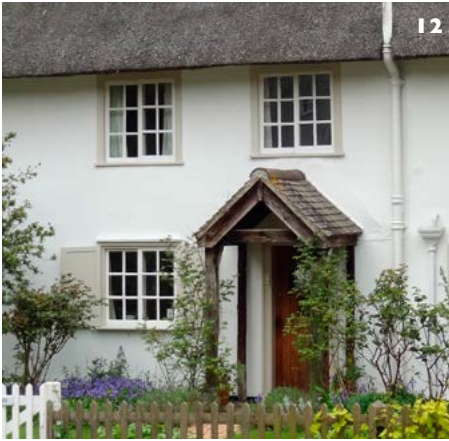
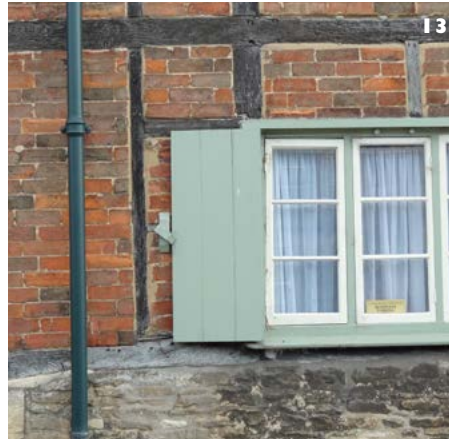
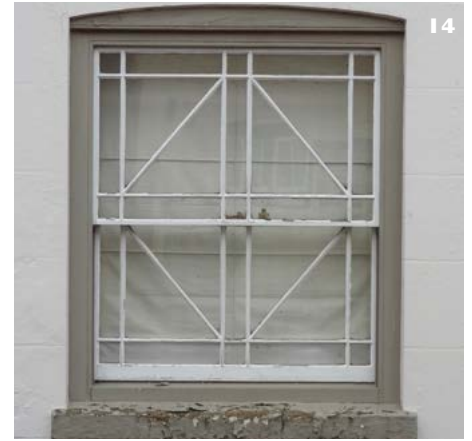
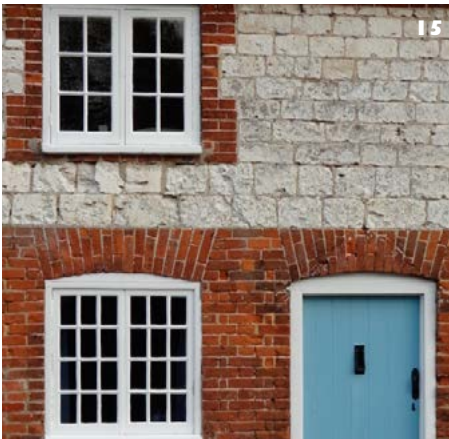
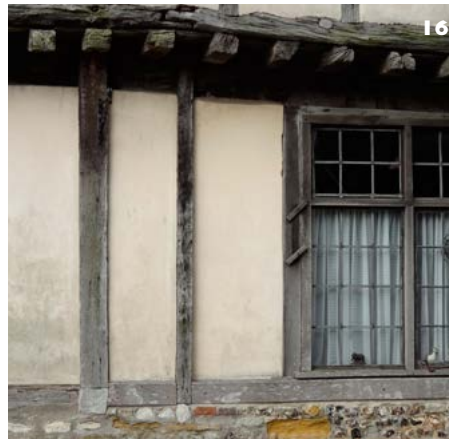
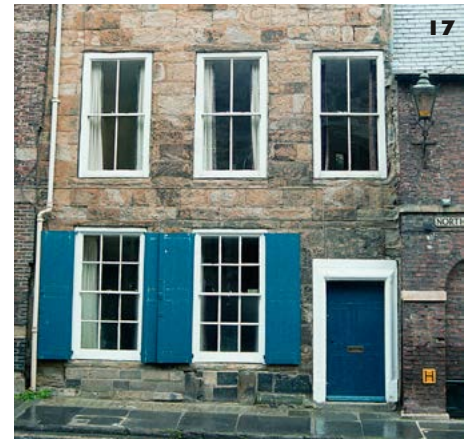
9–17: Surviving historic fenestration is an irreplaceable resource which should be conserved and repaired whenever possible.

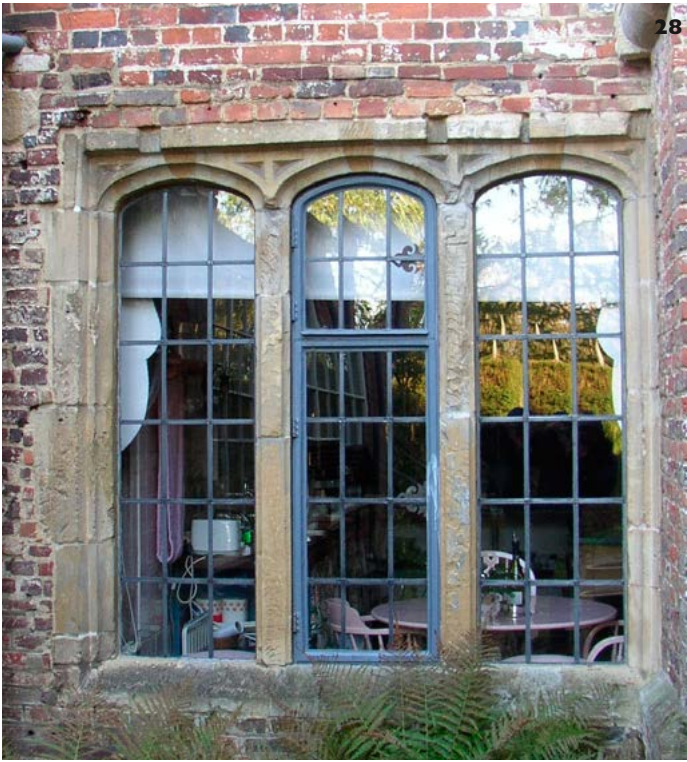
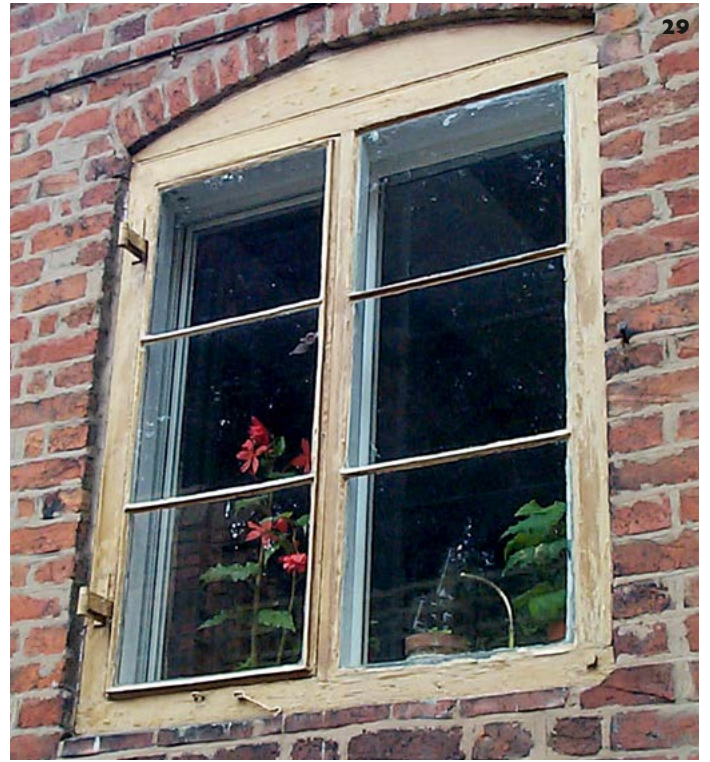
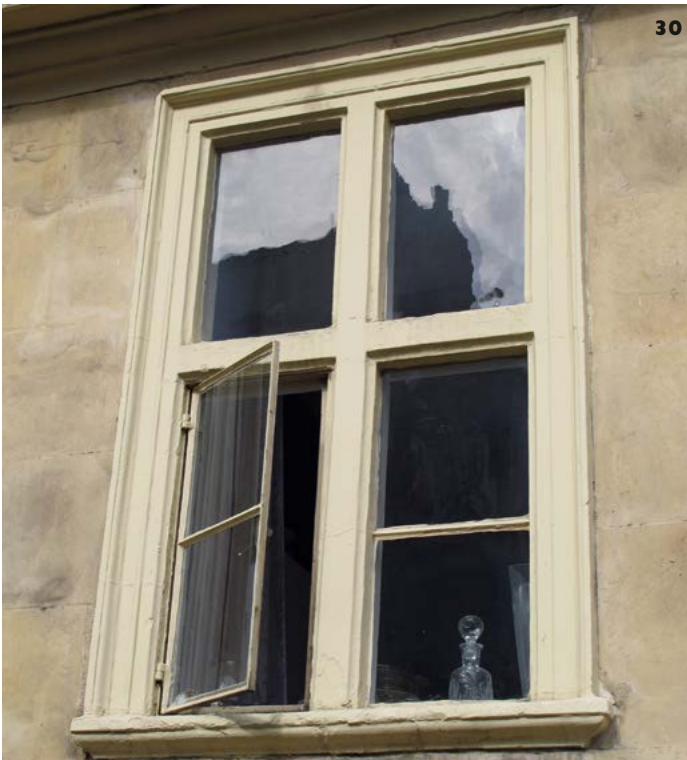
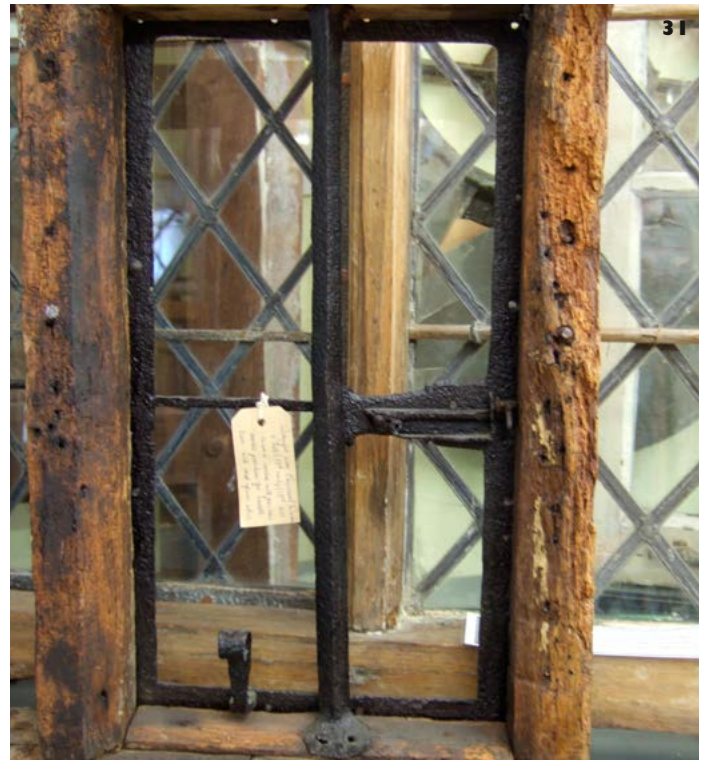
28: Leaded glazing set within stone mullions with a later steel casement to the central bay.

29: Late 17th or early 18th –century oak framed window with an opening side hung iron casement.

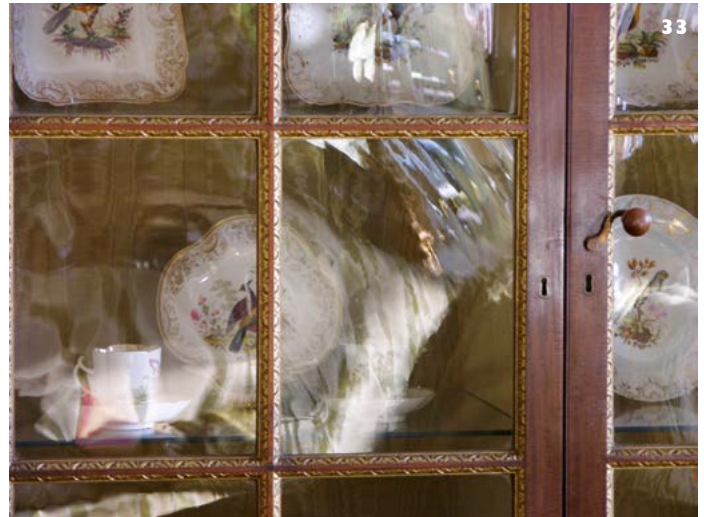
33: An example of crown glass which is now very rare but was widely used for windows until the mid 19th-century.

A method of producing sheet glass in which a bubble of molten glass is transferred onto a metal 'punty rod' or 'pontil rod' which can be spun between the hands of the glass-blower. The spinning causes the molten glass to blow open into a disc. The earliest known crown glass in England dates from the 1440s; crown glass was widely used for windows until the mid-19th century, when taxation by weight ceased and cylinder glass became cheaper. Crown glass has not been manufactured since the early 20th century.

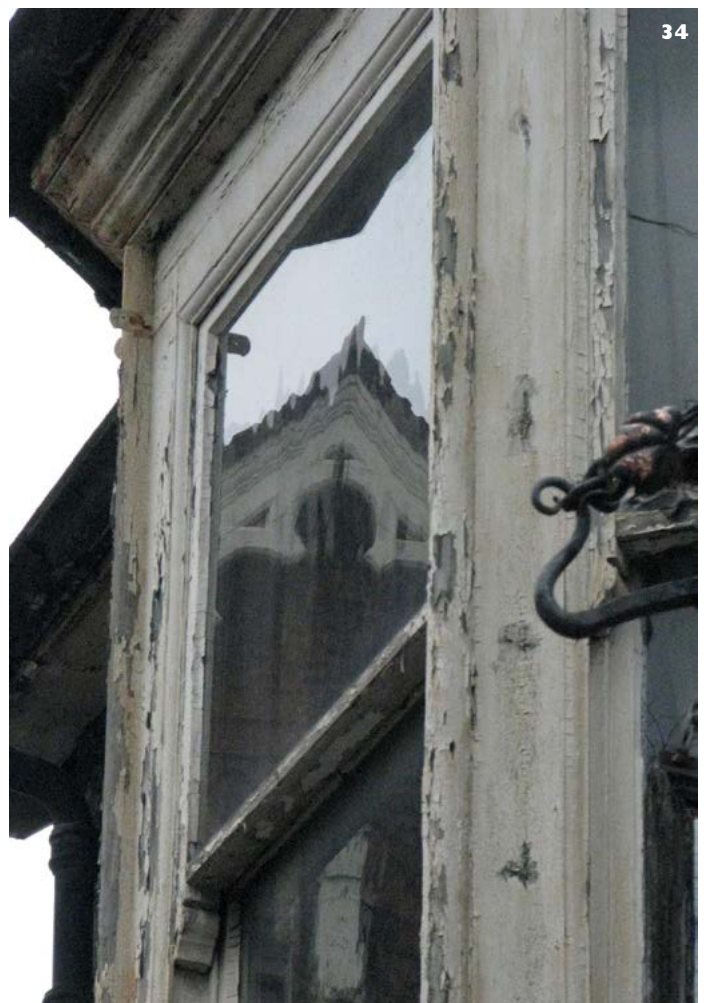
34: An example of drawn sheet glass which was produced from early in the 20th-century.

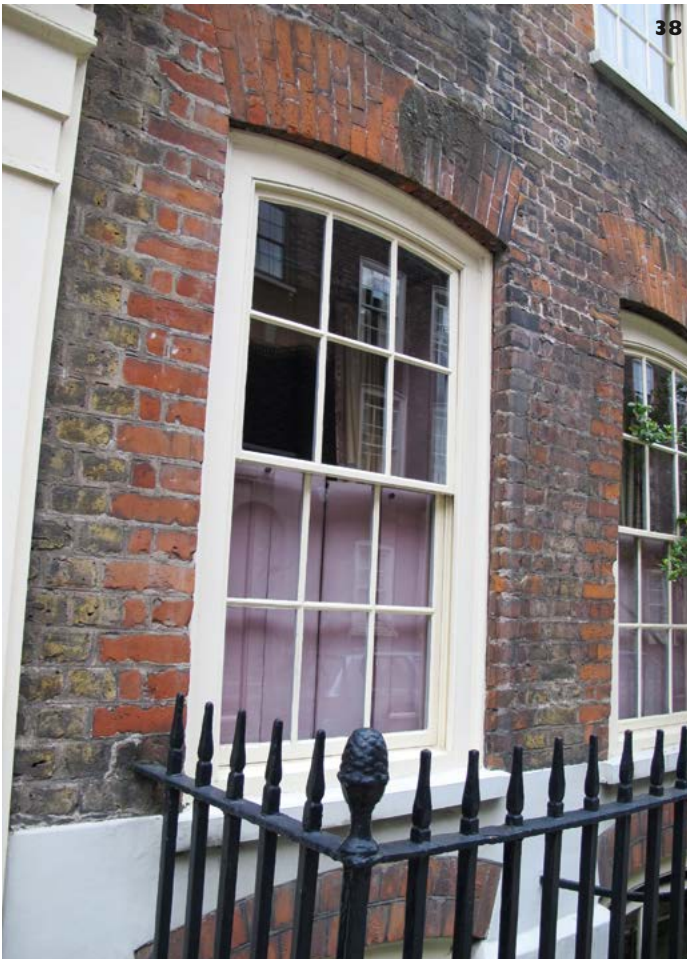
38: In the cities of London and Westminster, legislation came into force in 1709 which required window frames to be set back from behind the wall face.

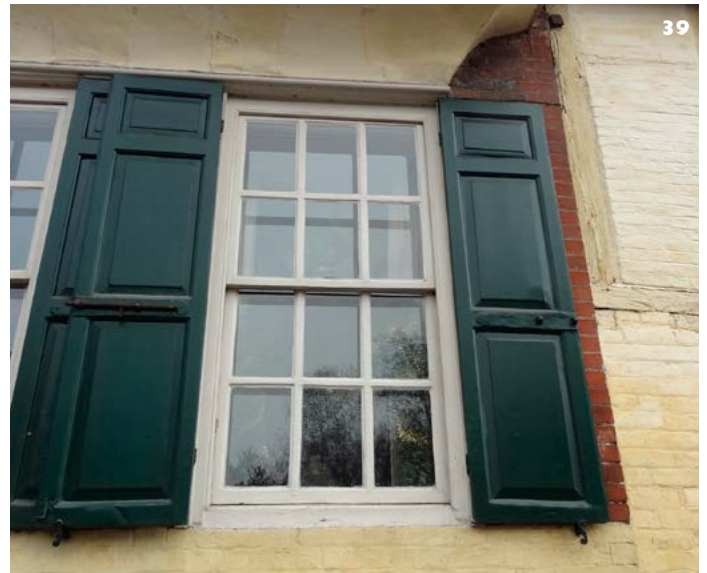
39: Late 17th to early 18th century glazing bars were considerably thicker than later profiles.

Early glazing bars were thick and robust, usually made of native oak or a similar hardwood. They were often almost 40mm thick to support and protect the fragile glass. However, the increasing use of oak for shipbuilding coincided with the growing availability of cheaper softwoods from Scotland, the Baltic states and Scandinavia. Most late 17th and early 18th-century glazing bars were based on the ovolo, or quarter-circle moulding and used 'deal', a generic term for pine or fir softwood. Crown glass was used for glazing; being lighter it lent itself to larger sashes. Thinner, finer glazing bars, with pointed (gothic) and lamb's tongue mouldings also became very popular. By 1820 some glazing bars were only 12mm wide (although, to provide lateral strength, they could be up to 38mm deep). Venetian windows which have round-headed windows as part of the design are often found in the late 18th and early 19th centuries. These were partly a response to the window tax, a property tax based on the number of windows in a house that was introduced at the end of the 17th century and eventually repealed in 1851. This often resulted in *trompe l'oeil* fake painted sashes or plain masonry recesses where windows had been blocked up. However, not all blocked windows can be attributed to the window tax.

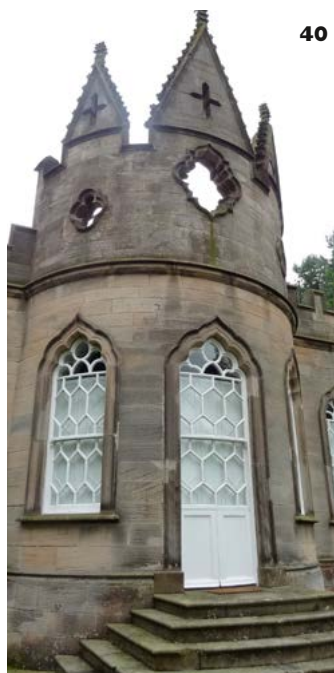
42: Bow windows are curved rather than polygonal in plan.

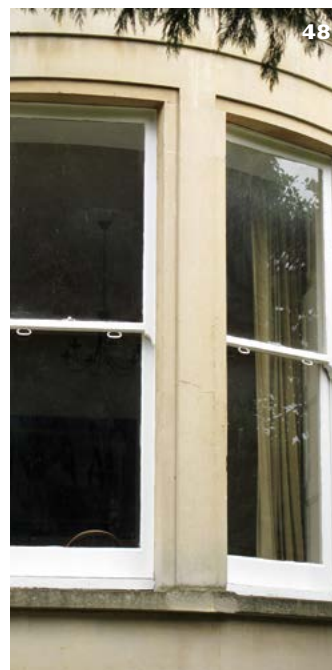
48

47 & 48: In the late 19th-century vertically sliding sash windows began to make use of larger and heavier panes of glass. The weight of the glass, coupled with the disappearance of the glazing bars that had given support to the horizontal meeting rails, led to the development of 'horns' which strengthened the joint between the meeting rail and the stiles.

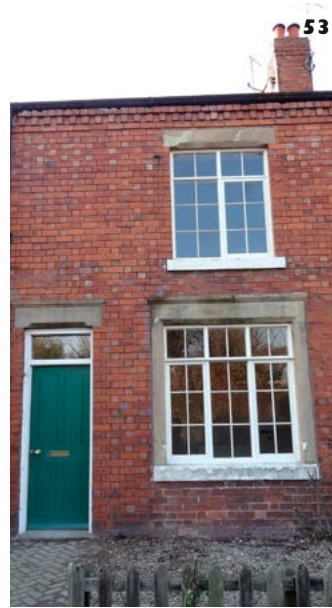
53

52-53: Small pane cottage windows became popular towards the end of the 19th century for model workers housing as shown here at Port Sunlight and New Bolsover.

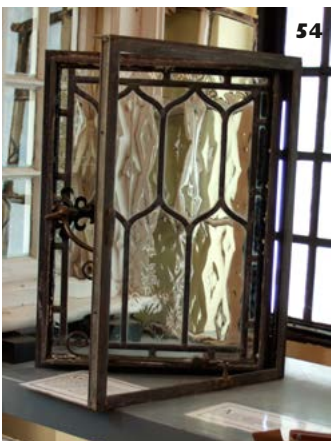
54

54: Early 20th-century Crittal window dating from 1904 (from the Brooking Collection).

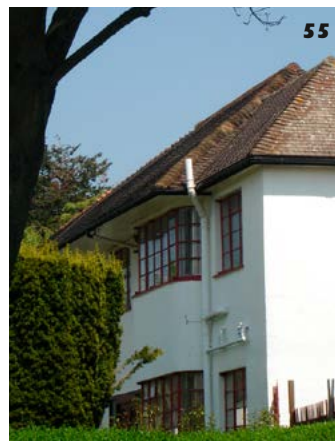
55

55: Steel windows became a feature of inter-war suburbia.

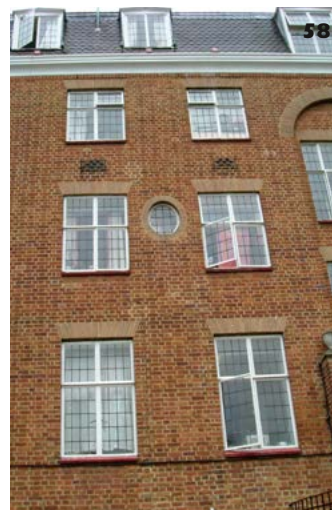
58

58: Steel windows combined with leaded lights in a block of 1930s flats.

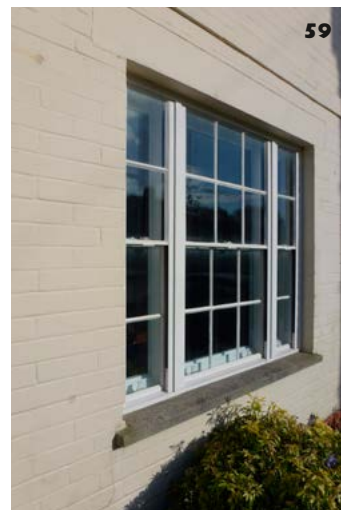
59

59: A rare three light steel sliding sash window dating from the early 1950s.

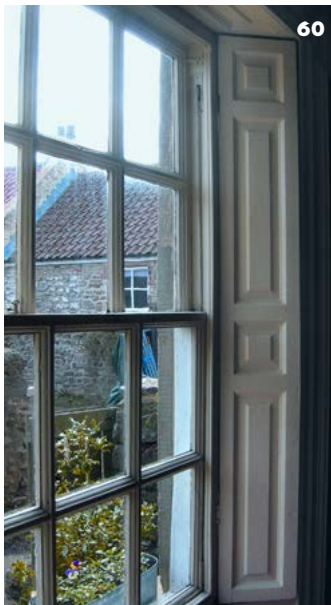
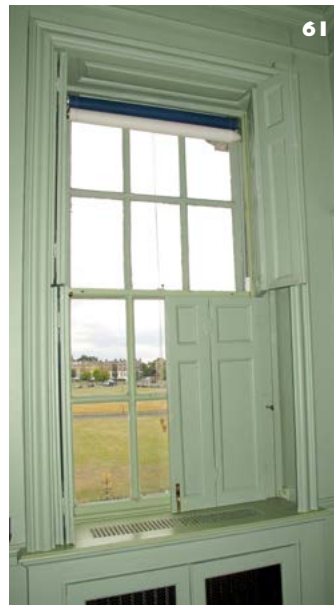
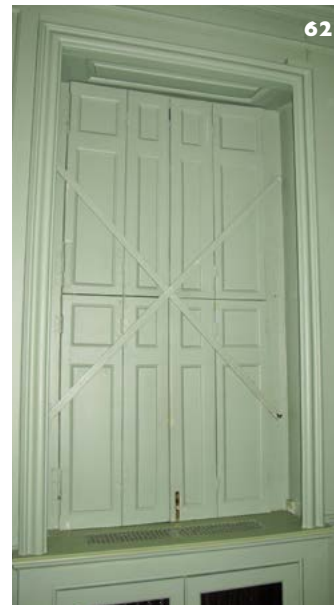
60–62: Double hung sash windows with internal shutters which fold into recesses on each side of the window. When fully closed the shutters are secured tightly with iron shutter bars.

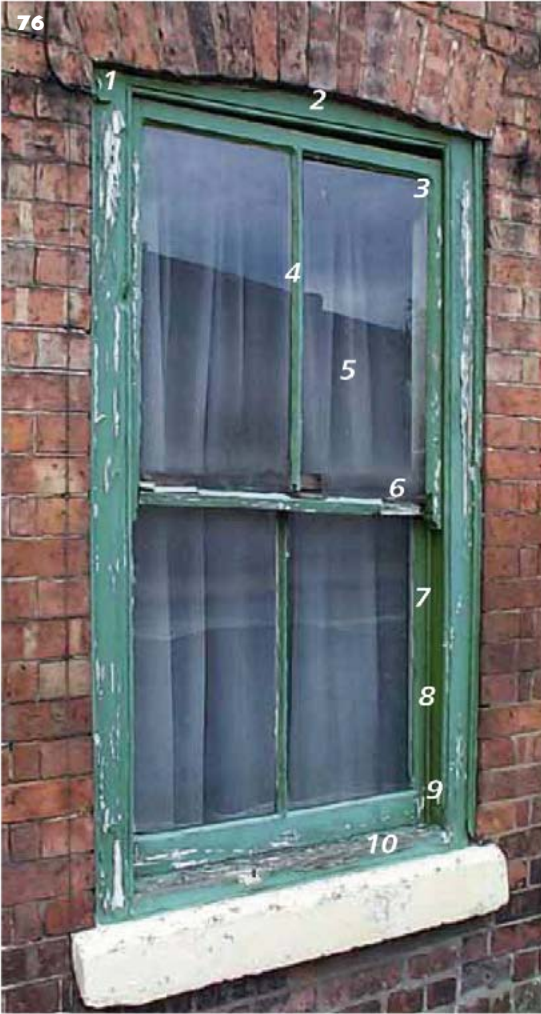
76: Some of the problems to look out for when inspecting older windows.

1. Holes drilled in frame for cable entry may admit water and cause decay
2. Deformation of window caused by structural movement in wall; sashes no longer fit or slide properly
3. Broken sash cords
4. Breakdown of paint and putty caused by lack of regular maintenance; this allows water to penetrate and become trapped, causing decay
5. Glass displaced or broken due to deformation of sash
6. Failure of joints, caused by timber decay due to water penetration
7. Opening parts of window jammed due to accumulation of paint
8. Worn or damaged beads, causing rattles and draughts
9. Decay of stile (or jamb) and outer lining at junction with sill due to water penetration
10. Decay of sill caused by water penetration after breakdown of paint. Water may also creep into the joint between the timber sill and the masonry sub-sill

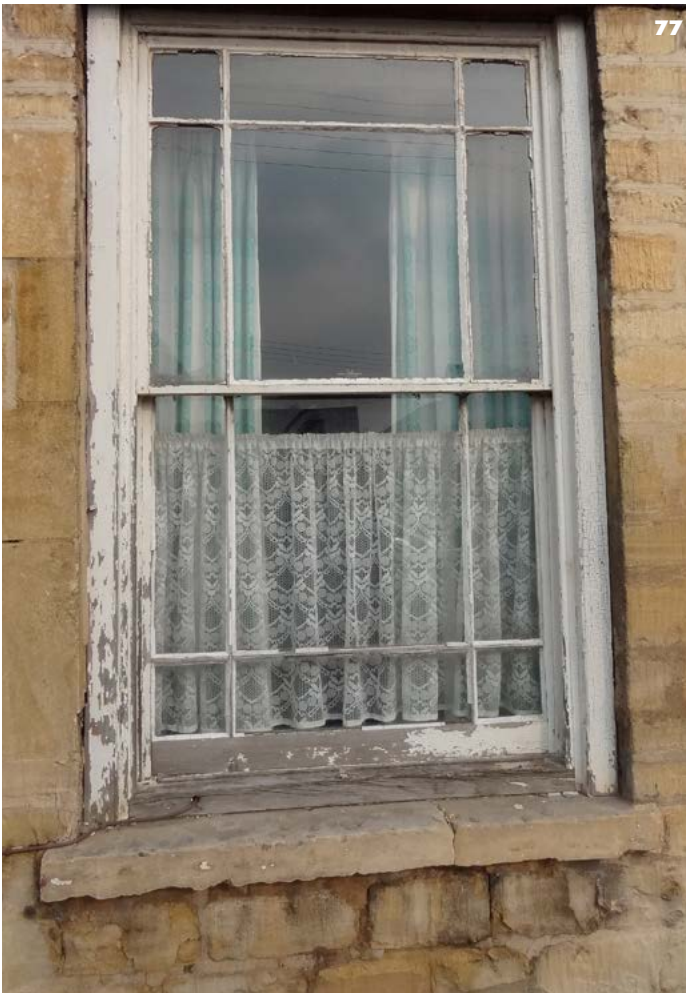
77

77: A double hung sash window lacking maintenance but still easily capable of being overhauled.

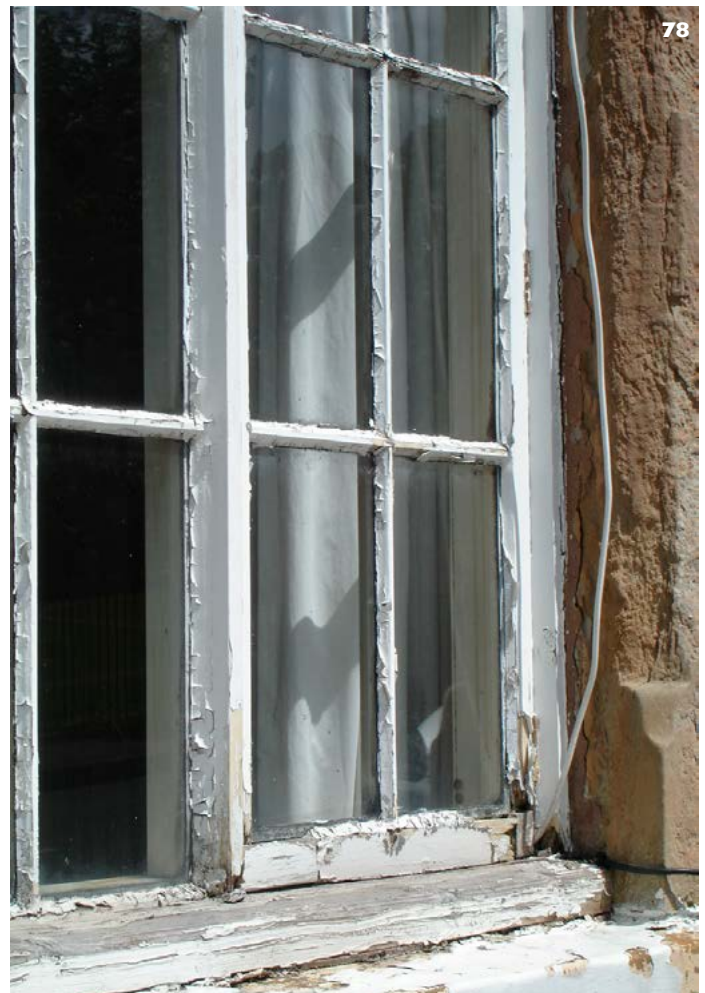
78

78: Lack of maintenance has resulted in lost putties to glazing and rot at the base of the window frames all capable of repair: Cables fed through the base of the frame have allowed water to enter and contribute to the rot.

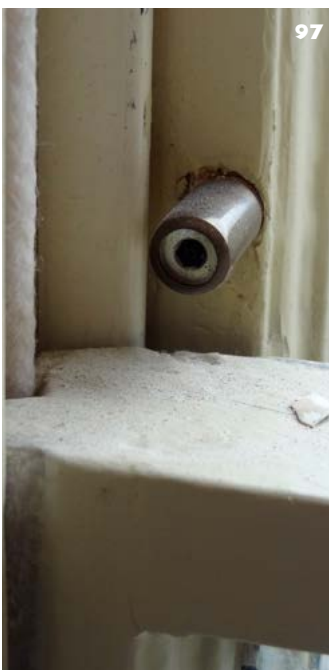
97: Height restrainers allow a degree of ventilation without compromising security.

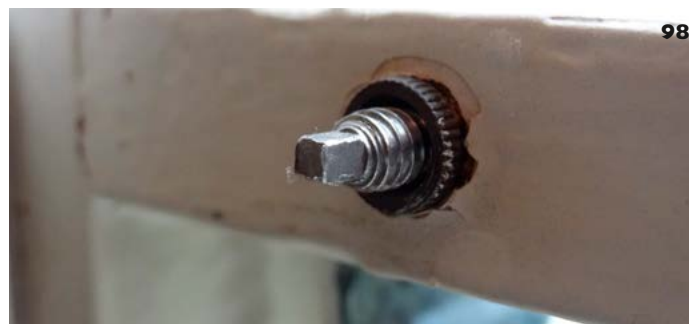
98: Bolts inserted into the meeting rails of a sash window keep the two sashes firmly locked in place.

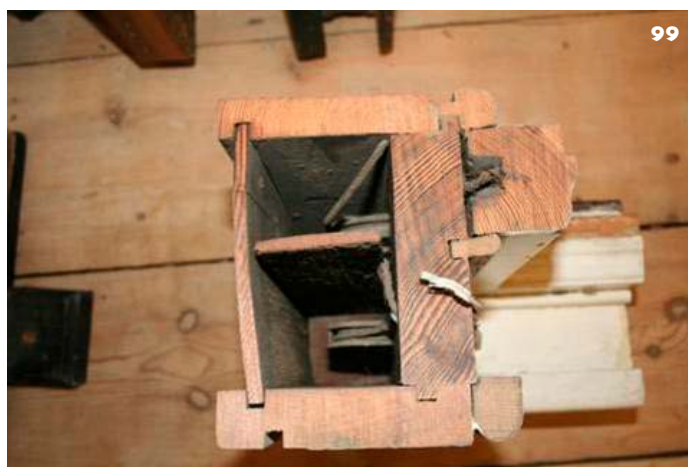
99: This section through a sash box shows the high quality of the timber used during the 19th century.

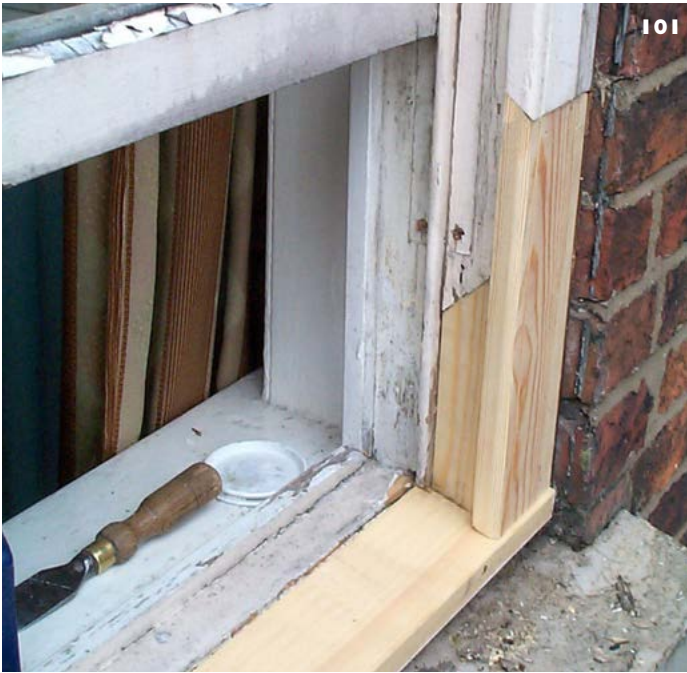
101

101: Decayed timber at the base of the pulley stile, the outer lining and the exterior of the cill has been cut out and new timber inserts have been pieced in.

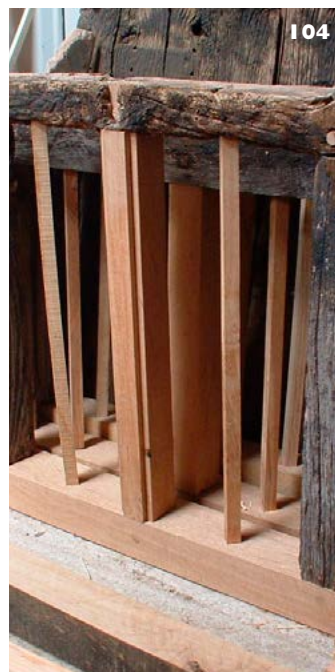
104

104: An example of skilled joinery repair in the workshop where the central mullion and cill have been replaced.

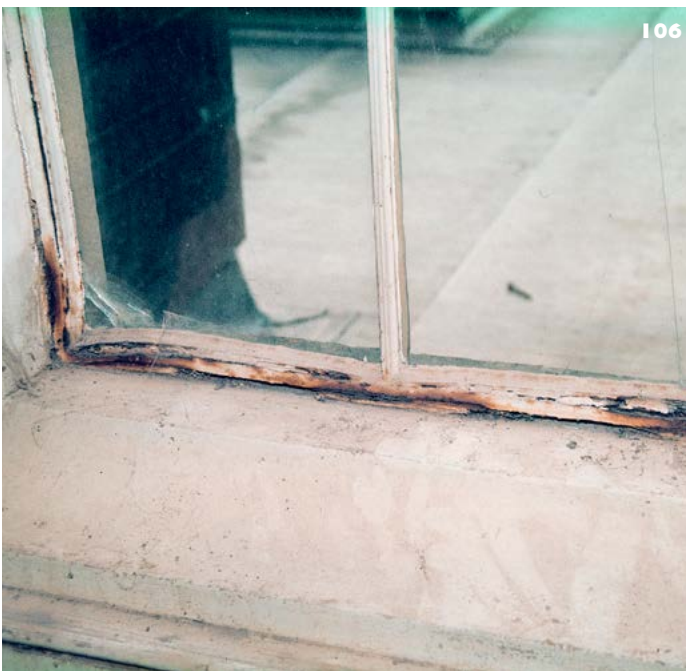
106: Steel window showing severe corrosion to the bottom rail of the frame and distortion from 'rust jacking' which has cracked the glass.

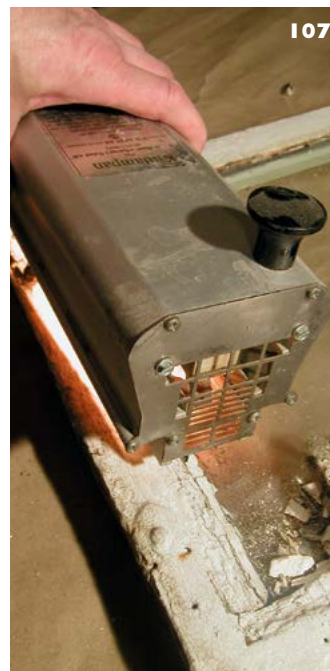
107: A putty lamp should be used where old putty needs to be renewed as this reduces the risk of cracking the glass.

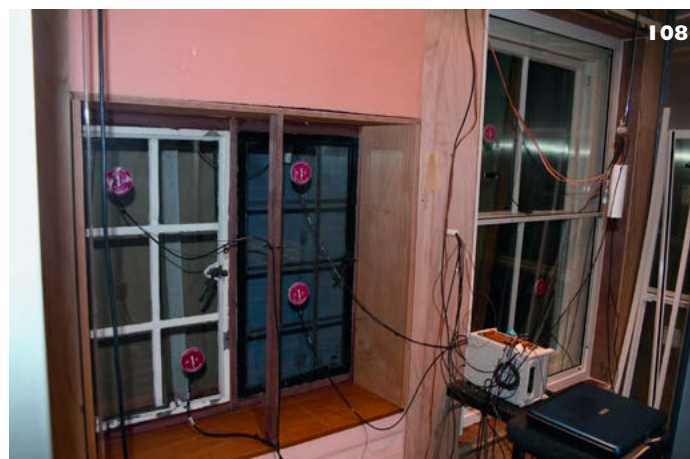
108 & 109: Testing windows in the climate chamber at Glasgow Caledonian University.

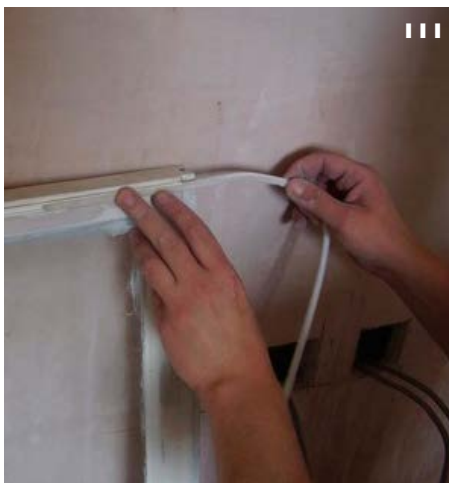
111: Nylon brushes being inserted into the sash as draught-proofing.

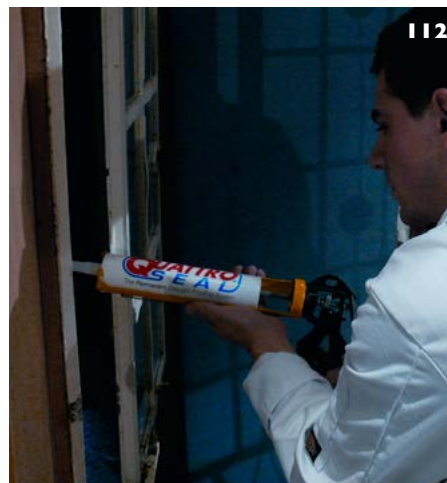
112: Silicone being injected into gaps between the frame and casement to exclude draughts. The casement is first painted with a releasing agent. The silicone is then left to cure with any excess trimmed back.

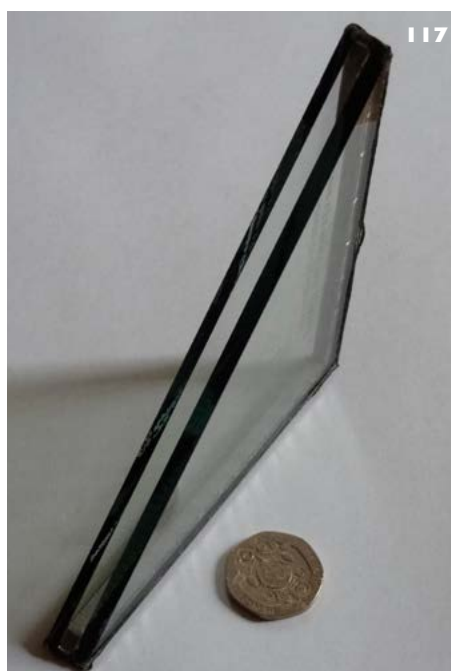
117: This slim profile IGU comprises 3mm outer glazing a 3mm gas filled cavity and 4mm Low-E inner glazing giving a total thickness of 10mm.

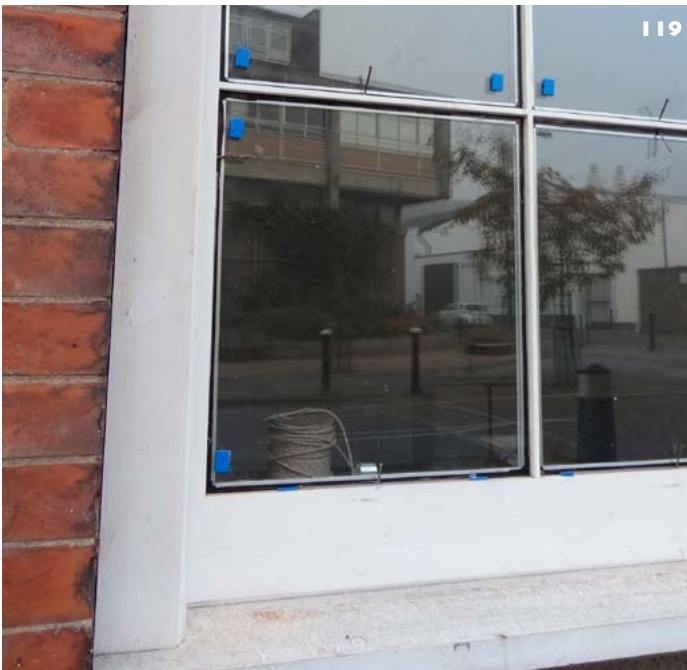
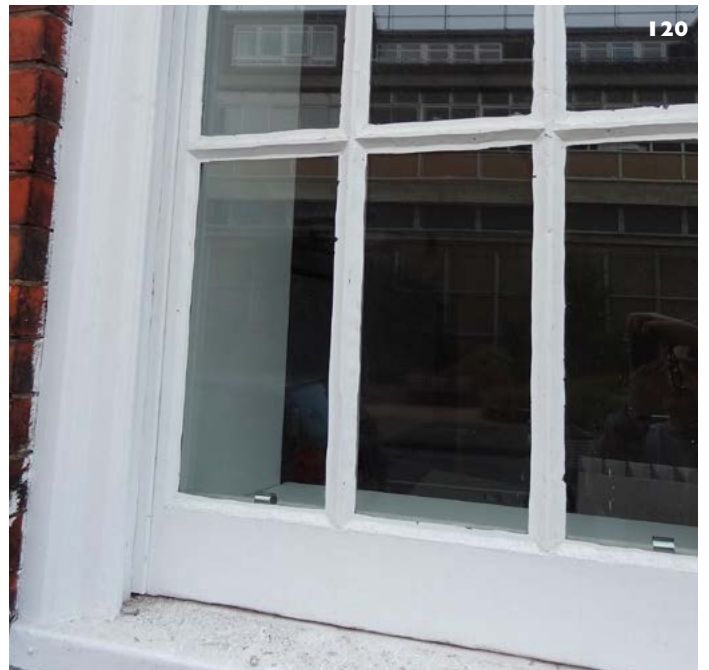
121–122: All the double hung sash windows to this Victorian tenement were completely renewed with replica sash windows incorporating IGUs. The timber glazing bars have been applied onto the IGU. Although the workmanship is of a good standard the overall appearance is rather flat and lifeless.

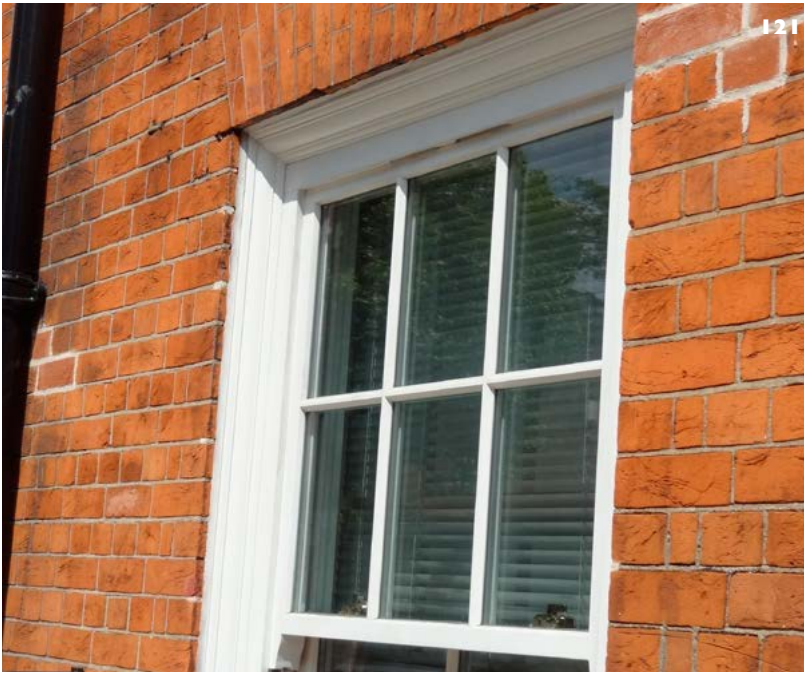
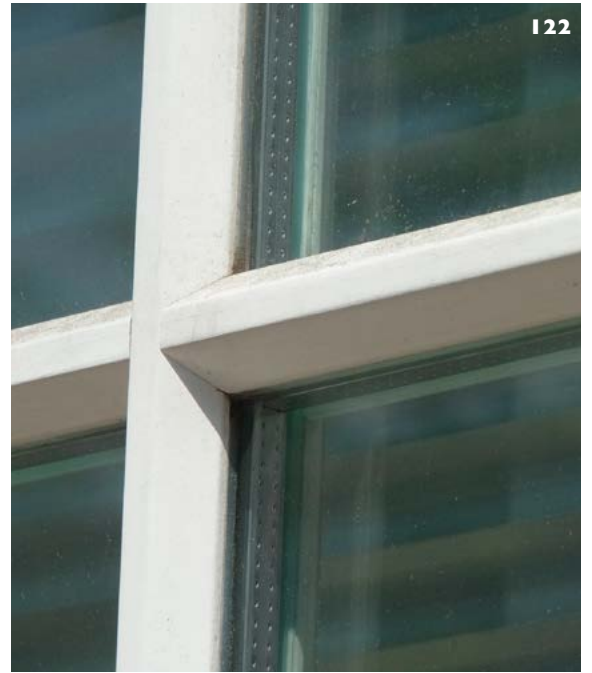
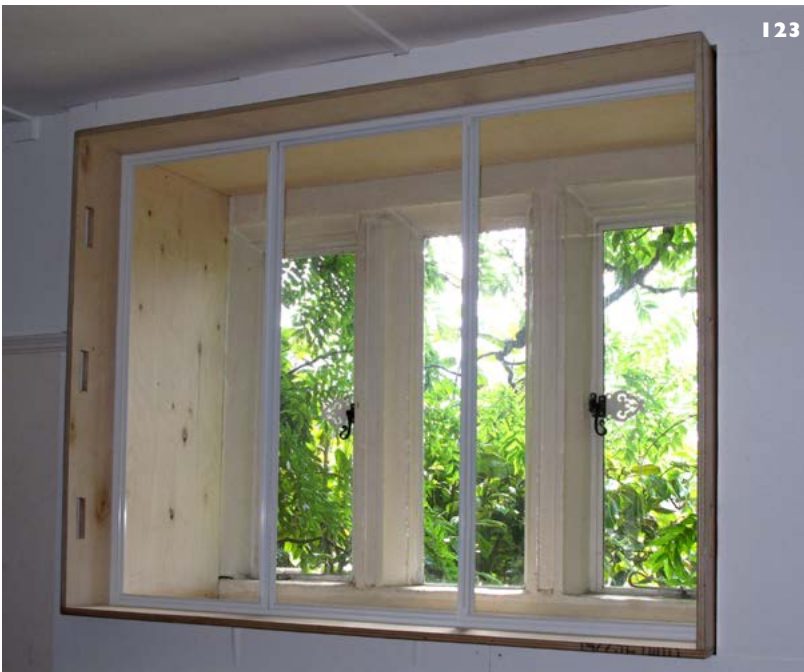
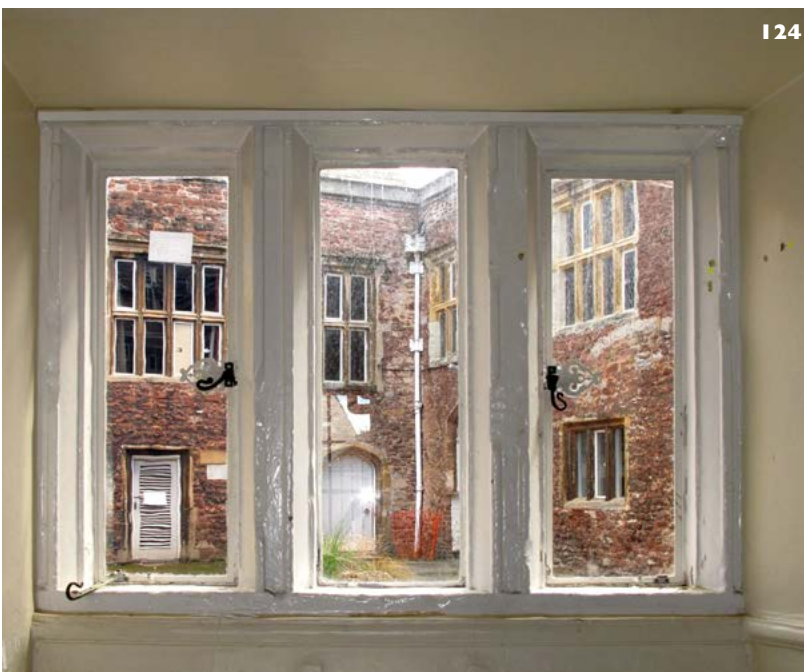
123–124: Following a mock up of secondary glazing units these steel windows were fitted with slim IGUs as this solution had less impact on the significance of the window. There was no historic glass and the steel sections were able to accommodate the thickness of the IGUs.
