HISTORIC LANDMARK COMMISSION STAFF REPORT

534 N Wall Street Window Replacement Minor Alteration

PLNHLC2015-00168
Meeting Date: May 14, 2015

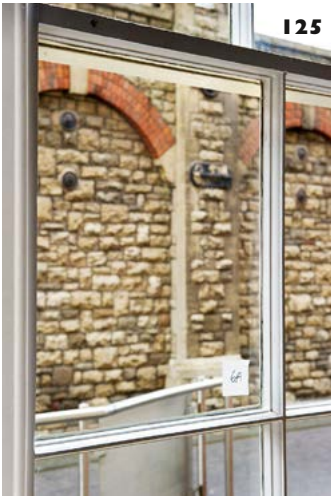
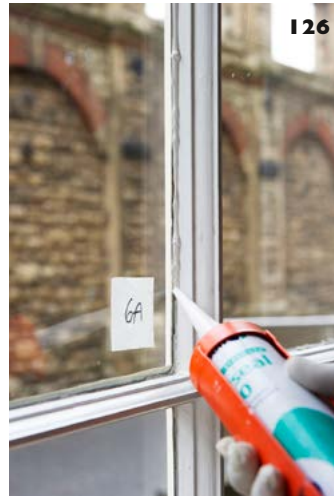
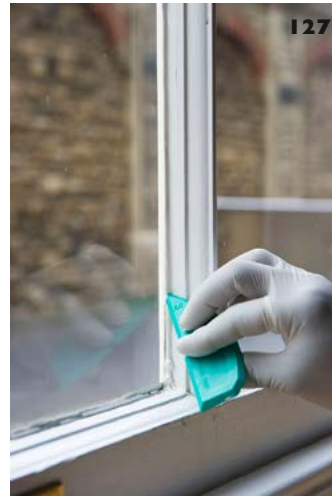
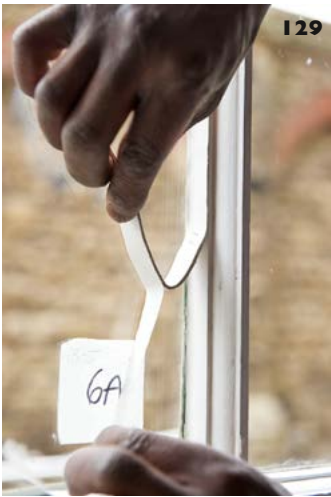
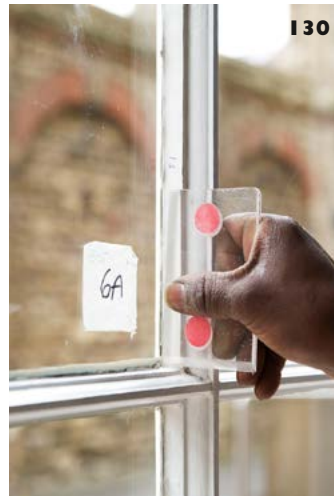
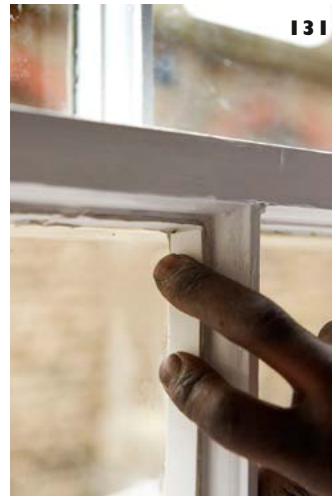
125–139: This sequence shows the addition of precision cut acrylic glazing to small paned windows. This allows the existing glazing to remain in place.

The edges need to be carefully sealed to prevent moisture entering the cavity. This is backed up with a specially developed dessicant material inserted in the cavity to prevent condensation.

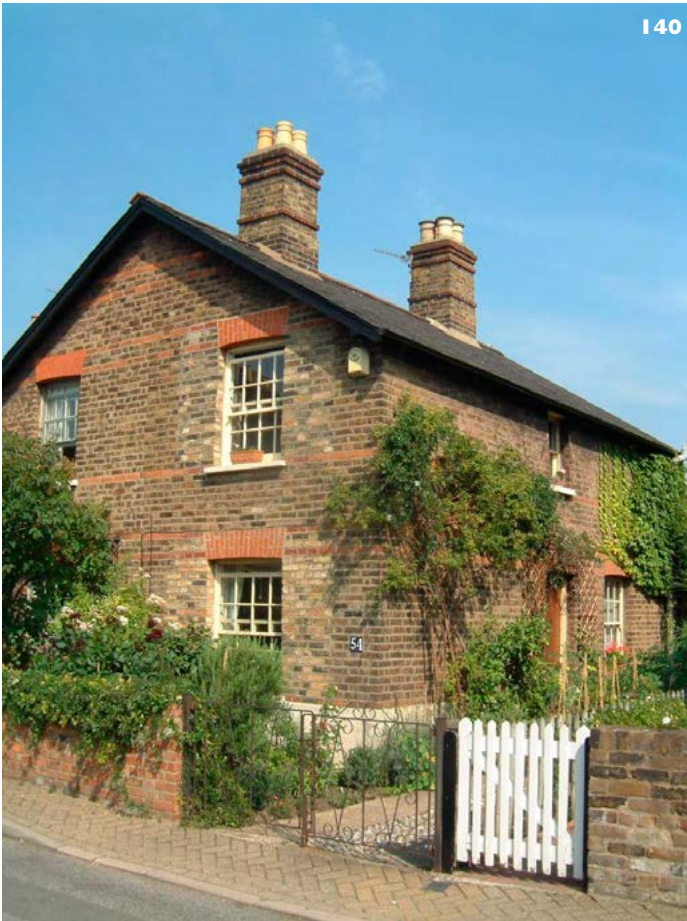
140

140: Windows of the original size and pattern have been reinstated in this south London conservation area which has involved reinstating the original masonry openings.
