Staff Report

To: Salt Lake City Historic Landmark Commission
From: Katia Pace
801 535-6354 or katia.pace@slcgov.com
Date: August 4, 2016
Re: PLNHLC2016-00569 Relocation of City Landmark Building – Hawk Cabin at 458 North 300 West
PLNHLC2016-00419 Major Alteration

MAJOR ALTERATIONS & RELOCATION OF A LANDMARK SITE

REQUEST: Relocate, Restore and Add to the Hawk Cabin at approximately 458 North 300 West -

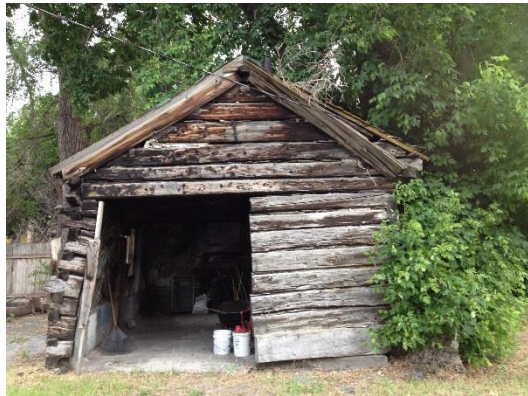
North Elevation

- A door is proposed for the north elevation where a garage door was cut. The proposal is for a pair of doors with three lights on each door. Additional wood that matches the original cabin will be necessary to cover the wall.
