Staff Report

Re:	PLNHLC2016-00250 – Park Street Window and Door Replacement
Date:	July 7, 2016
From:	Kelsey Lindquist 801-535-7930 or Kelsey.lindquist@slcgov.com
To:	Salt Lake City Historic Landmark Commission

MAJOR ALTERATION

PROPERTY ADDRESS: 764 South Park Street **PARCEL ID:** 16-07-203-019-0000 **HISTORIC DISTRICT:** Central City Local Historic District **ZONING DISTRICT:** SR-3 (Special Development Pattern Residential District) **MASTER PLAN:** Low Density Residential (1-15 dwelling units/acre)

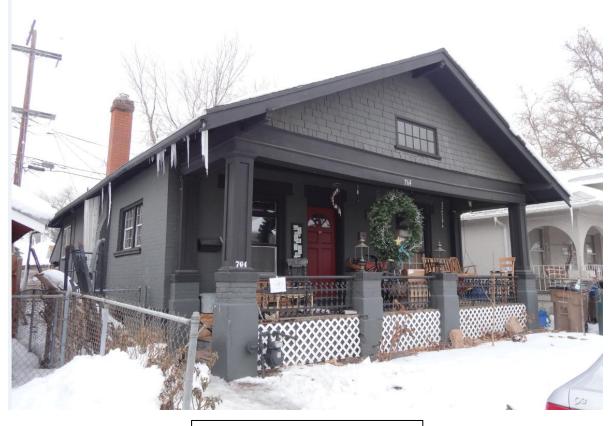
Subject property prior to modifications

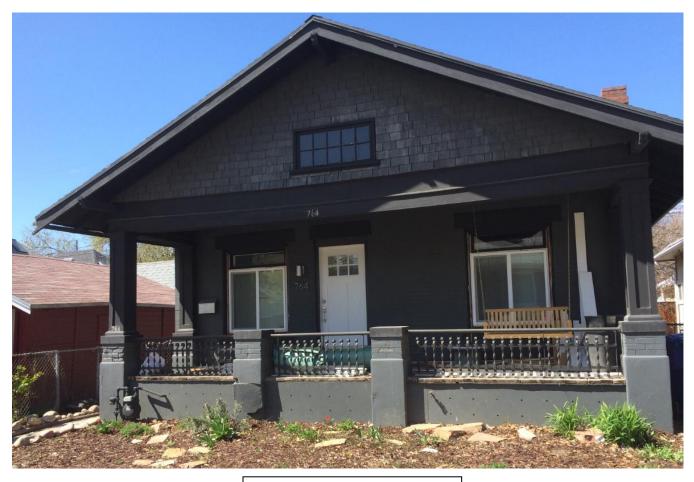
Subject property post modifications

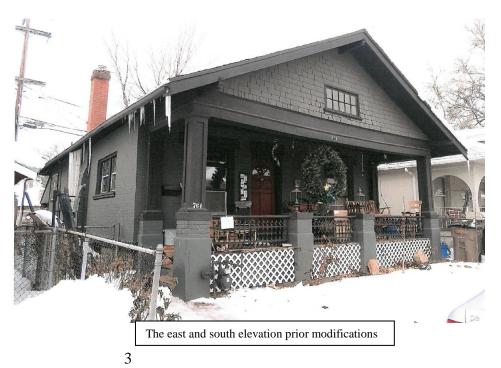
The two windows that were replaced on the front façade were previously a double or singlehung window, with a transom window above. Additionally, the windows appeared to have had aluminum screens installed on

the lower sash.

The windows were removed and replaced with vinyl sliding windows. It is difficult to know what the previous material was with certainty; however, the previous windows appear to be too thick in profile to have been comprised of aluminum. The image on page 3, illustrates the front façade windows prior to replacement and the additional image, illustrates the front façade windows post replacement.

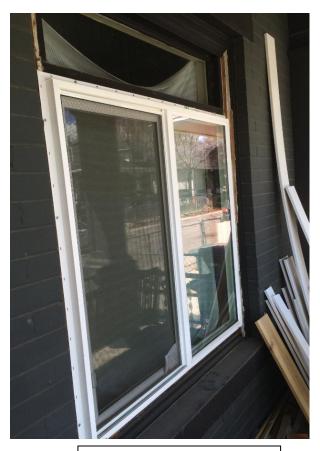
The transom windows remain above the newly installed vinyl sliding windows. The recently installed vinyl sliding windows do not recess from the front façade. The windows are installed in such a way that they protrude approximately 2-3 inches outward from the existing transom, which is illustrated in the image to the right. The windows, while they are currently untrimmed, were installed directly on the casing from the previous window. This diminishes the historic character of the structure and any dimensionality that it previously contained. Additionally, the recently installed windows are inappropriate as to window type and style. The applicant replaced the window towards the south to meet egress requirements. This window could have been replaced with a casement window, which would have been a more compatible window style.

Image illustrating the installation

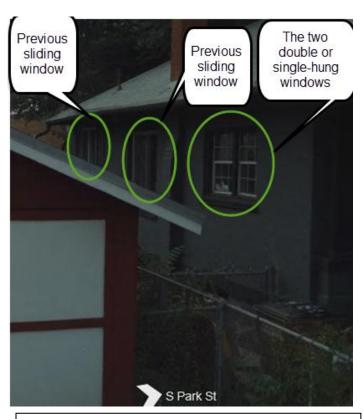
The previous windows on the south façade consisted of two double hung windows and two sliding windows, illustrated in the image below. The windows did not appear to be original to the structure. However, the openings were original to the structure. The image below on the right, illustrates the previous windows that were recently removed and the openings that have been modified.

The two windows towards the east were single or doublehung windows separated by a large mullion. The applicant removed the two double-hung windows and the mullion and installed one single picture window, see the image below on the right. The recently installed picture window does not fit the opening. There is approximately 2-3 inches below the window that has been filled with wood, the image below illustrates the space between the window opening and the vinyl sliding window.

Image illustrating the previous windows on the south facade

The two windows towards the rear do appear to have been aluminum sliding windows. While the windows were not historic, the sizes of the openings were original to the property. The second picture window on the south façade does not fit the opening. There is substantial space beneath the recently installed window and sill. The space is filled with plywood.

The applicant explained that he removed the previous sliding window and installed a significantly smaller window to accommodate the kitchen cabinet height in the interior, see Attachment B. The window size is approximately 9 inches shorter than the original opening. The space measuring 9 inches below the recently installed window has been filled in with plywood, which is illustrated in the image below on the right. The window towards the west on the addition appears to be appropriately sized; however, it is not an inappropriate style for a readily visible facade.

The middle window on the south façade was also replaced with a vinyl sliding window. This window size was also modified to accommodate a cabinet height on the interior. This installation also protrudes from the façade. This window is inappropriate in size, design, materiality and placement.
		The window opening on the north façade was also modified to fit a new replacement window. This window replacement is inappropriate in regards to size.
	Compliant	Window on the West Facade As stated earlier, the locations that are conducive for vinyl replacement windows are located on the north and west facades. These two facades are not visible from the public way. The window on the West façade did not modify a historic opening and is appropriate in regards to material and style.
	Compliant	Front Door The recently installed front door did not replace a historic or original door. The door is compatible in regards to design, style and material.

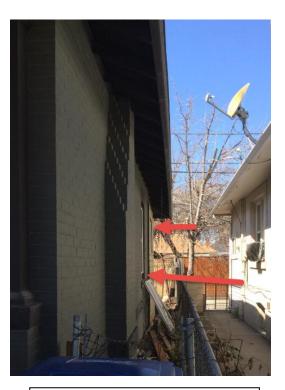
The windows located on the north façade were previously a singlehung window and a vinyl sliding window. The window located towards the east was replaced with a compatible style, but the opening was modified. The size of the window has been decreased with the replacement window. There is approximately 2-3 inches below the window. Even though this façade is not readily visible from the public way, modifying the historic window openings is not appropriate.

The window towards the west was replaced with a vinyl sliding window. This opening does not appear to have been modified. Vinyl windows are an appropriate material for facades that are not readily visible from the public way.

The north elevation post modifications

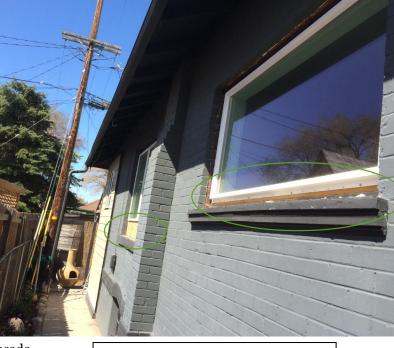
Image illustrating the size modifications

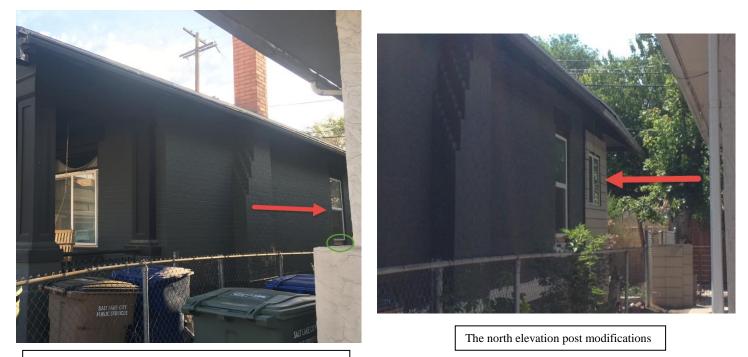
Image illustrating the size modifications on the north elevation

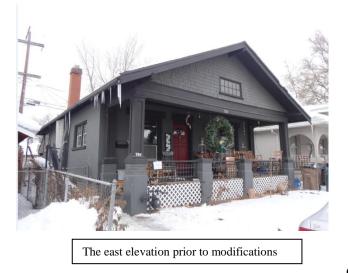
In addition to the window request, the applicant is requesting a certificate of appropriateness for the replacement of the front door. The door that the applicant removed was not original to the structure and the new door is an appropriate replacement. The original door, illustrated in attachment E, contained four sections of glazing and a distinct block pattern. While the replacement door does not match the original, it is similar in regards to style and design. The new door is composed of fiberglass.

The east elevation post modifications
