Memorandum

To: Historic Landmark Commission
From: Lex Traugher, Senior Planner
Date: January 7, 2016
Re: University Historic District Reconnaissance Level Survey (RLS) Update
Part 2

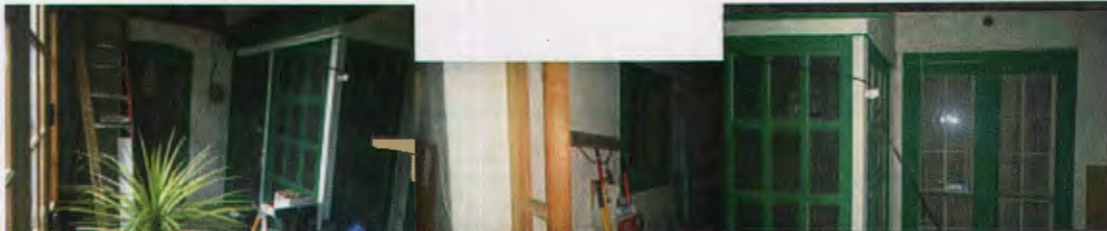
The current addition was built around the existing historic home and sits completely on its own secondary foundation. It could be completely removed leaving the 1884, 1892, 1909, 1915 & 1928 home intact. Original windows on the north side of the addition are visible through the new foundation by employing a shadow box around each one.

Rear views **inside** of the 2015 addition showing the 2015 addition is built around all versions of the home 1884, 1909, 1915 and 1929 left intact.

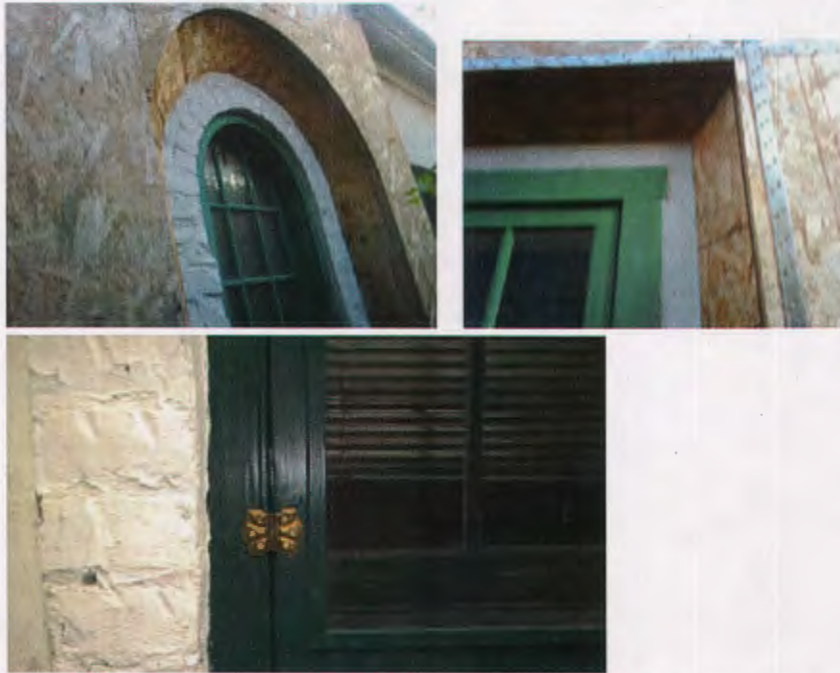
North side original windows during construction with shadow boxes built around them. Completed window once preserved.

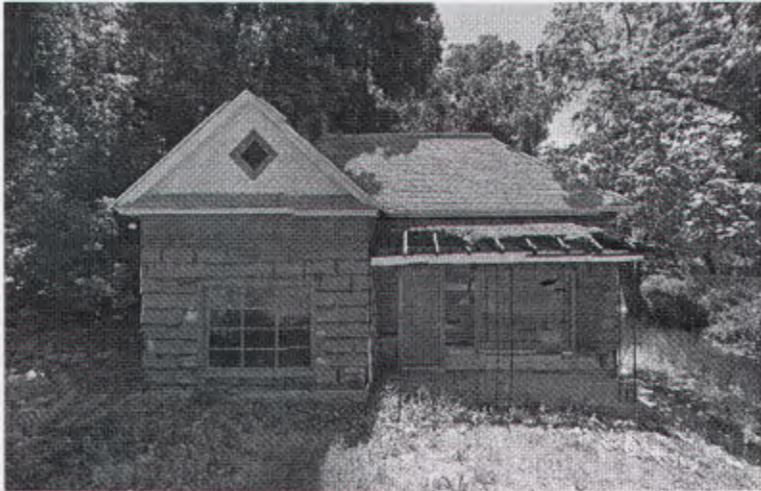
current condition of house

Per Salt Lake and County records, in 1972, major alterations were made to the structure. Windows were removed and replaced and in some cases the window openings were enlarged. The porch was removed and replaced, which architecturally represents circa 1970. Asbestos siding shingles were added/placed over the existing wood siding. And a second story was added, resulting in major structural alteration that has compromised the structure (see structural report).

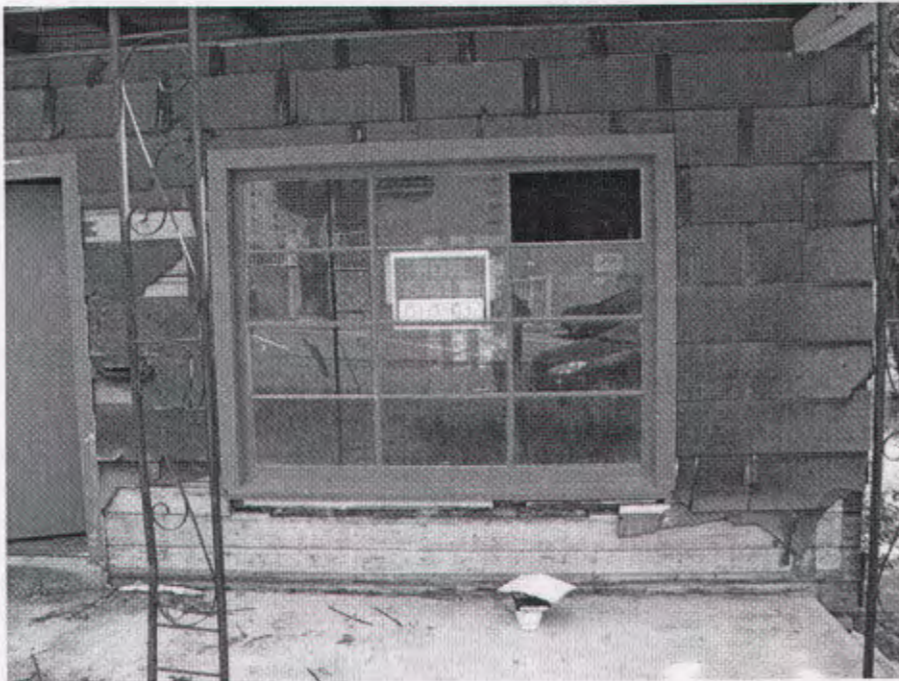
North Porch Window

- a. The north facing window has been removed, replaced and enlarged. New framing present.
- b. The front door with window and window transom has been removed and replaced with a flat slab door. New framing present.
- c. The porch itself has been removed and replaced. Current porch has been toenailed into siding.
- d. (4) Original square wood columns have been removed and replaced with (2) newer wrought iron assemblies.
- e. Column trim has been removed.
- f. All exterior window, door and cornice trim has been removed.

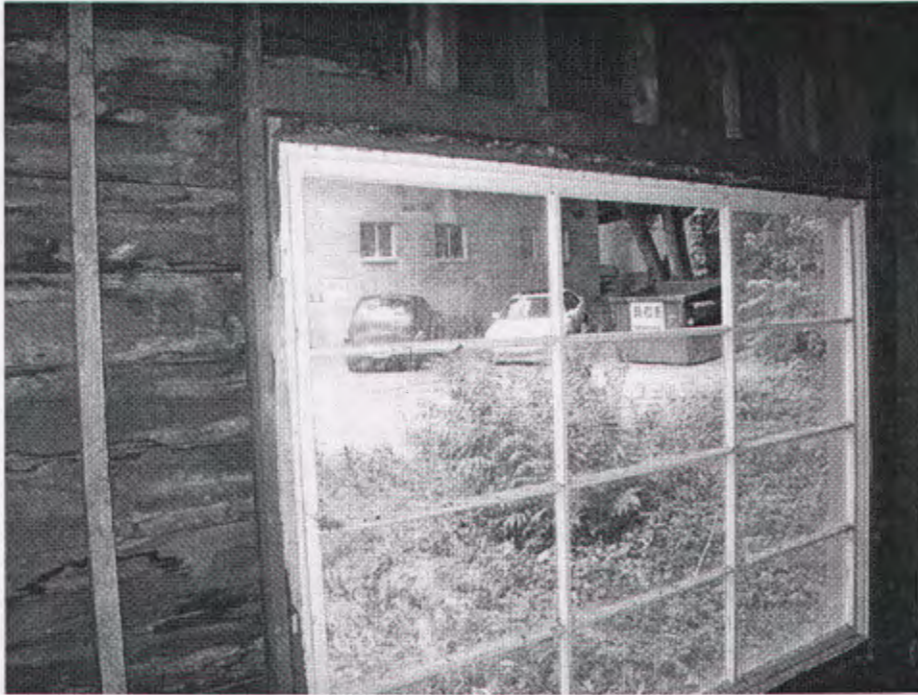
North Porch Window Interior

The north facing window has been replaced and enlarged. New framing present.

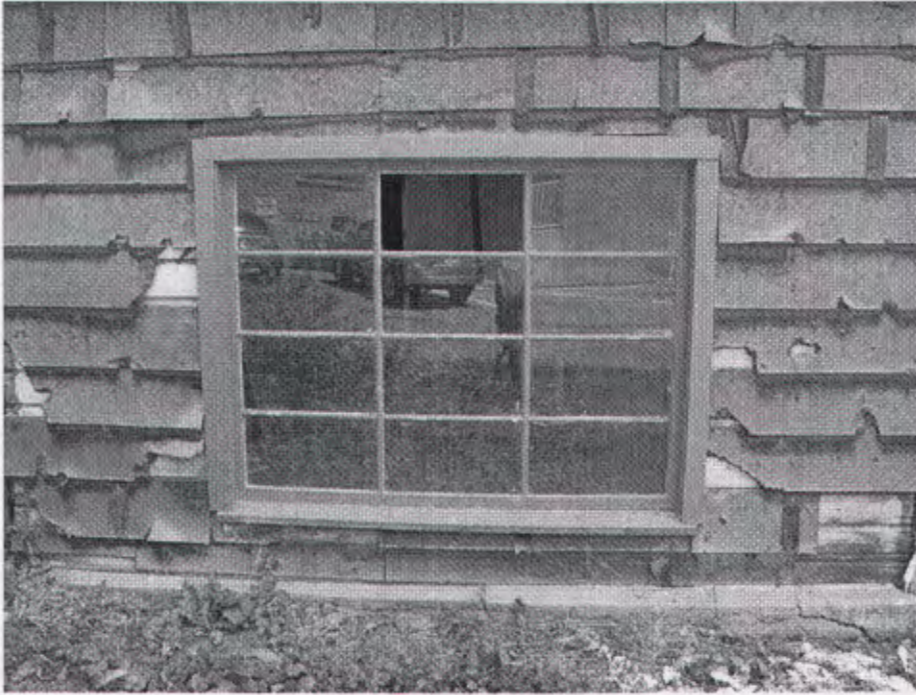
North front of home window.

North front window interior. Original front window with transom lite has been removed and replaced with larger, wider window. Trim removed and replaced.

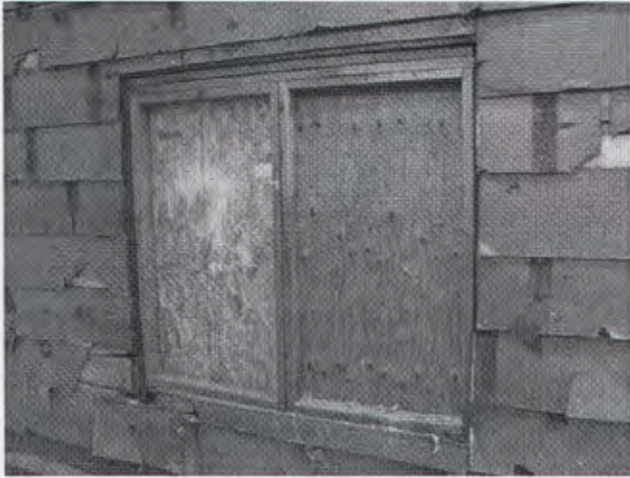
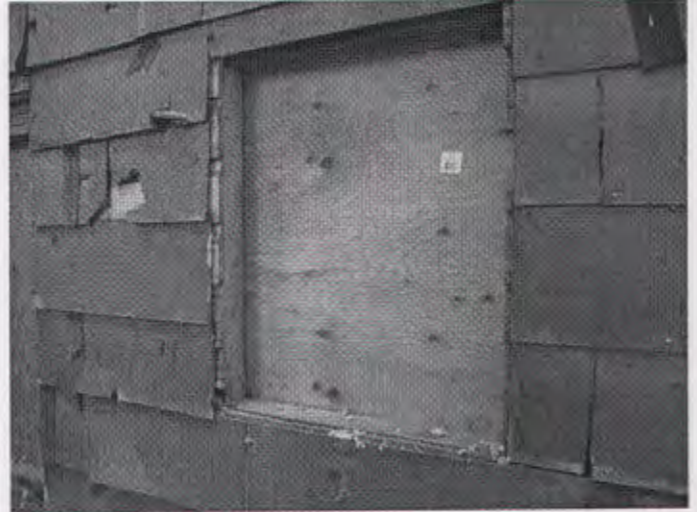
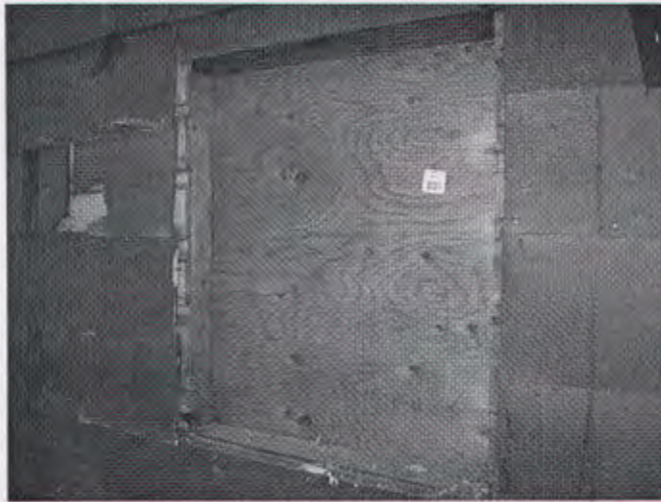
East Side of Home.

All windows been replaced and new openings cut into the exterior walls.
Newer framing evident in all windows.

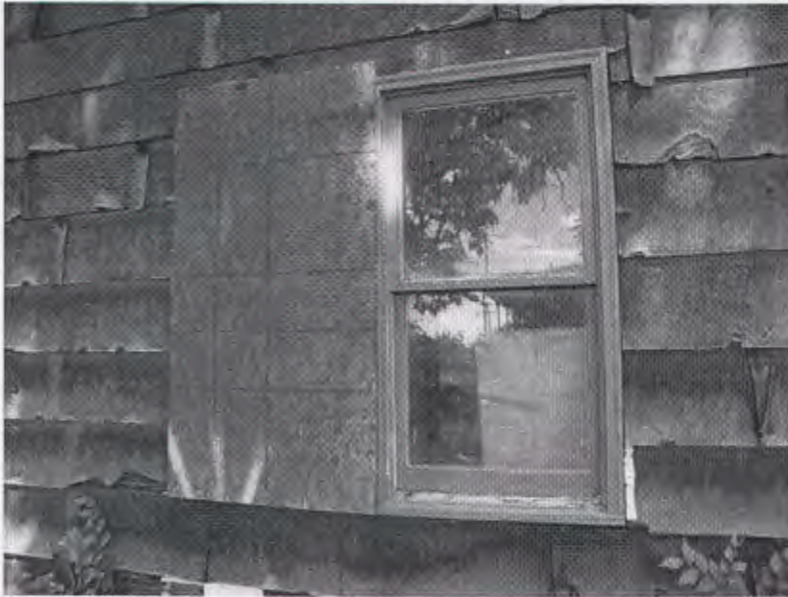
West side of home. North window has been expanded and replaced.

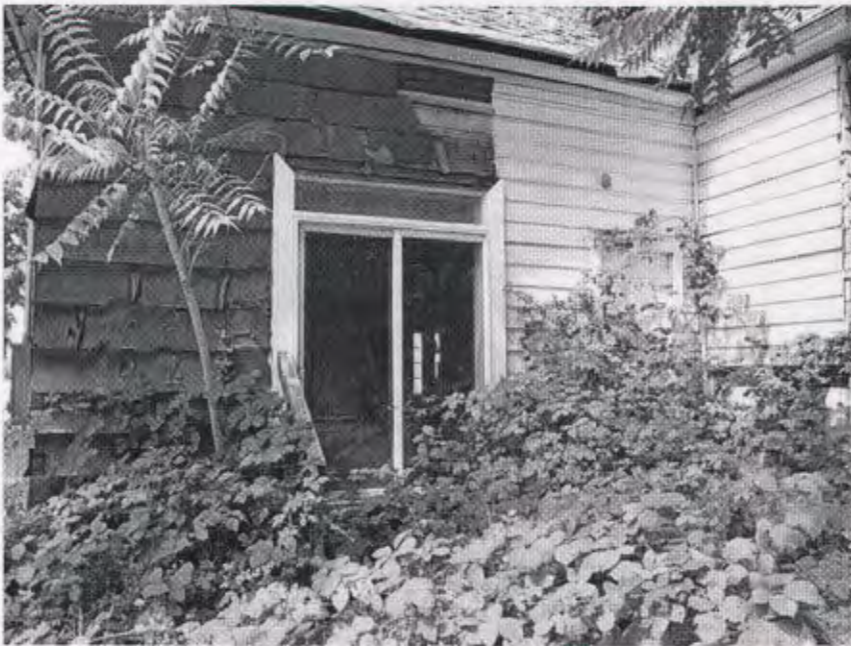
A vinyl slider has been installed. New framing evident.

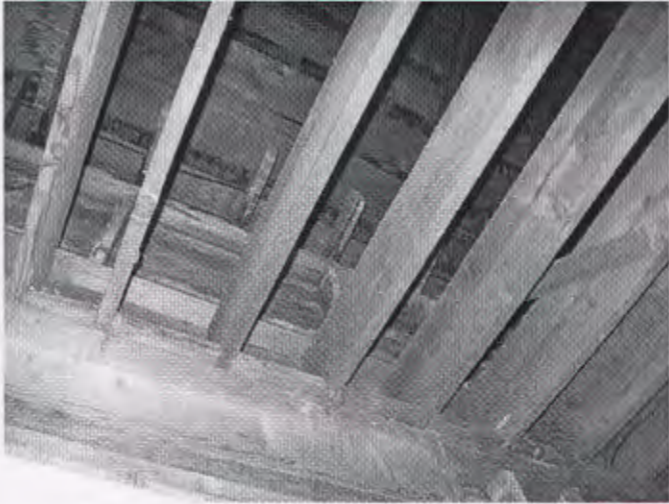
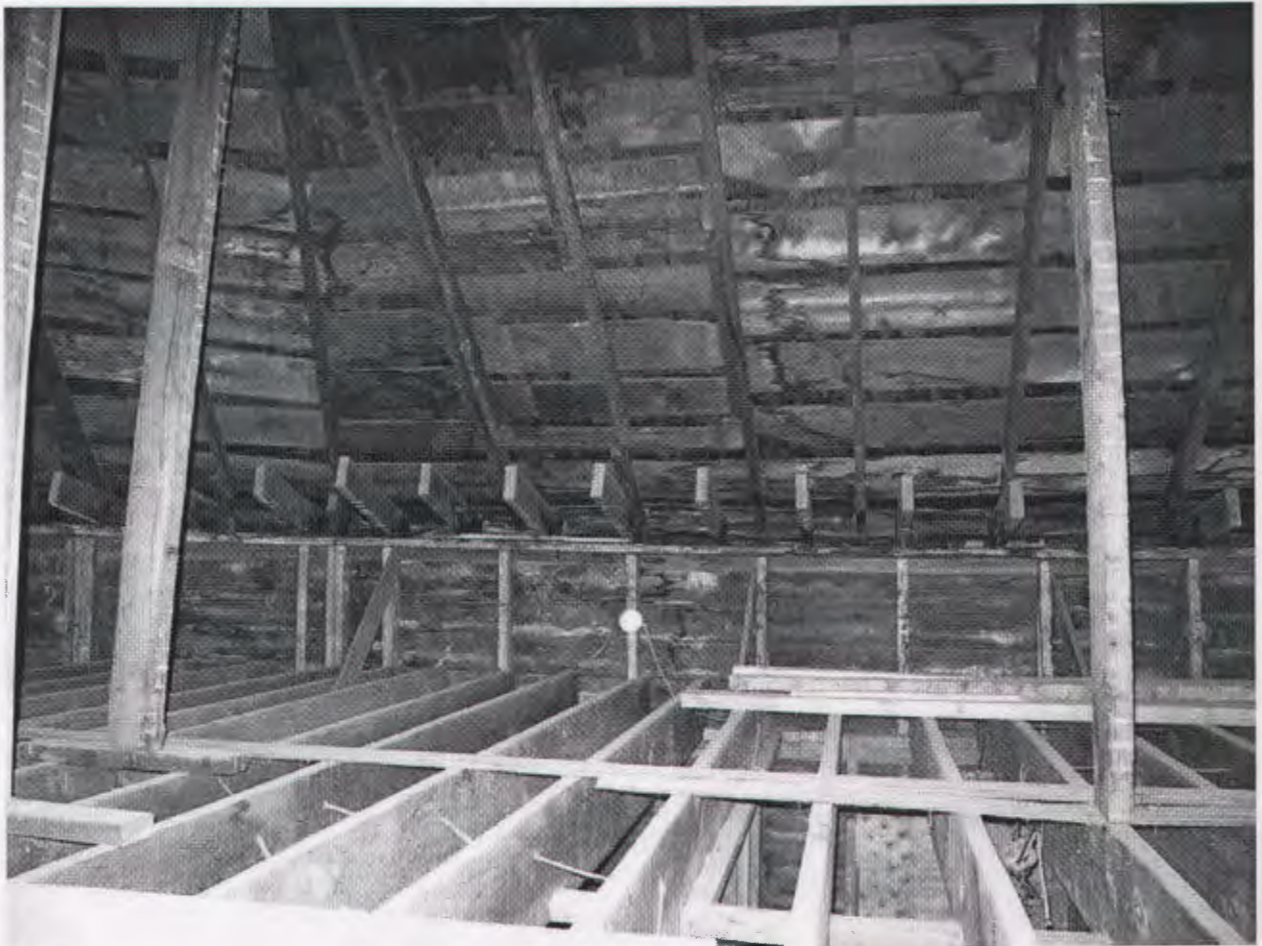
3. Much of the newer framing was not secured to the siding and is structurally unsound.
4. The lower cords of the roof assembly - the ceiling cords have been severed, resulting in the soffit and fascia dropping substantially. Most importantly this has resulted in a structurally unsafe building.

The lower roof cords have been cut, with the remaining pieces rising up as the roof settles.

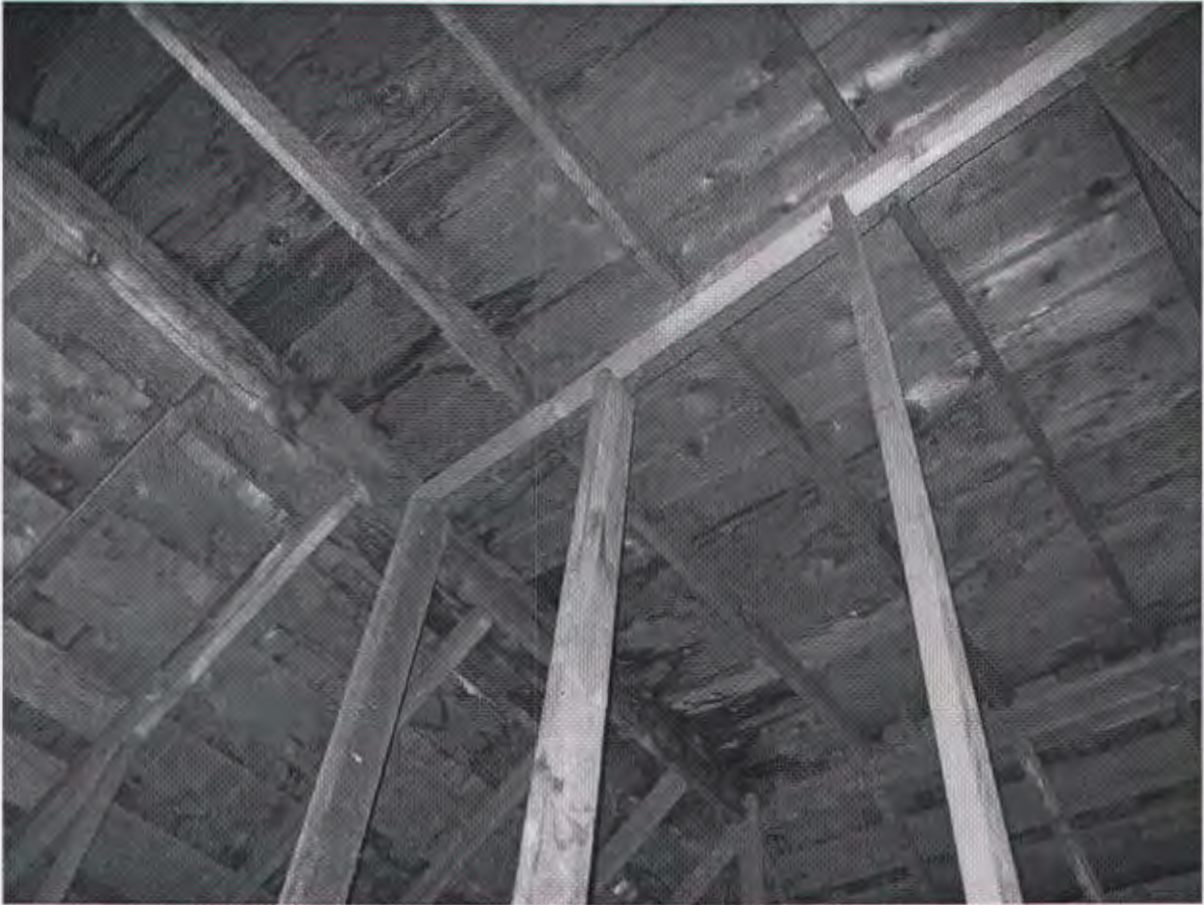
5. Currently the roof is being supported by a few vertical 2x4's due to the removal of the previously mentioned cords.
6. The NE corner of the home has framing members that appear to have been broken by a large rock that rolled down the abutting hill.

These 2x4's are the primary means of support for the roof structure.

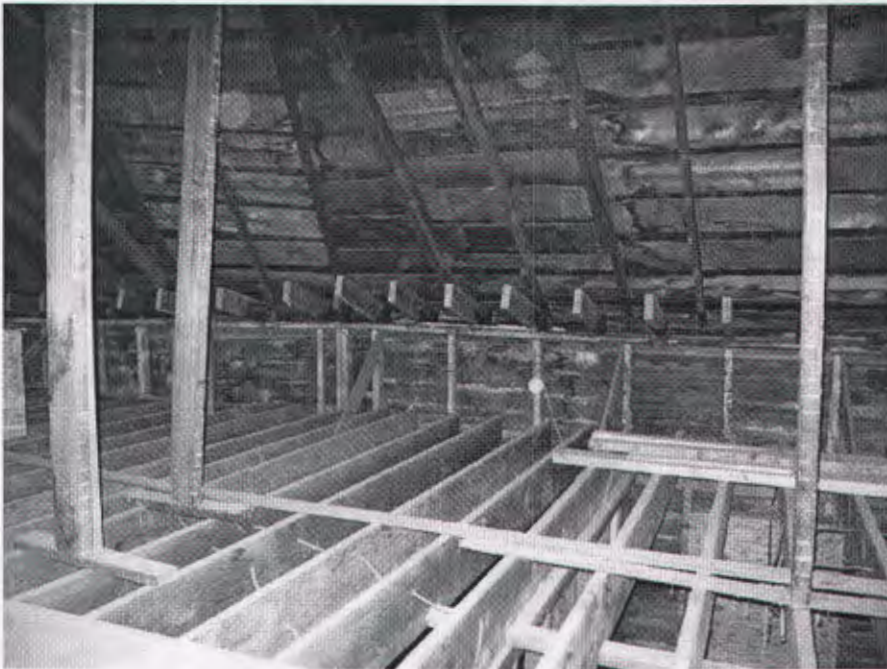
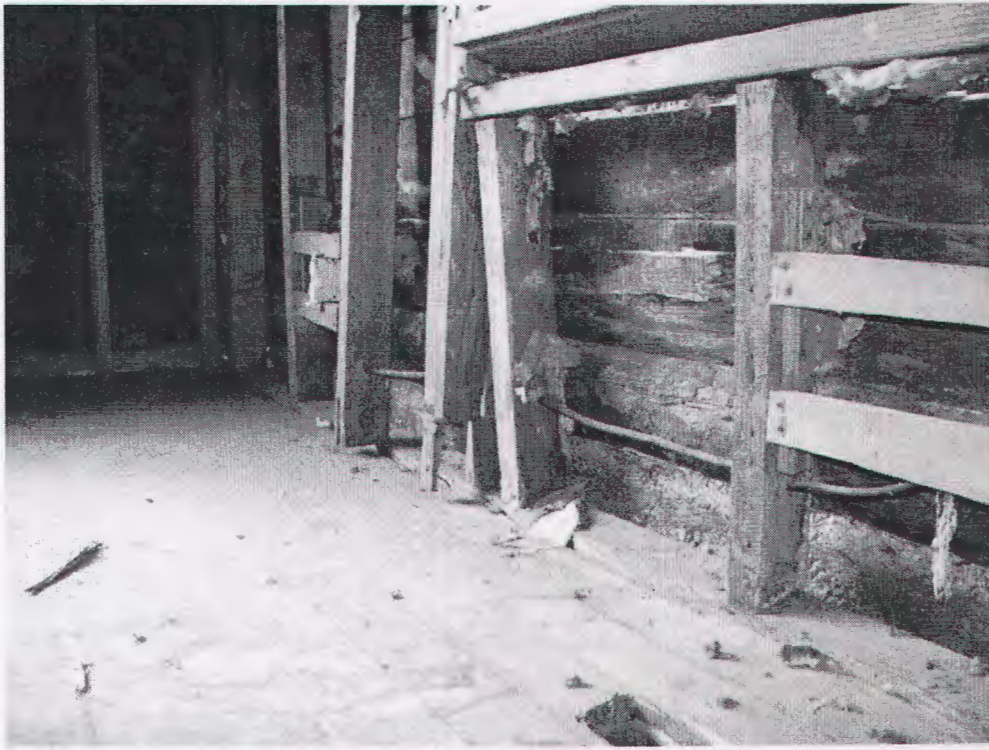
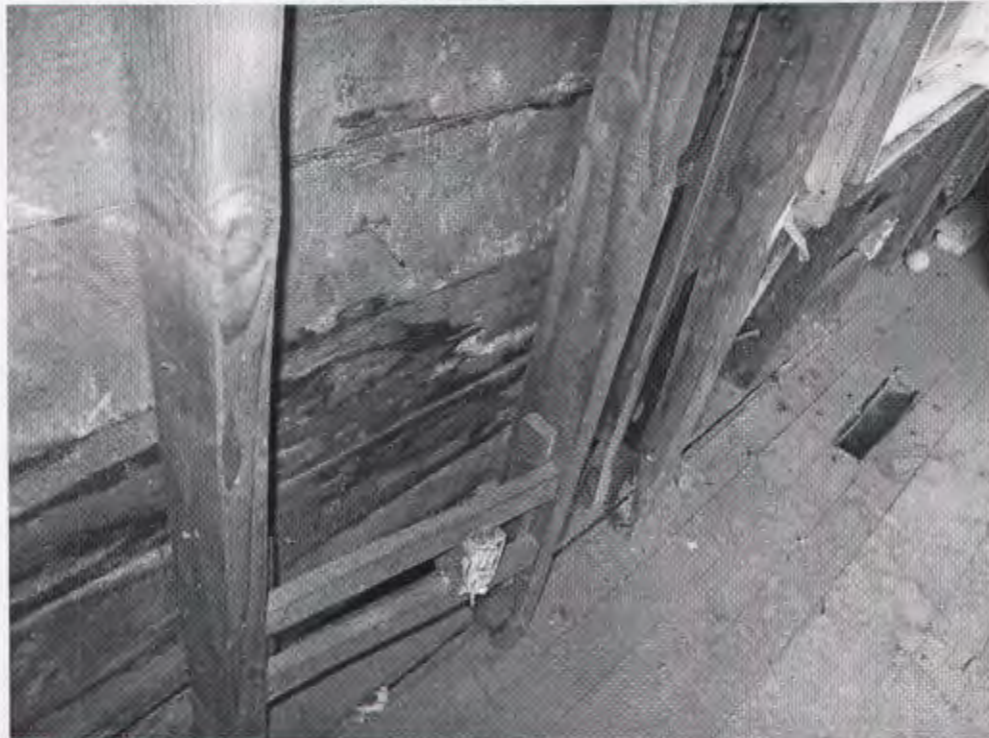
Examples of structural deficiencies.

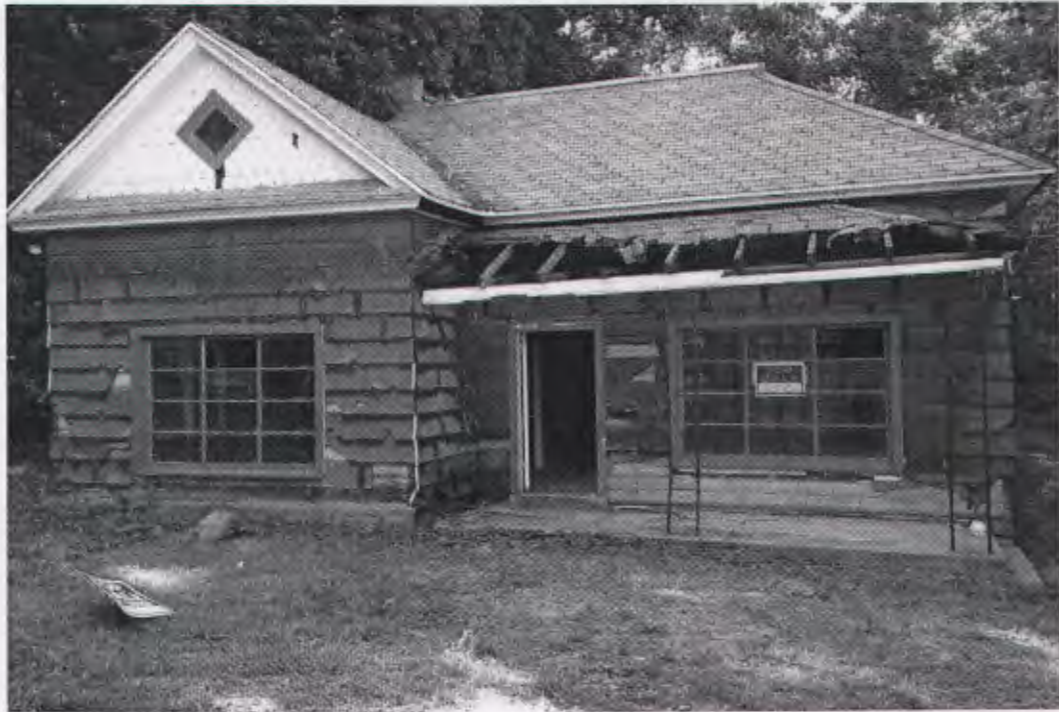
Photo 1: Front view of house

I observed a one-story house that had been altered in an attempt to construct a second story, refer to photo 1. The north side of the structure faces the street. The perimeter of the structure is approximately 40 feet by 40 feet. The roof is hip style with a flat section at the center of the house. The walls are wood-framed and are supported by a combination of field stone and mortar and poured concrete foundation walls, refer to photo 2. There is an unfinished second story that is framed with 2x12 floor joists, refer to photo 3.

Based on the above, it is my engineering opinion that the structure is unsalvageable. The cost to reinforce the dangerous conditions would make salvaging the building unfeasible. Most structural elements throughout the building would need to be removed and replaced or reinforced.

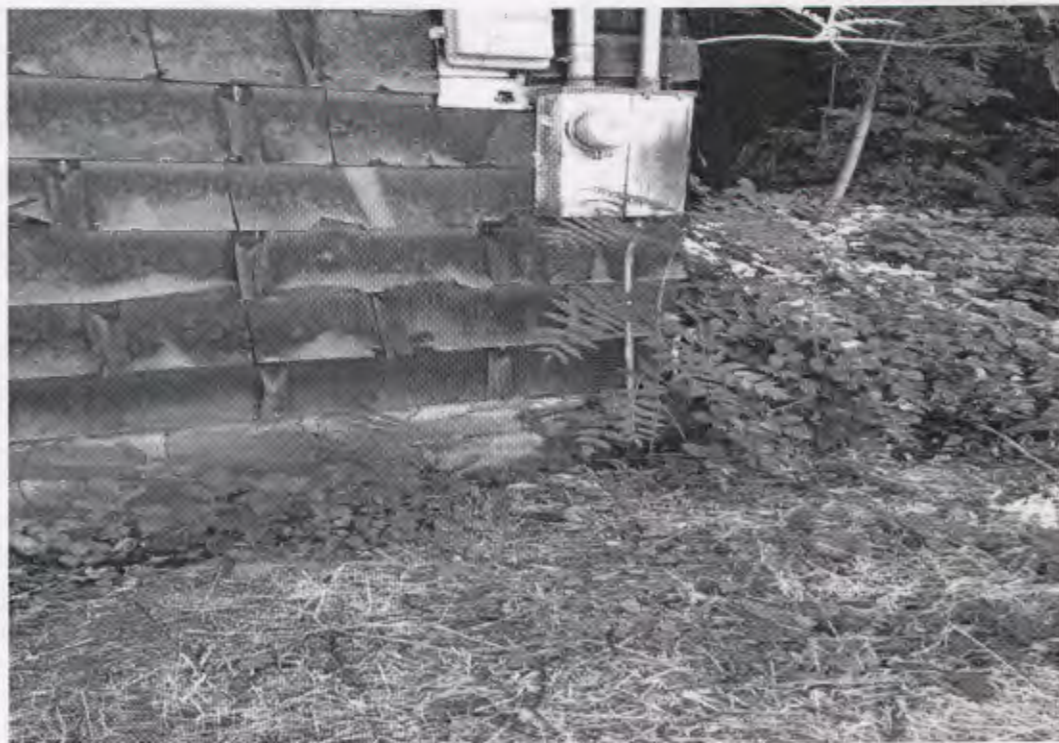
Photo 2: Stone and mortar foundation walls

There was a full height basement in roughly half of the building area, while the other half was a crawl space. The original foundation walls were constructed with field stone and mortar. At the full height basement, poured concrete foundation walls had been constructed to the interior of the stone and mortar foundation walls, refer to photo 9.

Locations where the mortar has deteriorated should be re-mortared. The existing interior brick pier footings shall be removed and replaced with new poured concrete footings. Although, upgrading the

anchorage of the wall to the foundation walls is not required, it is highly recommended in order to adequately resist seismic forces. The installation of new anchorage would entail constructing new concrete foundation walls around the perimeter of the crawl space in order to install the new anchorage into them. Constructing new concrete foundation walls is necessary for new anchorage because the installation of new anchors into the brittle stone and mortar foundation wall would not adequately resist seismic forces.

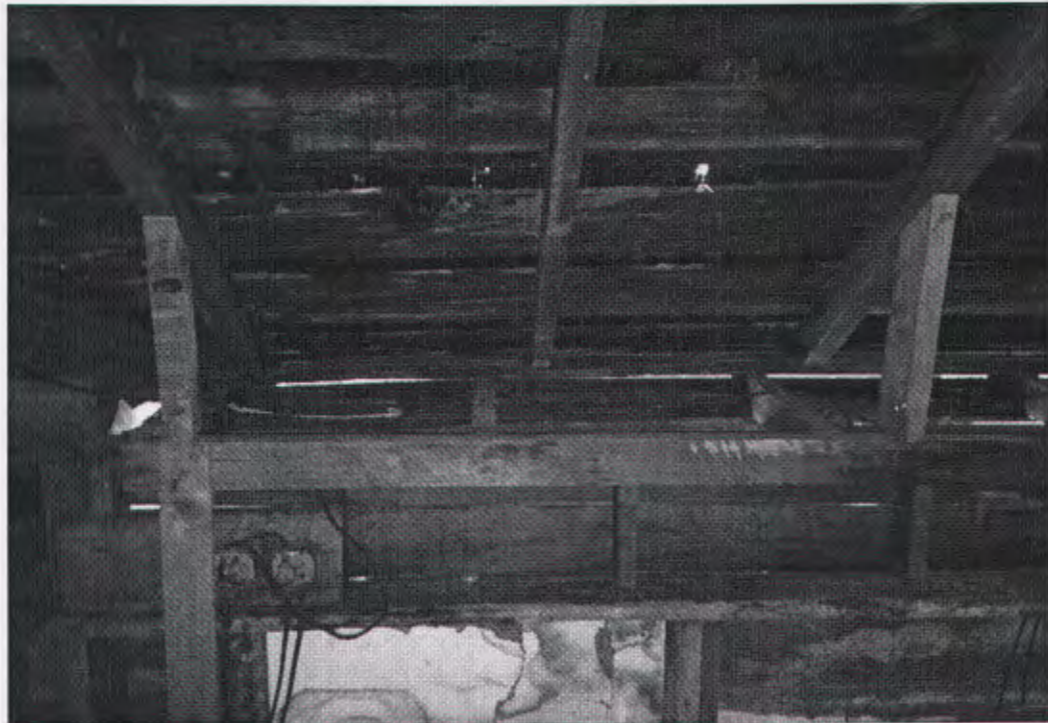
Photo 4: Cut rafter ties

The rafter ties had been cut one to two feet from the exterior wall, refer to photo 4. The rafters did not connect to the exterior walls. Roughly 1/4 to 1/3 of the roof sheathing exhibited signs of deterioration. The roof sheathing had spaces between the slats of about 6". It appeared that the roofing shingles spanned the spaces between the roof sheathing. Interior bearing walls had been constructed in order to support the roof framing, but these walls appeared to have been intended to be temporary.

The wall framing does not have adequate strength to transfer the outward thrust because the majority of the wall studs have been cut or damaged. In addition to not having a continuous top plate, many wall studs were damaged or cut when the second floor framing was installed. Due to the fact that, in several locations, the second floor framing was not connected to the wall studs, the second-floor-framing-to-wall-stud-connection was not adequate. These aforementioned items represent dangerous conditions and should be remedied.

To follow is a list of the roof structural members that must be reinforced or replaced for gravity load support:

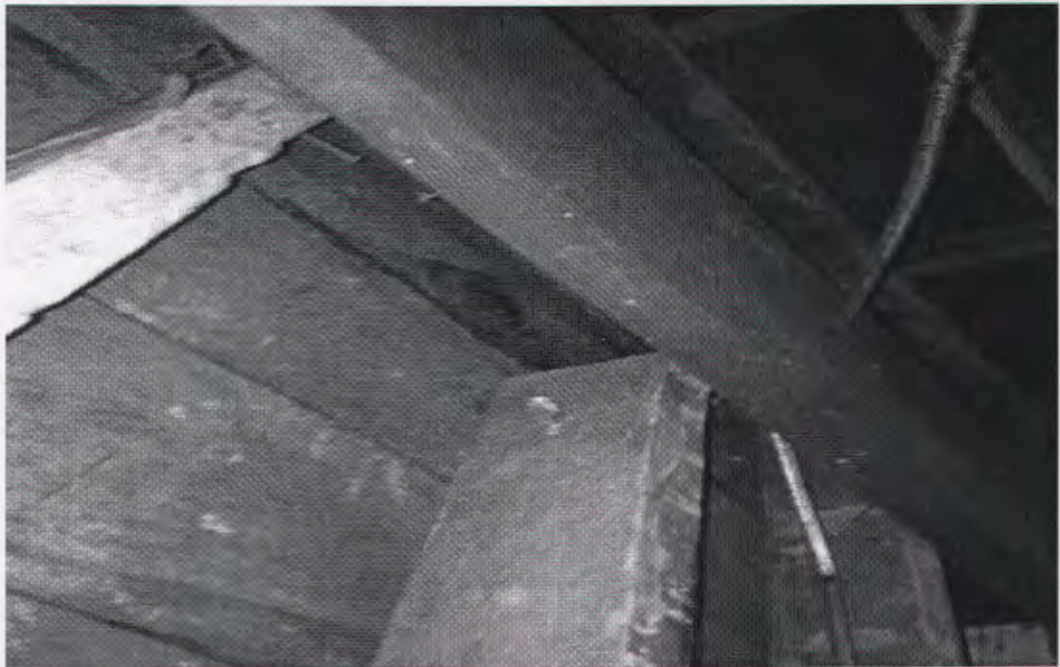
Photo 5: Cut wall stud

A portion of the wall framing consisted of 2x4 studs that spanned from the foundation wall to the roof bearing, while other locations of the wall framing consisted of 2x4 studs that spanned from the foundation wall to the second floor framing. A majority of the wall studs had been cut in order to install the second floor framing, refer to photo 10. There is not a continuous top plate at the roof bearing level or at the second floor bearing level.

The exterior wall studs have been cut or damaged throughout the house and must be reinforced. Firstly, the wall studs should be cut at the second floor framing in order to make a second floor wall and a first floor wall. This new second floor wall shall have a new double top plate installed and any wall studs that are cut or damaged must be sistered with an additional stud. A new bottom plate would also have to be installed at the second floor wall.

A new double top plate would have to be installed at the first floor wall in order to tie the wall together and to adequately support the second floor framing. In addition to the new double top plate, all wall studs that have been cut or damaged must be sistered. The sill plate must be replaced at any location that it is deteriorated. The existing wall slats should be replaced with sheathing, as well.

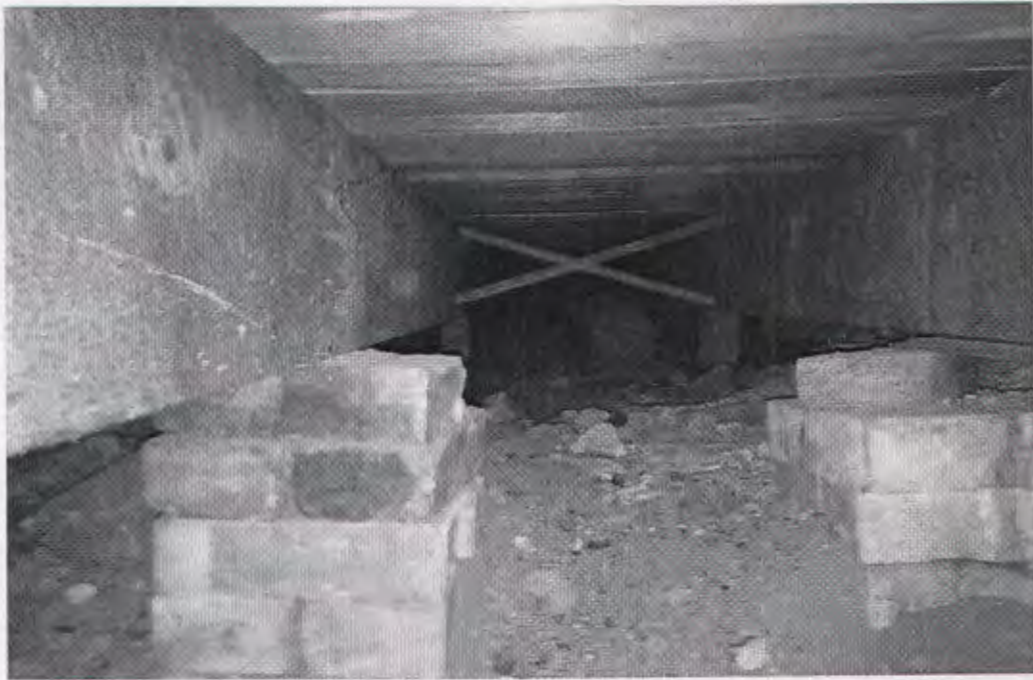
Photo 7: Brick pier footings

The first floor was framed over a basement and a crawl space. The floor framing was constructed with nominal lumber that spanned from the perimeter foundation wall to interior bearing lines. The interior bearing walls at the crawl space were supported by ungrouted brick piers bearing directly on crawl-space soil, refer to photo 7. There were locations where deterioration of the first floor framing was visible due to the lack of flashing or waterproofing, refer to photo 8.

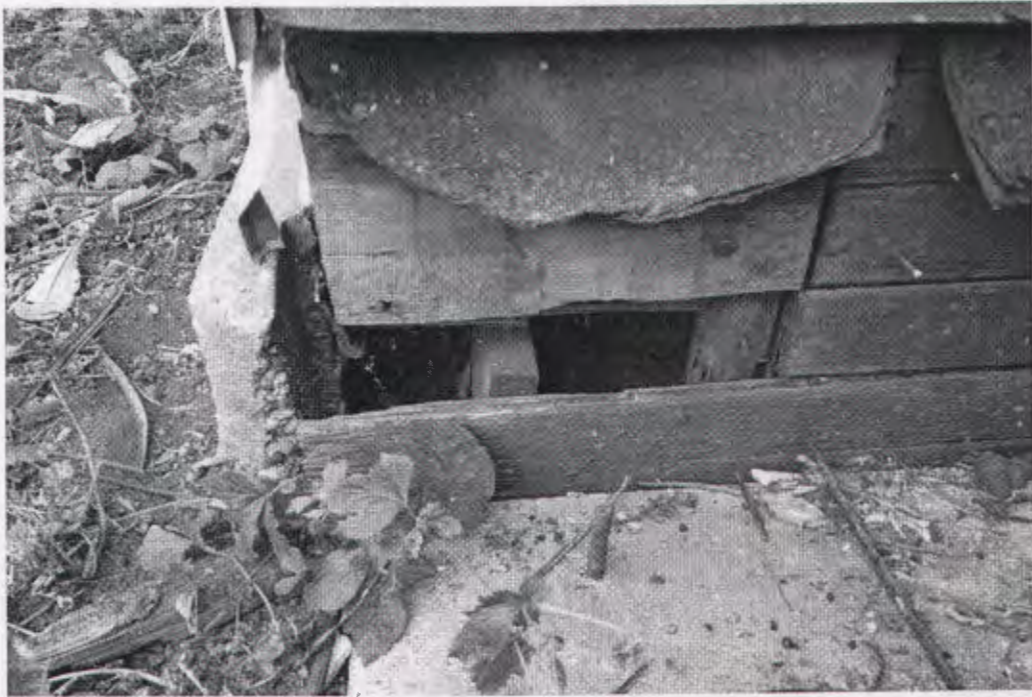
Photo 8: Deteriorated framing

The first floor framing will have to be checked for strength and might have to be reinforced in order to support the typical area floor loads. However, the first floor framing will have to be reinforced in order to support the columns from the second floor framing. Additionally, the bearing walls at the crawl space will have to be reinforced, along with areas where the existing floor framing has deteriorated due to lack of exterior flashing or waterproofing.

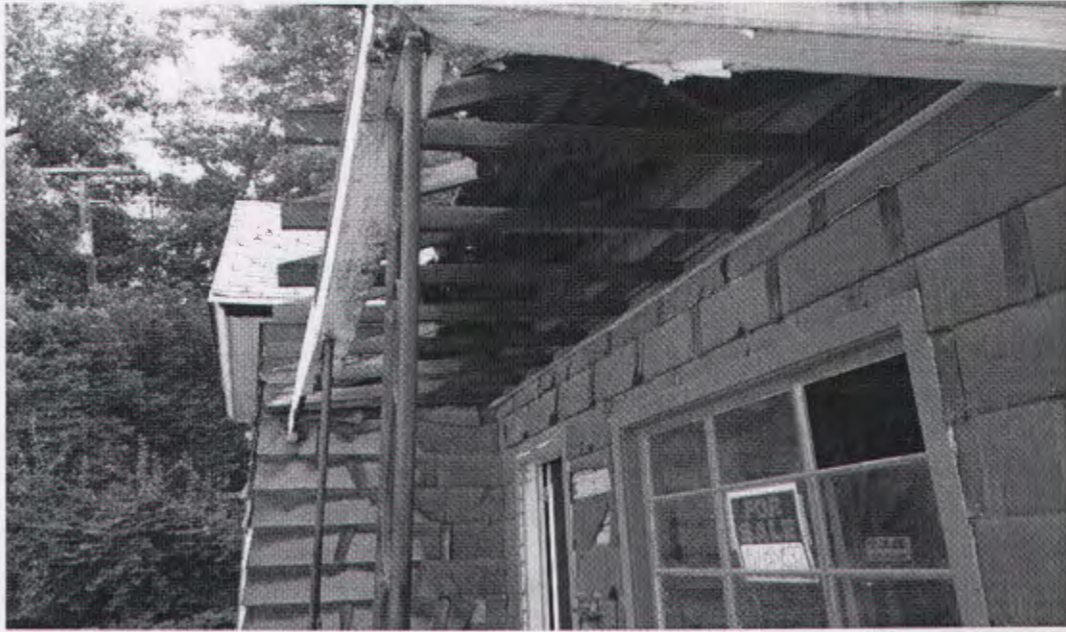
Photo 11: Deteriorated front porch beam

The entry roof was toenailed into the walls and the beam along the perimeter of the entry roof was deteriorated, refer to photo 11. The decorative steel columns were bent and damaged, as well.

The connection of the front entry roof to the wall and roof of the main structure must be reinforced with a new ledger and screws. New beams and columns must be installed and any damaged rafters must be sistered.
