Staff Report

To: Salt Lake City Historic Landmark Commission
From: Anthony Riederer - Principal Planner
(801) 535-7625 or anthony.riederer@slcgov.com
Date: April 20, 2017
Re: Petition PLNHLC2017-00014, Demolition of the Residential Structure at 241 W. Bishop Place

DEMOLITION OF A CONTRIBUTING STRUCTURE IN A LOCAL HISTORIC DISTRICT

PROPERTY ADDRESS: 241 W. Bishop Place

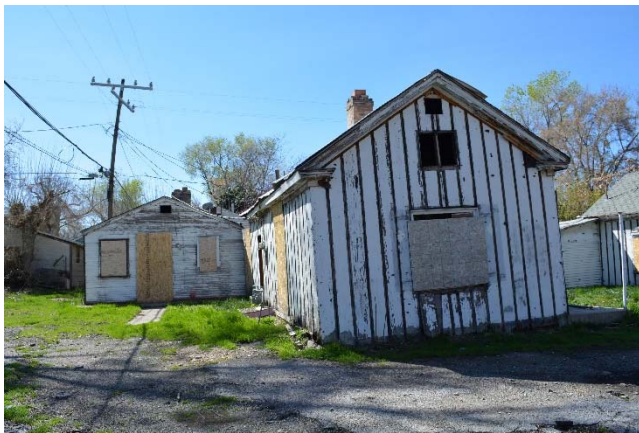
Current Day

The subject building is a one and a half story, gable roofed house with frame extensions. It abuts a smaller, connected, house immediately the southeast. The buildings are constructed in what is generally considered the National style. This style represents the period in which building forms common to American Folk architecture - and previously seen constructed of locally hewn materials - were adapted to the availability of milled lumber, brought with the advent of cross-continental railroad service.

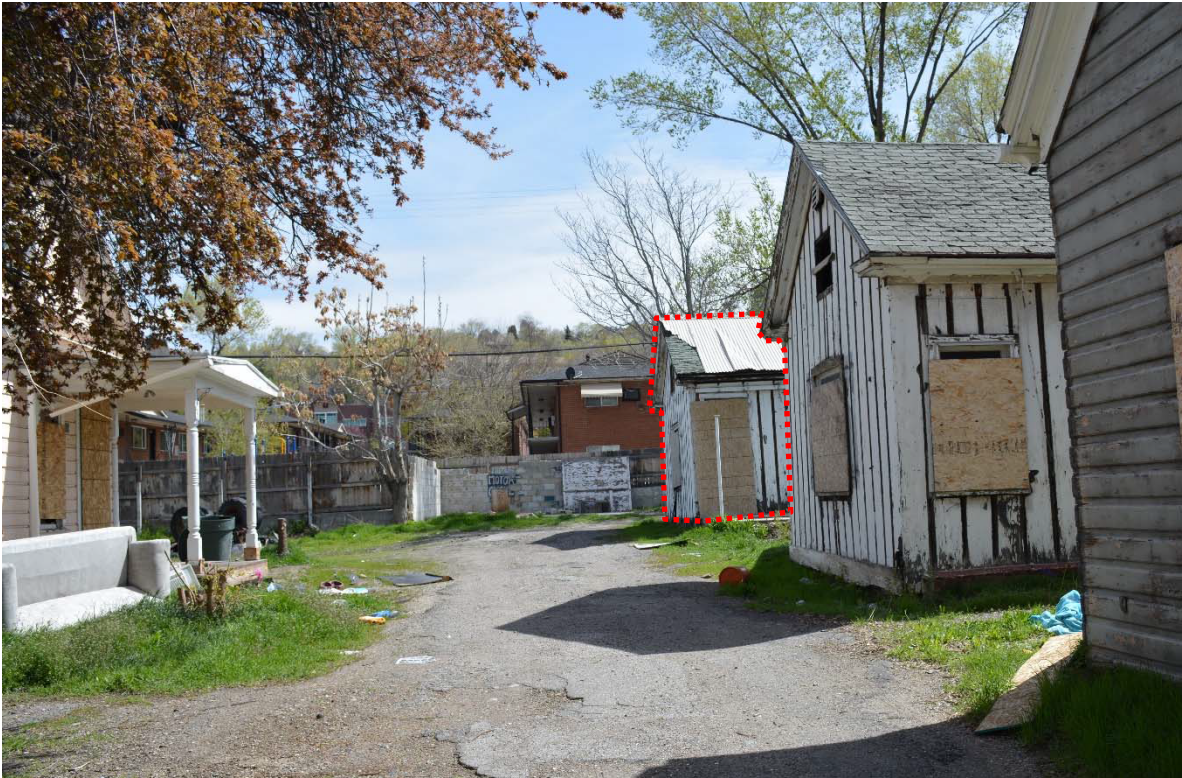
Bishop Place, current day

While it is evident that structures have been modified and lost in this area, further losses – to say nothing of the wholesale removal of an intact ensemble – will be significantly detrimental to the integrity of the site specifically and to the Capitol Hill Local Historic District as a whole.

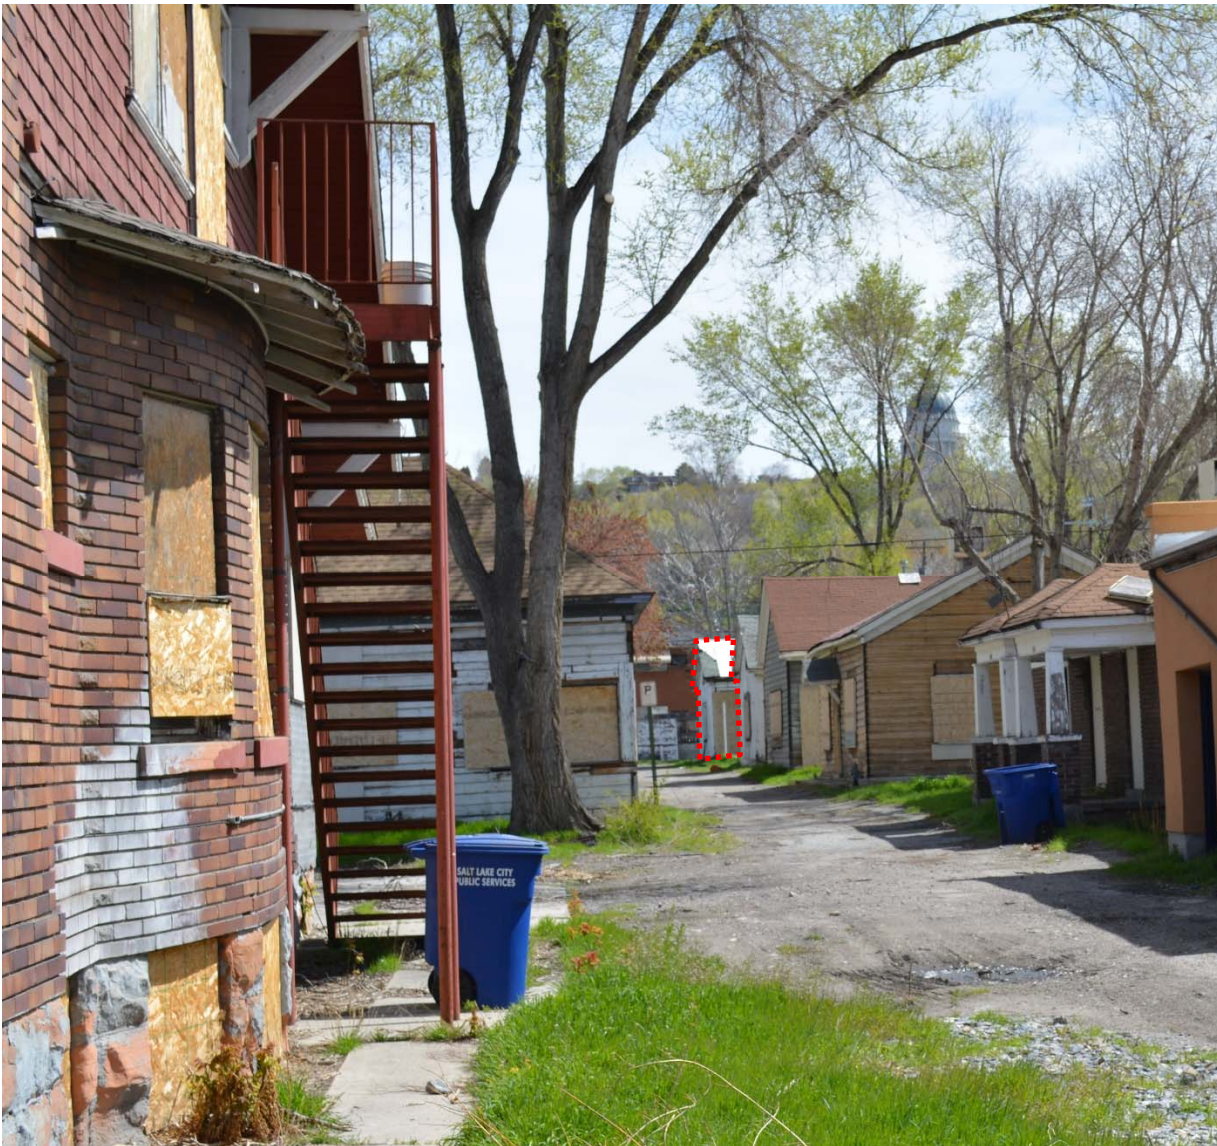
View from sidewalk along 300 West, Subject Structure highlighted

The subject property is one of a number on the south side of Bishop Place that, on account of their consistent front yard setbacks, are clearly visible from 300 West.

The ability to, from the public way, look down Bishop Place and understand some of the historic pattern of development common to the area is a feature that contributes significantly to the character of the Capitol Hill Historic District.

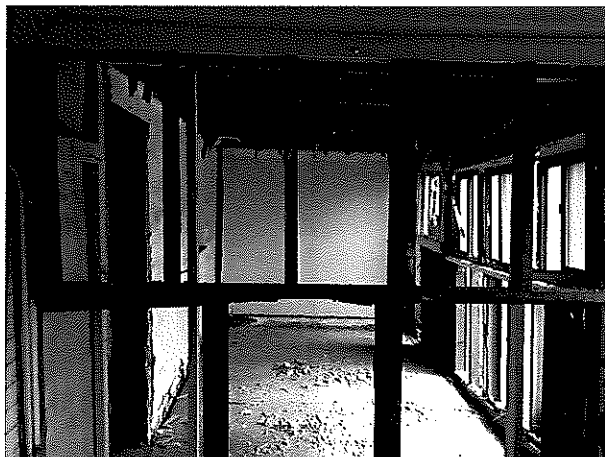
This home, like many others on Bishop Place, has deteriorated past the point of restoration. First, it lacks a foundation. Some effort appears to have been made many decades ago to create a foundation by installing a cement-like product as a footing. This was accomplished by digging 4 to 6 inches below grade and pouring the cement-like product 4-6 inches above the wood base of the home. Contrary to the intention, this provided no structural support. To properly create footings for 241 Bishop, under the direction of a licensed engineer, IRES would need to undertake significant excavation, attempt to remove the cement-like material, and create new footings with rebar and cement. Alternatively, IRES could lift each home up and create a foundation or footing. Given the deteriorated state of the home, either effort would likely result in the collapse of the existing home.

Second, the stone and lumber within the home has eroded, leaving floor beams, support studs and beams, and trusses in a dangerous condition. The home is sagging and leaning as a result of this deteriorating.

Third, the back portion of the roof completely collapsed, leaving the home open to the elements.

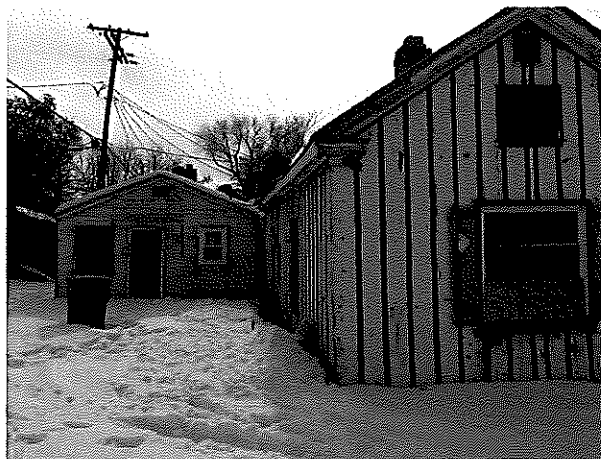
However, in its current state, the majority of the siding has deteriorated and portions are missing. The windows and doors have been changed, and there is little left that, under even the most generous view, would be called historic.
