# Staff Report

Re: PLNHLC2017-00540 – Replacement of Front-Facing Windows

**PROPERTY ADDRESS:** 134 G Street  
**PARCEL ID:** 09-31-478-002  
**MASTER PLAN:** Avenues  
**ZONING DISTRICT:** SR-1A (Special Development Pattern Single-Family Residential)

**REQUEST:** Rusty Carson, on behalf of the property owner, is requesting approval from the city to replace three front-facing historic windows with new replacement windows of contemporary manufacture.

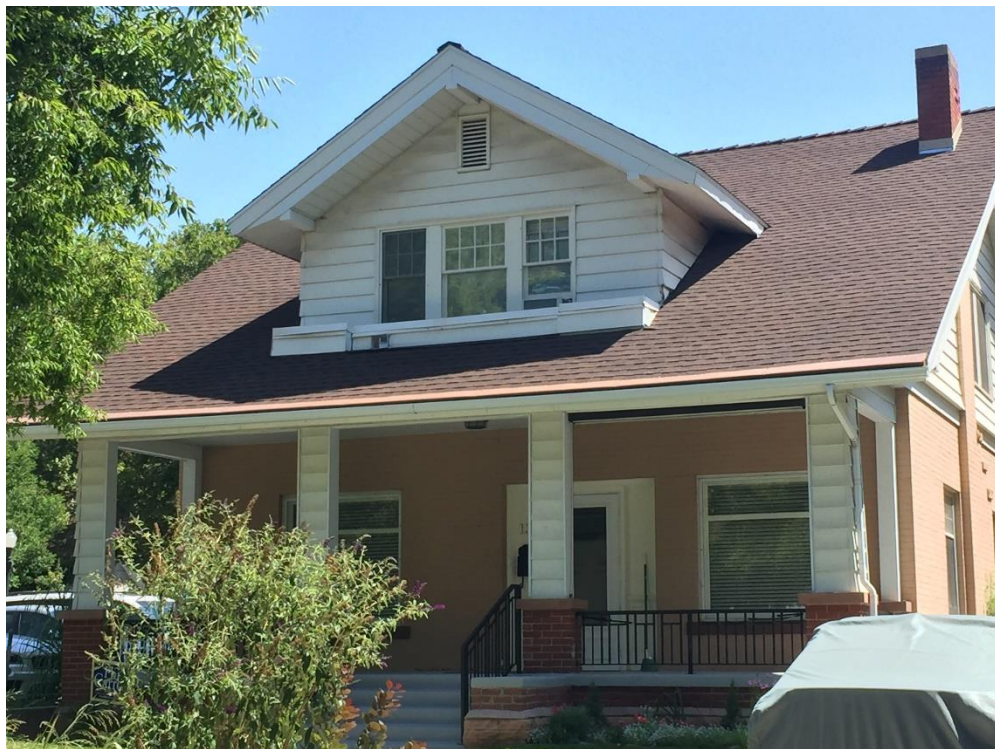
The existing windows are historic double-hung units with subdivided panes in the upper sash, over one large pane in the lower. This style of window is common in houses of this style and age and is a character defining feature both of this property, and of the style of house more generally. Given their location in the front-facing gable, the windows in question are highly visible from the public way.

*View of 134 G Street, from G Street*

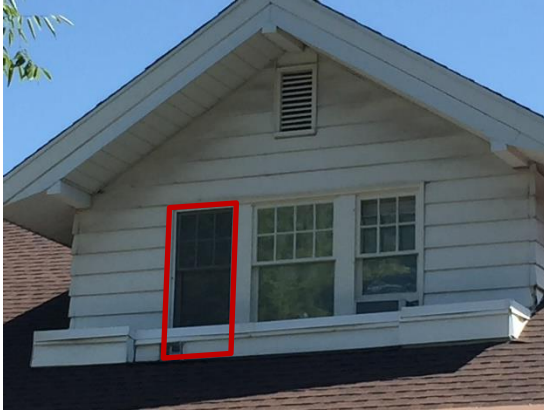
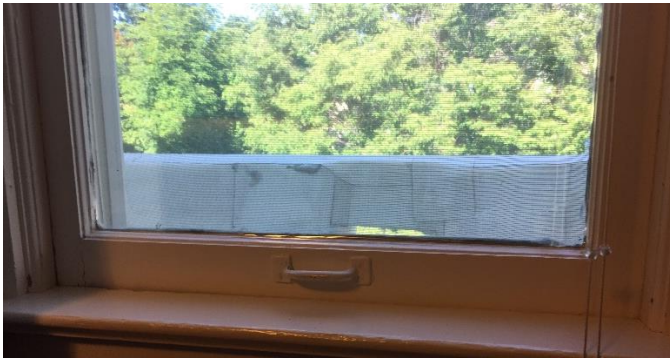
## WINDOW 1 (NORTHERN UNIT)

- The wood elements (sash, rails, muntins, etc.) of Window One are in excellent condition, showing little to no signs of deterioration.
- All panes of glass were intact and had been augmented with after-market solar film, ostensibly to improve energy performance.
- The window remained operable, but the track was fairly sticky and one of the two sash cords, which link the lower pane to the ballast weights inside the wall had been cut.

In the opinion of staff, this window remains in excellent physical condition and could be restored to like-new operability with relatively minor intervention and continued maintenance. Energy performance could be further enhanced, quite possibly beyond the performance of a contemporary replacement window, with the use of either an internal or external storm window. Additionally, after-market screen inserts are available that allow for bug-free use in warm weather months. Replacement is not necessary.

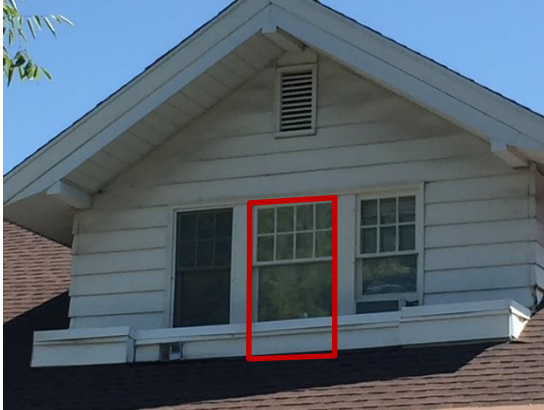
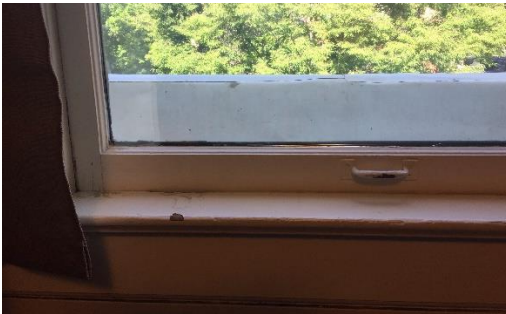
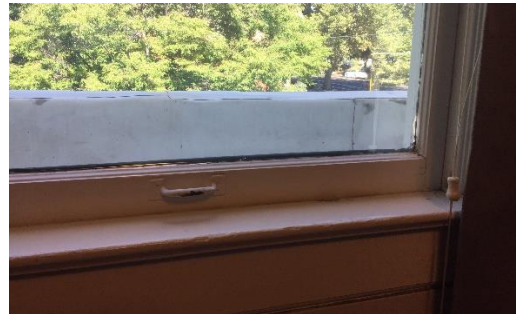
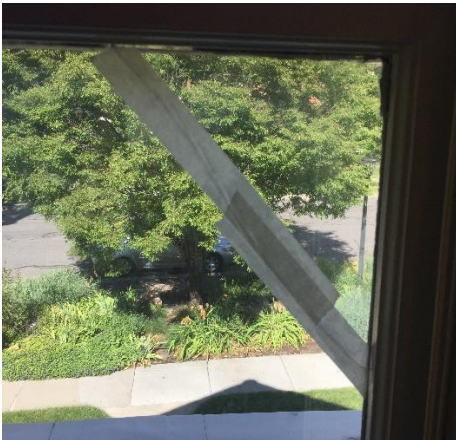
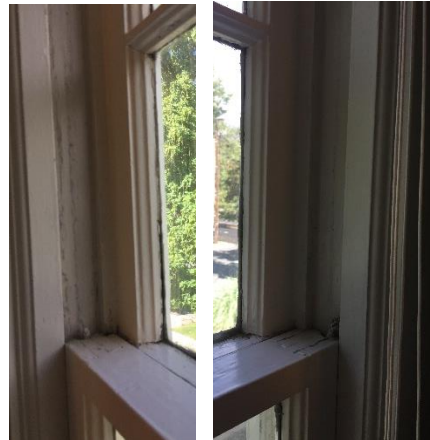
## WINDOW 2 (CENTER UNIT)

- The wood elements (sash, rails, muntins, etc.) of Window Two are in excellent condition, showing little to no signs of deterioration.
- The pane in the lower sash has a crack across the upper right corner. This pane could easily be replaced by a professional restorer. All panes had been augmented with after-market solar film, ostensibly to improve energy performance.
- The window remained operable, but the track was fairly sticky and both of the sash cords, which link the lower pane to the ballast weights inside the wall had been cut.

In the opinion of staff, this window remains in good physical condition and could be restored to like-new operability with minor intervention and continued maintenance.. Energy performance could be further enhanced, quite possibly beyond the performance of a contemporary replacement window, with the use of either an internal or external storm window. Additionally, after-market screen inserts are available that allow for bug-free use in warm weather months. Replacement is not necessary.

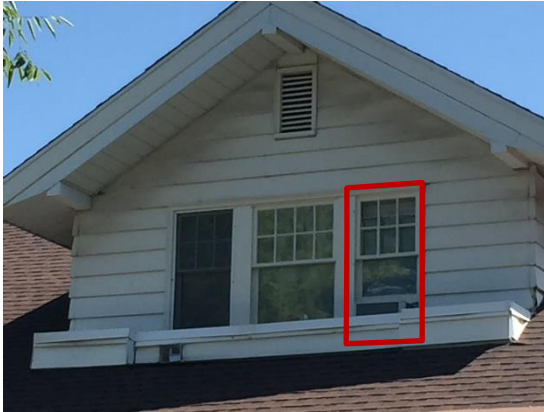
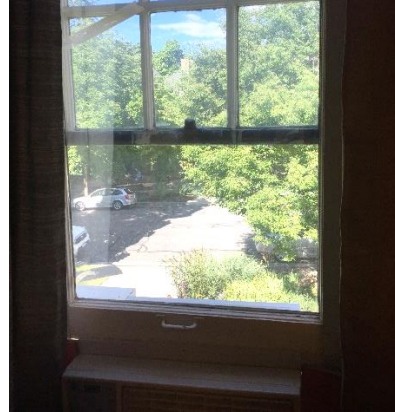
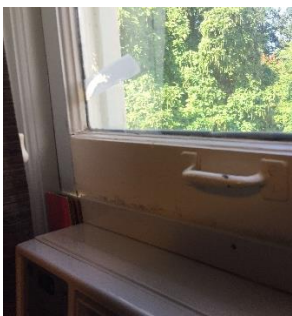
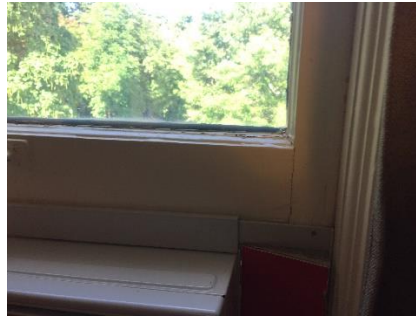
### WINDOW 3 (SOUTHERN UNIT)

- The wood elements (sash, rails, muntins, etc.) of Window Three are in excellent condition, showing little to no signs of deterioration.
- All panes of glass were intact and had been augmented with after-market solar film, ostensibly to improve energy performance. The tape visible in the upper left corner of the lower sash is to supplement a scrape in the solar film, not so seal a crack. All panes had been augmented with after-market solar film, ostensibly to improve energy performance.
- Operability of this window could not be assessed because of the placement of a window-mounted air conditioner. Both of the sash cords remained intact.

In the opinion of staff, this window remains in good physical condition and could be restored to like-new operability with relatively minor intervention and continued maintenance. Energy performance could be further enhanced, quite possibly beyond the performance of a contemporary replacement window, with the use of either an internal or external storm window. Additionally, after-market screen inserts are available that allow for bug-free use in warm weather months. Replacement is not necessary.

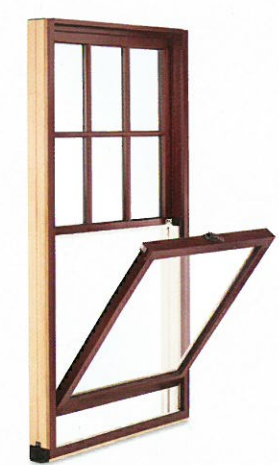
THE TILT-IN SASH ALLOWS FOR CONVENIENT EXTERIOR ACCESS, AND MAKES CLEANING THE WINDOW EASIER THAN EVER.
