# Staff Report

**Re:** Petition PLNHLC2017-00677 Demolition of a Contributing Structure

#### DEMOLITION OF A CONTRIBUTING STRUCTURE IN A LOCAL HISTORIC DISTRICT

**PROPERTY ADDRESS:** 50 S 700 East Street (formerly 46 S 700 East Street)

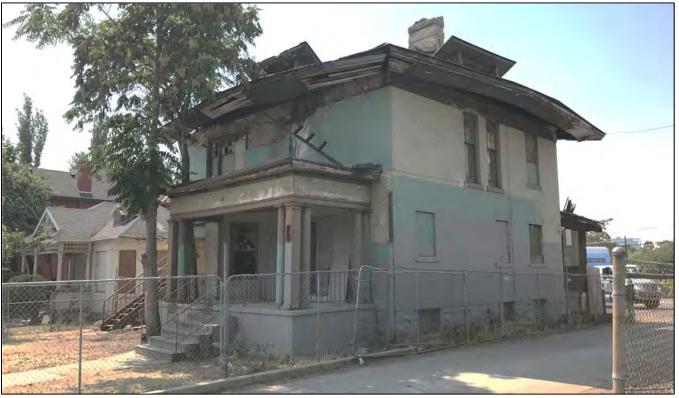
Street View of Subject Property (September 2017)

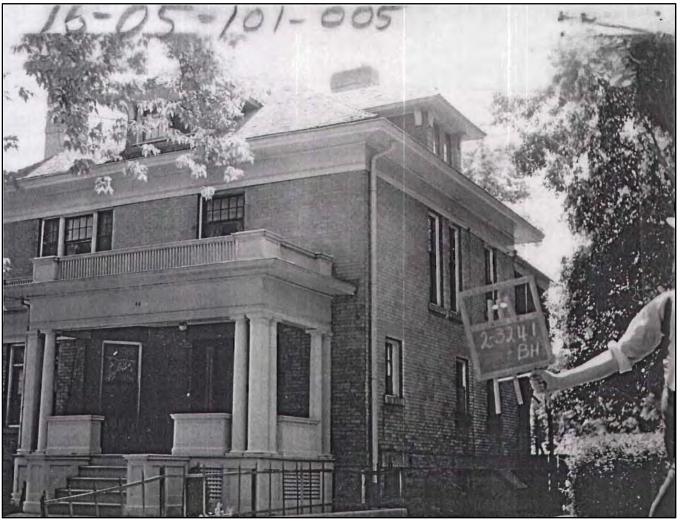
Historic Photograph of Subject Property (date unknown)

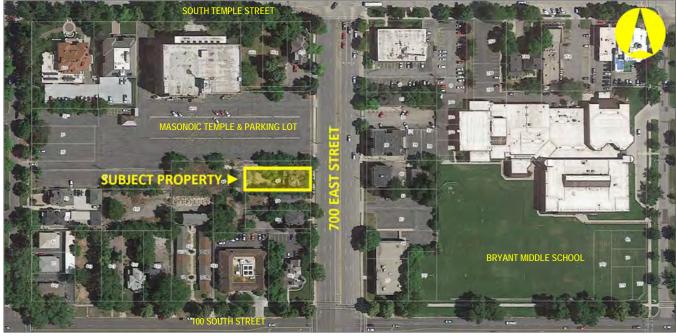
Aerial View of Subject Property (2015)

As evident in the previous maps, and noted within Exhibit A - Applicant Information, several buildings located northward from the subject property were demolished to construct a parking lot for the Salt Lake Masonic Temple, which building fronts South Temple Street.

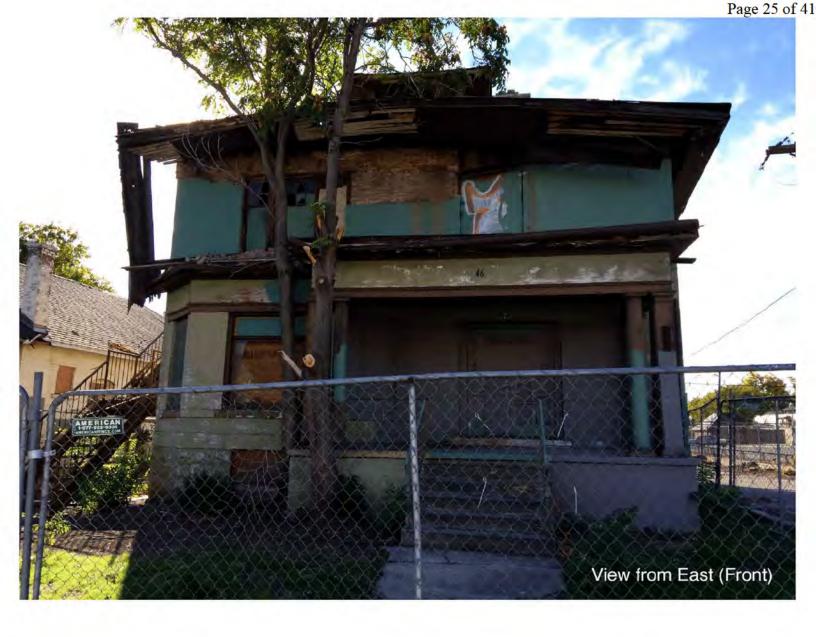
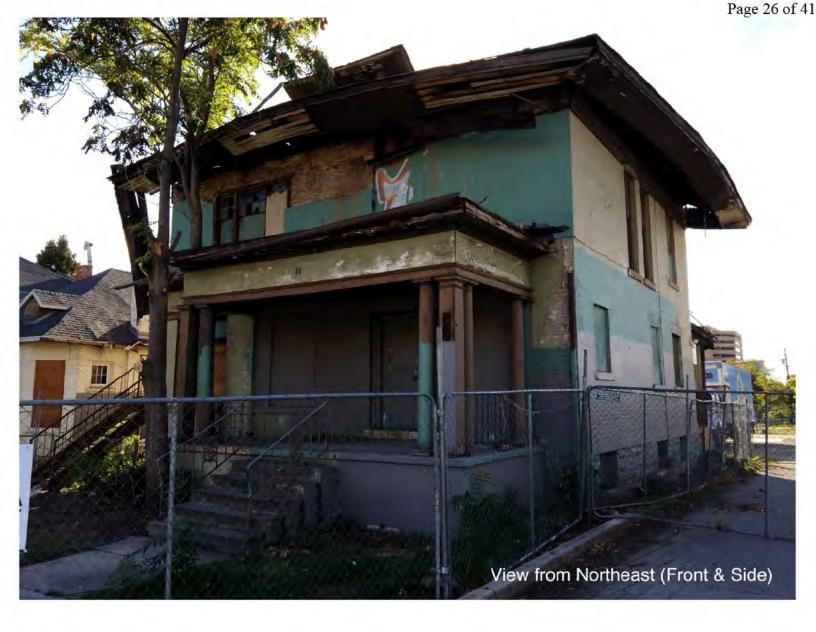
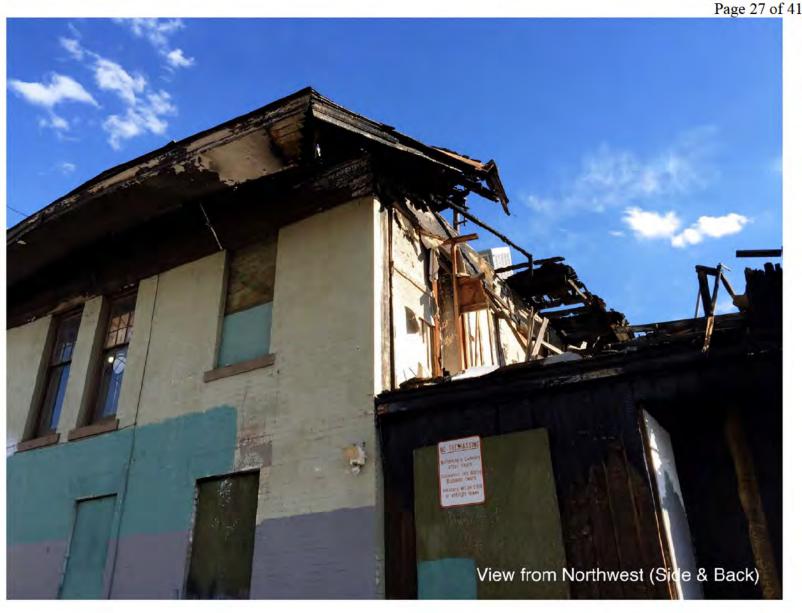
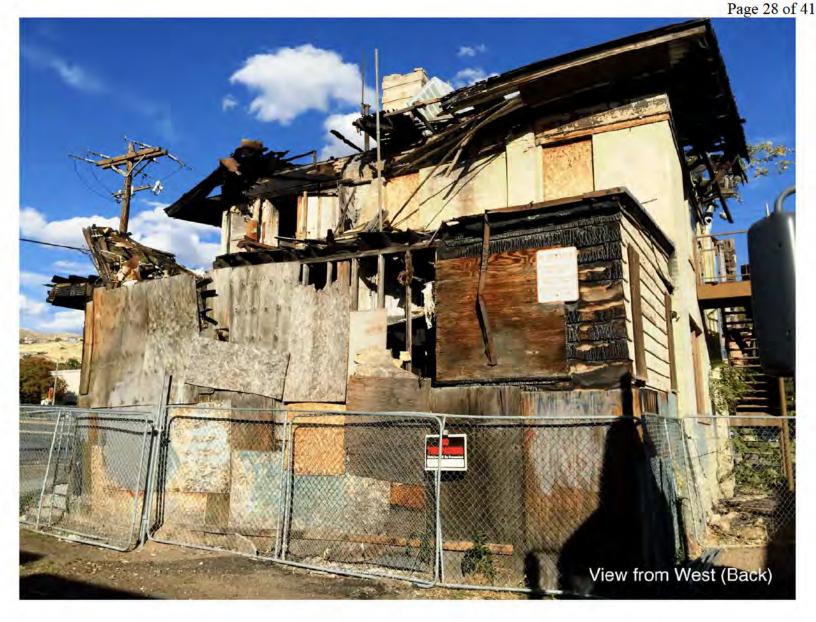
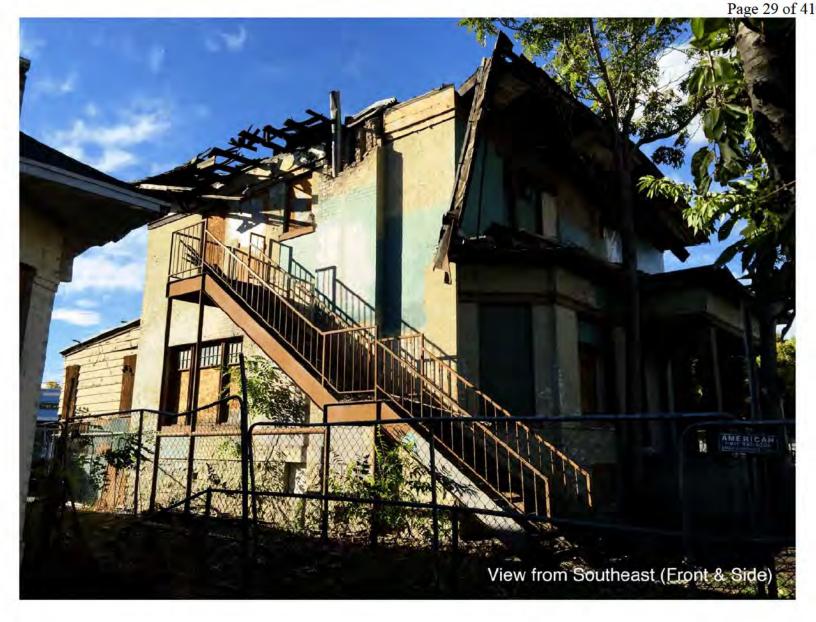
Existing Building Photos

The structure is a former residence, and was severely damaged by fire many years ago, prior to the property being purchased by The Other Side Academy. The building is very clearly "collapsing, either in whole or in part." The roof of the structure has entirely collapsed and caved in, and portions of roof structure dangle in the air inside and outside the perimeter walls. The interior walls and floors of the structure are also collapsed and completely unstable. During high wind conditions large pieces of the structure have recently blown off the building onto the ground nearby. The size and weight of falling debris from this building are enough to severely injure if not kill someone. The entire structure is exposed to the elements, and there is significant ongoing water damage and rot occurring to the structure, in addition to fire damage.

The property is a life and safety risk for anyone entering. The roof and interior floor and walls have collapsed and the entire structure is highly unstable. Even approaching the building is highly risky, due to the damaged roof structure extending beyond the exterior walls. The Other Side Academy,

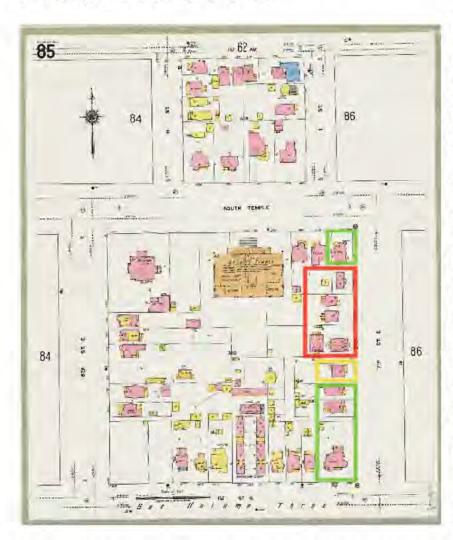
The subject property is highlighted in yellow on the map to the left. The other remaining structures on the block face are highlighted in green, 5 of the 10 historic structures on the block face have been previously demolished, highlighted in red. All of the previously demolished structures were replaced by parking lots, either for the Masonic Temple, or for the Anniversary Inn, both of which face South Temple.

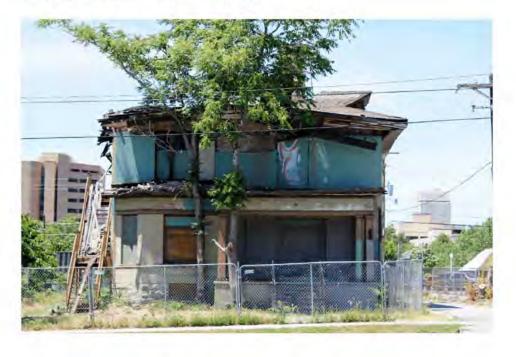
46 South 700 East - Subject Property

The blighted and hazardous condition of the subject structure in its present condition has a significant negative impact on the streetscape. Whether the property reuse is landscaping, which is anticipated as the interim use, or the structure is eventually replaced by a new structure, which is the anticipated long-term use, the net effect will be an overall improvement to the block from its presently blighted condition. The design guidelines for new construction sufficiently address compatibility of a new structure in a way that will not negatively impact the streetscape long-term.

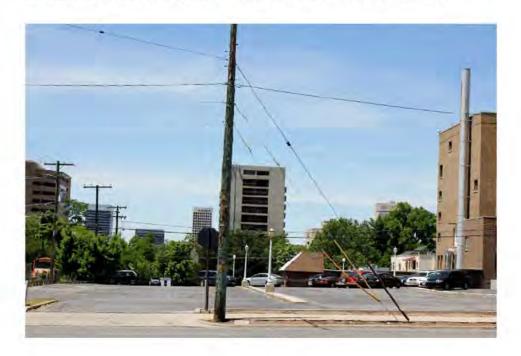
Figure 1: Parking lot footprint in historical district.

Adjacent to the proposed demolition site, this large parking lot of the Masonic Temple covers roughly 2.5 acres, as pictured in the photo and Figure 1 below. Further north is a second, smaller parking lot for the Anniversary Inn Bed & Breakfast. Historically, these lots included both single and multi-family dwellings. The removal of historic buildings for these parking lots substantially altered the streetscape and block face in this portion of the Historic District.

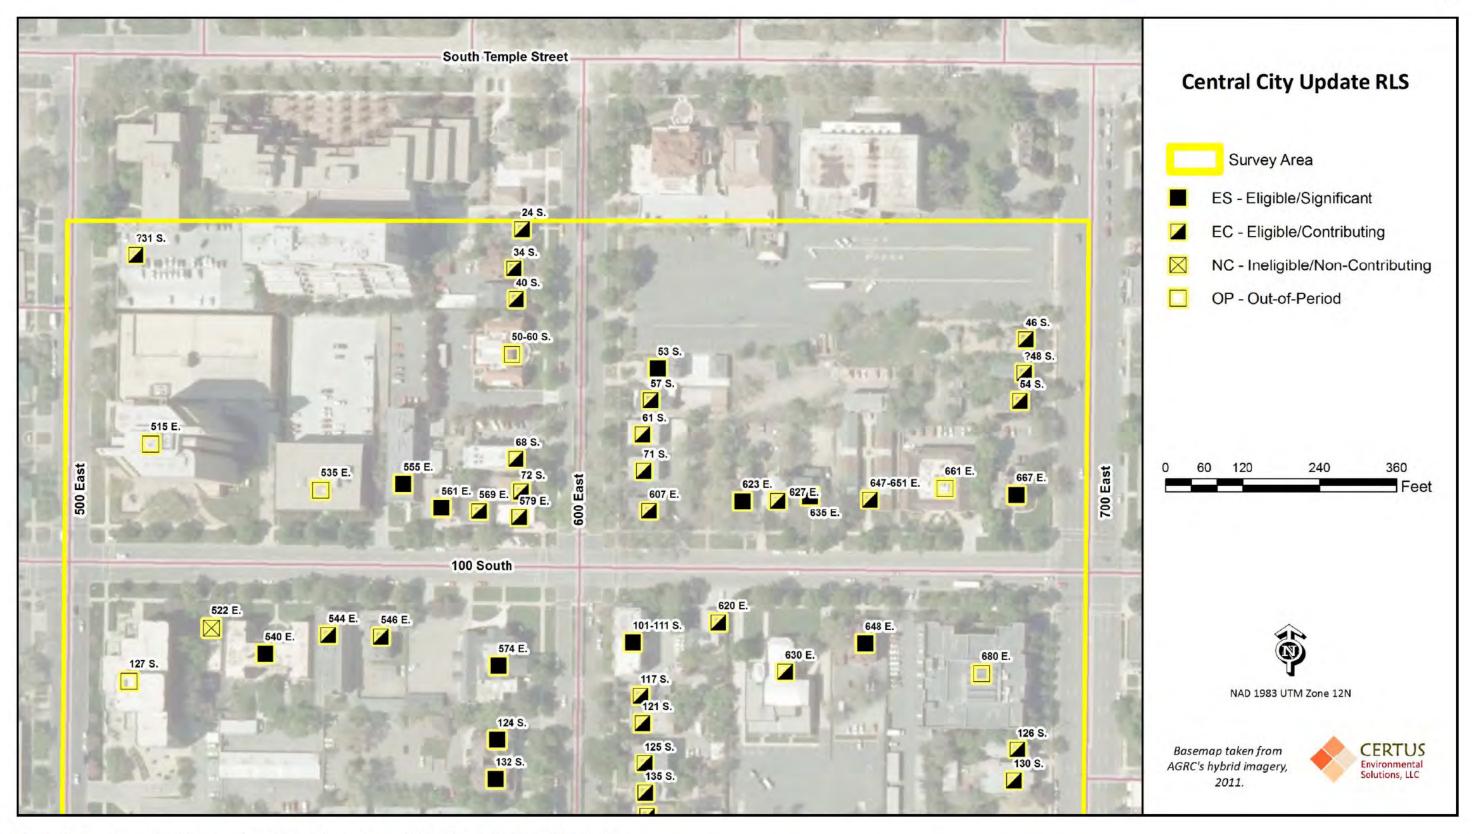
Figure 3. Location of buildings and eligibility ratings, Central City Historic District (Map 1 of 8).
