# Staff Report

**To:** Salt Lake City Historic Landmark Commission  
**From:** Lex Traughber – Senior Planner  
(801) 535-6184 or lex.traughber@slcgov.com  
**Date:** December 7, 2017  
**Re:** Petition PLNHLC201-00850, Relocation of 665 E. Ely Place

## RELOCATION OF A CONTRIBUTING STRUCTURE IN A LOCAL HISTORIC DISTRICT

**PROPERTY ADDRESS:** 665 E. Ely Place  
**PARCEL ID:** 16-05-353-014  
**HISTORIC DISTRICT:** Central City Historic District  
**ZONING DISTRICTS:** FB-UN2 (Form Based Urban Neighborhood District) &  
H – Historic Preservation Overlay District  
**MASTER PLAN:** Central Community Master Plan – Medium and Low Residential/Mixed-Use

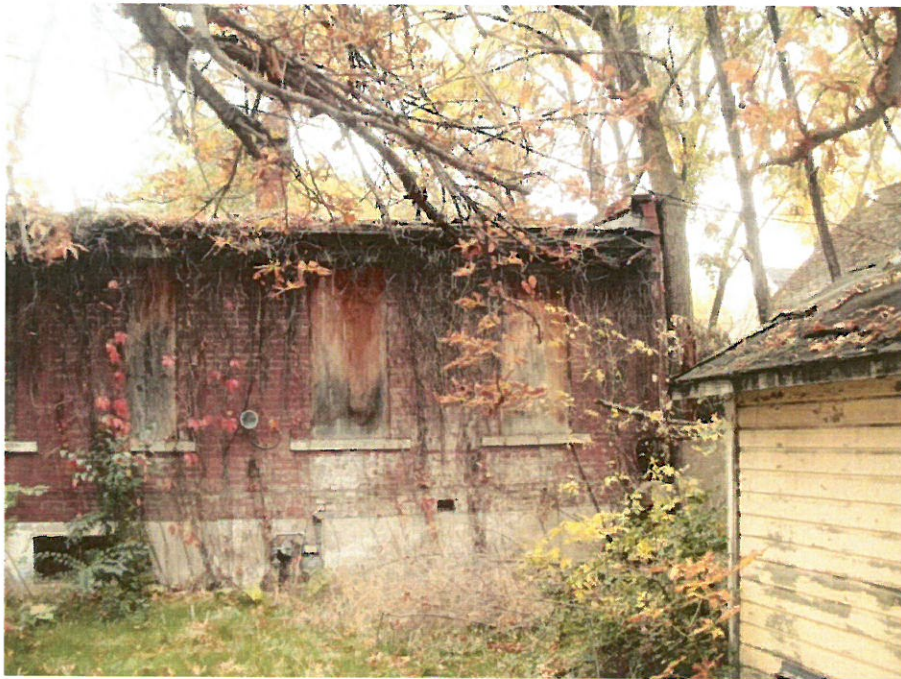
**1910 Residential Structure**

The residential home is located at the address noted above. The original building appears to have been constructed in 1910 based on information the owner obtained from the county assessor. The estimated building area is approximately 680 square feet on the main floor. The building has a partially excavated

basement/crawl space. The structure is constructed of materials typical to construction at the time the building was completed, namely wood floor joists and roof joists supported by unreinforced stone or adobe walls with brick veneer.

The foundation system consists of rock foundation walls. It is unlikely that there are concrete footings beneath the rock foundation walls. Solid sawn wood timber posts are used to support the floor joist in the middle of the floor. The posts do not appear to be supported by any type of footing and are not adequately attached to the floor framing. The exterior walls of the building were constructed using unreinforced stone or adobe with a 4" brick veneer. The interior walls were covered with lath and plaster or gypboard. The main floor is also wood framed and covered with lath and plaster or gypboard. The sloping roof framing consists of wood rafters that slope towards the south side of the building.

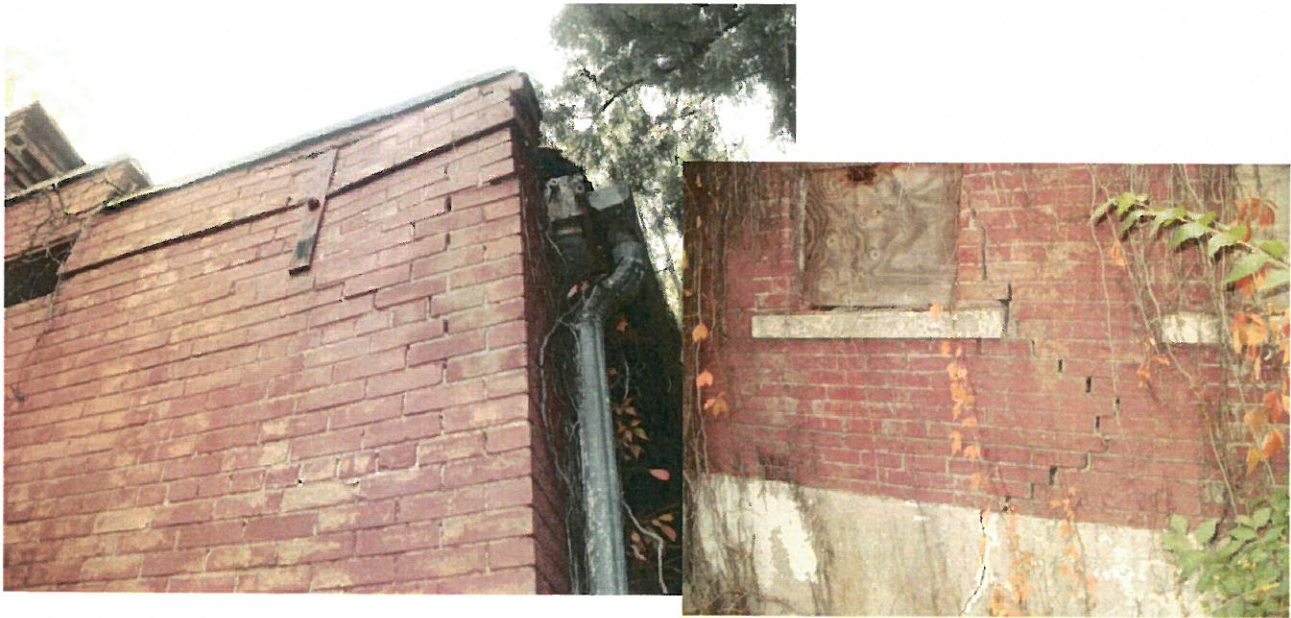
**Foundation settlement in South-West corner has caused walls to crack and separate**

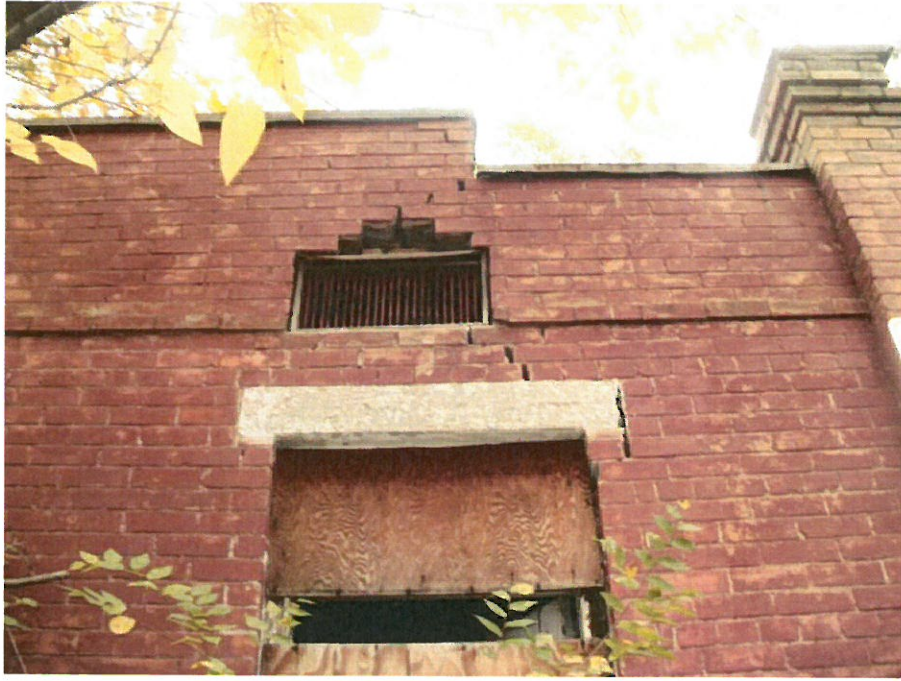
**Foundation settlement in South-West corner has caused walls to crack and separate.**

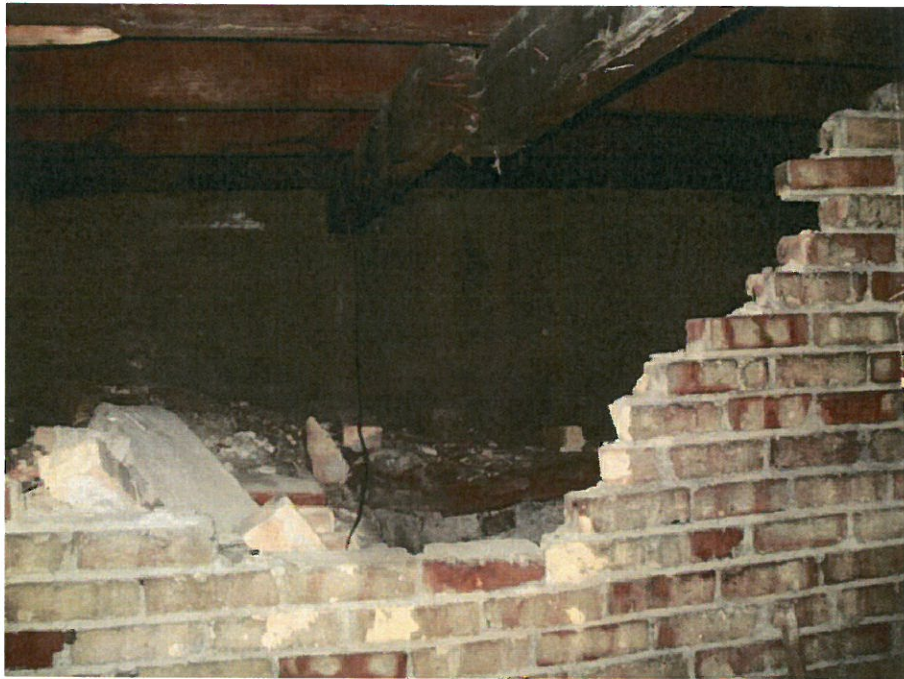
**Walls supporting beams in the floor have been damaged, leaving floor joists above unsupported**

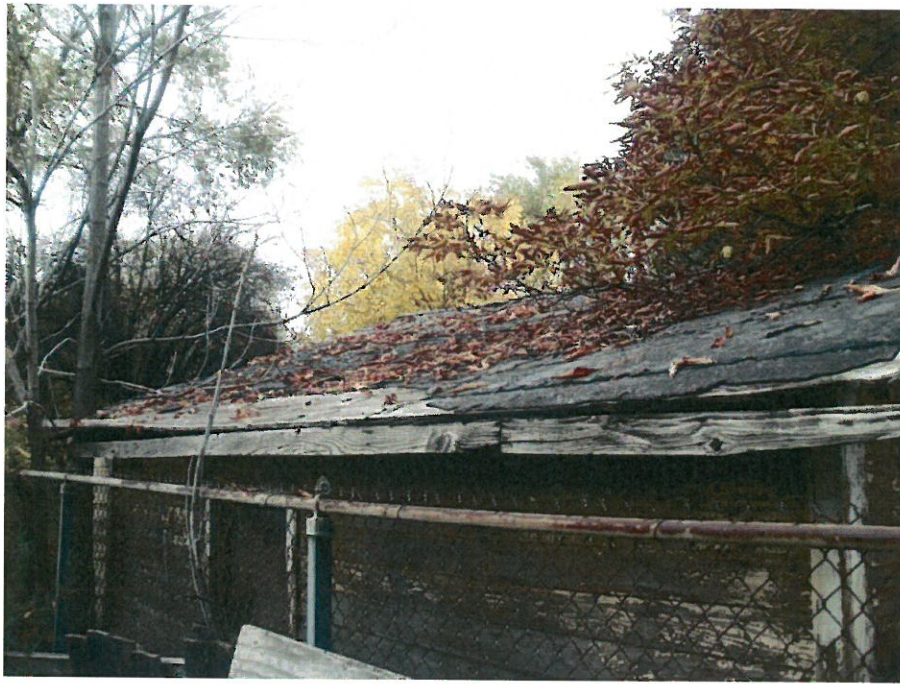
**The roof for the shed is sagging and severely deteriorated**

There are (2) wood framed sheds on this site that also appear to be safety concerns. The roof joists are severely sagging and the bearing walls do not appear to be plumb. There does not appear to be a continuous foundation around the perimeter walls. The roofing has deteriorated and it appears that structural members are in poor condition. To rehabilitate these sheds would require a complete tear down of existing elements in order to support gravity loads (code prescribed dead loads and roof snow loads) and resist some specified level of wind and seismic force.
