Staff Report

To: Salt Lake City Historic Landmark Commission
From: Lex Traugher – Senior Planner
(801) 535-6184 or lex.traugher@slcgov.com
Date: December 7, 2017
Re: Petition PLNHLC201-00851, Relocation of 658 E. 600 South

RELOCATION OF A CONTRIBUTING STRUCTURE IN A LOCAL HISTORIC DISTRICT

Re: Limited Structural Evaluation of Trolley Square Property 353-002
658 E 600 S, SLC, UT
ARW Project: 15426

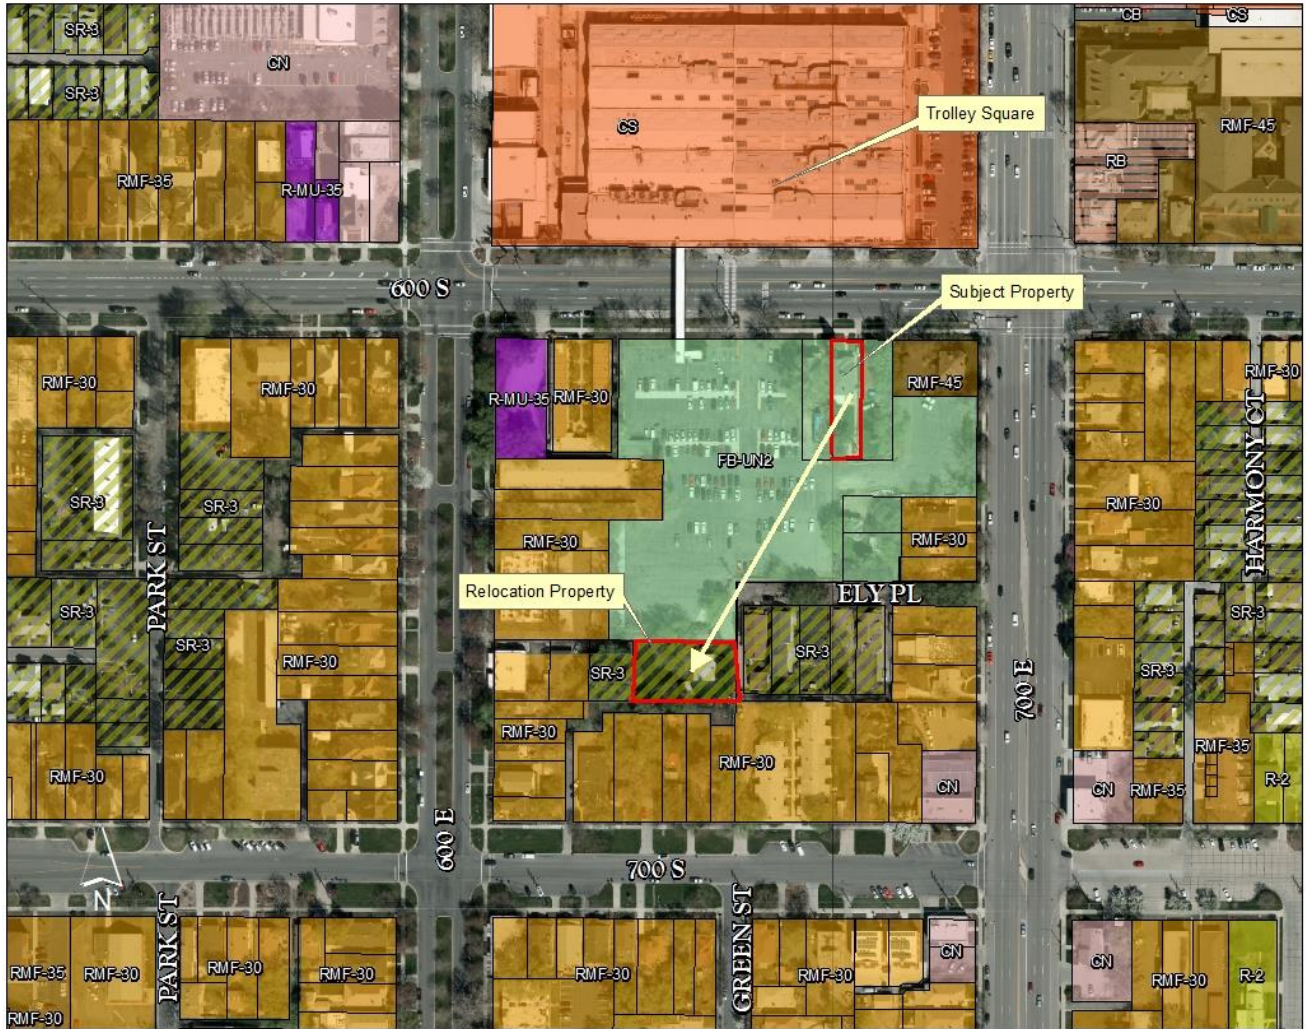
ATTACHMENT A: VICINITY MAP

A request by Trolley Square Ventures, LLC, to relocate the structure located at 658 E. 600 South to approximately 630 E. Segoe Avenue in the Central City Historic District. Please see “Attachment A” which shows the proposed move. The property where the structure is currently located is zoned FB-UN2 (Form Based Urban Neighborhood District). The property where the structure is proposed to be relocated is zoned SR-3 (Special Development Pattern Residential District). The building is a contributing structure in the Central City Historic District.

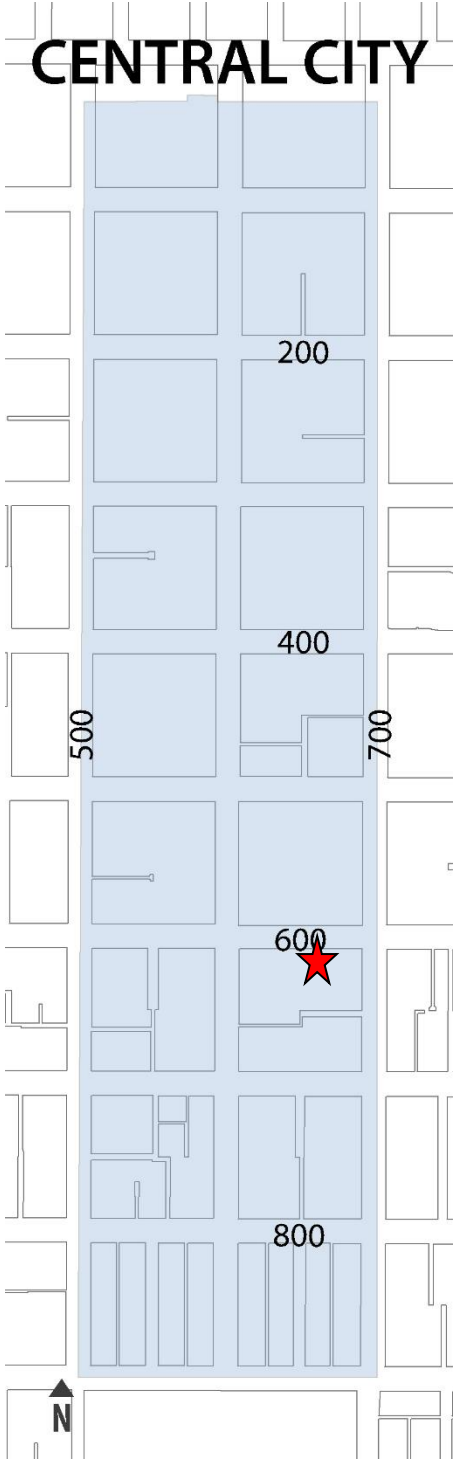
ATTACHMENT B: HISTORIC DISTRICT MAP

★ *Approximate Project Location*

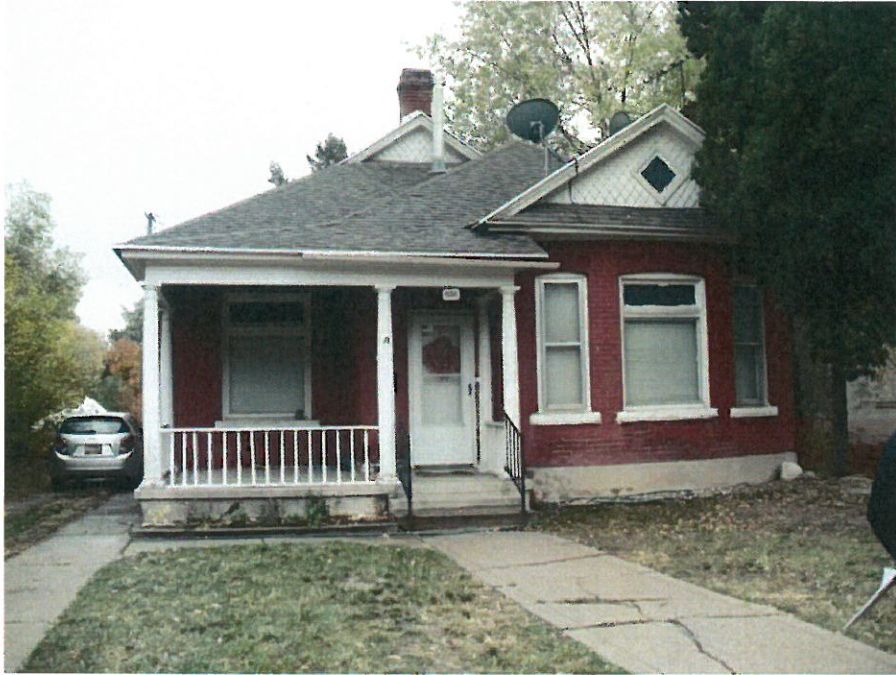
1904 Residential Structure

The residential home is located at the address noted above. The original building appears to have been constructed in 1904 based on information the owner obtained from the county assessor. The estimated building area is approximately 1146 square feet on the main floor. The building has a partially excavated

basement/crawl space. The structure is constructed of materials typical to construction at the time the building was completed, namely wood floor joists and roof joists supported by unreinforced stone or adobe walls with brick veneer.

The foundation system consists of rock foundation walls. It is unlikely that there are concrete footings beneath the rock foundation walls. Solid sawn wood timber posts are used to support the floor joist in the middle of the floor. The posts do not appear to be supported by any type of footing and are not adequately attached to the floor framing. The exterior walls of the building were constructed using unreinforced stone or adobe with a 4" brick veneer. The interior walls were covered with lath and plaster or gypsum board. The main floor is also wood framed and covered with lath and plaster or gypsum board. The roof framing consists of wood rafters.

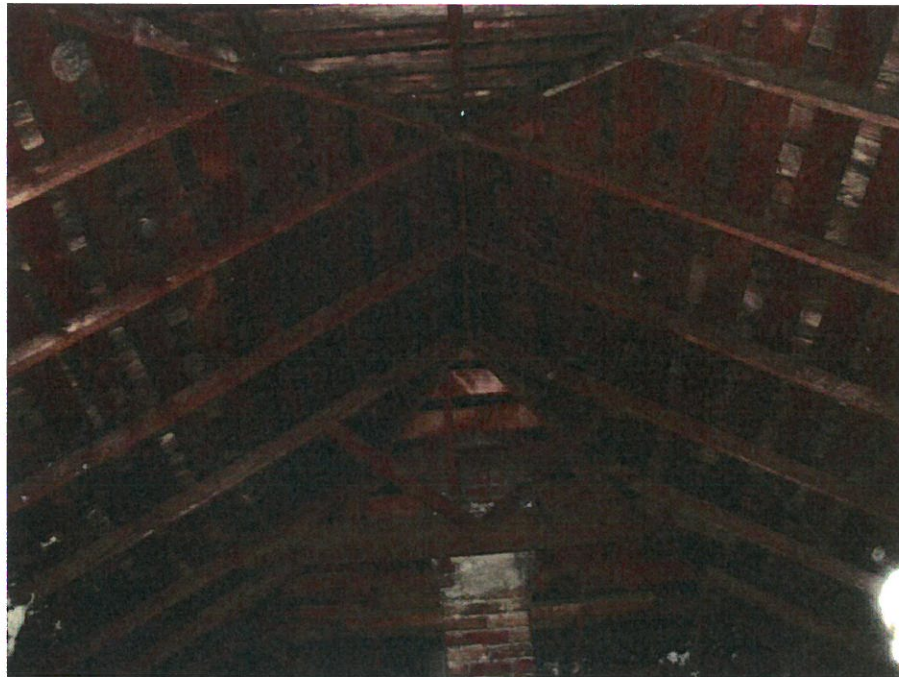
Roof framing and un-reinforced brick chimney

Another structural consideration is the roof framing. There is already evidence of significant structural distress and it is common to have no insulation in the attic space. The existing roof framing is likely inadequate if analyzed based on current code required design snow loads. The existing structure has likely not experienced a design snow event because snow accumulations would melt rather quickly with a heated building and limited or no insulation.

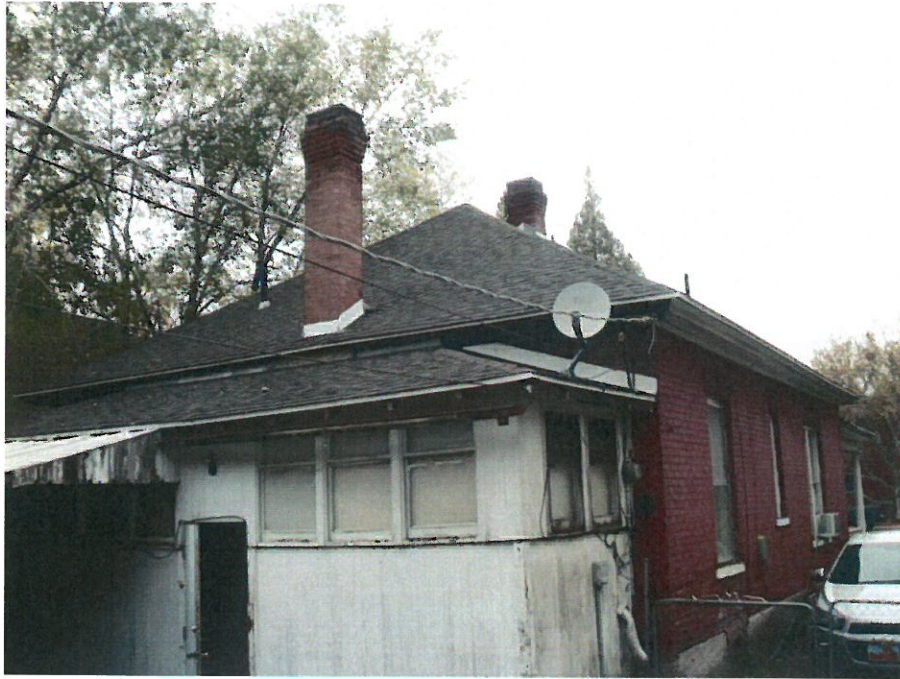
Chimney requires bracing and the roof is sagging behind the chimney

There was limited access to structural elements while conducting the visual observation. Observing and reviewing the walls, roof and floors seems to indicate that the structure has served well with no major noted structural problems, with exception to the roof joists and chimneys. The roof joists on the southern portion of the roof are visually sagging. Some of the framing members used to stick frame the roof appear to have permanent deflection. The unreinforced masonry chimney is too tall and narrow and does not meet required height to thickness ratios required by current codes. There does not seem to be any significant settling or movement in the exterior walls. The exterior rock foundation walls do not show signs of excessive settlement or cracking. A complete observation of the structural conditions of other various elements and connections was not observed due to building finishes and safety concerns.

Based on the limited evaluation and observation completed for this residential structure, it is our opinion that the structure lacks the necessary strength and construction detailing to resist significant seismic (earthquake) or wind forces. It also appears to have an overstressed roof structure. The unreinforced brick chimney would need to be braced back to the roof structure. Solid sawn wood posts in the basement would require new footings and positive attachments to the floor beams. It is likely with proper evaluation, analysis, and design; the building can be rehabilitated to resist some specified level of seismic force. To rehabilitate this structure would require a significant tear down of existing roof elements in order to support gravity loads (code prescribed dead loads and roof snow loads) and resist some specified level of seismic force.
