Staff Report

Re: Petition PLNHLC2016-00918, Demolition of the Residential Structure at 658 E. 600 South

DEMOLITION OF A CONTRIBUTING STRUCTURE IN A LOCAL HISTORIC DISTRICT

PROPERTY ADDRESS: 658 E. 600 South

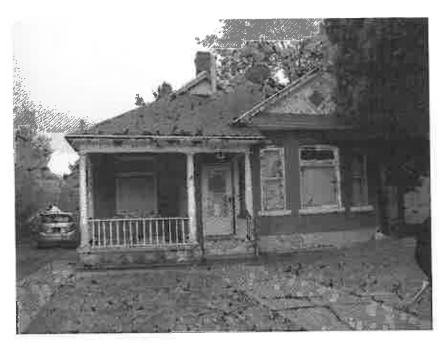
1904 Residential Structure

The residential home is located at the address noted above. The original building appears to have been constructed in 1904 based on information the owner obtained from the county assessor. The estimated building area is approximately 1146 square feet on the main floor. The building has a partially excavated

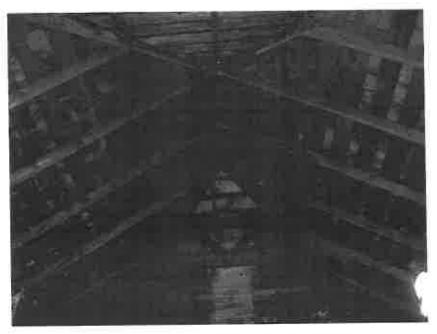
Roof framing and un-reinforced brick chimney

Another structural consideration is the roof framing. There is already evidence of significant structural distress and it is common to have no insulation in the attic space. The existing roof framing is likely inadequate if analyzed based on current code required design snow loads. The existing structure has likely not experienced a design snow event because snow accumulations would melt rather quickly with a heated building and limited or no insulation.

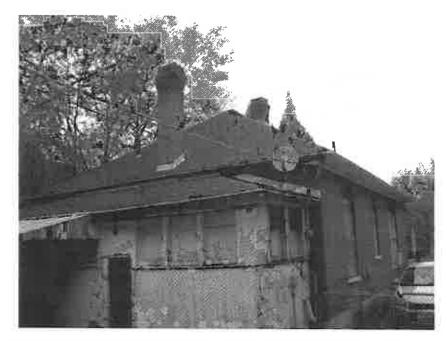
Chimney requires bracing and the roof is sagging behind the chimney
