Staff Report

To: Salt Lake City Historic Landmark Commission
From: Carl Leith, Senior Planner
801 535 7758 or carl.leith@slcgov.com
Date: May 3, 2018
Re: **PLNHLC2018-00167 Roof Alterations at approximately 501 4th Avenue**

REQUEST: Roof Alterations at approximately 501 Fourth Avenue – A request by David Richardson, Capitol Hill Construction, on behalf of owners Robert and Annette Becker, to relocate a HVAC unit onto the roof of this building and to replace the principal roof material with standing seam steel roofing. The house is a contributing building in The Avenues Historic District, is on a corner lot and the proposed alterations would face and be visible from Fourth Avenue and G Street. This proposal is being referred to the Historic Landmark Commission for decision because the proposed roofing system is not a material characteristic of residential structures in a historic district. The subject property is zoned SR-1A (Special Development Pattern Residential District).

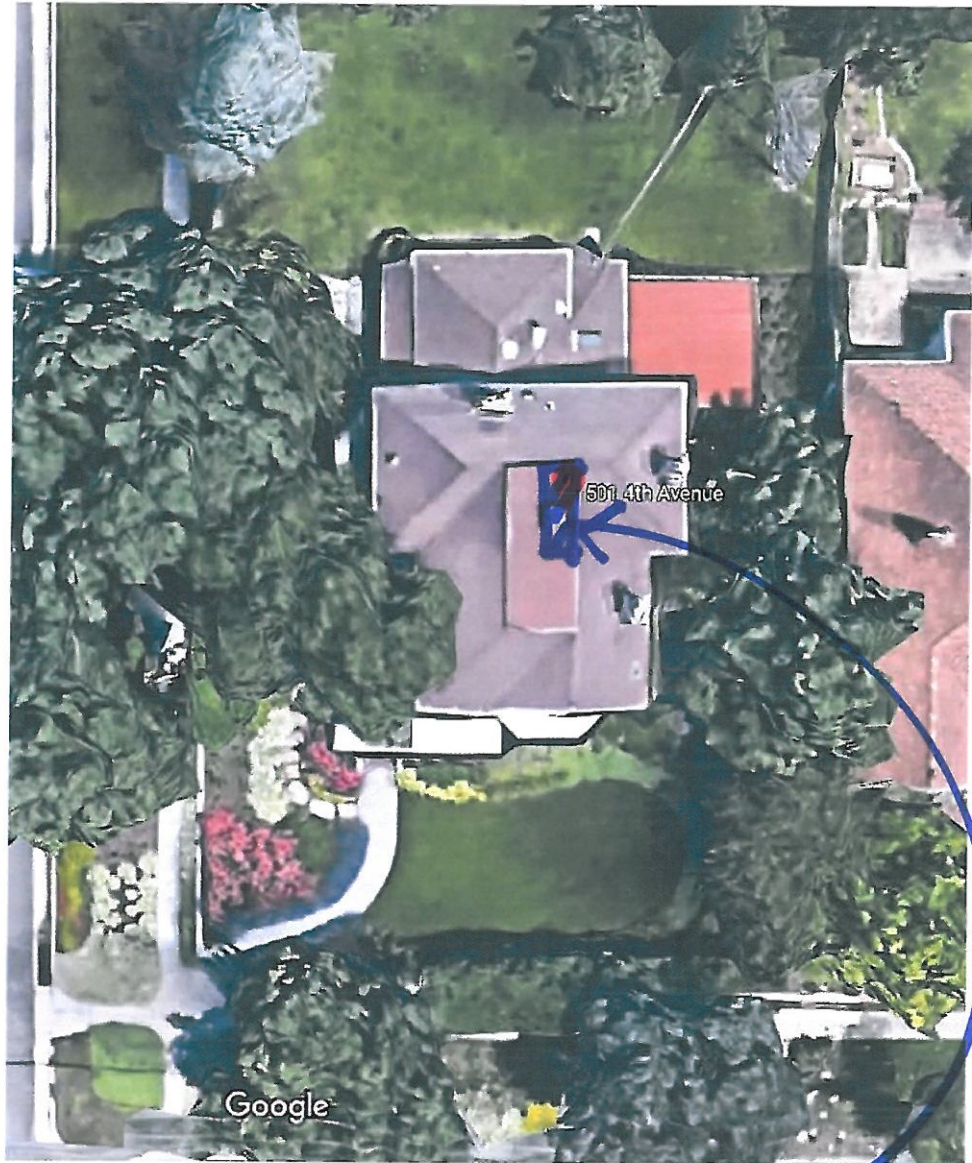
LOCATE ROOF TOP
HVAC EQUIPMENT IN
THIS AREA ONLY.

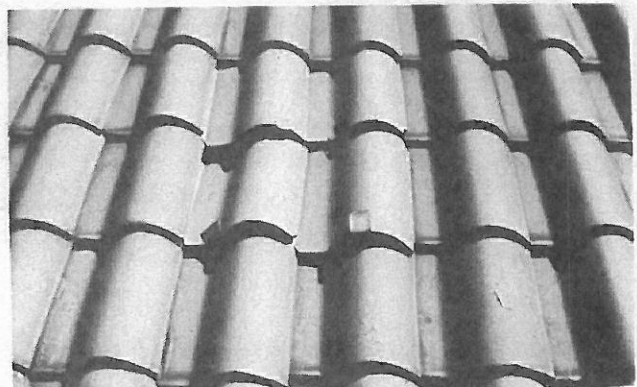
Repairs on this pantile roof were made with new tiles held in place with metal hangers. (Main Building, Ellis Island, New York)

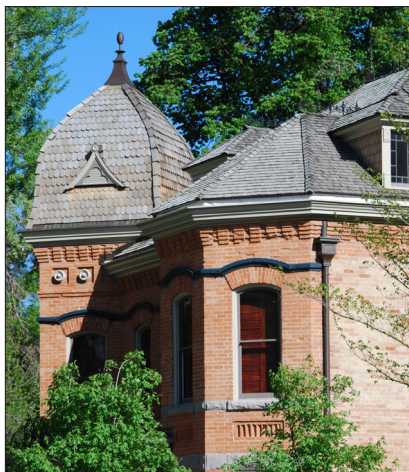
*Asphalt Shingles
Appropriate for: All except Spanish
Colonial Style*

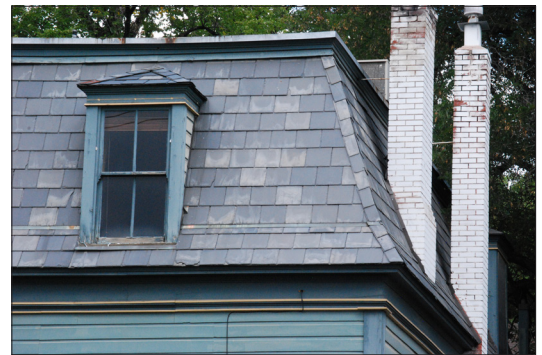
Natural slate is rare in the city and is the most durable of traditional roof materials, usually requiring only piecemeal replacement of damaged individual slates.

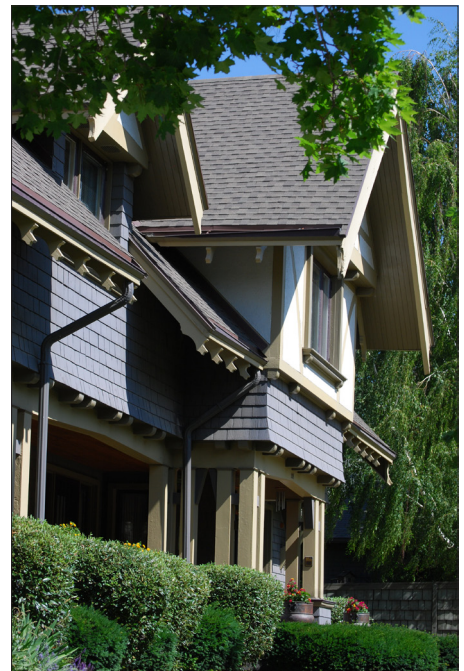
Gables, deep eave profiles & rafter tails are key elements of the design.

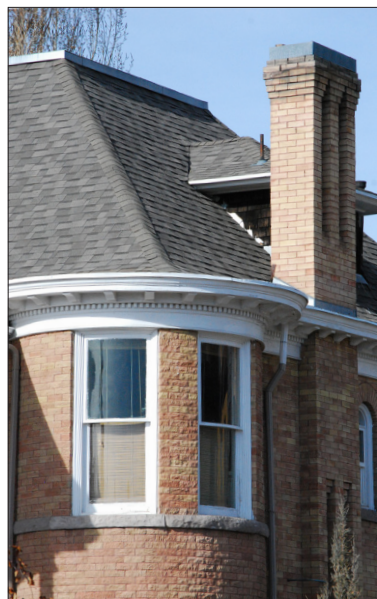
Asphalt shingles are the typical and appropriate roofing material for this style and period of architecture.

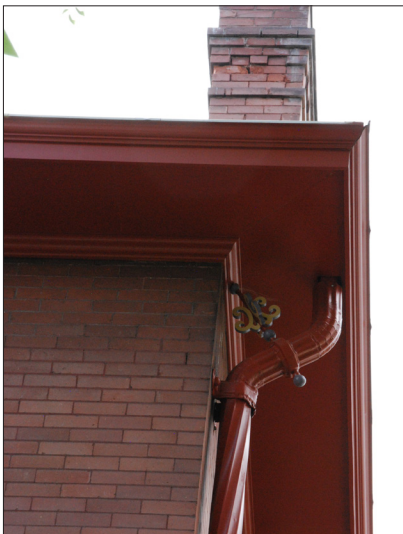
Gutters and downspouts may be a considered part of the building design.

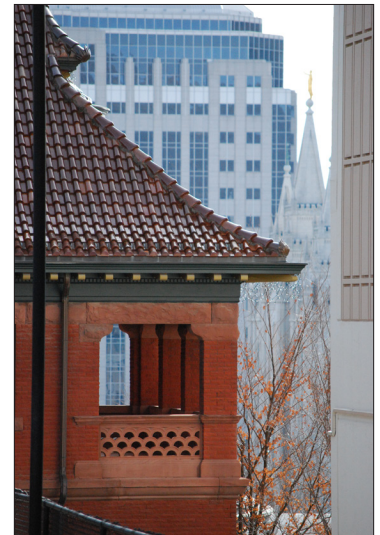
Cedar, clay and slate create special roof textures, colors and character.

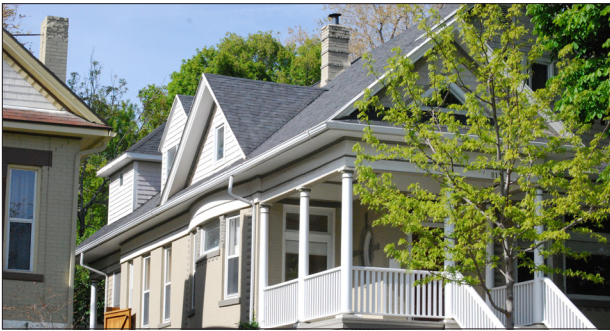
Rear addition designed to integrate with the historic roof form.

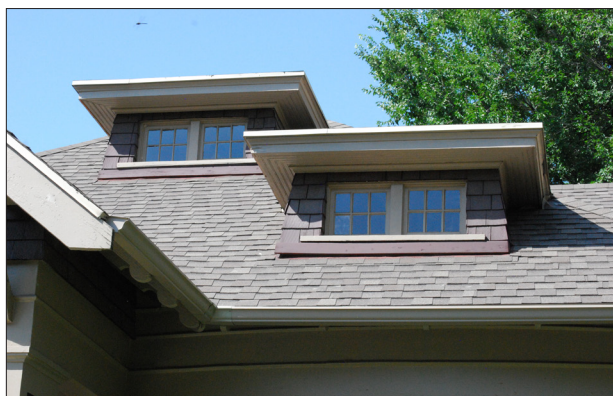
Dormer design is usually an integral part of the roof composition.
