Staff Report

To: Salt Lake City Historic Landmark Commission
From: Mayara Lima
(801) 535-7118 or mayara.lima@slcgov.com
Date: November 1, 2018
Re: PLNHLC2018-00517 - Minor Alteration
PLNHLC2018-00676 - Special Exception

Minor Alteration & Special Exception

PROPERTY ADDRESS: 1017 E 1st Avenue

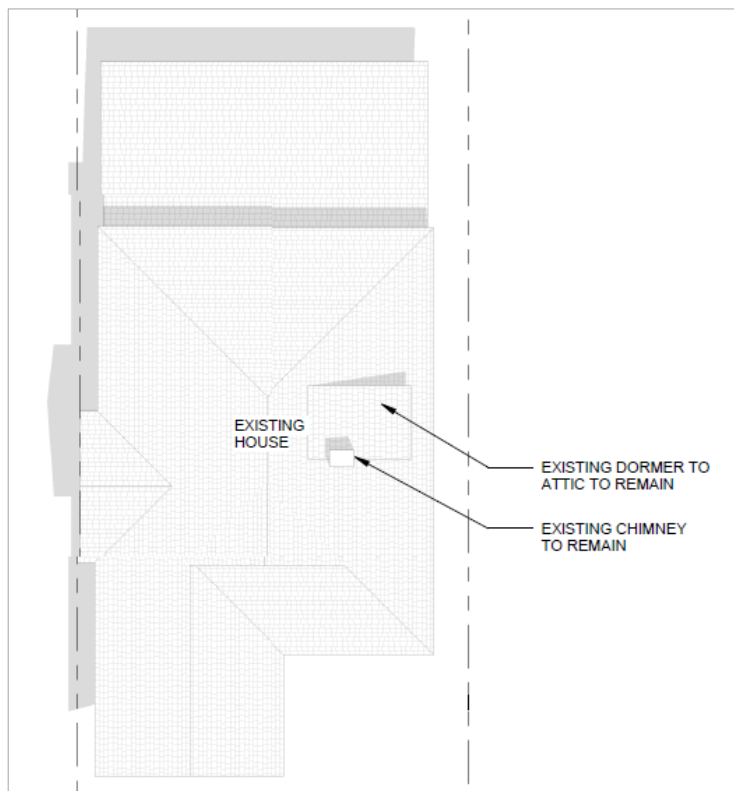
Figure 1 - Roof plan of the historic home before the attic additions

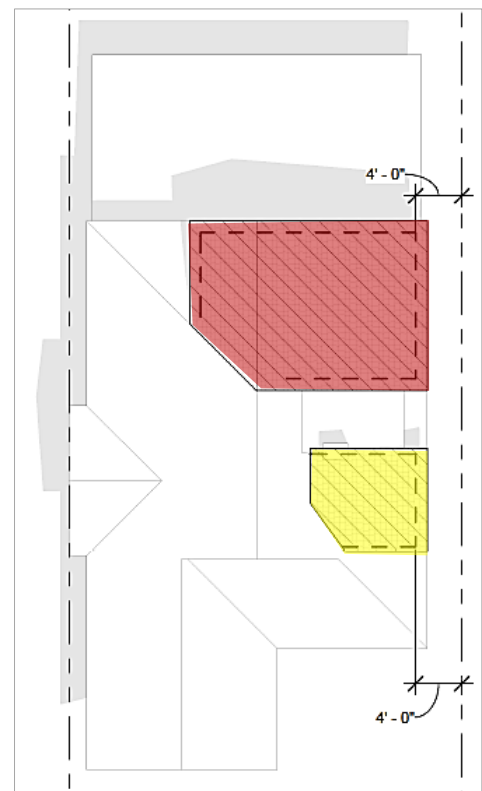
The applicant wishes to maintain as is the already constructed attic additions. The additions consist of a dormer on the east (side) façade, and a rooftop addition on the north (rear) façade of the historic home. The purpose of the additions was to provide sufficient headroom in the attic to create usable space.

Figure 2 – New dormer is shown in yellow and rooftop addition in red.

The two attic additions are rectangular in massing and located adjacent to an existing shed dormer, which was also re-cladded without permits, and an existing chimney. The new dormer has a shed roof form situated below the ridge of the roof of the existing home with a pitch similar to the slope of the roof of the existing east dormer. The rooftop addition follows the ridge of the roof of the existing home and adds height to the east side of the home.

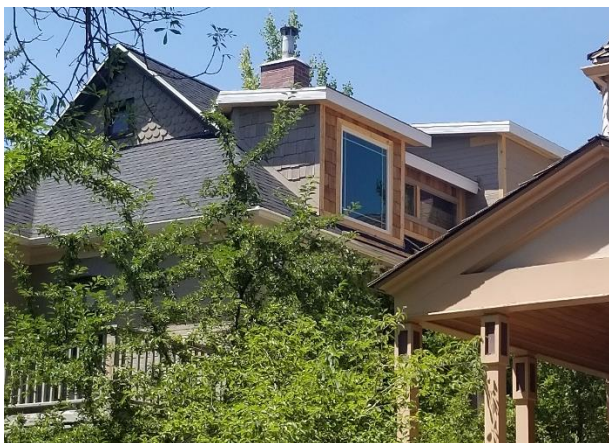
The new dormer and the existing dormer were cladded with natural wood shingles on all sides. The rooftop addition was cladded with a combination of painted white pine siding, natural wood shingles and rough sawn shiplap panels. The material choice of natural wood shingles was an attempt to relate to the existing wood shingles on the front gables of the historic home.

Figure 4 – Dormers were cladded with wood shingles

The wood shingles installed on the new attic additions are different from those present on the front gables of the existing historic home. The former is rectangular-shaped while the latter is fishscale-patterned. The variation of materials can be found in some examples of the same period and architectural style, but are typically used in combination on the same building façade to create wall texture variations. The different shingles used separately draws attention to the dormers, which is strongly discouraged in attic additions.

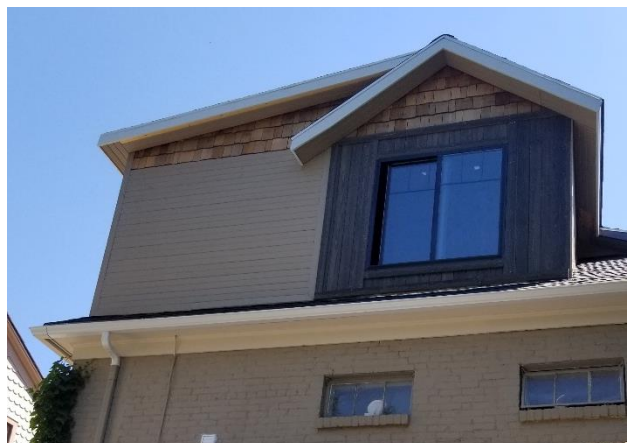
Figure 5 – Cladding of rooftop addition includes wood shingles, pine siding and rough sawn shiplap panels.

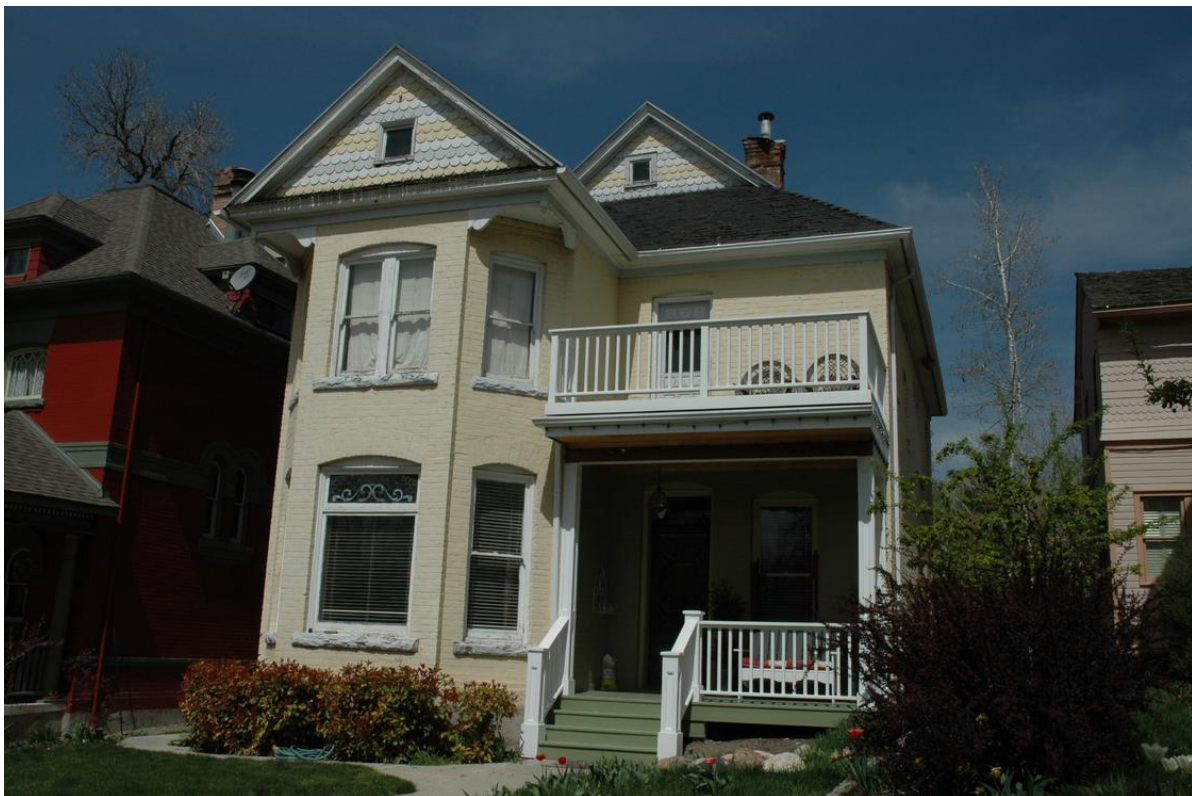
The original portion of the home is primarily made of brick, with sandstone foundation, and patterned wood shingle accents on the front gables. A brick chimney sits on the side of the gable on hip. The front porch/balcony, rebuilt in 1997, is made of wood and the front gable is supported at the corners by scroll-sawn wooden brackets. All windows have arched brick openings and stone sills, and the large, single paned front window has an art-glass transom. There are also small square windows placed on each of the two front gables.

Figure 6 – Front façade of the historic home in 2007.

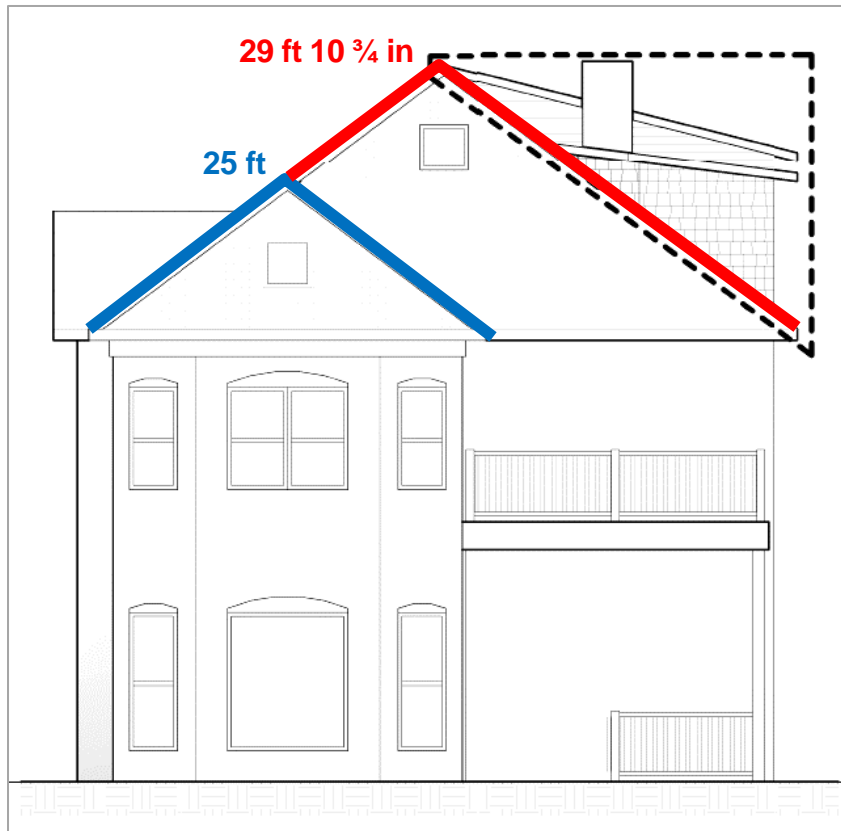
Submitted plans show that the central block of the home measures approximately 29 feet, 10 ³/₄ inches from the existing grade to the peak of the hipped roof. The secondary roof form is the front gable, which measures approximately 25 feet above existing grade.

Figure 7– Schematics of primary and secondary heights of the historic home.

The applicant is requesting Special Exceptions for both additional building and wall height. The SR-1A zoning district limits overall building height to 23 feet for pitched roof forms, and to 16 feet for flat roof forms. The rooftop addition has a pitched roof form that matches the ridge of the existing roof at approximately 29 feet, 10 ³/₄ inches. The new dormer has a flat roof form that measures approximately 26 feet, 6 inches in height. In this case, the applicant is not requesting to exceed the established overall height of the historic home.

The maximum permitted exterior wall height is 16 feet for walls placed at the building setback established by the minimum interior required yard. The wall of the rooftop addition that is adjacent to the interior side yard measures approximately 26 feet, 1 inch and the wall of the new dormer measures approximately 25 feet, 1 inch. Based on the plans submitted, the walls of the existing home do not exceed 18 feet, 5 inches in height. In this case, the applicant is requesting to exceed the established height of the existing home by more than 6 feet.

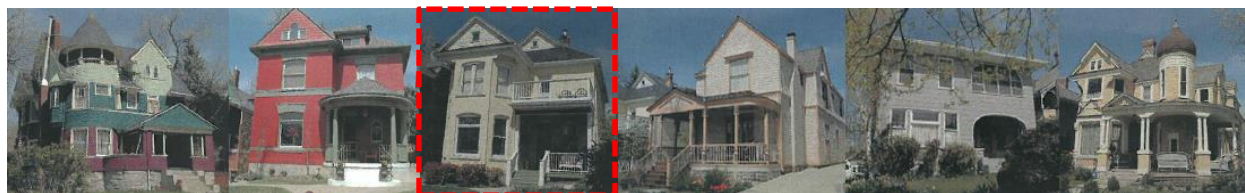
Figure 8 – Single-family homes located on the same block face. Subject home is marked in red.

As can be seen in Attachment D, all structures along 1st Avenue between Q and R Streets are considered to be contributing to the Local Historic District. All the principal structures on the block face are 1890s Victorian Eclectic two-story to two and a half-story single-family homes. Four out of the six homes are Queen Anne style structures with all or some shingle siding on the front facade.

The majority of the homes on the north and south block faces of 1st Avenue between Q and R Streets have similar roof structures, which consists of hip roof forms and front gables. Two homes on each side of 1st Avenue have front dormers and two of the homes on the same block face have small side dormers. No rooftop additions were found on the homes.

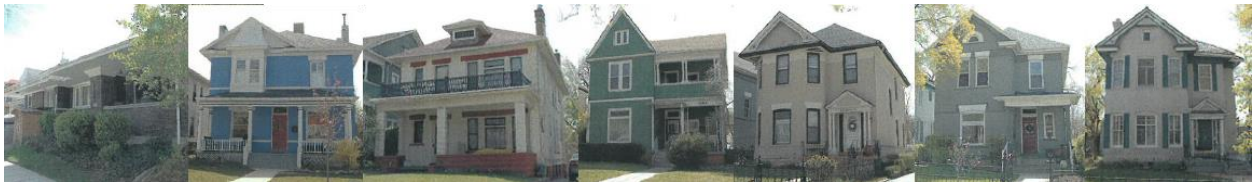
Figure 9 – Single-family home located on the block face directly across from the subject property.

The properties immediately across the block face include four 1890s Victorian Eclectic homes, two 1900s Victorian Eclectic Fourquare homes and one 1920 Victorian Eclectic Bungalow. With the exception of the Bungalow, all the principal structures on that block face are two-story homes.

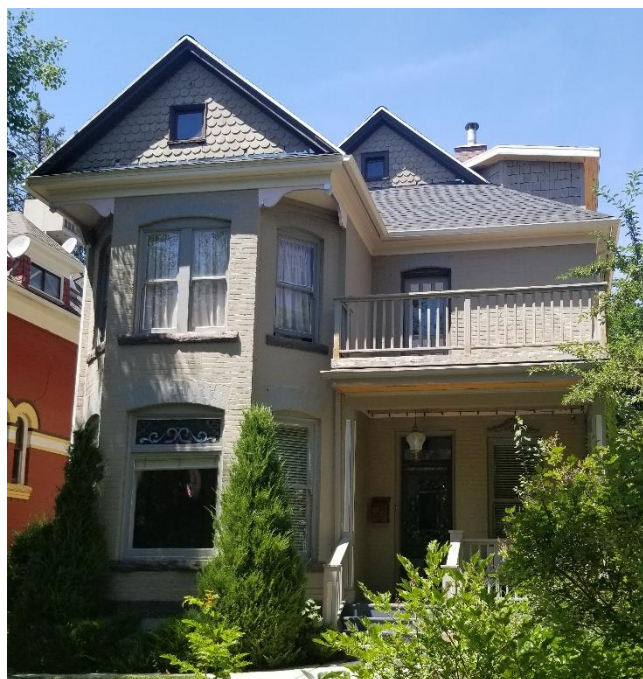
The roof form and height of this historically-contributing home is a primary character-defining element of the structure. The constructed attic additions, due to its mass, height and roof forms, have changed how the home is perceived from the street. The new shed dormer is readily visible from the front façade, and the rooftop addition, although situated back from the front of the building, is also visible from the street. Moreover, the new dormer hides a portion of the chimney, which is a significant feature of the building. Both additions are not visually compatible with the original building, interfering with how one reads the roofline of the home and compromising the home's historical significance.

Figure 11 – New dormer is readily visible from the front façade of the home.

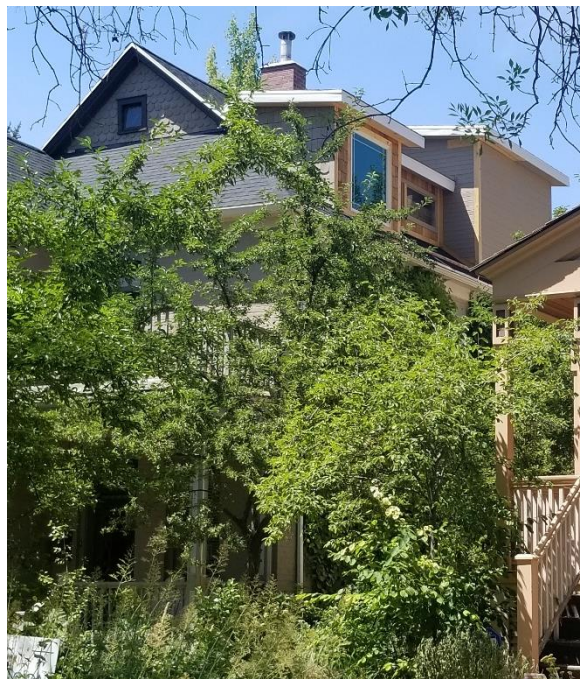
Figure 12 – Rooftop addition, although situated back from the front of the building, is also visible from the street.

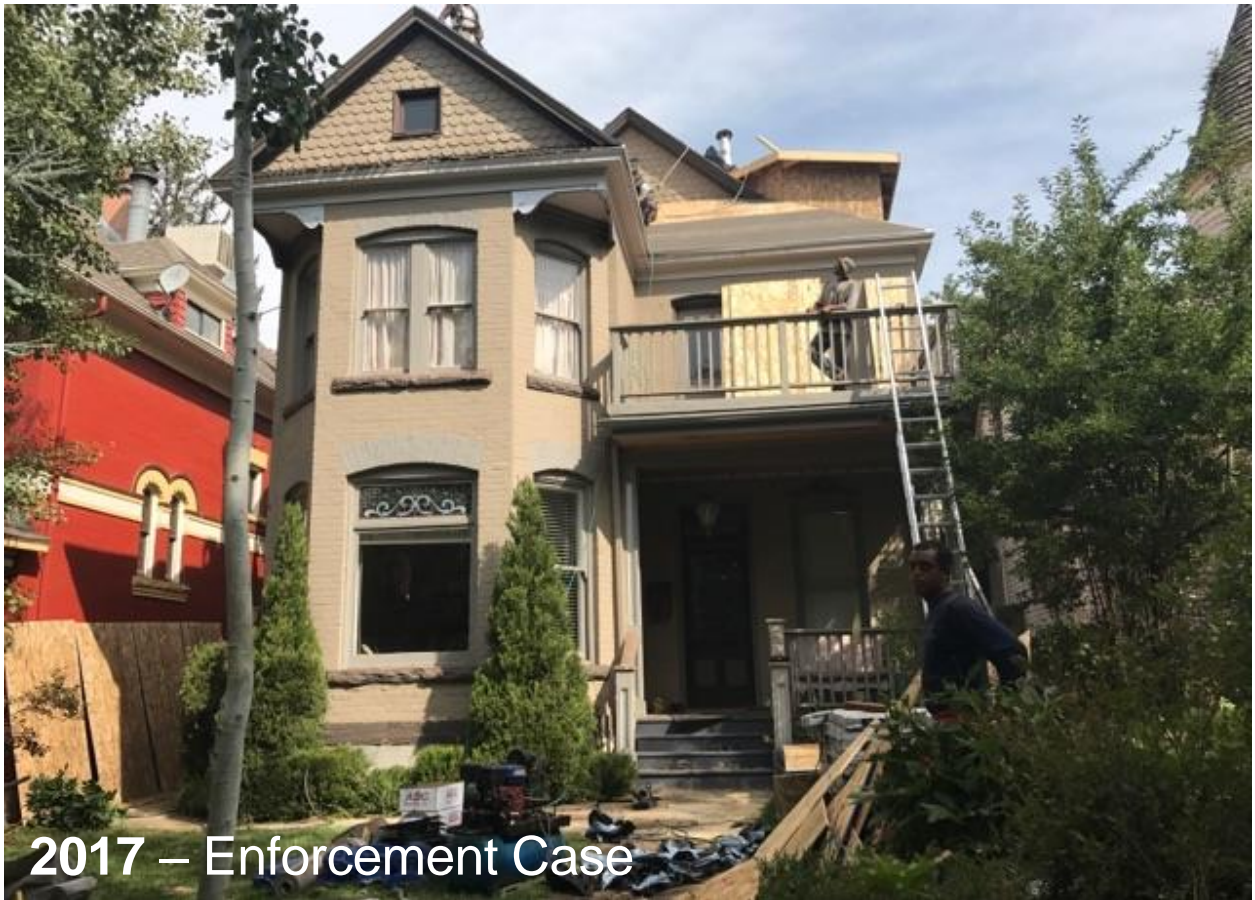
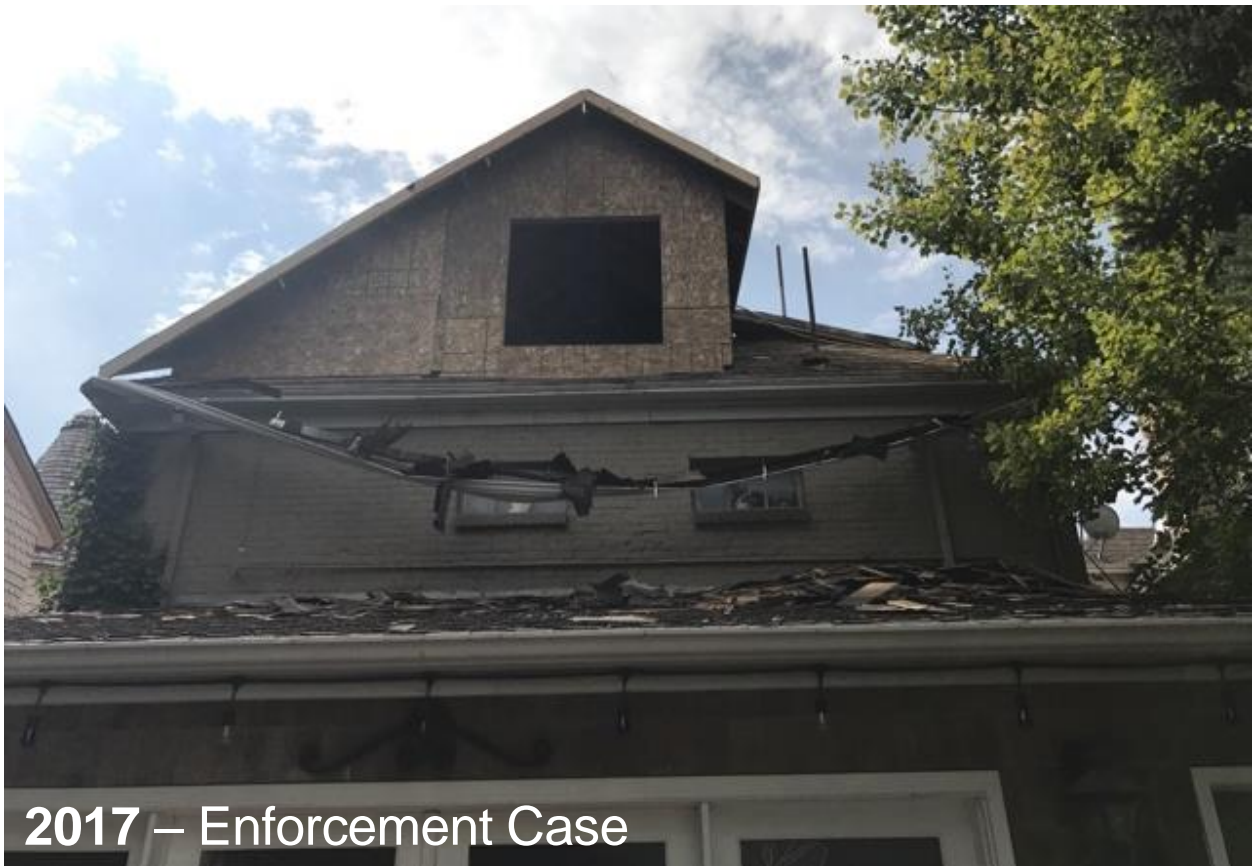
2017 – Enforcement Case

August 31, 2017 Due to a complaint, Salt Lake City Code Enforcement visited the property and found that work was being done without permits. Enforcement officer Antonio Padilla noted that the roofline had been modified. A Stop Work Order is issued under Enforcement Case # BCE2017-07680.
