# Staff Report

## ALTERATIONS TO COTTAGE & ADDITIONS TO ADJACENT BUILDING

**PROPERTY ADDRESS:** 287 G Street & 480 6<sup>th</sup> Avenue

**REQUEST: Alterations to Cottage and Additions to Adjacent Building at approximately 287 G Street and 480 6th Avenue** – Rodrigo Schmeil, Smith Hyatt Architects, on behalf of owner Pamella Jones Bloland, is requesting approval from the City to rehabilitate and to extend the existing cottage by removing the existing rear walls and constructing a new basement area. The proposals would also construct new additions to the adjacent commercial building to the south and the west of the cottage. Special Exception approvals will be required in association with these proposals. The cottage would be rehabilitated and extended as a commercial unit. The property is situated on the corner of G Street and 6th Avenue, lies within The Avenues Historic District (H Historic Preservation Overlay), and is zoned SR-1A (Special Development Pattern Residential District).

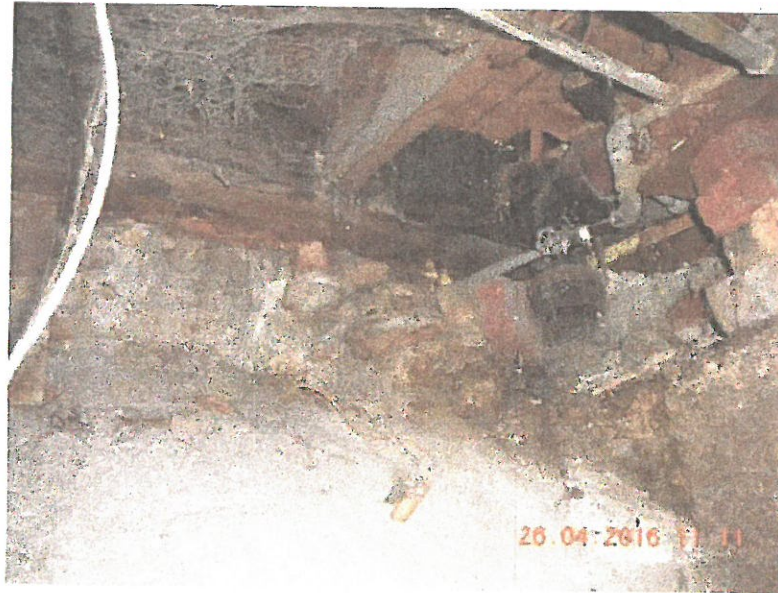
Photo 5 – Inadequate load transfer connection at deteriorating foundation

S-4	Deteriorated floor joists, non-treated wood embedded in concrete.	Remove rotten or deteriorated floor joists, new floor joists should bear on a pressure treated sill plate attached to the foundation.	1,4,5,10	3

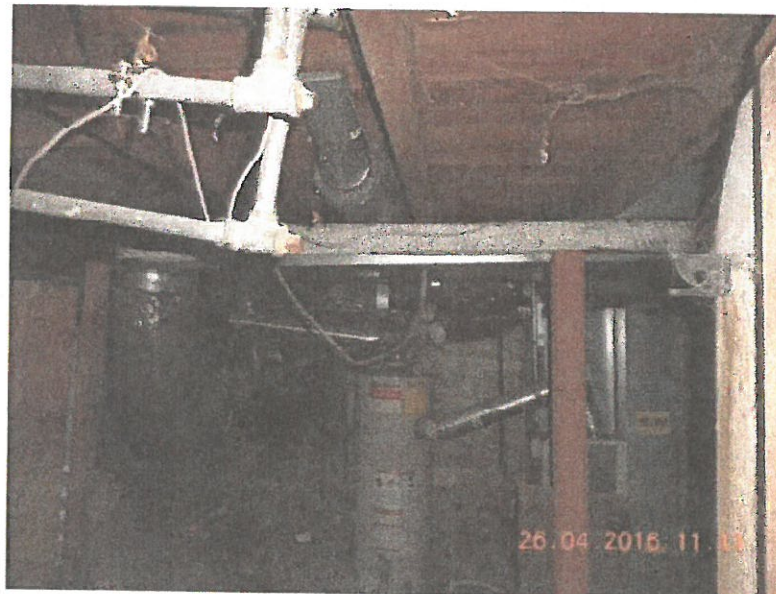
Photo 6 – Apparent added shoring for floor support

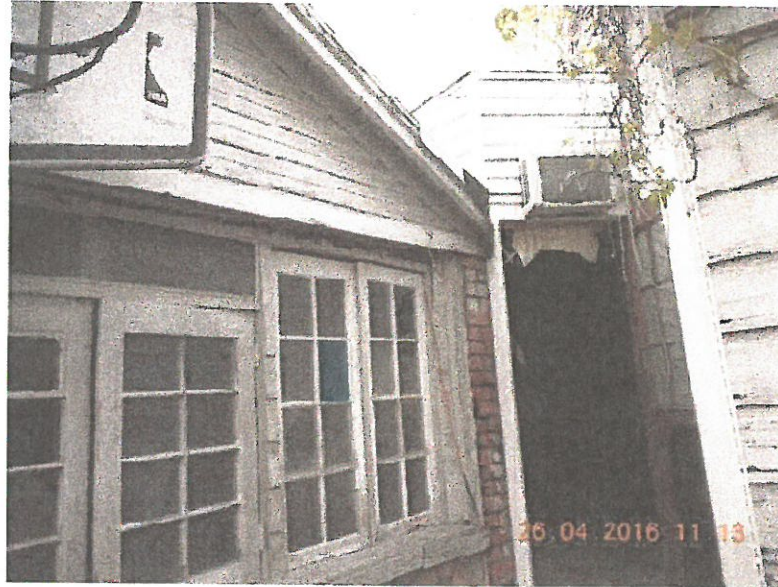
Photo 15 – Apparent addition between home and adjacent garage

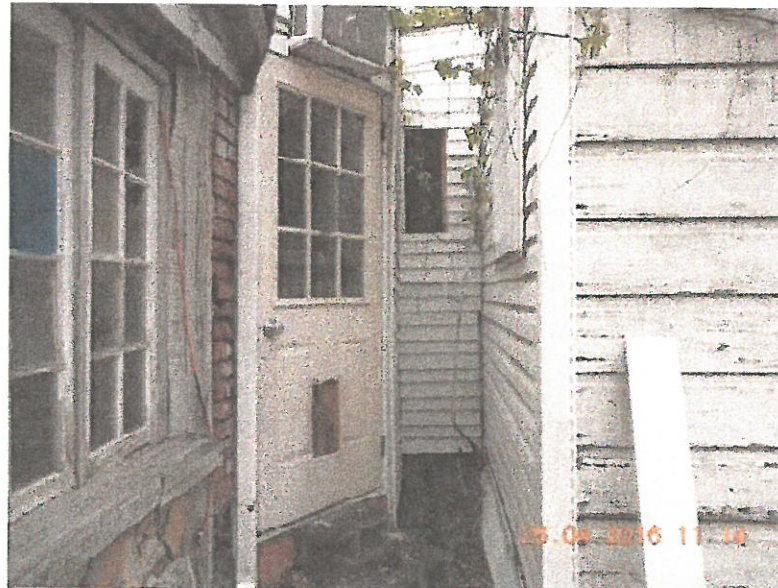
Photo 16 – Apparent addition between home and adjacent garage

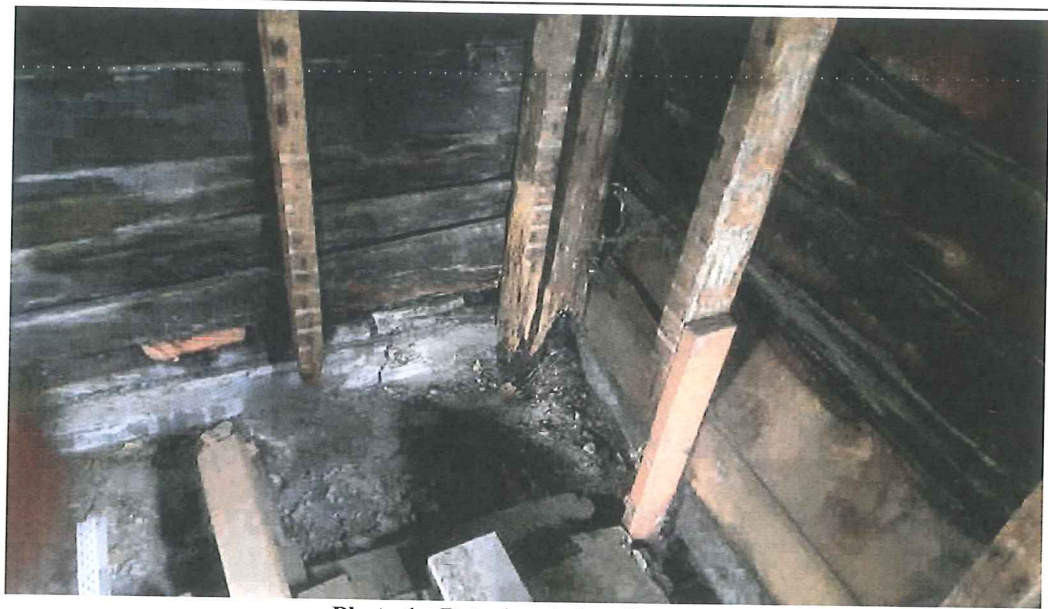
**Photo 1: Deteriorated walls studs**

Based on the observations made, this home is unsafe to occupy. The building lacks a continuous load path for both gravity and lateral loading. To bring this building up to current code, would require new footings, new and taller foundations, floor beams, spot footings, columns, wall framing, wall sheathing, roof trusses, roof sheathing, along with all interior and exterior finishes. The roof structure would need to be reframed to divert water away from portions of the building and provide proper roof drainage. The only thing salvageable would be the floor joists, and small portions of the roof framing. WCA recommends that this home be raised and a new structure be designed to be built in its place. The new structure would need to have foundations walls which extended a minimum of 6" above the surrounding grade. Typical photos of deficiencies are attached below.

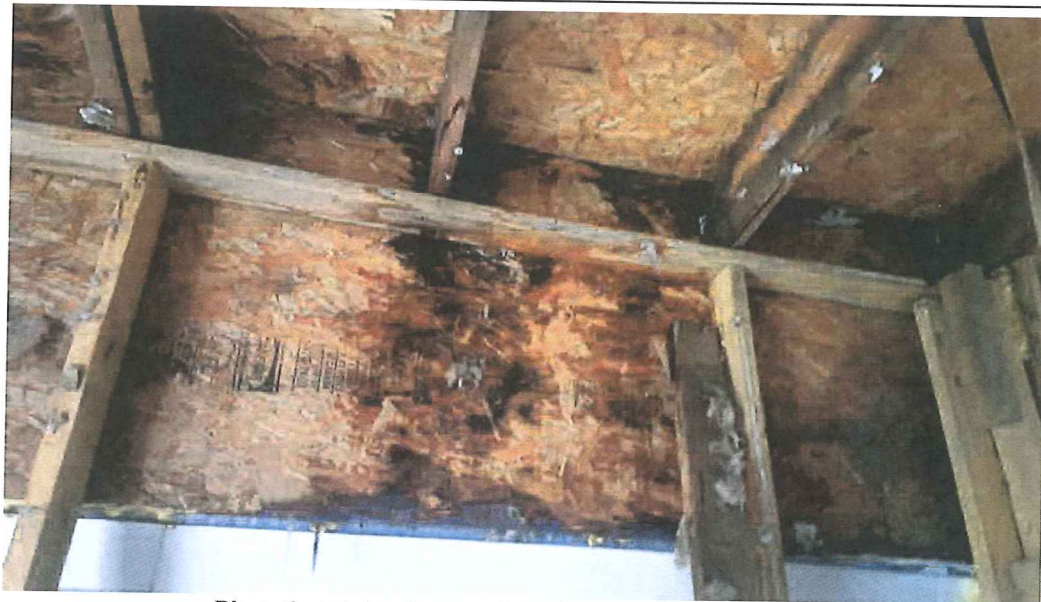
**Photo 2: Water damage from improper roof drainage**

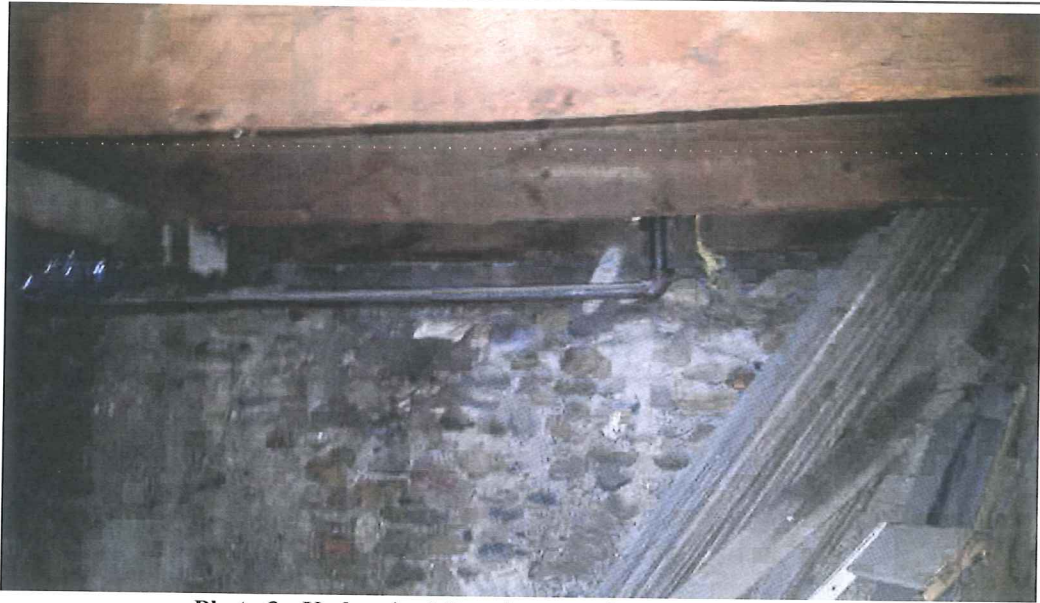
**Photo 3: Under sized floor beam and cobble foundations.**

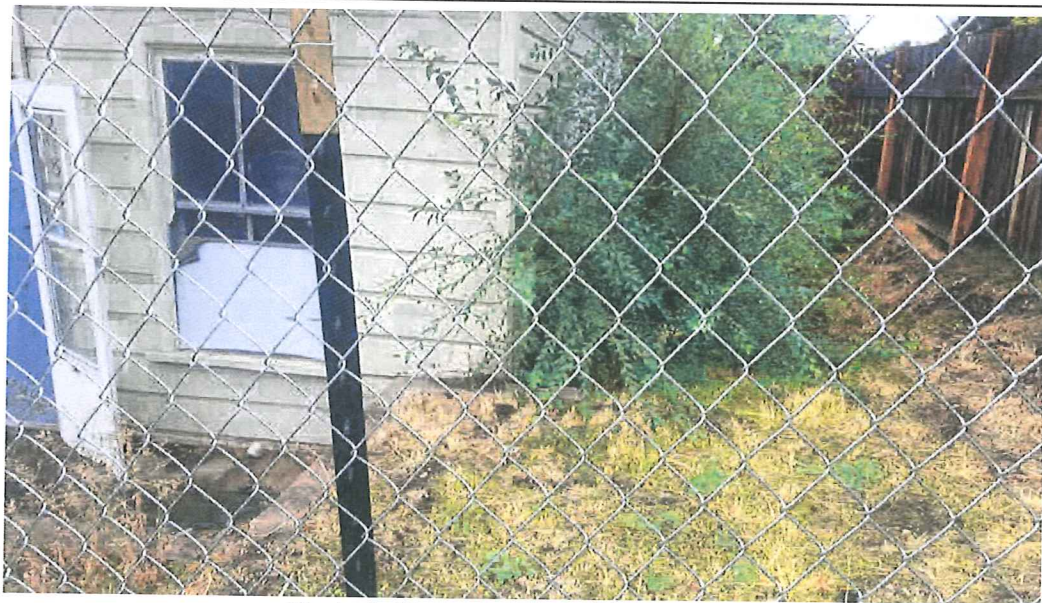
**Photo 4: Home constructed below grade.**
