Staff Report

Re: PLNHLC2020-00068, Demolition of a Contributing Structure - 58 E Hillside Avenue

Demolition of a Contributing Structure

PROPERTY ADDRESS: 58 E Hillside Avenue
PARCEL ID: 09-31-308-006
HISTORIC DISTRICT: Capitol Hill Local Historic District
ZONING DISTRICT: RMF-35– Moderate Density Multi-Family Residential & H – Historic Preservation Overlay District
MASTER PLAN: Capitol Hill Community Master Plan

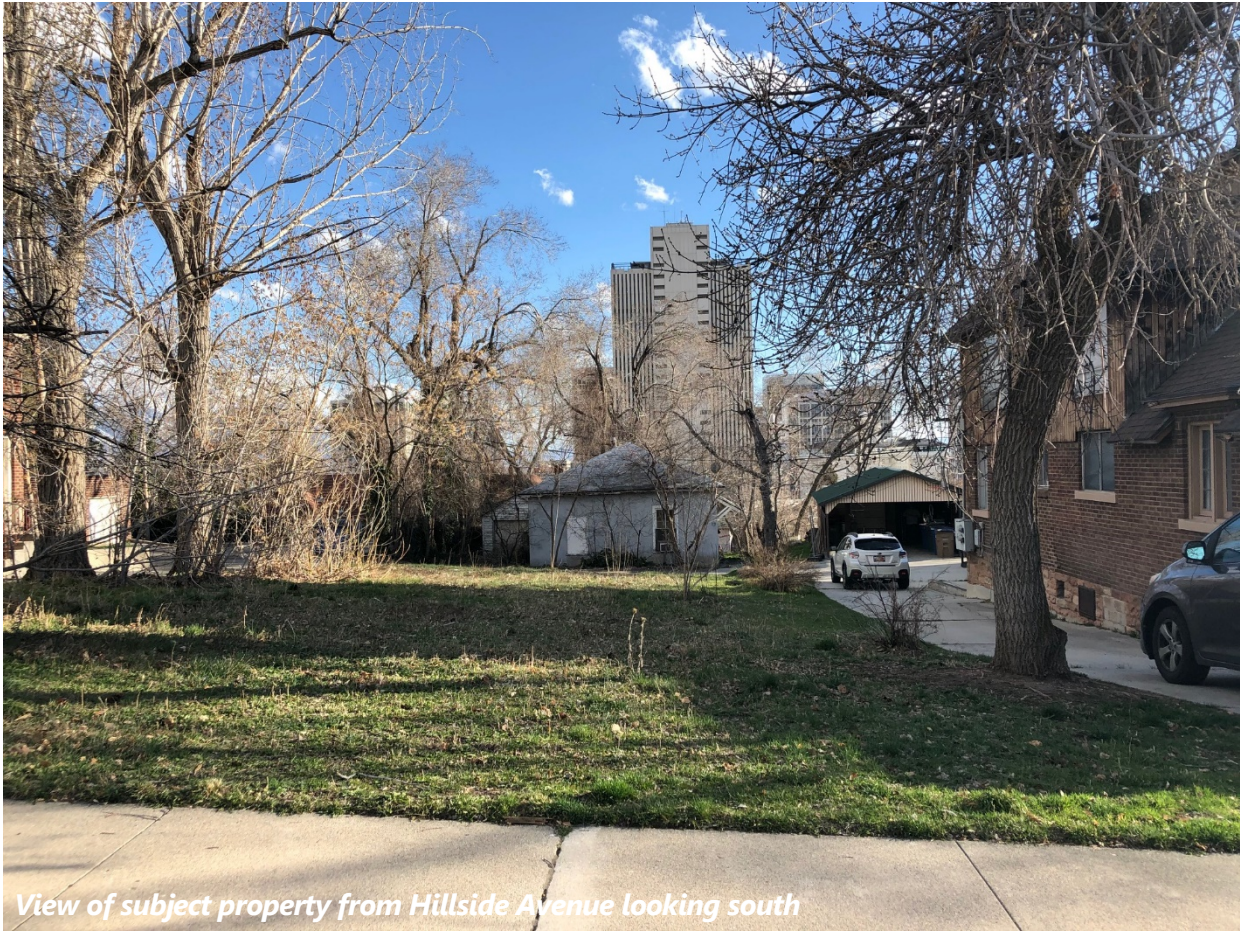
View of subject property from Hillside Avenue looking south

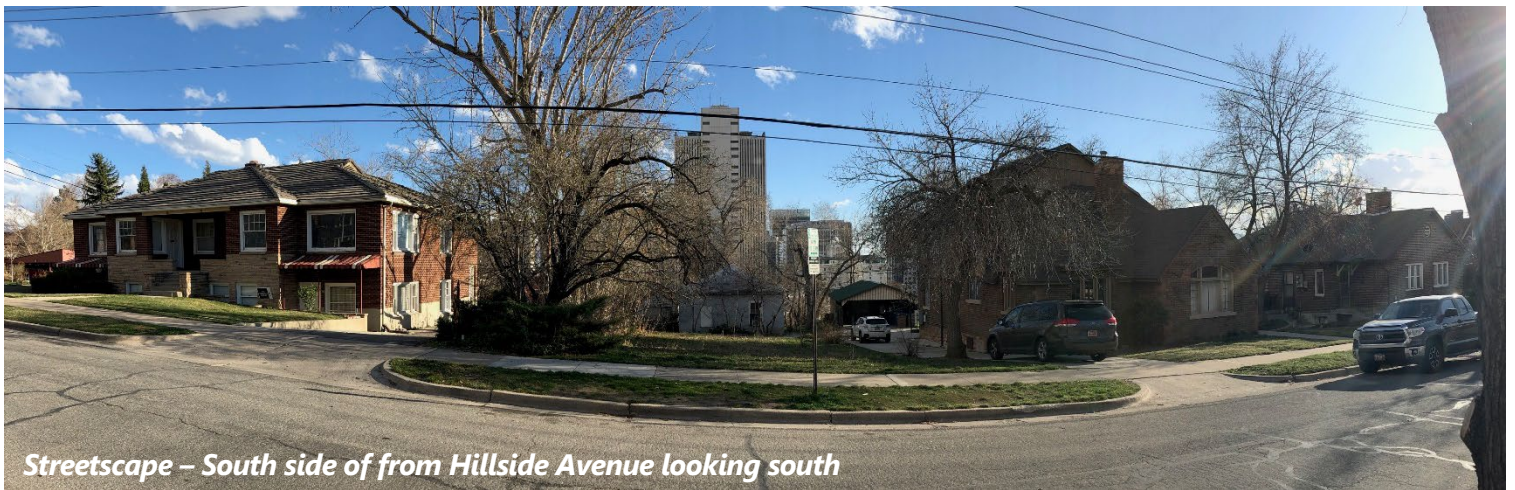
Streetscape – South side of from Hillside Avenue looking south
