# Staff Report

Re: PLNHLC2021-00605 – Re-roof

## Minor Alteration

**PROPERTY ADDRESS:** 1024 E 1<sup>st</sup> Avenue  
**PARCEL ID:** 09-32-459-007  
**HISTORIC DISTRICT:** Avenues Historic District  
**ZONING DISTRICT:** SR-1A  
**DESIGN GUIDELINES:** Residential Design Guidelines

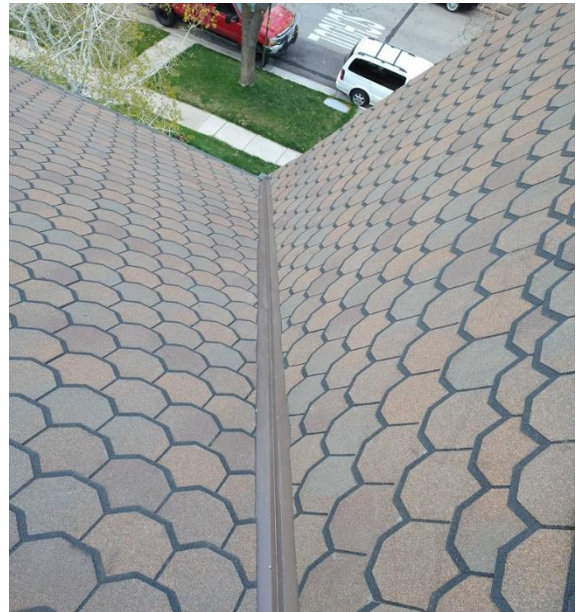
*Photograph provided by applicant of new roof. Please note that the work has already been completed.*

The project includes an asphalt shingle roof with a faux shadow line designed to look like a more dimensional shingle, creating a false sense of history and architecture. Primarily, the proposal does not meet Standard 21A.34.20.G.3 since the roofing material is designed to look like other materials.

**RECOMMENDATION:** Based on the analysis and findings outlined in this staff report, it is Planning Staff's opinion that the proposed material for a re-roof does not meet the applicable standards of approval, specifically standards 2 and 3. As such, Staff recommends that the Commission deny the request.

If the request is denied by the HLC, the applicant will not be issued a COA. The applicant could proceed with repair and replacement utilizing appropriate materials, as necessary, with another minor alteration application that could be reviewed administratively.

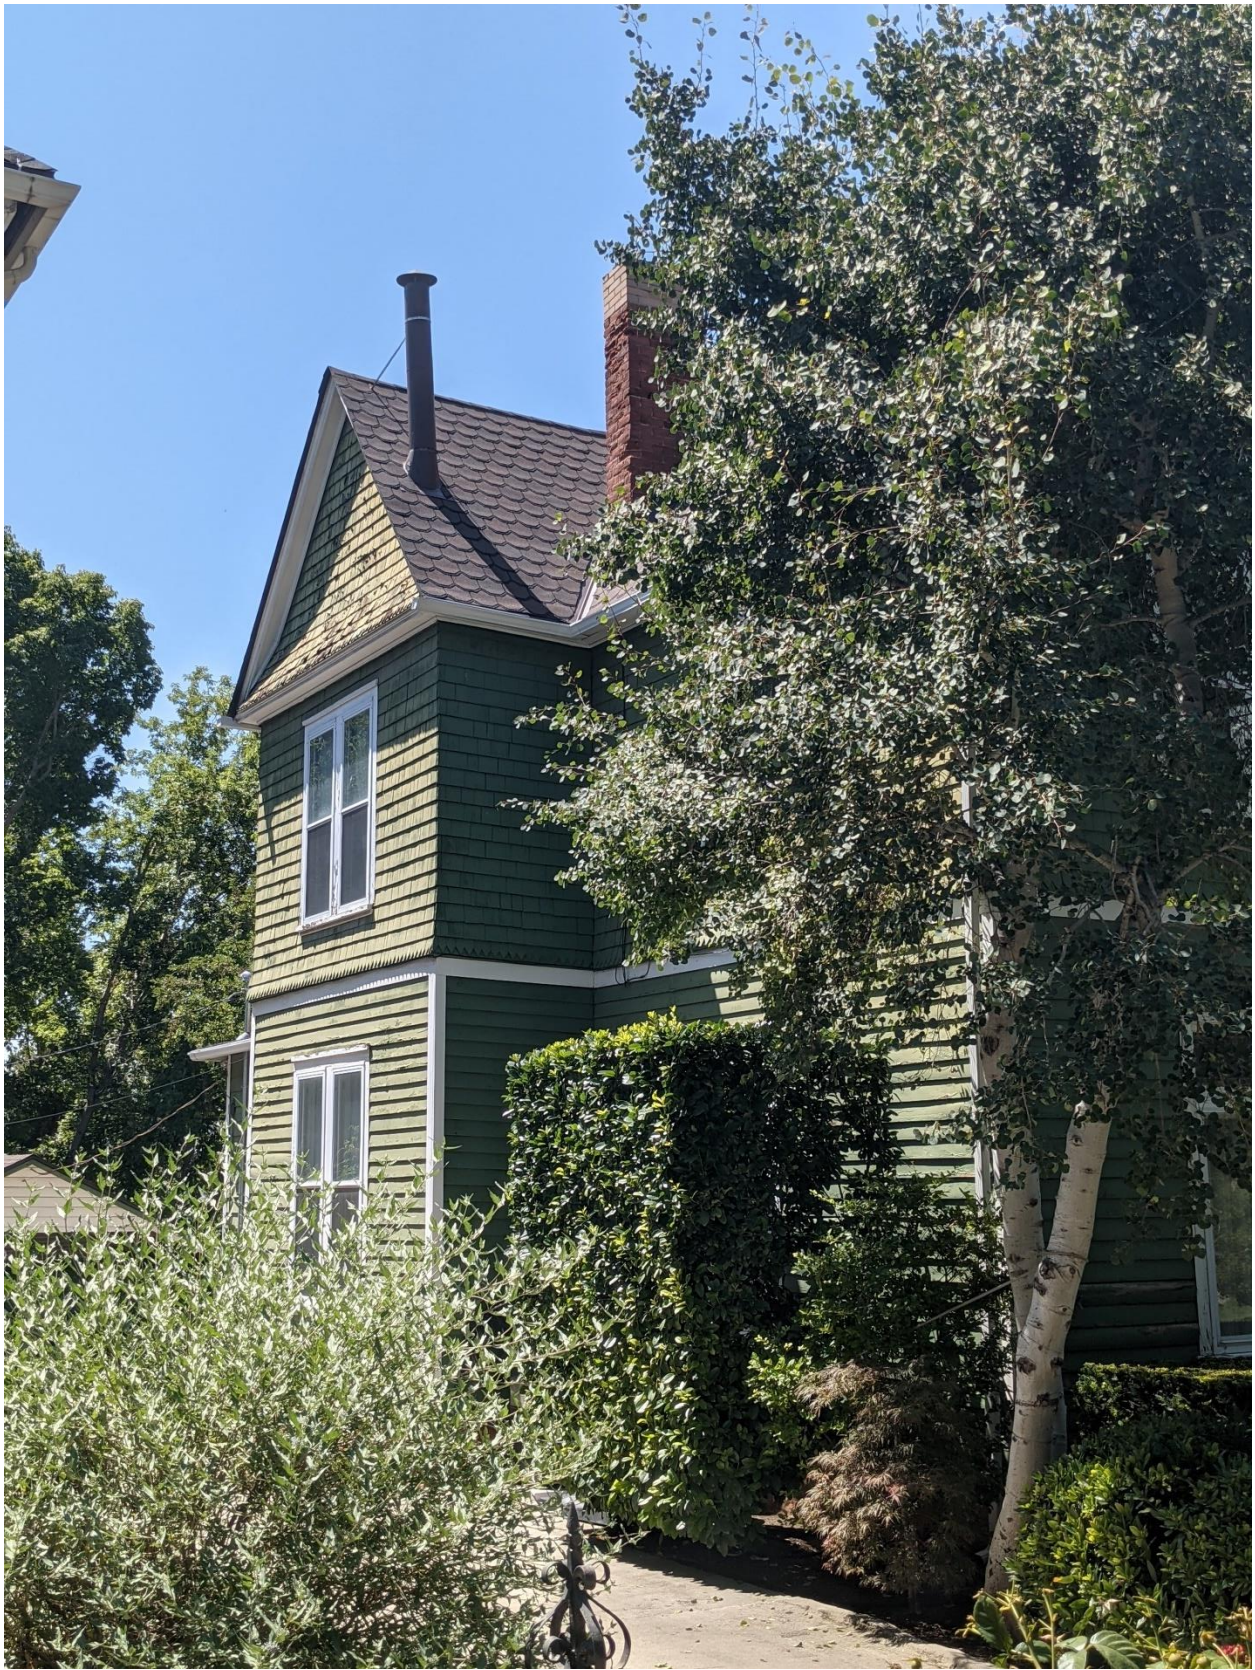
Additionally, the Historic Design Guidelines are specific in that the shingle shape and character should be similar to the original form. While it is difficult to see the roof in historical photos, more recent photos from the Avenues Local Historic District Reconnaissance Level Survey 2007-2013 appear to show a simple, typical shingle design. It is worth noting that it is somewhat difficult to see in photos given the height of the home from the grade of the street. The roof is most visible from the east-facing façade rather than directly in front of the house.

*Side/East façade*

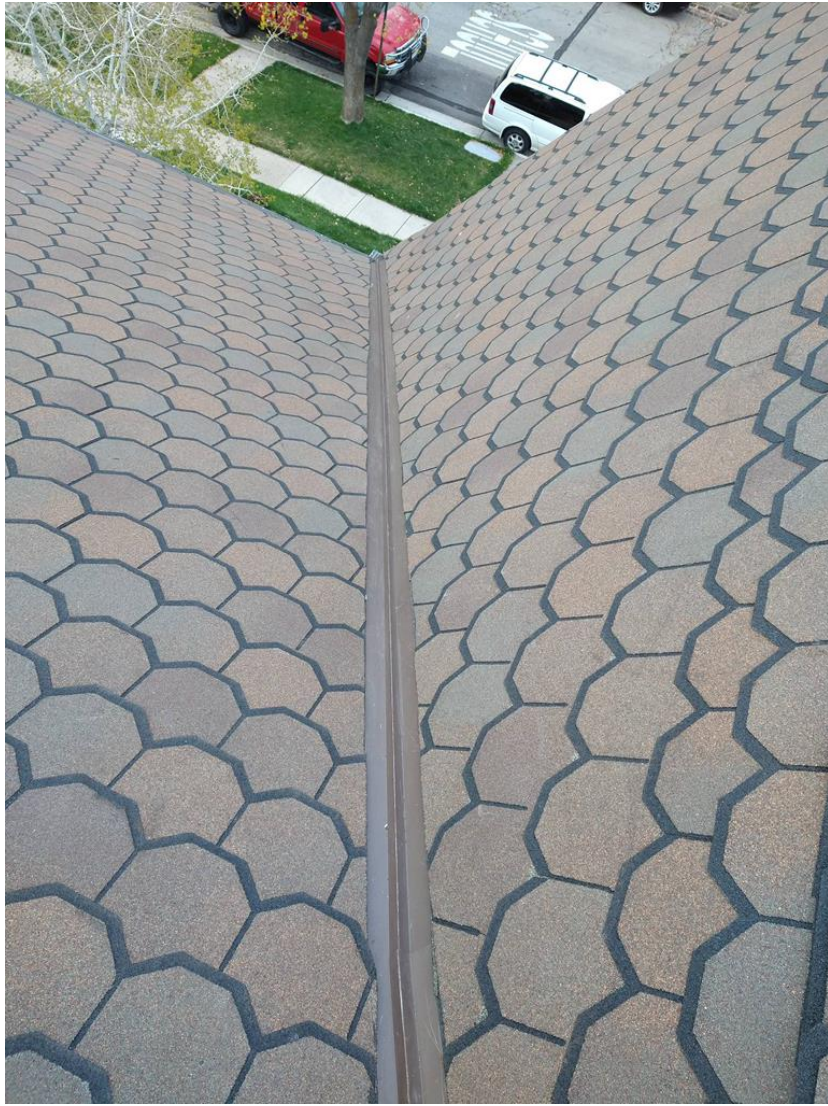
While asphalt shingles are generally an appropriate replacement material for most roofs, the design of the proposed shingles in this instance mimic a more dimensional shingle. The City's adopted historic guidelines and zoning ordinance discourage imitation materials designed to look like other materials.

*Image provided by the applicant of new re-roof*

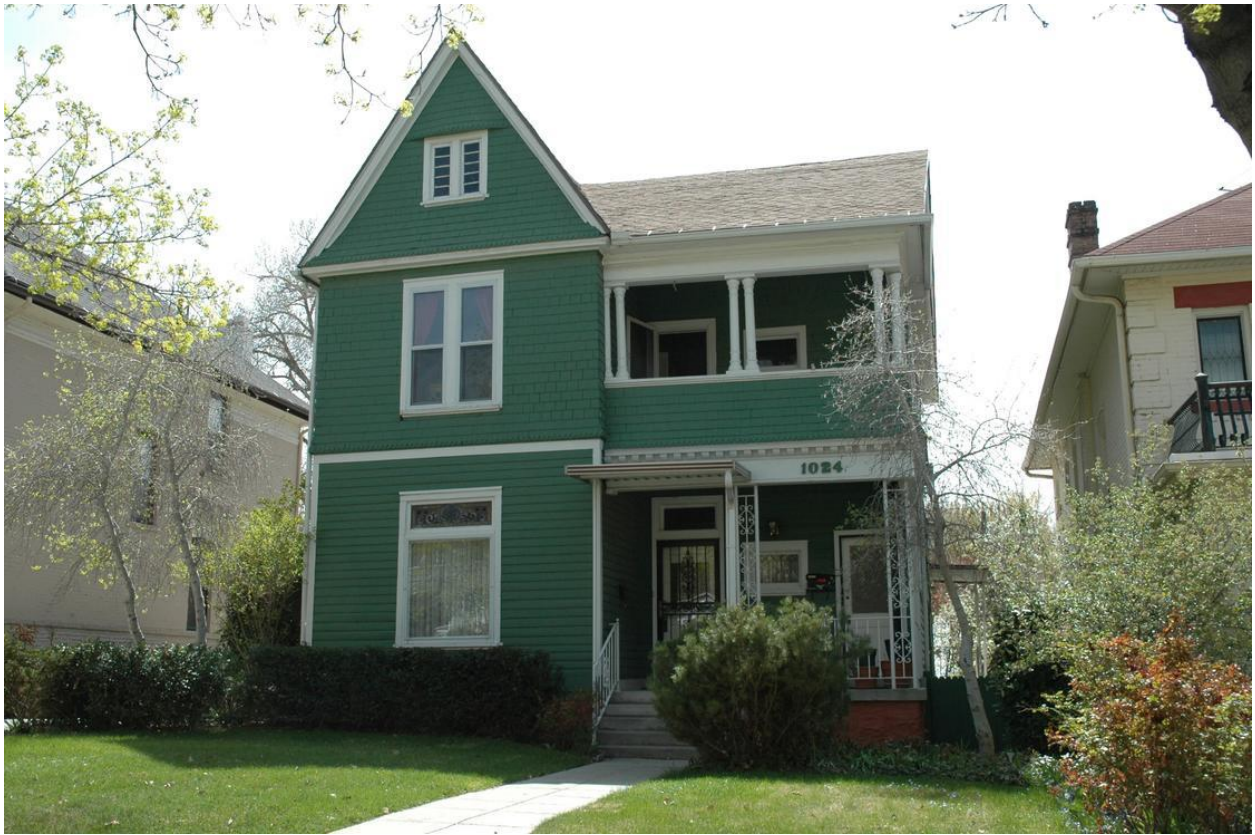
*Avenues Historic District Survey, 2007 - 2013*
