Staff Report

To: Salt Lake City Historic Landmark Commission
From: Caitlyn Tubbs
(801)-535-7706 or Caitlyn.Tubbs@slcgov.com
Date: April 7, 2022
Re: **PLNHLC2022-00180 Front Window Replacement 114 N F Street**

MINOR ALTERATION – WINDOW REPLACEMENT

PROPERTY ADDRESS: 114 N F Street

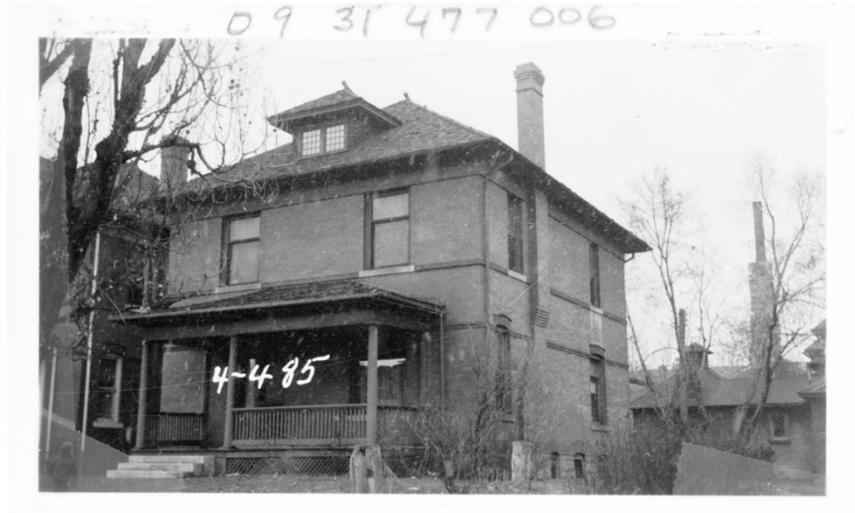
Figure 1: Photograph of subject property, courtesy Salt Lake County Archives

The subject property is a detached single-family dwelling unit which was constructed in 1900. The property is located in the Avenues Local Historic District and is listed in the 2007 survey as an Eligible/Contributing Structure. The Applicant filed a previous request for a Certificate of Appropriateness for windows on the sides and rear of the home which was approved administratively by planning staff on February 4, 2022. Since those windows were not located on a primary façade and were not readily visible from the public street, staff found they met the standards of approval

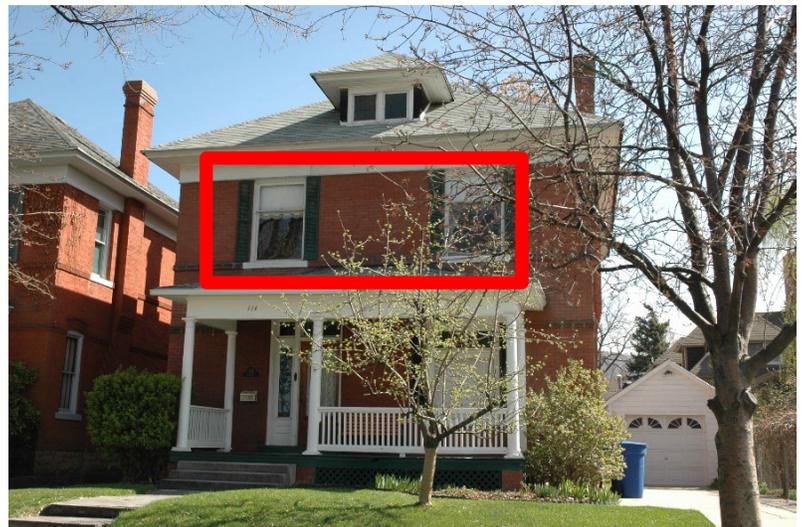
Figure 2: View of 114 N F Street from F Street, 2007 Avenues RLS Survey

The Applicants have not indicated the original windows are in disrepair and Staff visited the property and did not see any signs of damage to the windows on the exterior of the home. The Residential Design Guidelines stress the importance of repairing historic windows instead of replacing them wherever possible and in this case, where no damage has been demonstrated, a replacement window is not warranted.

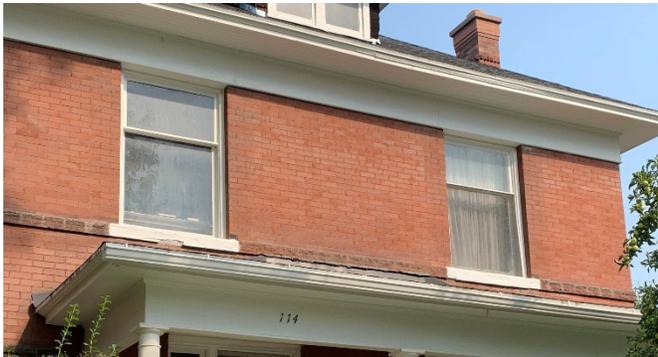
Figure 3: View of original windows

The existing windows are highly prominent on the front façade and contribute significantly to the home’s historic character. It is the City’s policy to retain historic features on buildings, particularly windows, on the front façade of contributing structures unless it is absolutely necessary to replace them. No evidence has been provided that the existing windows are in a state of disrepair.

Chapter 3 of the Residential Design Guidelines also outlines standards for replacement windows, the first of which is the replacement window should match the original in appearance to the greatest extent possible. The original windows are single hung and the upper portion of glazing is smaller than the lower. The proposed windows are double hung and the areas of glazing are the same size.

In summary, the Residential Design Guidelines discourage the replacement of windows when repair is possible. In this case, the existing original windows appear to be in good condition and the Applicants and homeowners have not indicated the windows are deteriorating in this application, so Staff has found replacing the subject windows is unnecessary and unsupported by the adopted Residential Design Guidelines which follow a repair before replacement strategy. Additionally, if evidence was provided to show the windows were beyond repair, the proposed windows do not match the proportions and profile of the existing windows and are not an appropriate replacement

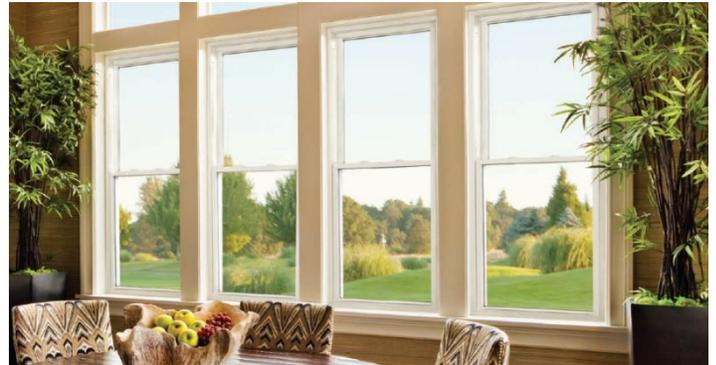
Figure 4: Example proposed windows, Alside Mezzo West Coast Brochure

The Residential Design Guidelines encourage replacement windows to be constructed of the same material as the original windows. The original windows on the subject property are of a wood construction and the proposed windows are a vinyl material. The Guidelines allow alternative materials as long as the result will match the finish, proportions and profiles of the original but the replacement of windows on front or street-facing facades are heavily discouraged, unless they are beyond repair. As discussed previously, the proportions of the glazing for the original and proposed windows are not comparable to the historic window. The existing original windows are set shallowly into the brick and the bottom sash of the window sits closest to the brick surface. The proposed windows would have the top sash and glazing segment sitting closest to the brick surface as indicated in the section diagram to the right. Essentially, the proposed windows would be “upside-down” from the existing windows and the overall profile would be different.
