# **Staff Report**

Re: PLNHLC2022-00164 - Major Alteration of 511 S. 500 E. (approximately)

### **MAJOR ALTERATION**

Approximately 511 S. 500 E.

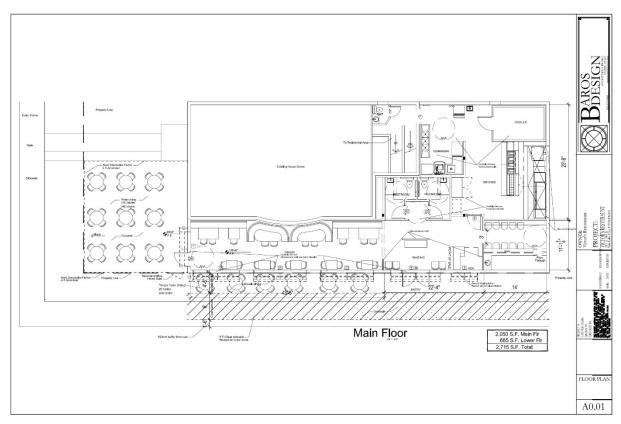
Figure 2: Site Plan/Floor Plan of Proposed Project

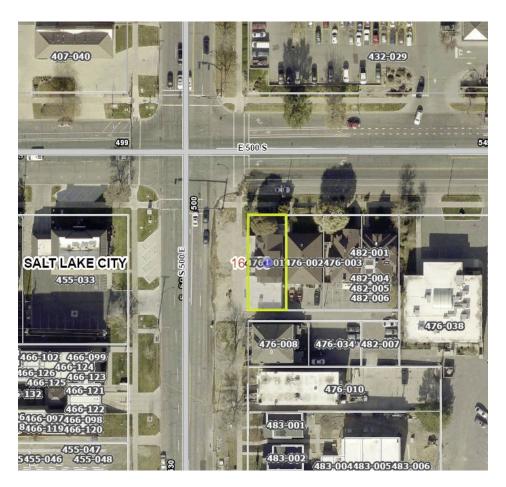
Figure 5: Existing Aerial View of Site and Portion of Surrounding Blocks. Source: Salt Lake County

The subject site comprises one individual property on the southeast corner of 500 S. & 500 E., totaling 0.098 acres in area, approximately 4,269 square feet in size. The subject property is located within the Central City Local Historic District. The property comprises one building: an historic single-family home (which faces 500 S.), which is connected to a large commercial addition (which faces 500 E.). This addition wraps around the home to the west and south. The commercial addition, while not original to the site, is still considered historic in its own right, and is clearly delineated from the original structure.

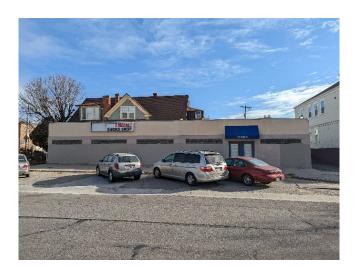
Figure 6: View of West Elevation

The proposal includes a request to remove the existing glass block windows on the elevation, and the subsequent installation of large aluminum storefront windows. Three 4-pane storefront windows are proposed for installation on this elevation with metal canopies above. Plans indicate that the southernmost window will be removed, and the opening filled in. The existing historic front doors are proposed for replacement with modern doors with sidelights on either side. An art glass window is proposed for installation on the west façade in place of the current doors. A metal canopy has been proposed above the new front entry doors and art glass window. The current historic doors are proposed for replacement to adhere to ADA width standards. The applicant has proposed to replace the stucco due to the material's deteriorated condition and underlying moisture issues. The chain link fence on the west property line between the north property line and the building is proposed for replacement with a decorative 4-foot metal fence. Outdoor dining is proposed adjacent to the sidewalk. No changes are proposed to the existing on-street parking stalls. On the west side of the property, site work is proposed underground to install a grease interceptor.

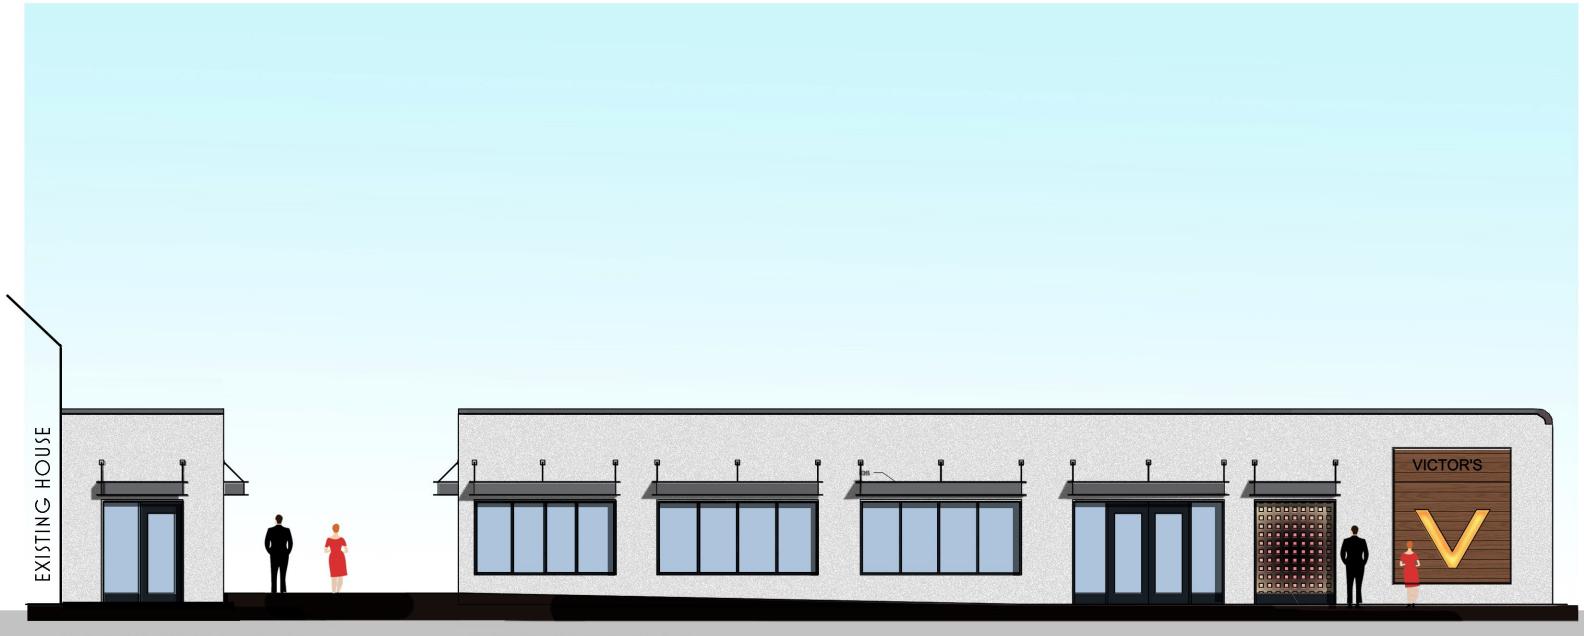
NORTH ELEVATION

WEST ELEVATION

Renovation to an old run down market to develop a vibrant restaurant at this city corner. Larger windows are planned to create a strong connection from inside the restaurant to the sidewalk area. The current fence will be removed. A new 4-foot metal fence will be installed at the north, east, and west property lines. Outdoor dining is planned. A small bar is planned inside the restaurant. Deteriorated stucco will be replaced "like for like" with a traditional hard coat stucco. See colored elevations.

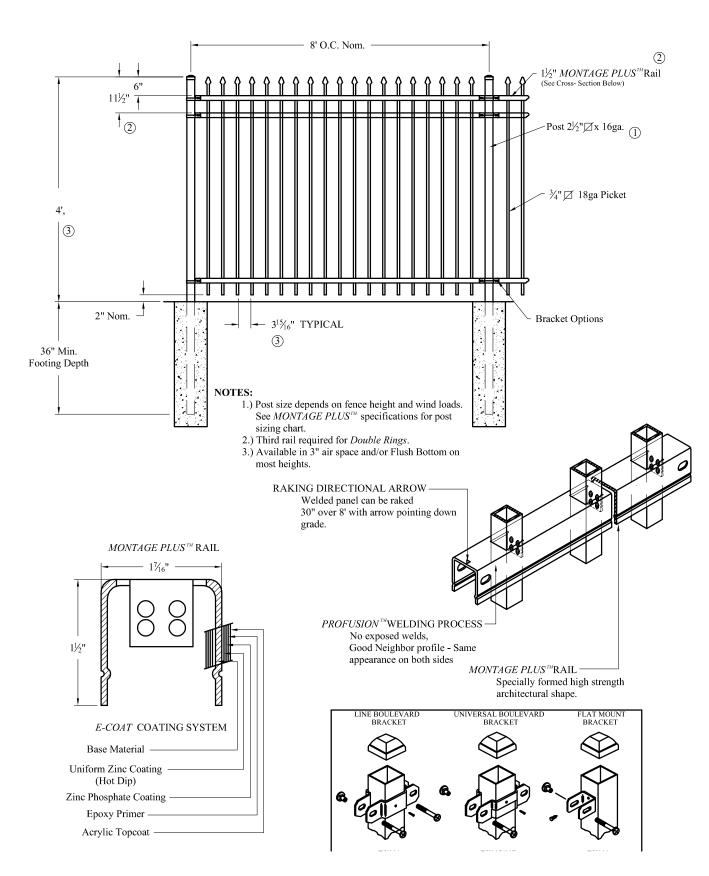
Ameristar Decorative Fence - 4 FT.

On the north side of the building, a door and sidelight are proposed for installation, with a metal canopy above. A decorative 4-foot metal fence is proposed to be installed at the north property line. The current chain link fence adjacent to the north property line is proposed for removal. Outdoor dining is proposed in the front yard. Replacing front yard landscaping with concrete to accommodate outdoor dining has been proposed.

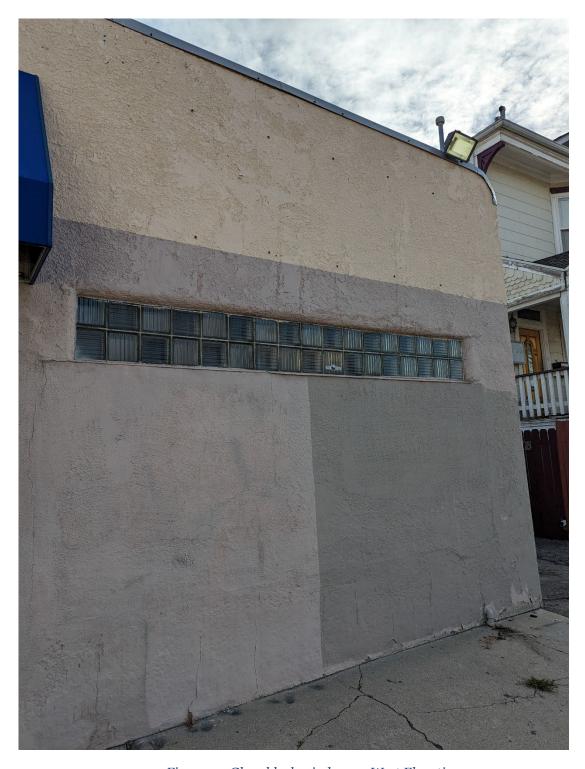
Figure 15: Glass block window on West Elevation

stucco veneer. If historic materials are removed, they should be replaced "like-for-like."  The current glass block windows and smaller openings are not considered character-defining features of the structure. Staff supports their removal for larger storefront windows. While the proposed windows are not the same as the previous windows on the building historically, staff believes that this sensitive alteration is in harmony with the historic nature of the structure and is an acceptable contemporary change.

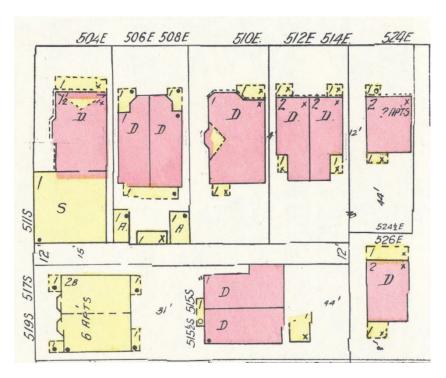
Figure 22: Sanborn Fire Insurance Map, 1950. Source: J. Willard Marriott Digital Library, University of Utah
