Staff Report

To: Salt Lake City Historic Landmark Commission
From: Kelsey Lindquist (801) 535-7930
Date: March 2, 2023
Re: PLNHLC2023-00118

Fisher Mansion Carriage House Major Alteration

PROPERTY ADDRESS: 1206 W. 200 S.

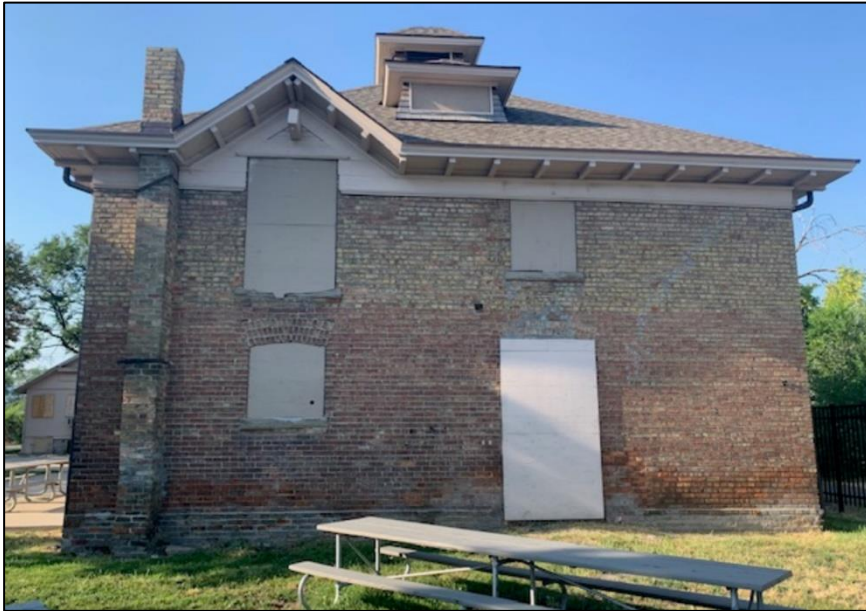
North Elevation HVAC Installation

The north elevation of the carriage house, which contains the subject HVAC installation, had significant damage to the masonry. The prior approvals included replacement of the sills, repointing the existing brick and minor cleaning. Additionally, staff approved two HVAC pads abutting the north elevation. After the various Historic Landmark Commission reviews of the project, staff issued the associated Certificate of Appropriateness, which included the two concrete pads on the north elevation.

Since that time, the applicant has gone beyond the approved scope of the project and installed approximately 8 mini split units. The installation also includes conduit lines running upward along the northern elevation. In order to protect the conduit lines and the equipment, SLC Engineering installed large steel cages around the units and metal covers over the conduit. After the installation occurred, the applicant contacted staff to seek a retroactive certificate of appropriateness for the work conducted outside of the approved scope. Staff informed the applicant that the installation is in conflict with the applicable historic preservation standards and guidelines. In response, the applicant is proposing to paint the conduit covers to match the brick and plant shrubs along the western portion of the on-site fencing.

The Residential, Commercial and Multi-Family Design Guidelines all indicate that mechanical equipment should be as minimally intrusive as possible. That means that the equipment should be located on an elevation that is least visible from the public way and the conduit should be installed to be noninvasive. Staff acknowledges that both the north and west elevations are highly visible from the Jordan River Trail. Additionally, the east elevation is visible during public events. While there isn't an ideal elevation for mechanical equipment, the primary issue with this installation is the sheer volume of units, cages and conduit. With that said, staff will often work with property owners and applicants on an acceptable installation approach to minimize the impact to the historic structure. In this case, the applicant did not contact staff until after the installation occurred. Staff finds that the installation is in conflict with the applicable guidelines and standards.

The applicant is not readily proposing to conceal the HVAC equipment or conduit lines. The proposal includes painting the existing conduit covers to be closer in color to the brick. The applicant is also proposing to plant Boxwood shrubs along the western fence to shield the view from the Jordan River Trail. Staff believes that even with the minor attempt to buffer and conceal the equipment, it will remain highly visible even with the proposed plantings, especially during times of year when vegetation loses leaves, and therefore it's screening capabilities.

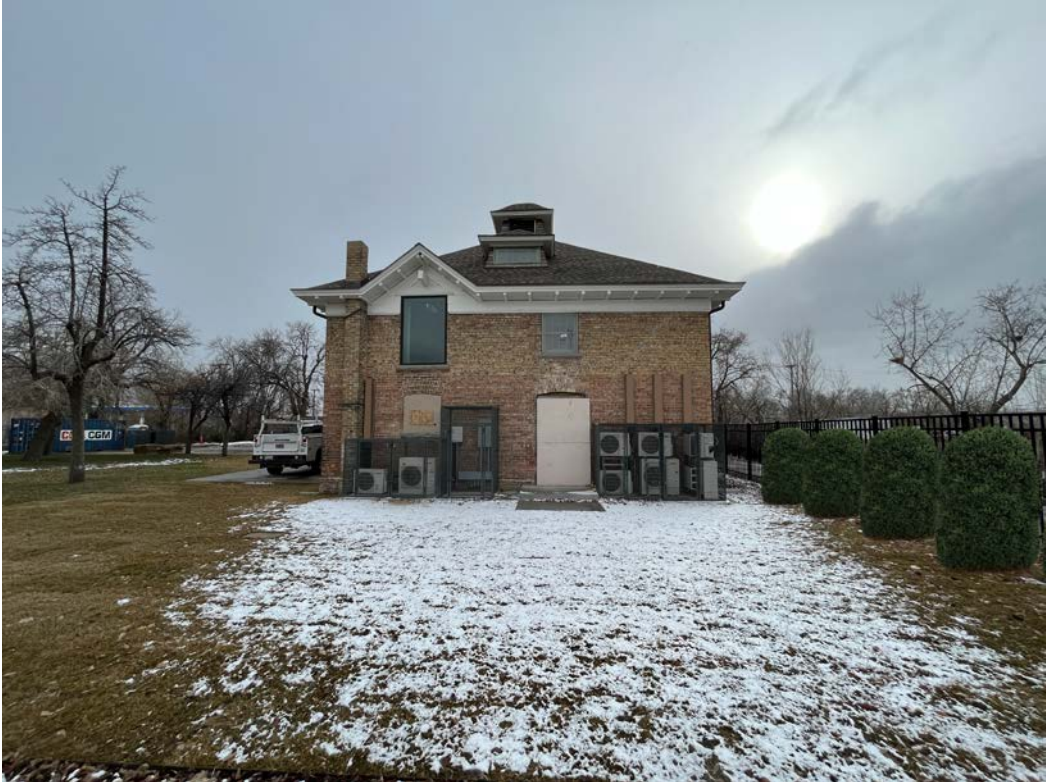
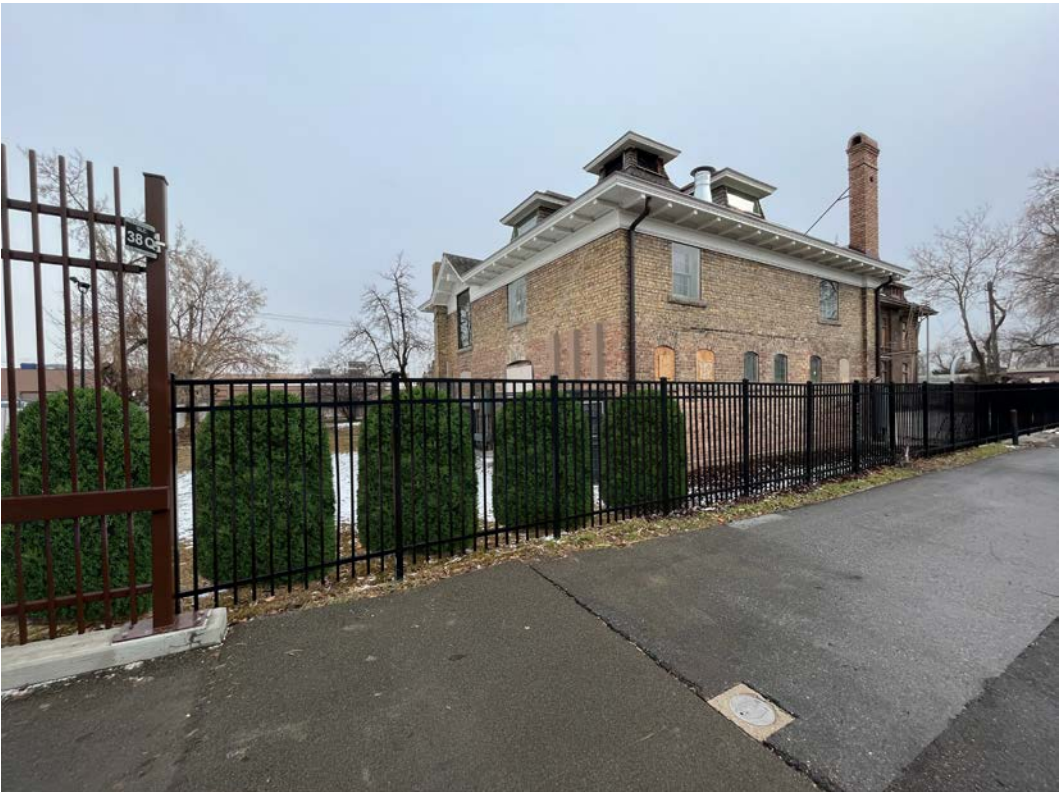
The following are the same views as presented in the first exhibit now with the "Titan Boxwood"

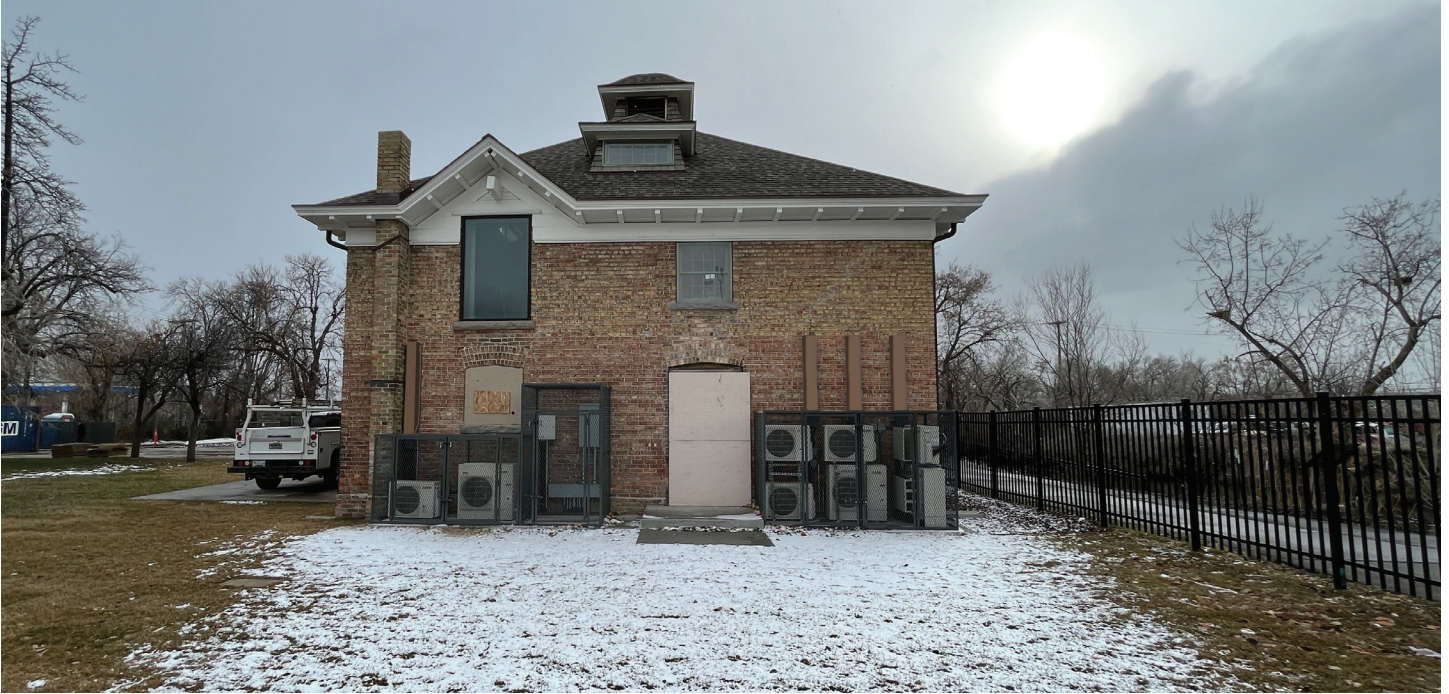
View 1 - Proposed painted conduit covers

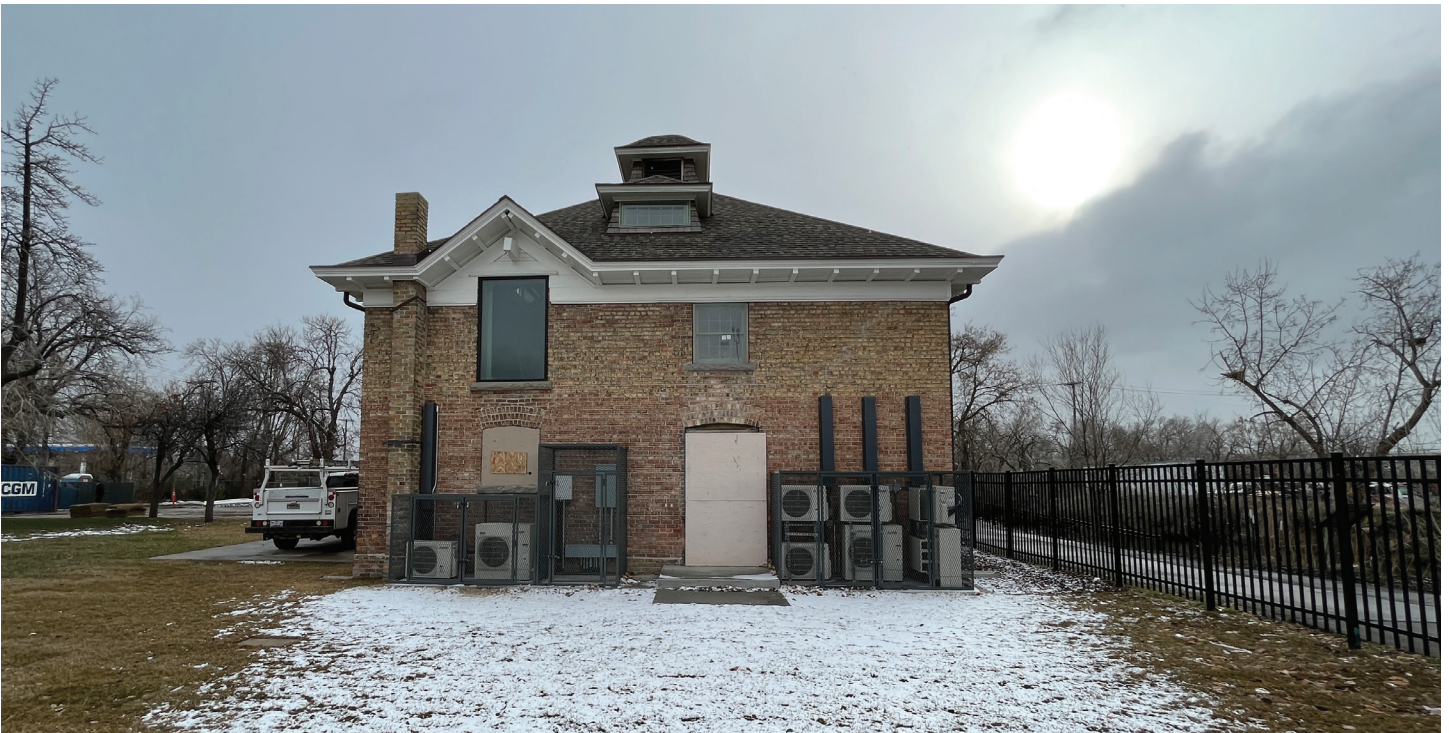
View 1 - Current painted conduit covers

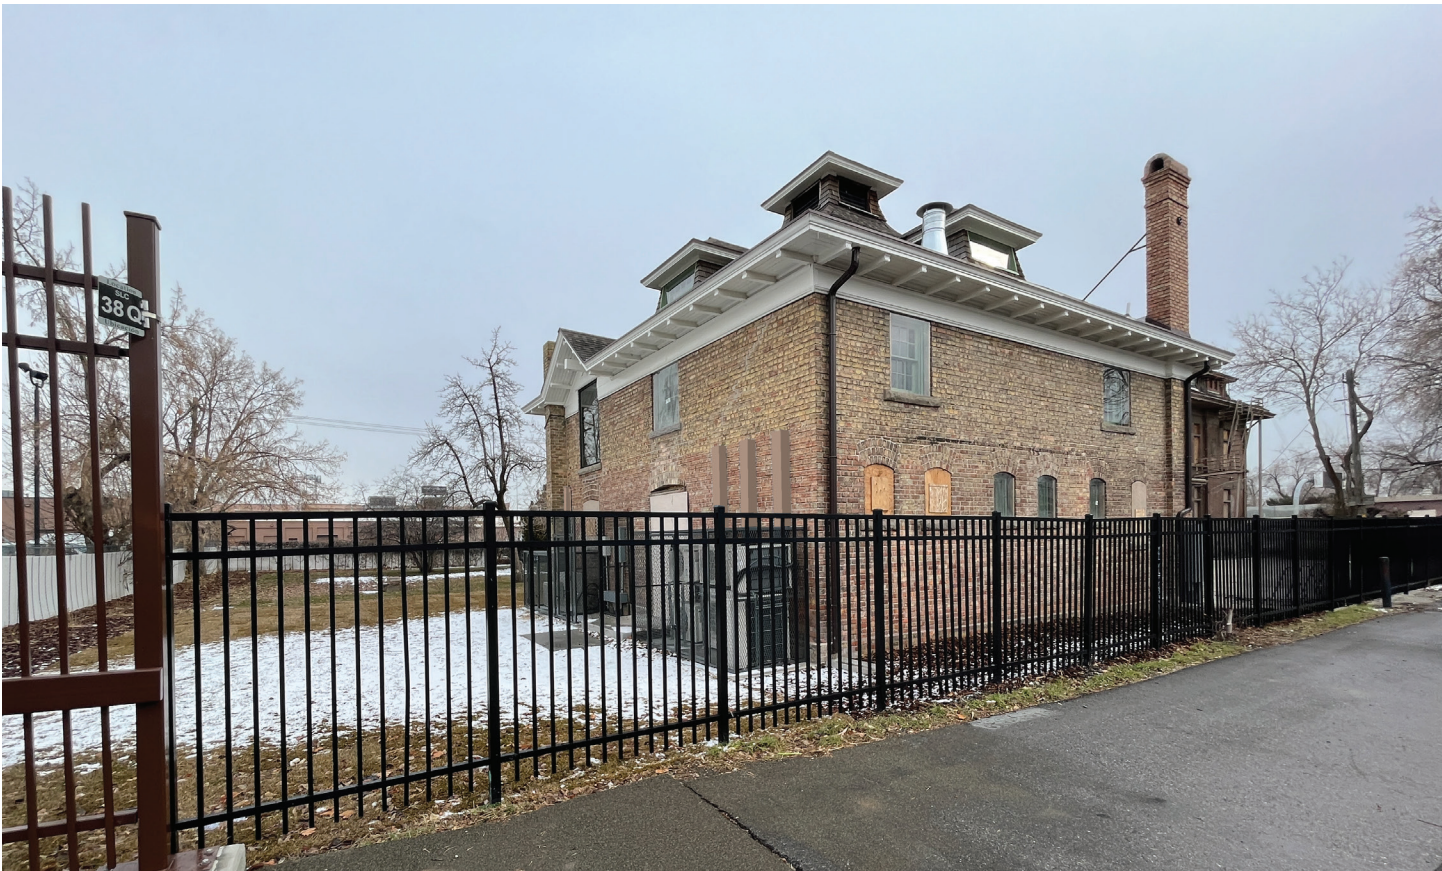
View 2 - Proposed painted conduit covers

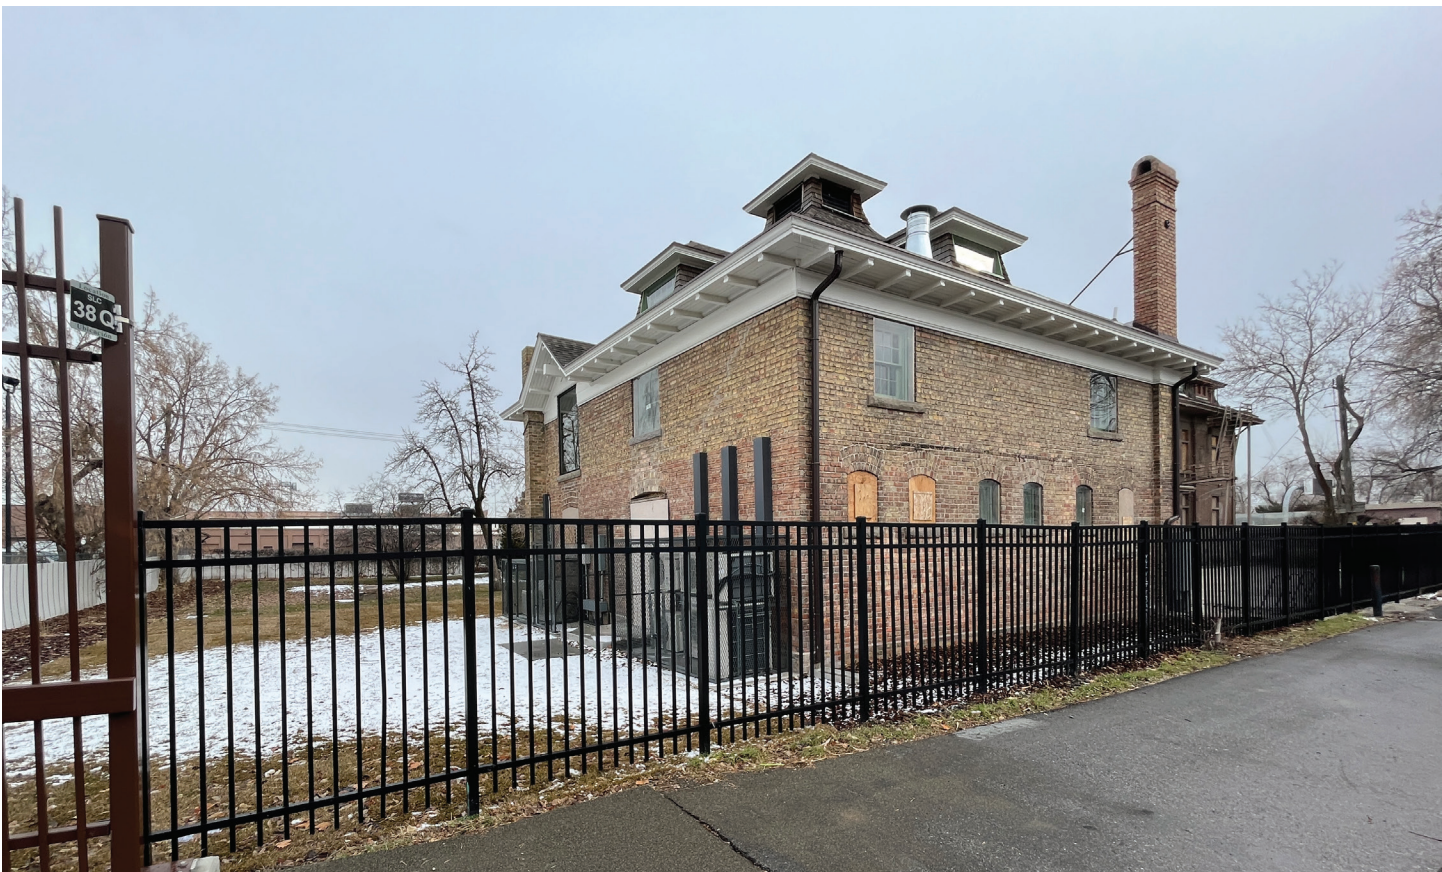
View 2 - Current painted conduit covers

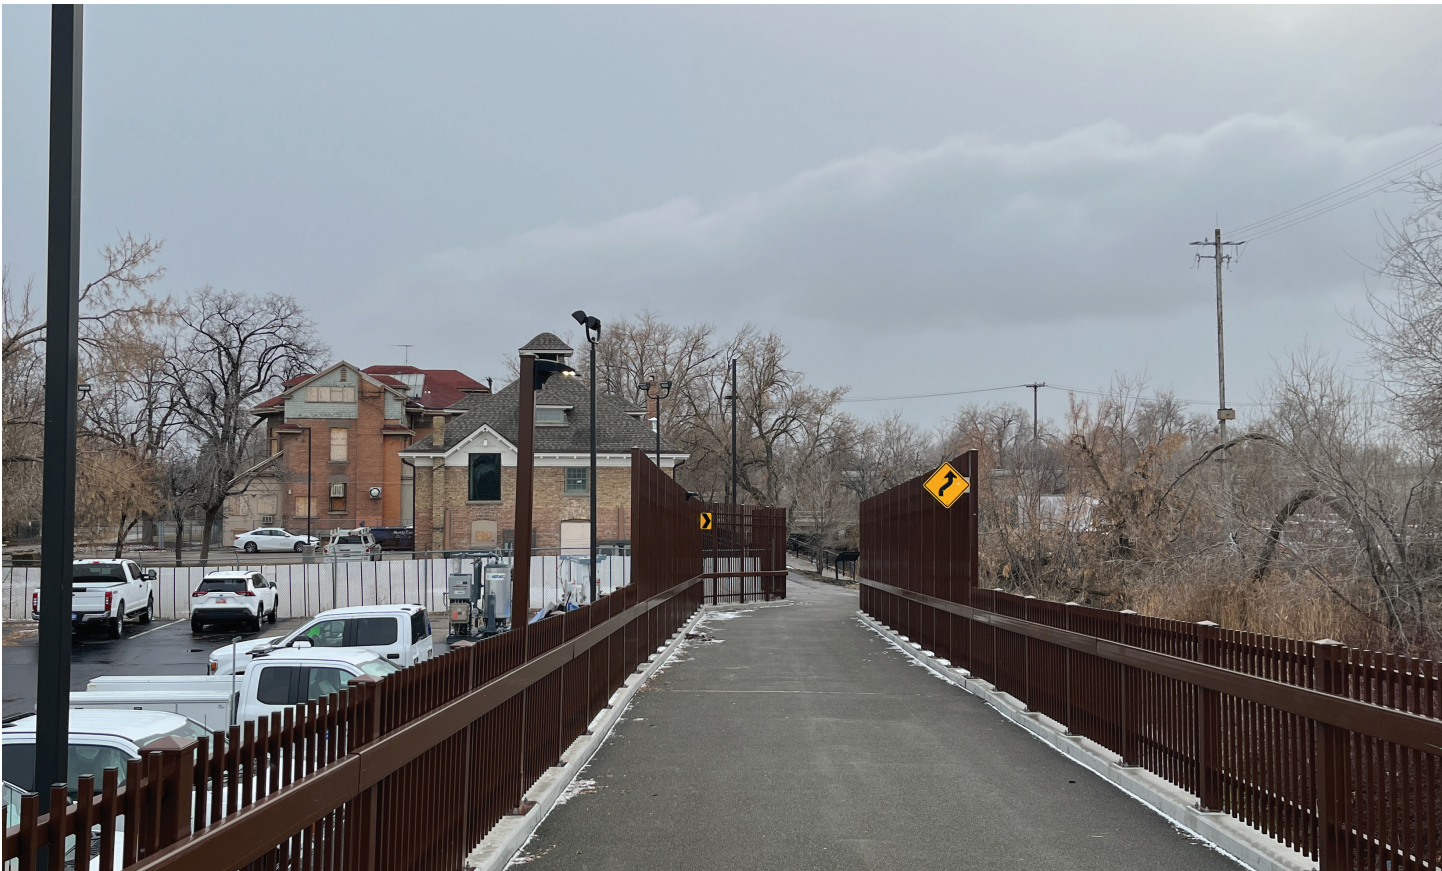
View 3 - Proposed painted conduit covers

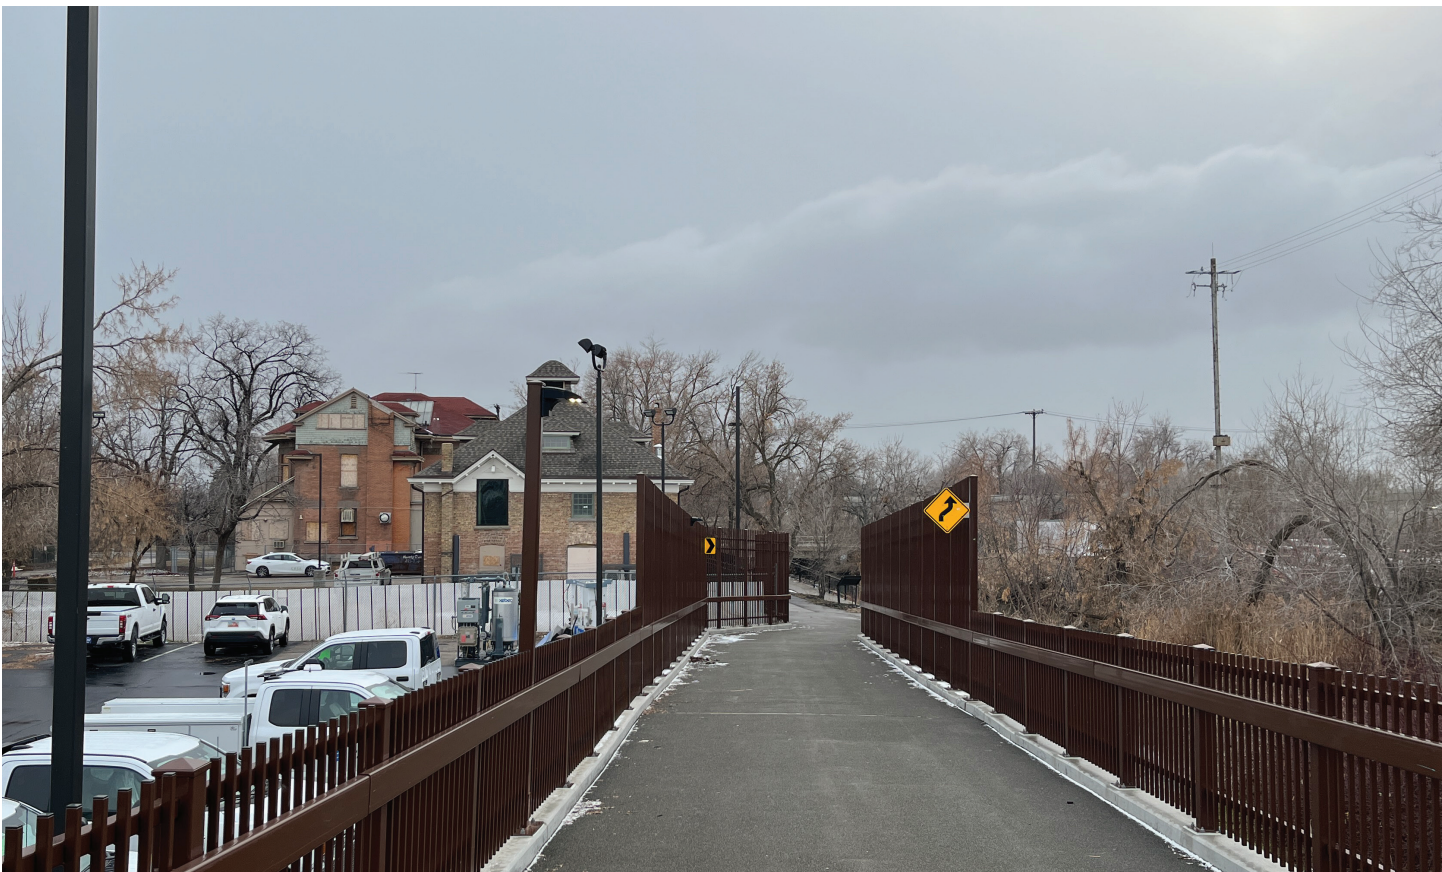
View 3 - Current painted conduit covers
