# Staff Report

**To:** Salt Lake City Planning Commission  
**From:** Aaron Barlow, Principal Planner, [aron.barlow@slcgov.com](mailto:aron.barlow@slcgov.com), 801-535-6182  
**Date:** February 1, 2024  
**Re:** PLNHLC2023-00100 – Painted Brick at 217-219 West 300 North

## MINOR ALTERATION (ENFORCEMENT)

**PROPERTY ADDRESS:** 217-219 West 300 North

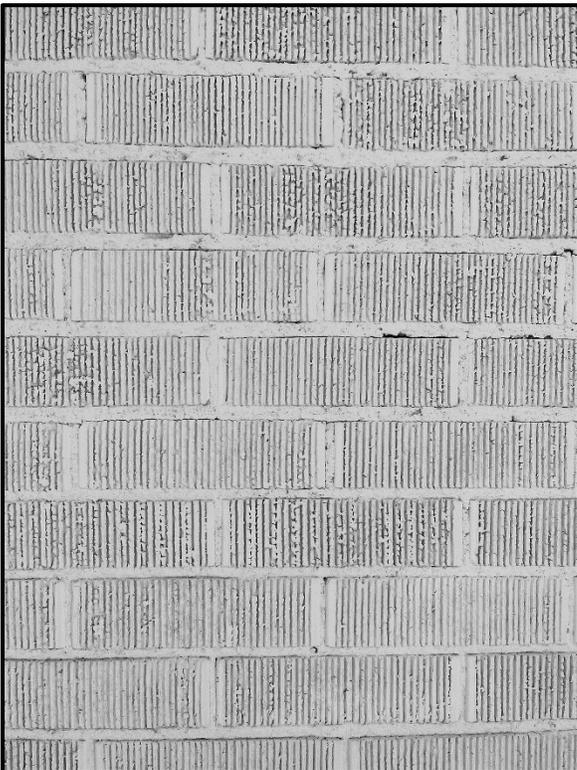
*Left: Detail view of painted brick on subject building*

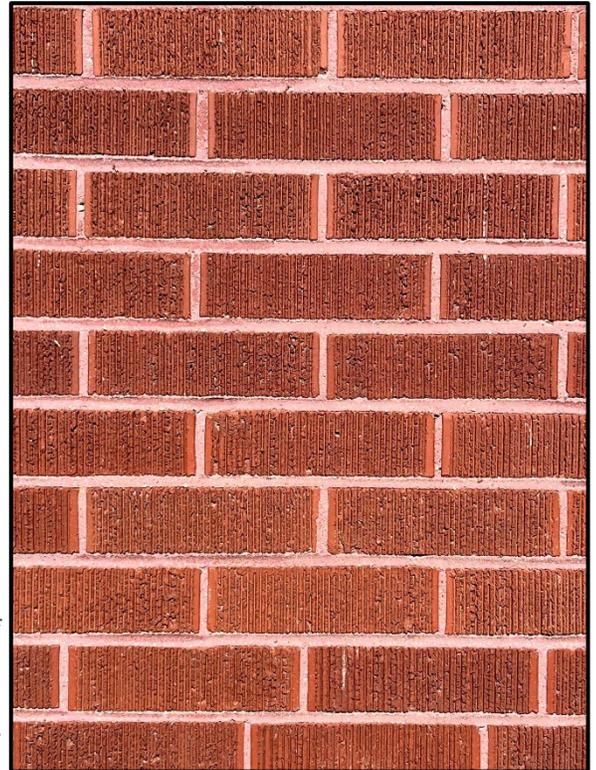
*Right: Detail view of adjacent duplex's brick, which is similar to the subject building's original color*

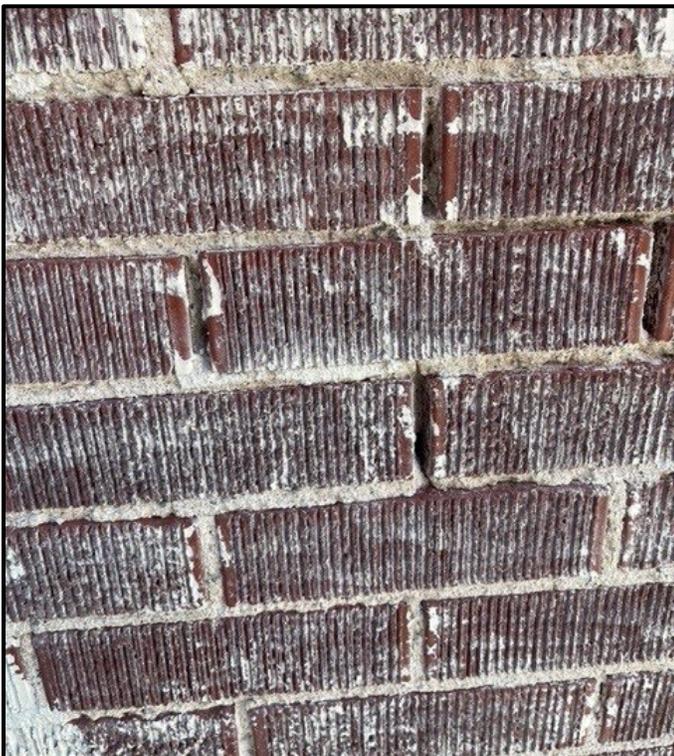
- **High-pressure wash:** The applicant also tried following up the chemical strippers with a powered wash. They argue that a pressure wash is the most effective method for removing the chemically stripped paint. However, they have found that it also destroys the mortar and outside layer of the brick.

*Examples of brick after different wash methods.*

*Left: high-pressure*

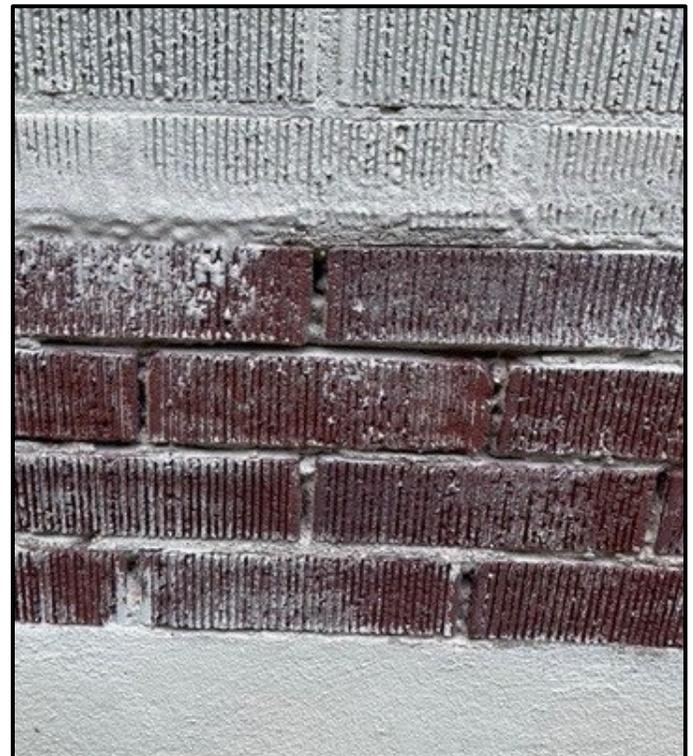
- **Water and sand pressure wash:** The contractor that made the initial test patch used a machine that added sand to a pressure wash to remove the chemically stripped paint. As expected by staff, this damaged the brick and cleared a significant amount of mortar.

*Right: sand and water*

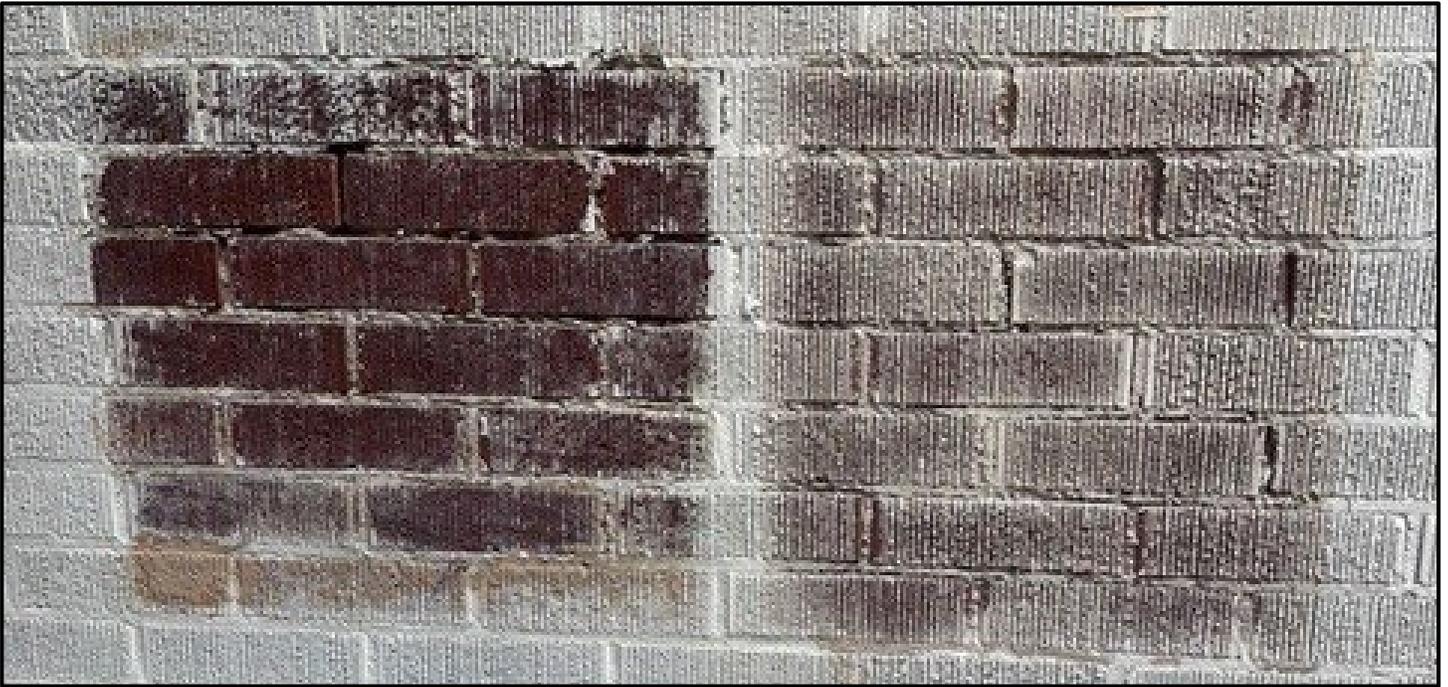
According to the applicant, in cases where they could get paint removed, mortar was also removed, and, in some cases, some of the brick's exterior was also damaged. Photos provided by the applicant show the effectiveness of (and extent of damage from) each method.

*Chemical removal patches: Smart Strip Gel (left) and EcoChem Liquid Caustic Stripper (right)*

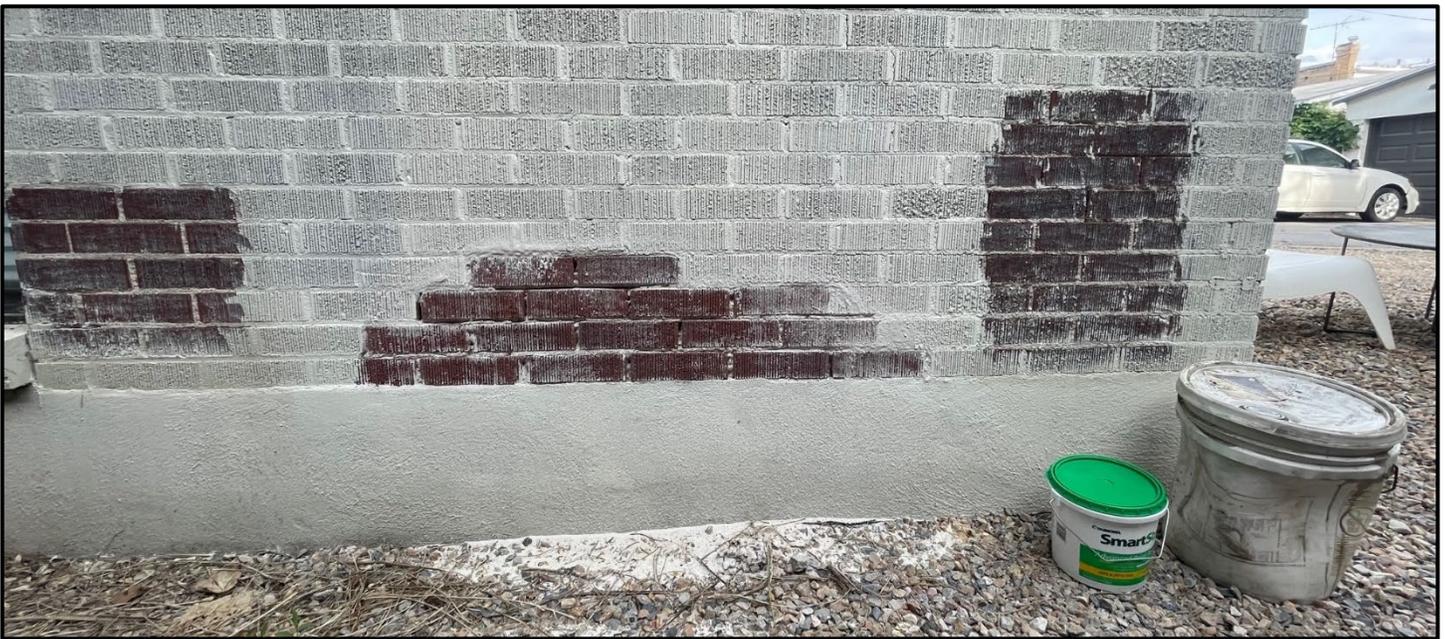
*Test patches on rear of house*

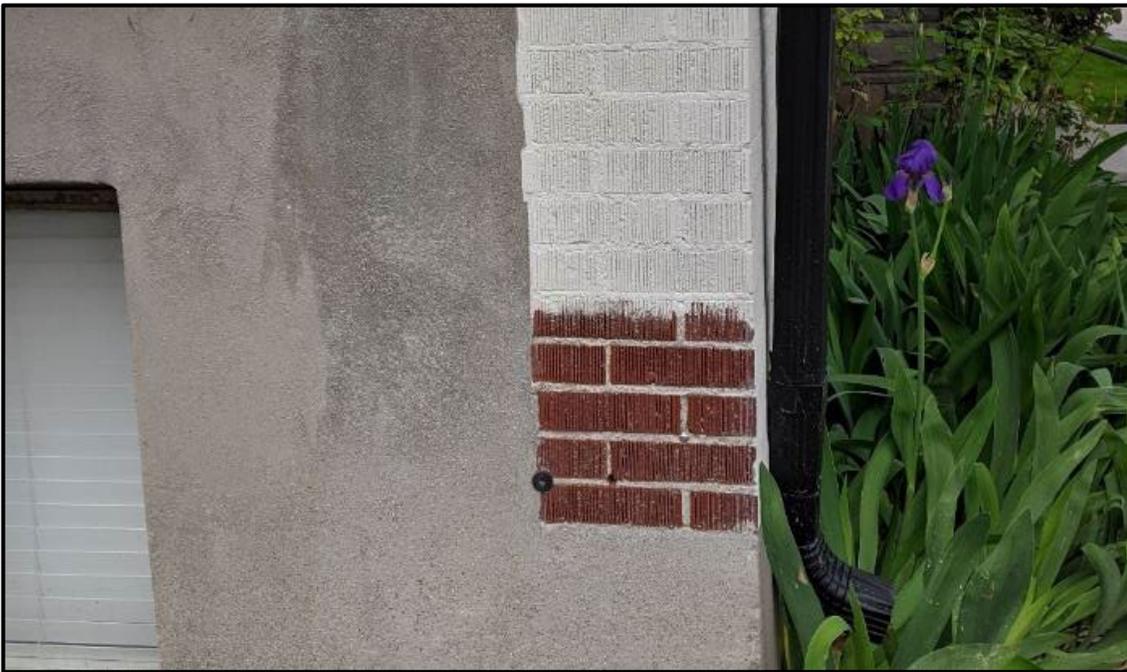
*Test patch on Jo-An Apartments using the process described in their report.*

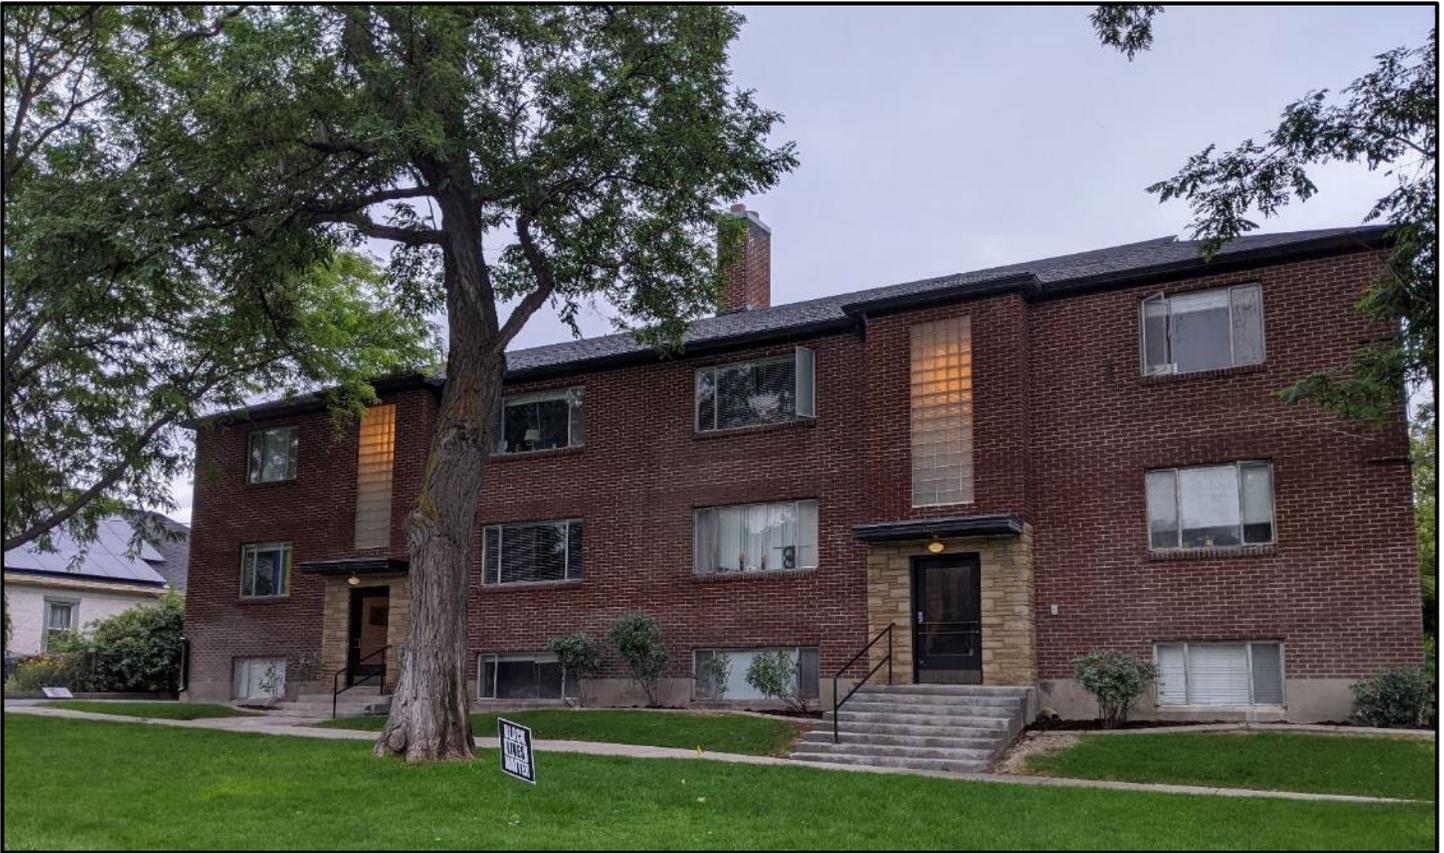
*Jo-an Apartments in 2020 after paint removal*

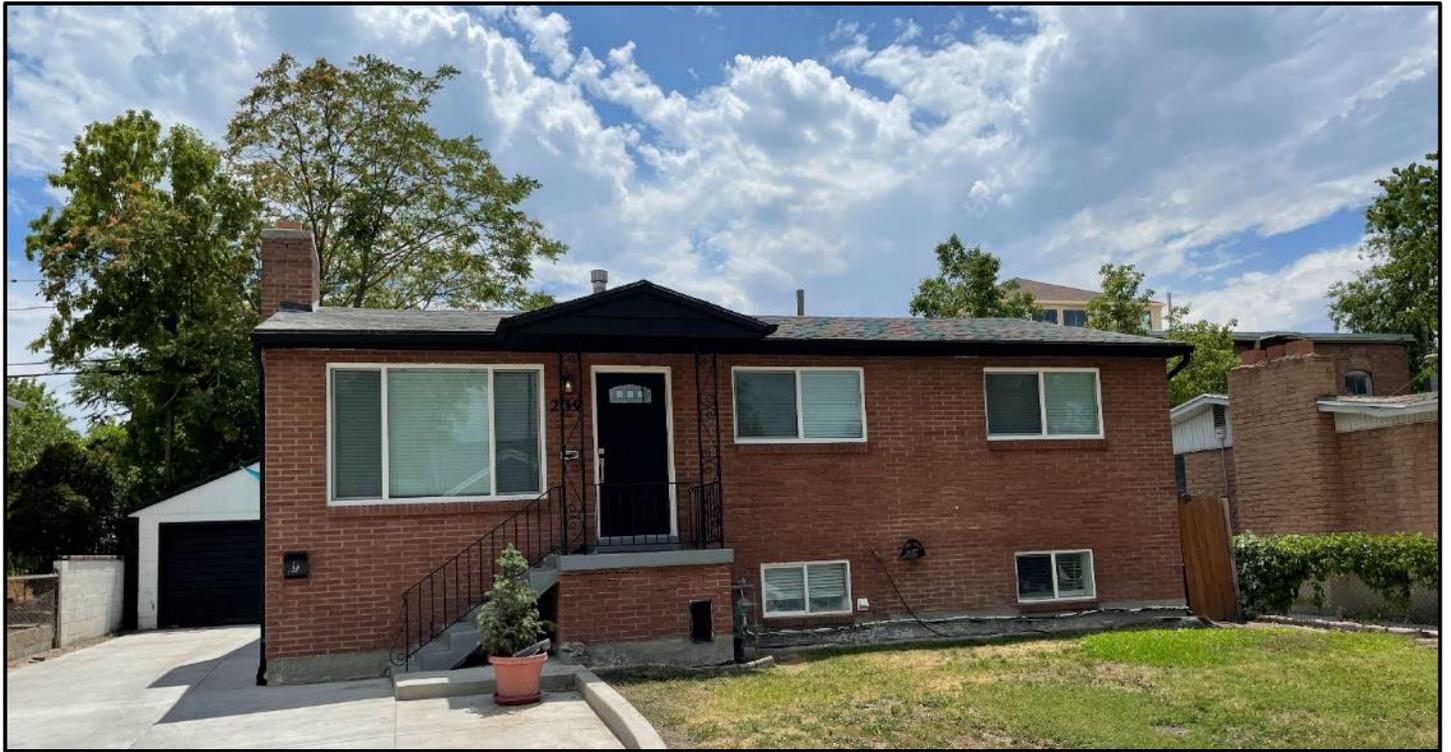
*239 Ardmore, paint removed 2022.*

After the commission's decision, the applicant provided a plan describing the removal process (included in [Attachment D](#) of this report). They applied *Multi-Strip Professional Pain Remover by Sunnyside Co.* with plastic sheets and duct tape for 24 hours. After that, they applied a hot water pressure wash and then a scrub with a heavy-duty brush. The process was completed in August 2022.

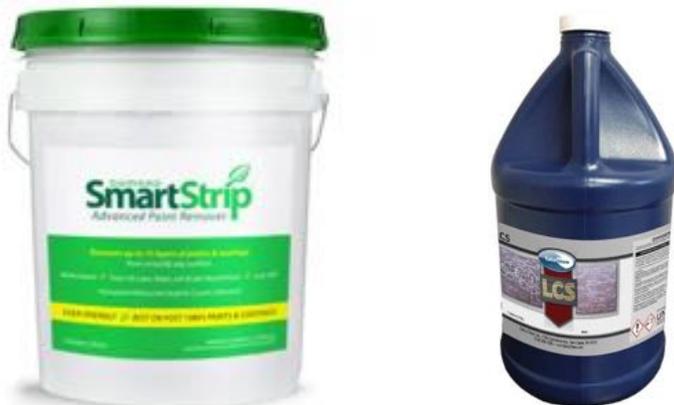
(Figure A) – Smart strip Gel & EcoChem Liquid Caustic Striper

*Smart strip is a paste that is applied and the wrapped with plastic for 12-24 hours. LCS is a caustic chemical that can either be sprayed or brushed on with a one hour wait time.*

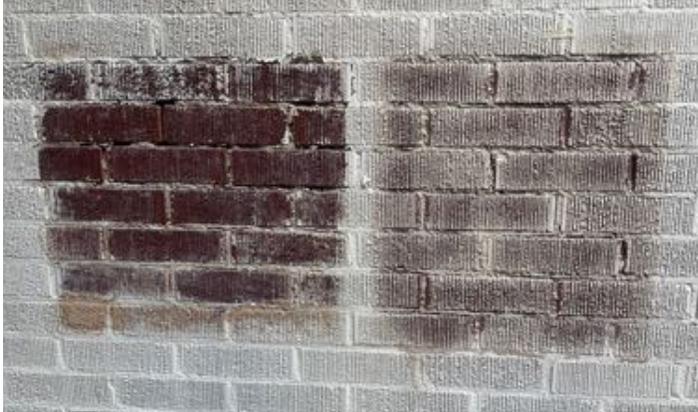
(figure B)

*Examples of chemical removal patches:*

*(SmartStrip gel on left)      (EcoChem Liquid Caustic Stripper on right)*

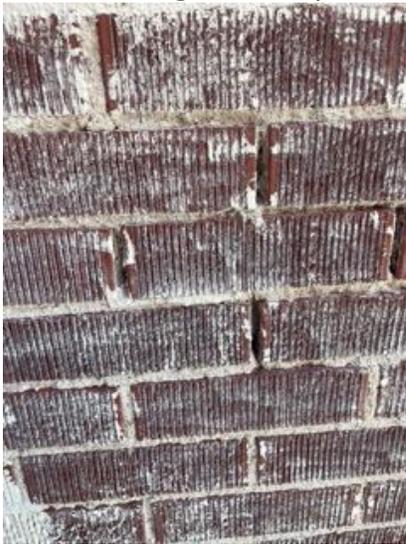
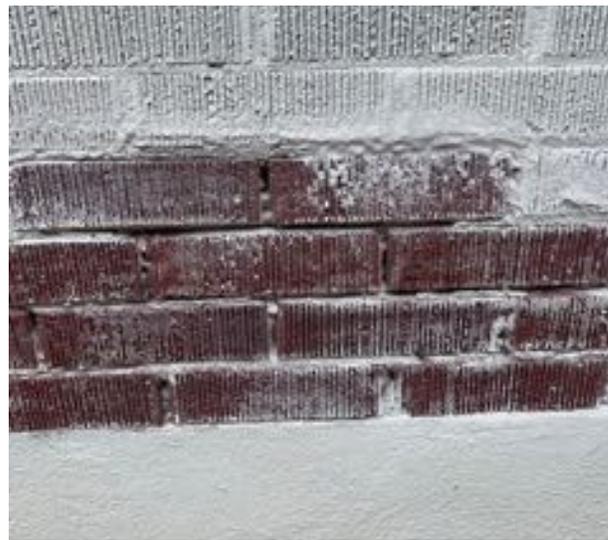
**(Figure C)**

*Examples showing small crevices on brick and despite the chemical stripping process, the pressure washing eats away at the mortar:*

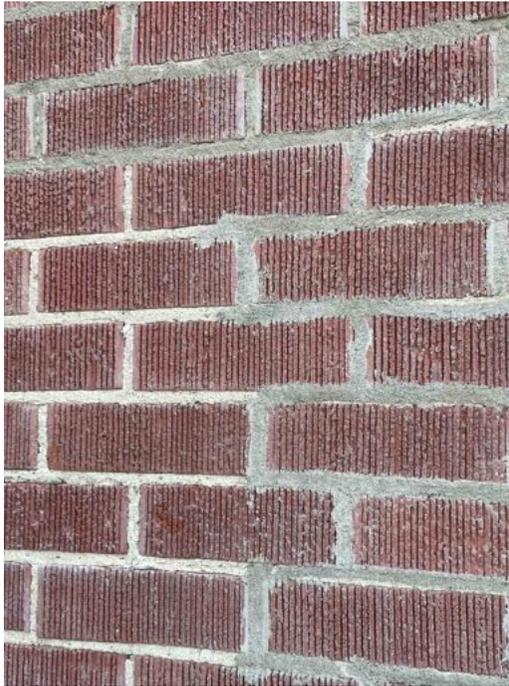
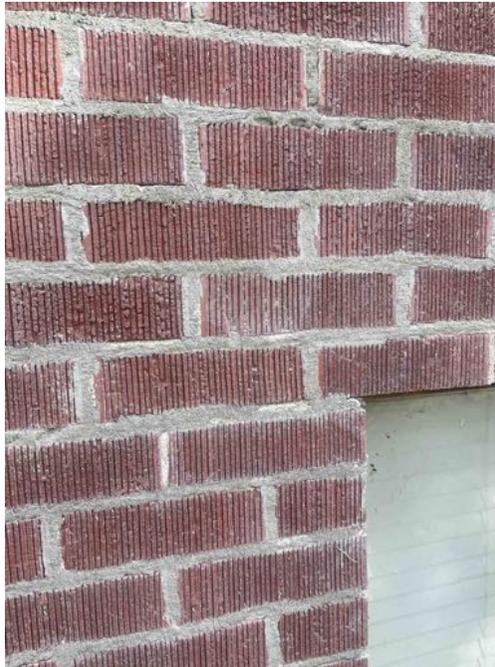
Example of similar brick condition at JOANN apartments after paint was removed. It was subsequently re-pointed. The mortar is does not match already appears to be coming off.

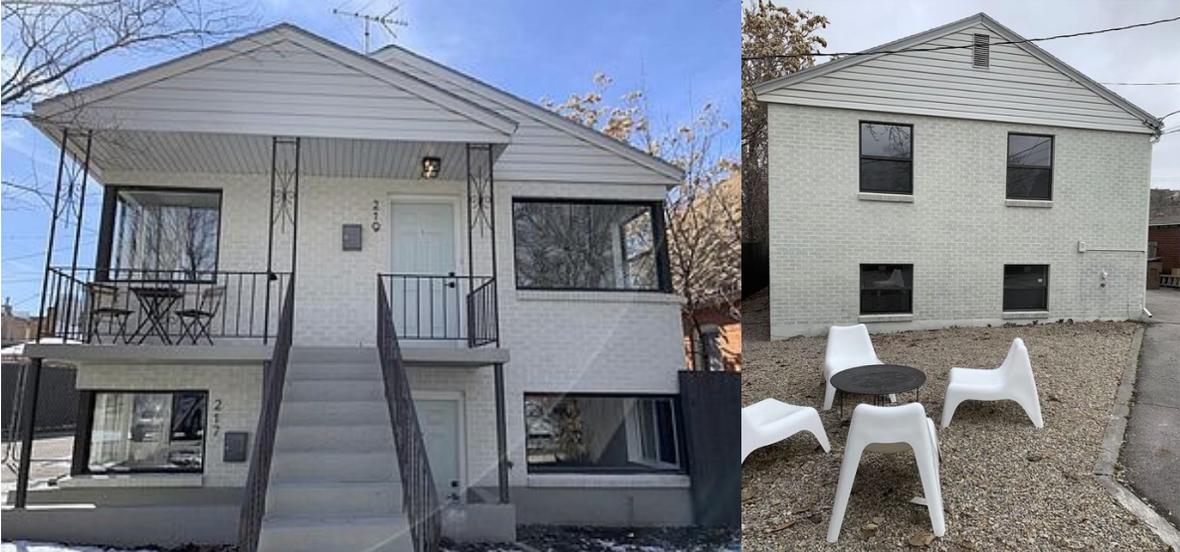
Painted white in 2019:

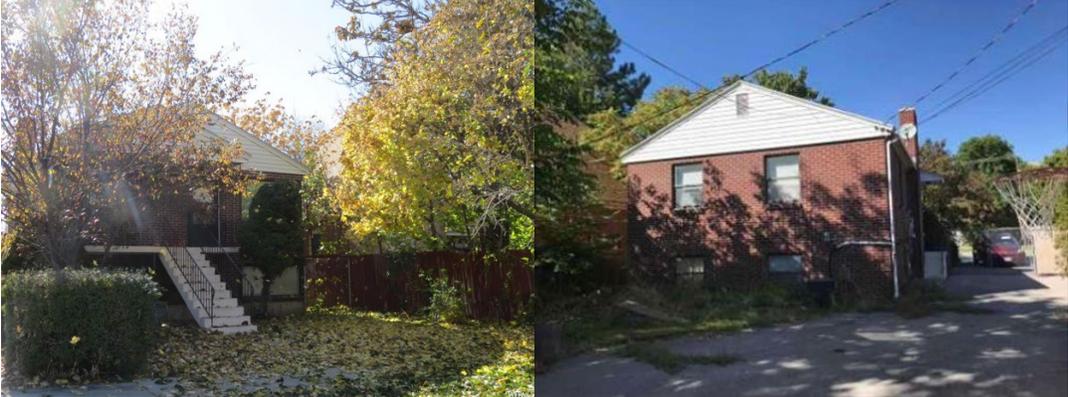
Original brick color before painting:
