2. Storefronts

Context & Character

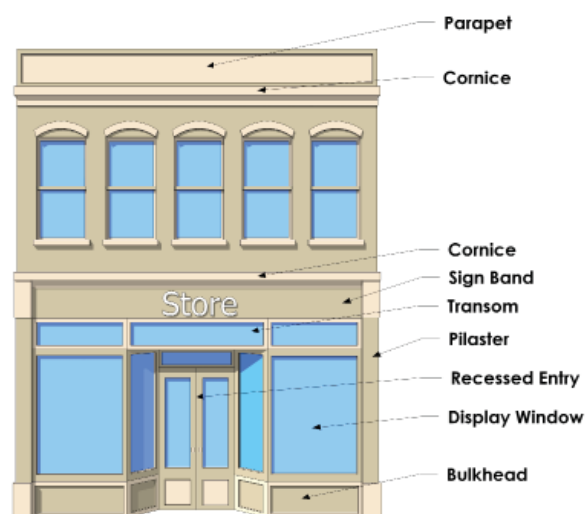
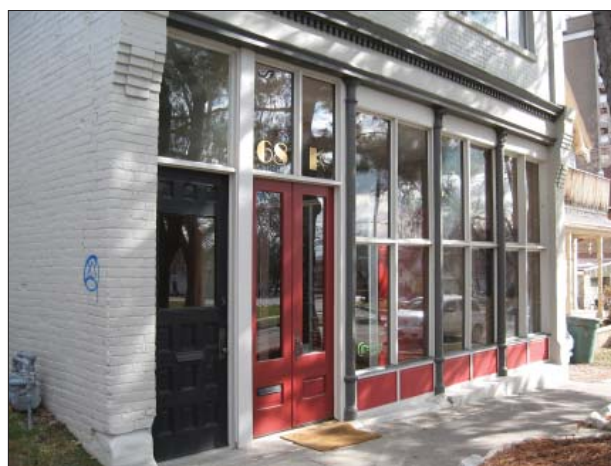
Traditional storefronts tend to comprise similar design elements. (68 N. 'K' Street)

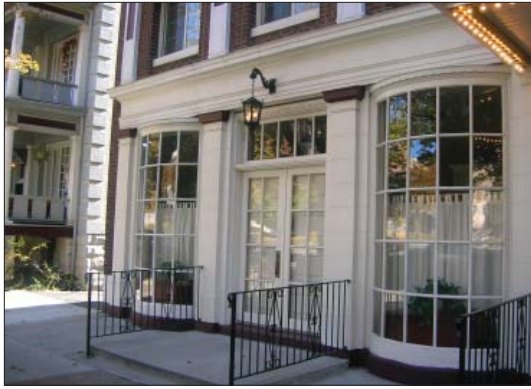
The bowed display windows at 140 E. South Temple Street are a unique feature of the building facade and district.

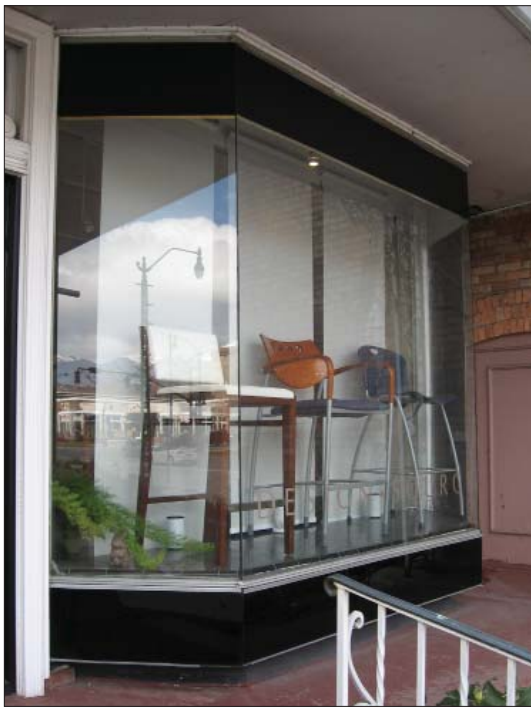
The Carrara glass is a distinctive characteristic of the storefront at 432-434 E. South Temple Street.

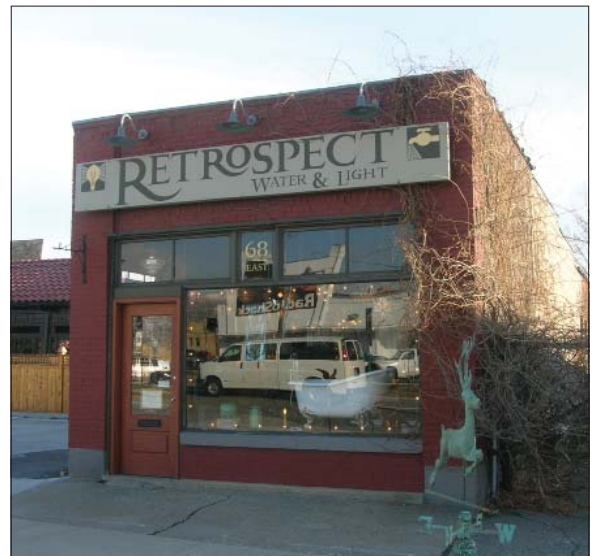
This simply detailed storefront is typical of the early 20th century.

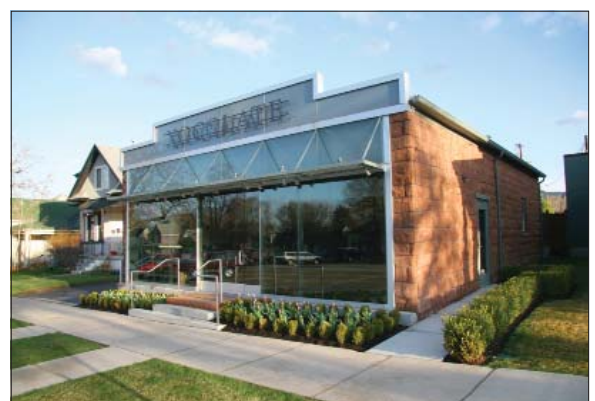
This is one design approach for replacing a missing storefront.

2.3 An alternative design that is compatible with the remaining character-defining features of the historic building should be considered where an original facade is missing and no evidence exists of its original appearance.

- The new design should take into consideration the proportions, dimensions and hierarchy of the historic building.
- A simplified interpretation of a traditional storefront is appropriate.
- The new design should be subtly differentiated so that a false historical appearance is not created.

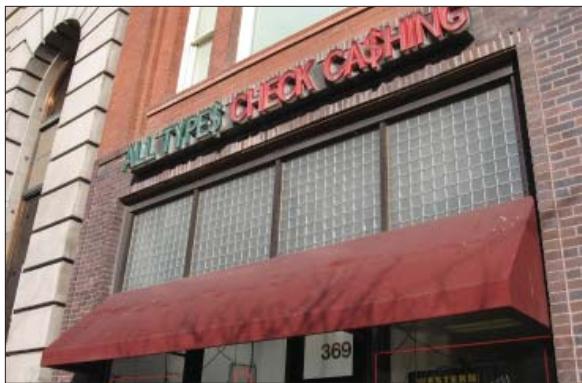
The distinctive Luxfer glass transom on the New Grand Hotel at 369-379 S. Main Street is intact and not concealed by the awning.

- Storefronts are an appropriate location for awnings.
- If pilasters or columns define the storefront, place awnings within this framework rather than overlap the entire storefront.
- Transom lights of prism glass or stained glass are important features of a building and should not be covered with an awning.

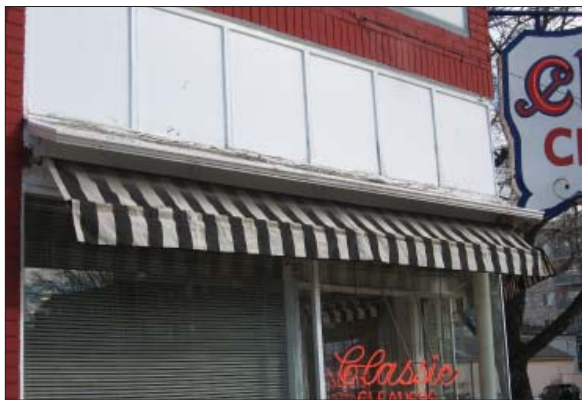
The awning fits within the window opening at 501 East 300 South.

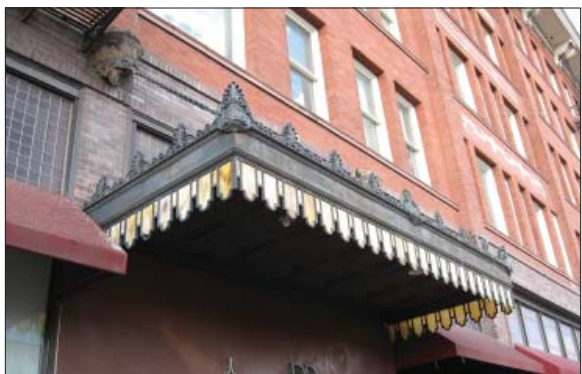
The distinctive canopy on the New Grand Hotel at 369-379 S. Main Street defines an entrance and provides shelter.

Early canopies were generally modest in detail and reflected the character of the building to which they were attached. As the design of buildings grew to be more elaborate, the detailing of canopies also became more sophisticated. Usually horizontal, they provided shelter and shade for the entrance or across the front of the building.

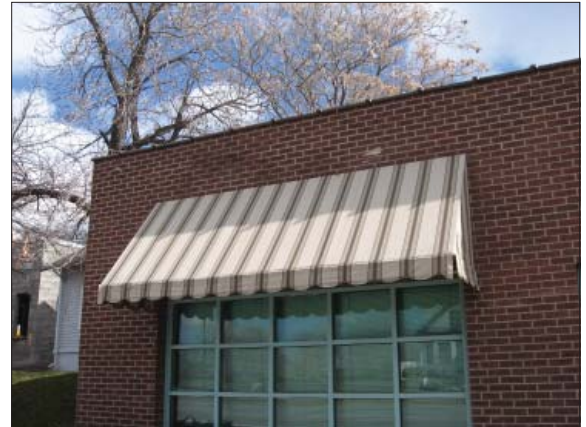
This shed awning draws attention to the window at 736 North 300 West.

- Simple shed awnings are appropriate for rectangular openings.
- Arched awnings may be appropriate for arched openings.
- Awnings may be retractable or fixed in place.
- The use of bubble, concave, or convex awning forms is discouraged except where used originally.

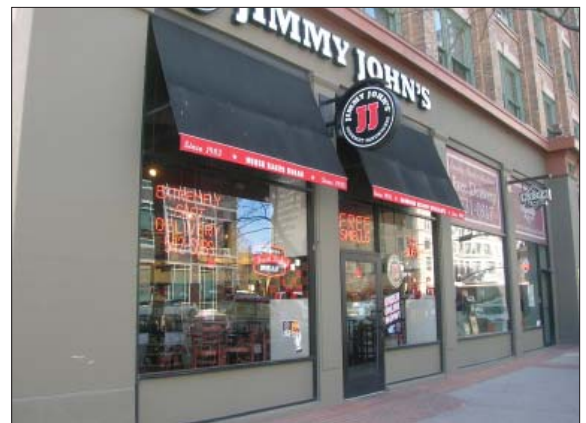
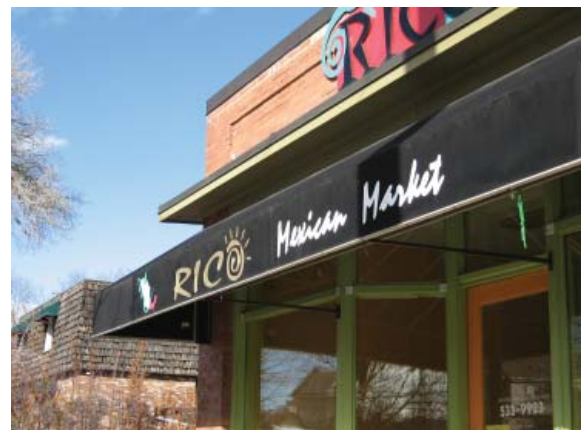
Awnings are generally simple in design, angled and fit within the building opening.

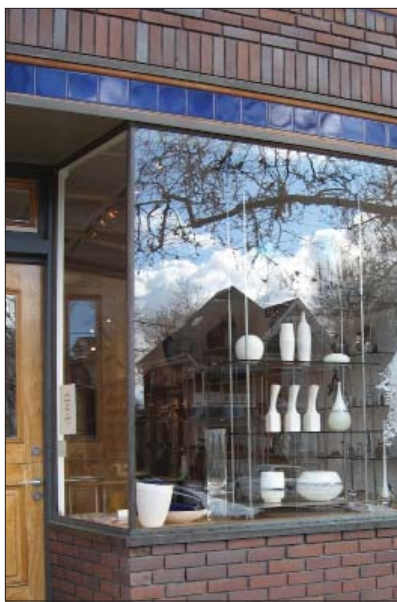
An original display window at 82 N. 'Q' Street.

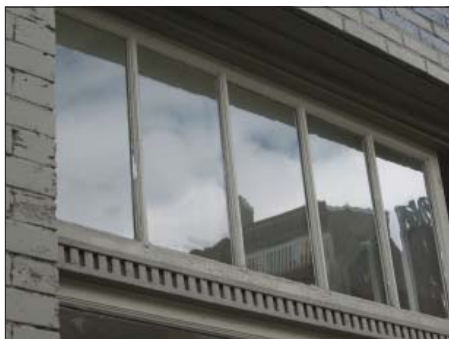
Original transoms contribute to the character of this historic storefront at 271 N. Center Street.

Transoms are traditional components of storefronts of the late 19th and early 20th centuries. Transoms appear above display windows and doors and are key architectural features of storefronts and entrances. On the practical side, transoms allowed additional natural light and often ventilation in stores. They also offered additional opportunities for visual interest and decorative detail especially decorative glass such as Luxfer glass or other divided glass.

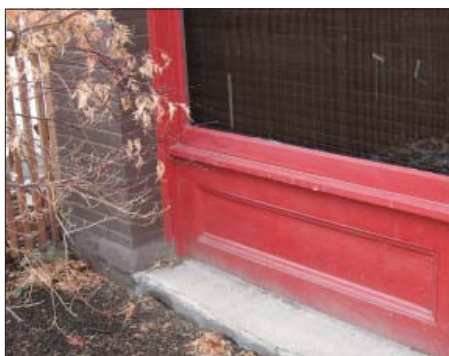
Original wood bulkheads such as those at 361 N. Main Street are central elements of historic storefronts.

Display windows and bulkheads are essential elements of traditional storefronts which provide a sense of scale and aesthetic quality to the facade of a commercial building. The arrangement, proportions and design of openings (“fenestration”) are important design elements of the architectural composition. Traditional storefronts of the late 19th and early to mid-20th centuries featured large plate glass windows at the street level of the facade to display merchandise. The lower panels or bulkheads on which the display window rest are often of wood or brick.

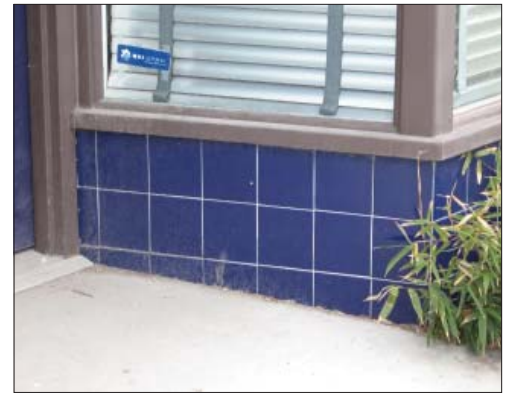
An original tile bulkhead at 422-426 North 300 West.

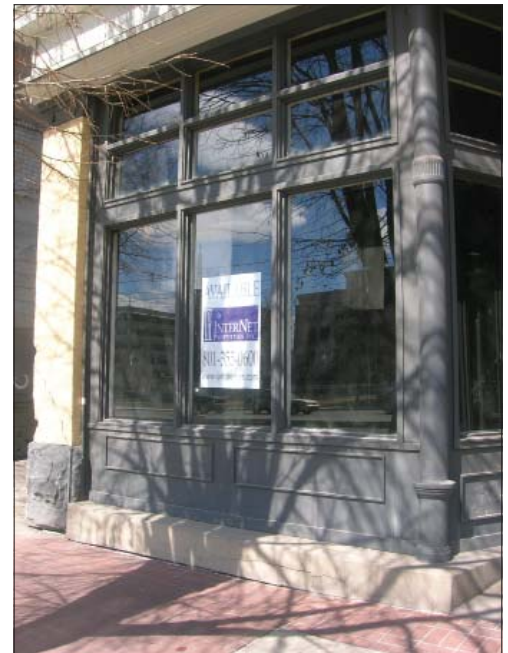
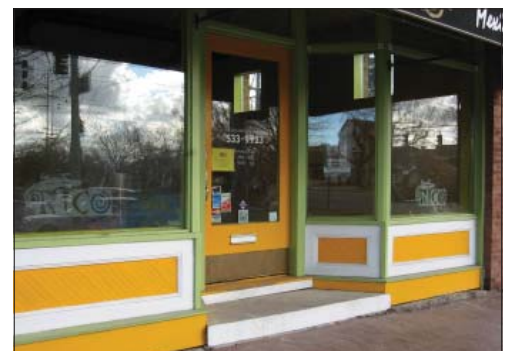
Bulkheads act as a platform for display windows.

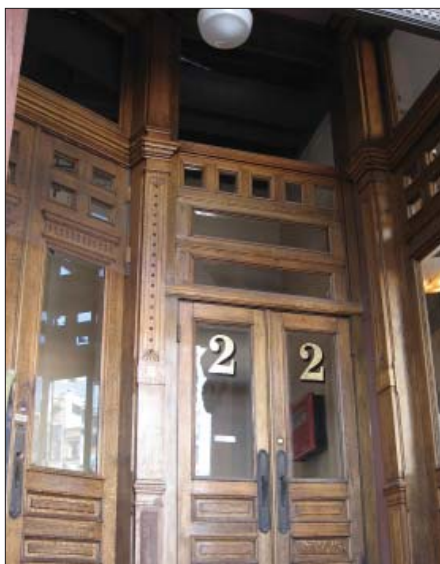
Wood doors on the Utah Commercial & Savings Bank Building at 22 East 100 South.

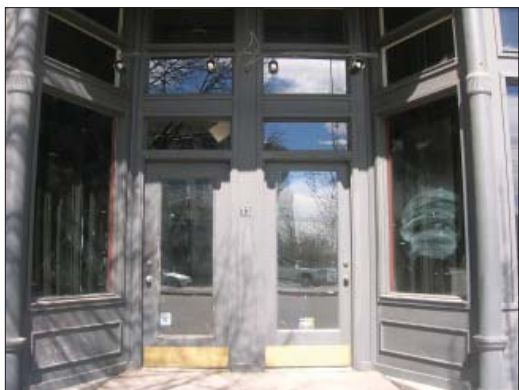
Traditional storefronts consisted of recessed single or double doors flanked by display windows.

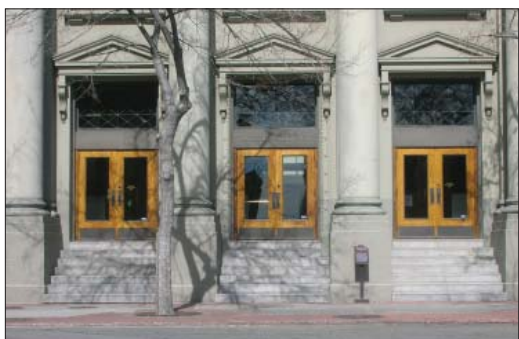
These three center bays are framed by four freestanding Ionic columns. Salt Lake Stock and Mining Exchange, 39 Exchange Place.

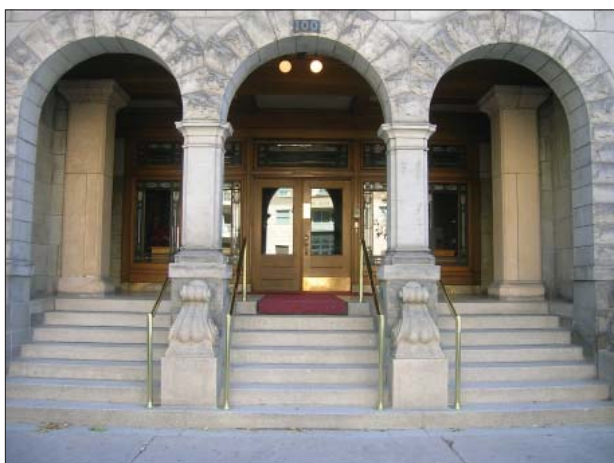
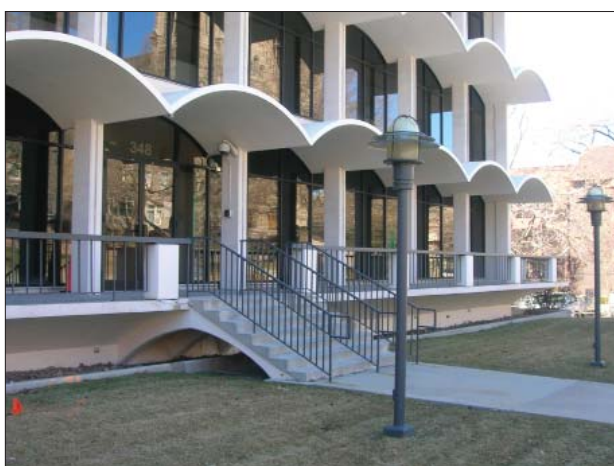
A progression of spaces between the street and the building, including a walkway, steps and landscape features, is typical of most buildings along South Temple.

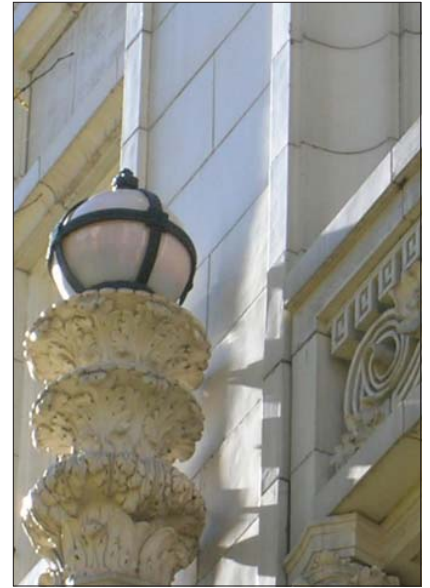
Historic lighting provides distinctive detail to the Kearns Building at 136 S. Main Street.

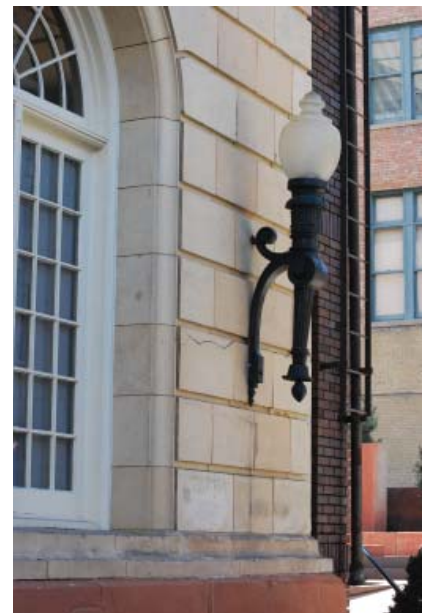
Architectural lighting provides illumination as well as ornamentation on the Commercial Club Building at 32 Exchange Place.

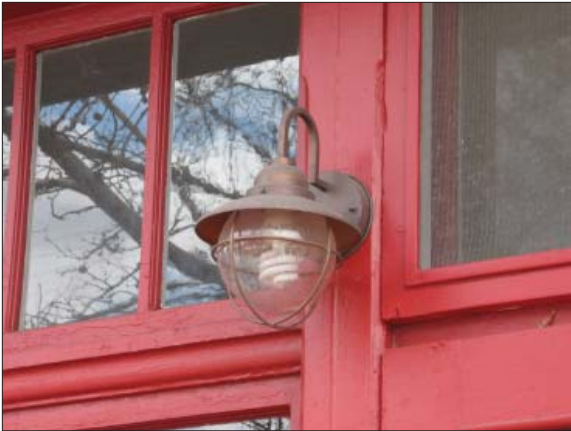
Good lighting choices for historic buildings are simple and unobtrusive, such as this example at 361 N. Main Street.

2.25 New exterior light fixtures should be simple in design and appropriate to the scale and character of the building.

- If modern light fixtures are desired as replacements or where light fixtures previously did not exist, ensure that they are unobtrusive and shield the light source.
- The use of exterior spotlights on a key character-defining facade is discouraged.
- Light fixtures that are installed in a way that damages or obscures architectural features or other building elements should be avoided.
- Lights should be positioned in a manner that enhances visibility without detracting from the building's historic character.
