5. Architectural Details

Design Objective

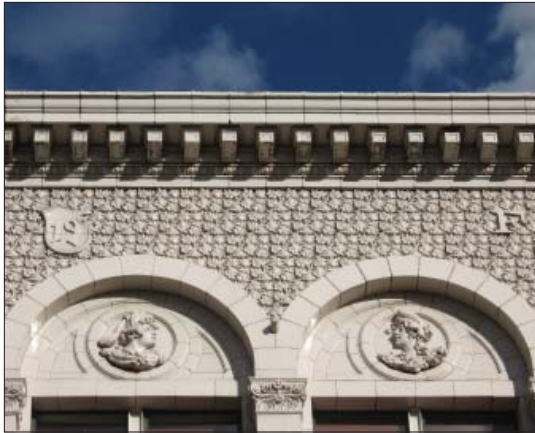
Architectural details exhibit craftsmanship and help convey the unique character of the Felt Building at 341 S. Main Street.

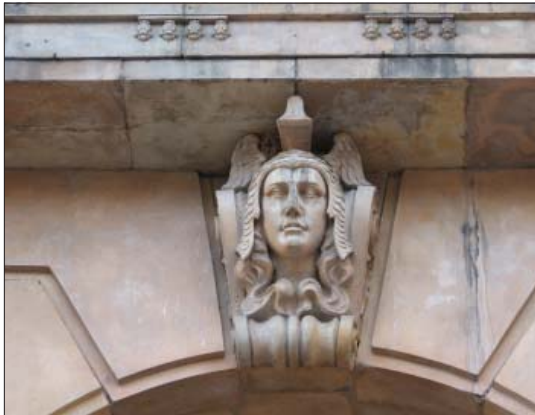
Decorative keystone of the Commercial Club Building at 32 Exchange Place.

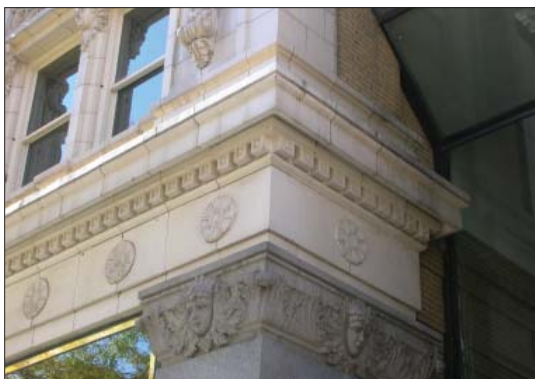
Molded terra-cotta rosettes adorn the facade of the Kearns Building at 136 S. Main Street.

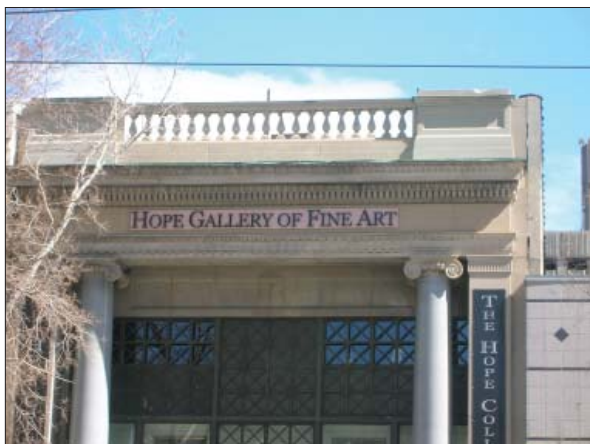
Cornices and balustrade add classical detailing to the street facade at 151 S. Main Street.

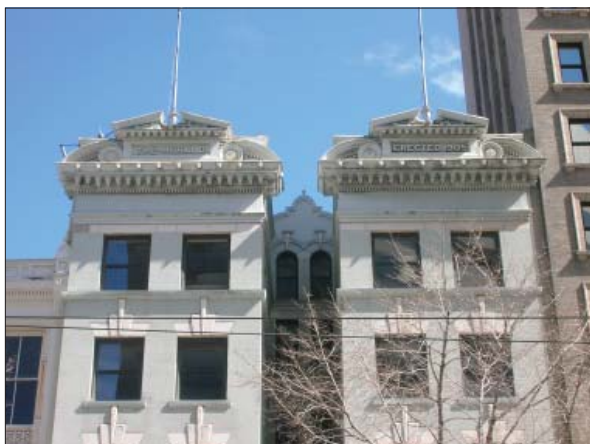
An ornate cornice crowns the Herald Building at 169 S. Main Street.

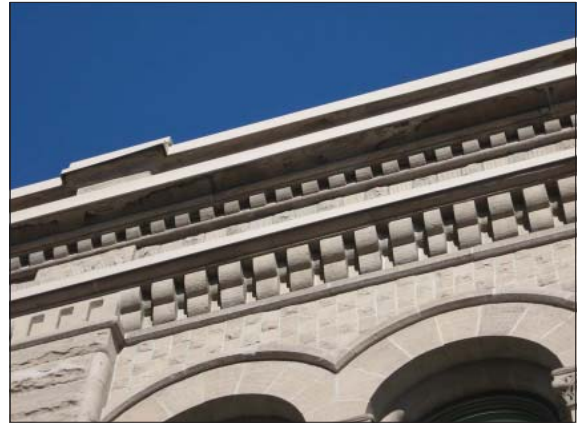
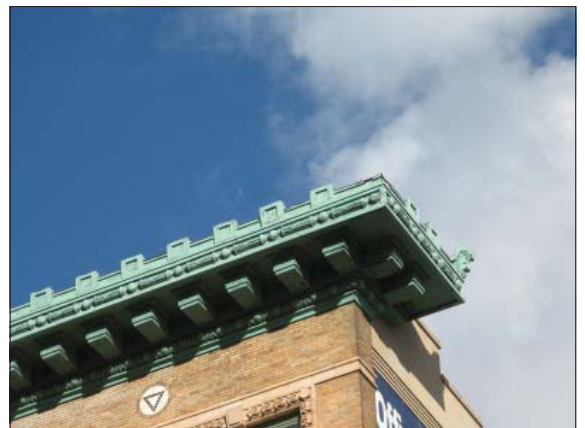
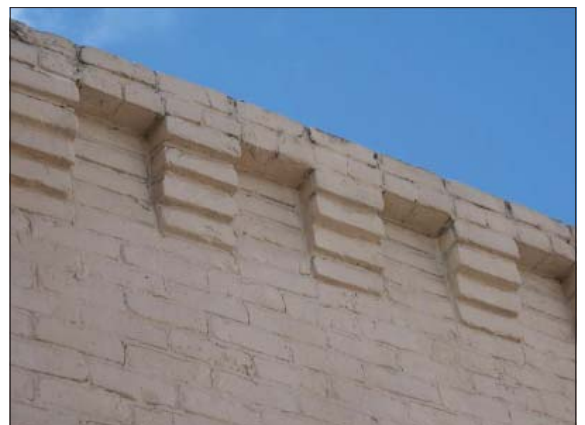
Salt Lake City commercial buildings offer a wide variety of cornice styles and materials, each helping to create the distinct character and identity of the building.
