Chapter 14

Capitol Hill

PART III Historic Districts

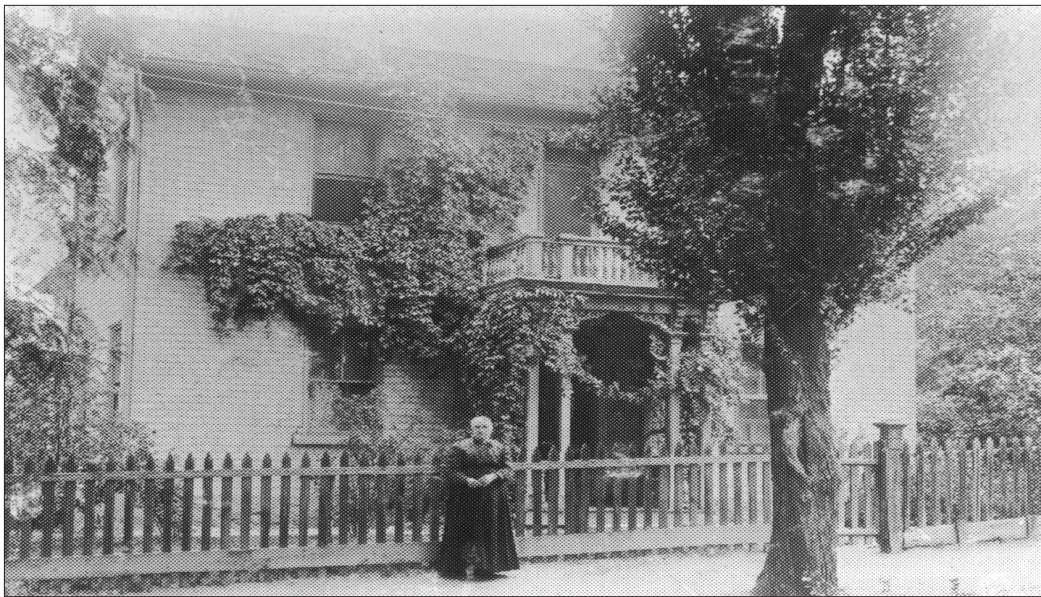
Cover page image: Sarah Hancock Beesley in front of the home of Ebenezer Beesley on 200 North Street. Italianate posts support a railing with turned balusters for a second floor porch in the background. Also note the wooden picket fence.

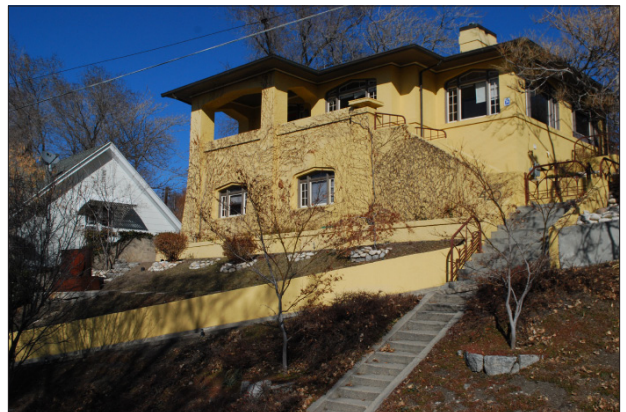
Steep slopes and elevated sites are central to the character of much of Capitol Hill.

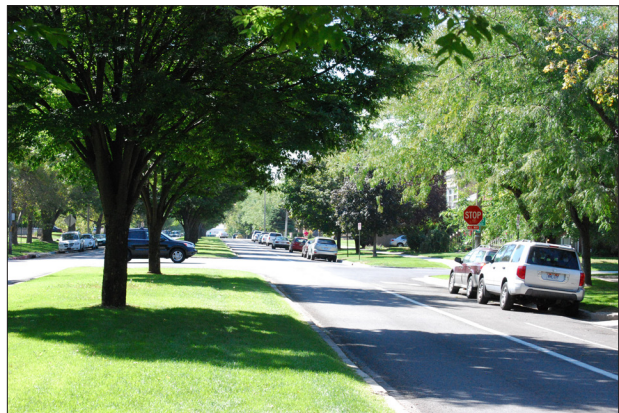
Parkways are a characteristic, sylvan amenity of 200 West, contributing significantly to the mature landscape character of the western section of Capitol Hill.

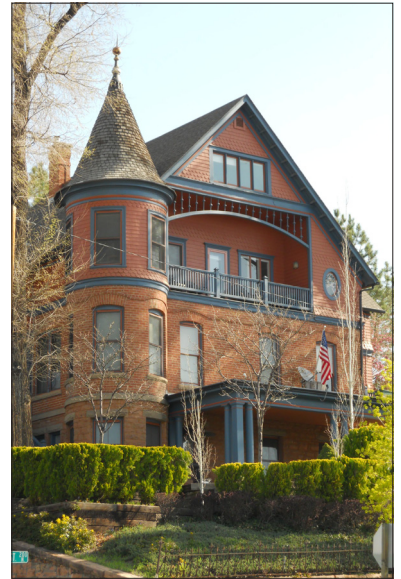
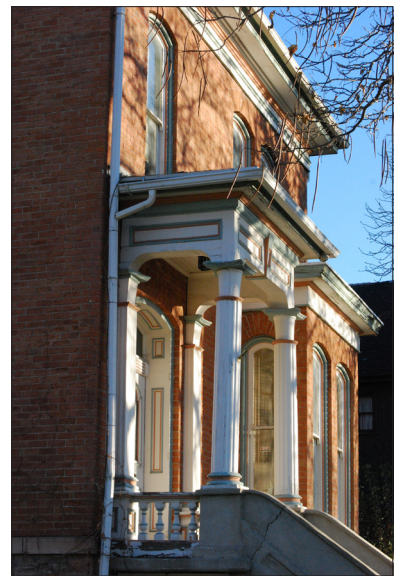
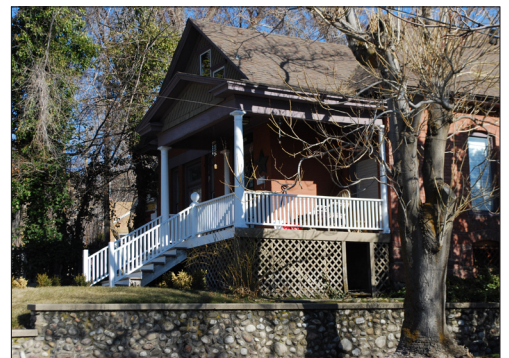
Architectural character varies considerably, whether set back from or immediately enclosing the street.

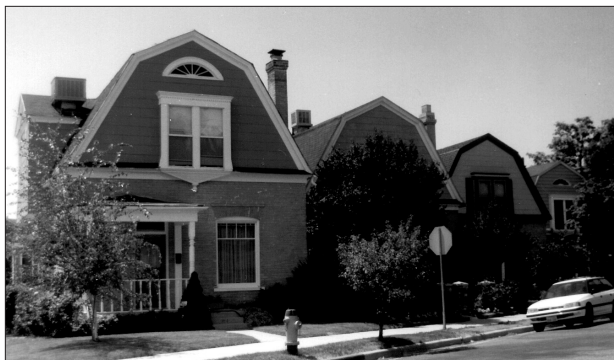
A row of Dutch Colonial structures angled with the street provides a distinct character to the streetscape of this block in the Capitol Hill district.

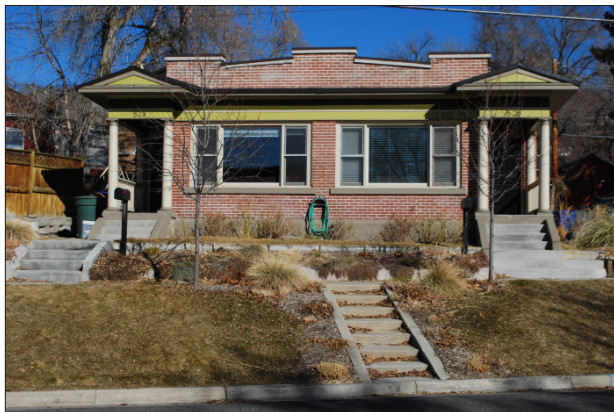
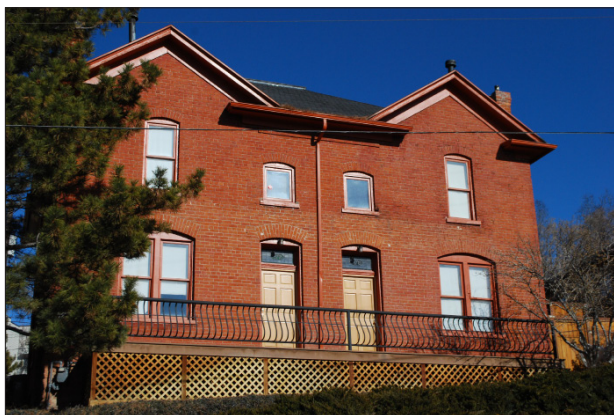
Duplex houses contribute to the character of Capitol Hill in a variety of forms and scales

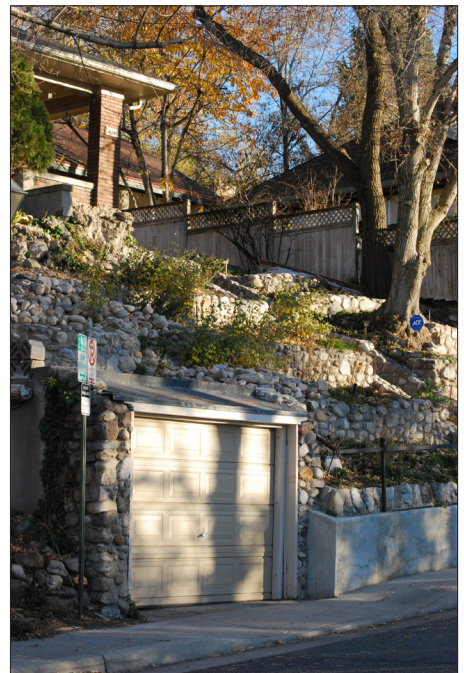
Retaining walls provide visual interest to the street, and serve as distinct character-defining features. This characteristic should be preserved.

The steep topography of the entire Capitol Hill district dictates the need for an extensive system of large retaining walls. These retaining walls, which have been used frequently to adjust for changes in slope, vary in texture, length and layout and are often paired with fences and plant materials. As a result, they provide visual interest to the street, and serve as distinct character-defining features. These characteristics should be preserved.

14.7 Original or early retaining walls and fences should be retained wherever possible.

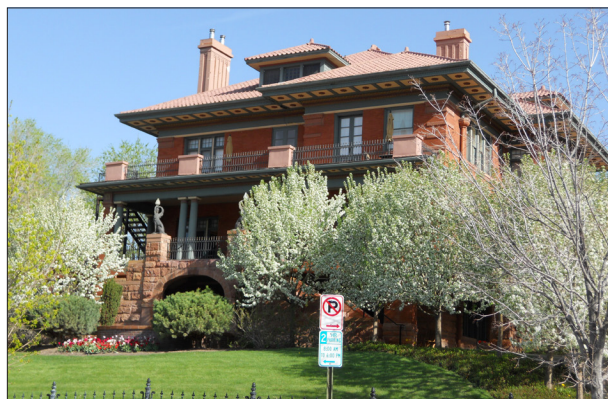
The “Woodruff-Riter-Stewart Home” at 93 East Second North Street is an example of the variety of architectural styles that can be found in the Capitol Hill Historic District.

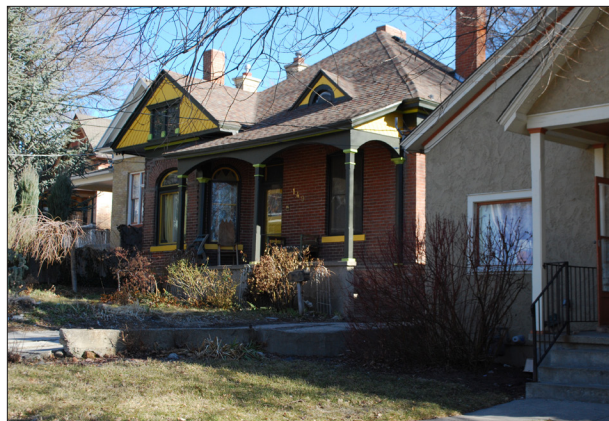
Staggered setbacks in the Marmalade district are due to a diagonal street pattern.

In this area of the district, the orientation of a building to the street varies, depending on the angle of the street itself. This irregular organization developed because many buildings were constructed to the points of the compass rather than at right angles to the street. The result is a wider variety in setback and orientation of buildings to the street.

- This positioning, mixed with variations in slope, caused rows of staggered houses, each with limited views of the streetscape.
- Staggered setbacks are appropriate in this part of the district because of the historical development.
- Traditionally, smaller structures were located closer to the street, while larger ones tended to be set back further.

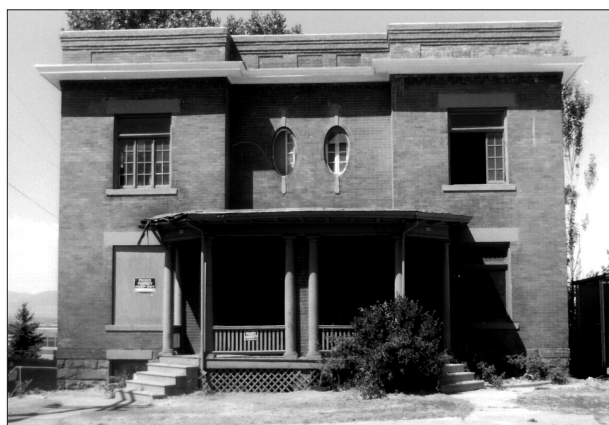
This classically-inspired duplex is an example of high style multifamily housing in Salt Lake City. A centrally located porch defines the entrance. This structure was extensively renovated in 1995.
