### Chapter 2

## BUILDING MATERIALS & FINISHES

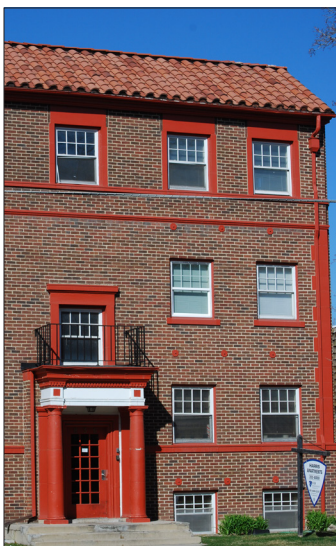
*Clay roofing tile as a visible characteristic.*

The roof materials are likely to be an element in the apparent character of particular architectural styles such as Tudor, Gothic and perhaps Spanish influences. A more complex roof form and steeper roof pitch will expose the roof treatment and materials. Similarly, materials characteristic of the style should be retained or if necessary replaced in kind. Care should be taken to ensure that a common approach is taken to the roofing materials which are a visible characteristic.
