MILLER PARK BIRD REFUGE AND NATURE PARK

Trail Access Improvements & Historic Structures Preservation

EXISTING CONDITIONS + IMPROVEMENT OPPORTUNITIES

IMPROVEMENT PROJECTS

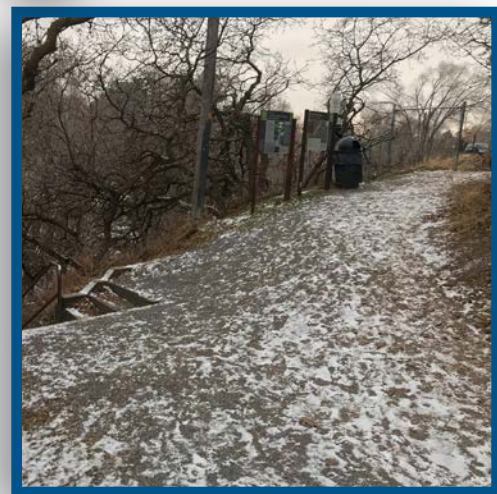
A SLOPE ISSUES

STEEP CROSS SLOPES
Some segments of the trail have steep cross slopes (higher than 2%) that limit the accessibility of the park.

PROJECT DESCRIPTION
Near the entrance at Bonneview Drive, the trail's cross slope should be corrected to be ADA compliant; doing so will require the addition of stairs and handrails to meet the proposed grade and potentially retaining timbers on the downslope side.

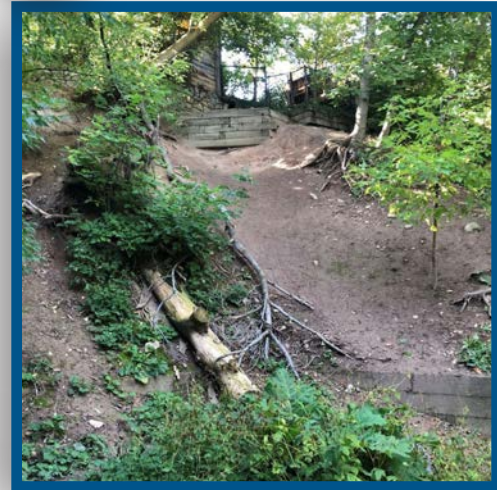
C DRAINAGE ISSUES

CONCENTRATED RUNOFF
Some locations with concentrated runoff from adjacent properties are causing erosion and damage to retaining walls.

Coordinate with property owners to prevent concentrated drainage from private property onto park property where it can cause damage including erosion, rutting, and undermining of retaining walls.

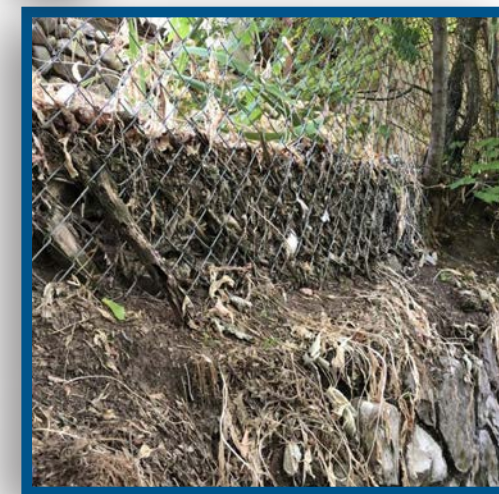
D MAINTENANCE ISSUES

DEBRIS & SOIL BUILD-UP
Chain-link fences on adjacent properties are collecting debris and retaining soil at multiple locations. These "debris dams" trap water behind the walls and could contribute to potential failures.

Coordination with individual property owners is needed to maintain downslope fences and keep them free of debris to prevent buildup of debris and water behind walls.

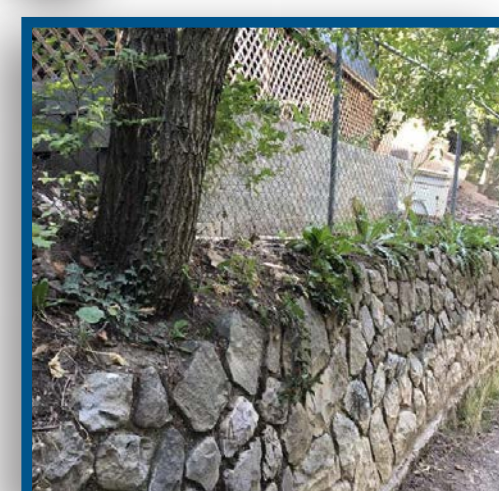
E ADDITIONAL LOADS ON STONE WALLS

TREES ADJACENT TO TOP OF WALL
Mature trees growing near the top of retaining walls apply additional loads and threaten the longevity of the walls.

Remove any non-native trees on park property growing within 5 ft. of the back of structural walls.

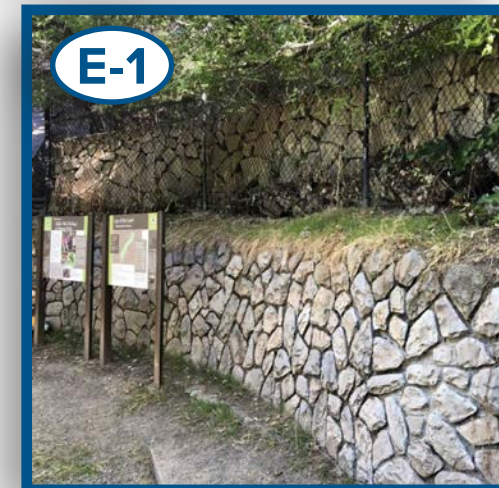
LOADS FROM ADJACENT STRUCTURES
Several adjacent properties contain structures, including walls, sheds, decks, etc. that contribute to loads on park retaining walls. Some structures sit on private lands while others are on park property.

Remove the stacked concrete retaining wall adjacent to the 900 S entrance and return the slope to its original profile. This wall places additional loads on the stone walls below and does not possess historic significance. Re-point cracks in stone walls.

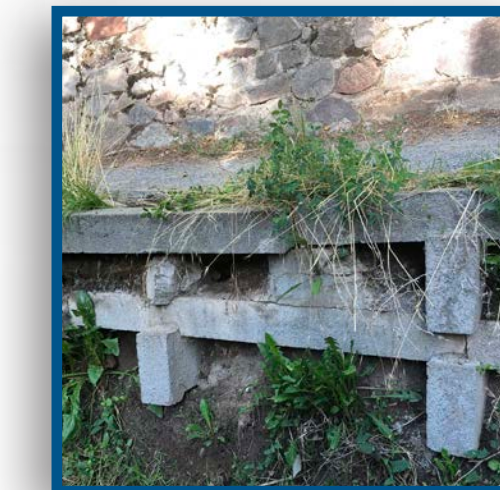
F DEVELOPING INFRASTRUCTURE PROBLEMS

FAILING CRIB WALLS
In some locations, crib walls are eroding or have been washed away by flooding.

Repair and replace eroding crib wall. Backfill crib wall with appropriate material and place geo-synthetic reinforcement grid for stability.

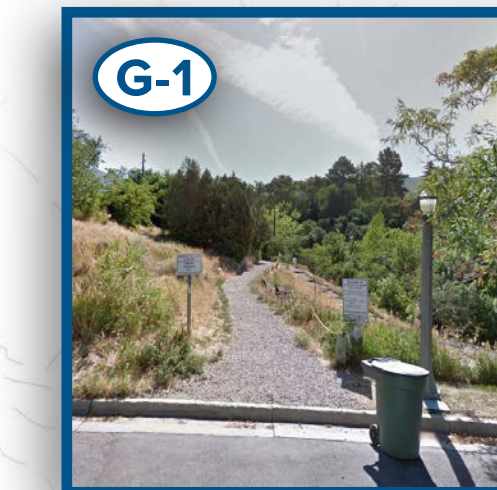
G ACCESSIBILITY ISSUES

NO ADA ACCESS
Park entrances at Bonneview Drive and 900 South are not ADA compliant; additionally, there is no continuous loop of accessible trail through the park.

PROJECT DESCRIPTION
Add curb cut and ramp from Bonneview Drive; coordinate with Streets department.

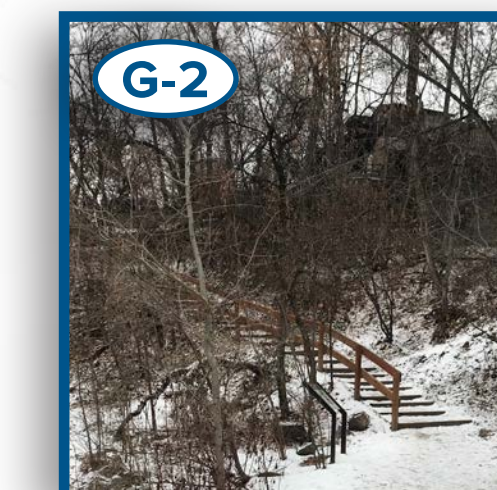
STAIRS
The stairs on the east side of the creek serve as a major barrier to wheelchairs. In addition, handrails, treads, and risers could be improved to better accommodate trail users.

PROJECT DESCRIPTION
Reconstruct stairs to make risers even and treads a consistent length; include a handrail on upslope side and 2-3 landings. Alternative: decommission stairs and upper trail if bridge and boardwalk are constructed (See G-3).
