Salt Lake City: BST West City Creek Trail Tread & Slope Maintenance

Partner: Department of Public Lands

Location: Salt Lake City, Utah

Dates: 11/01/2023-11/21/2023

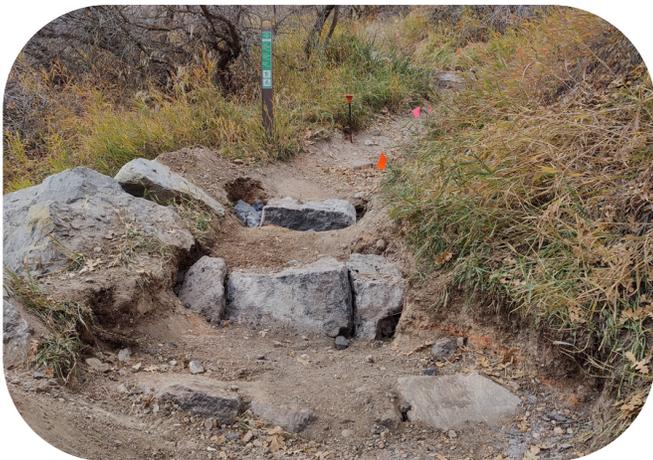
Top Left: Two sets of steps partially installed. The crew would still need to crush around the larger rocks. The crew was able to work on multiple steps at a time due to Jake Groth's preplanning of the spacing and step height.

Bottom Left: A crew member digging in preparation for the installation of a gargoyle.

Bottom Right: A finished step with two gargoyles keyed off the step.

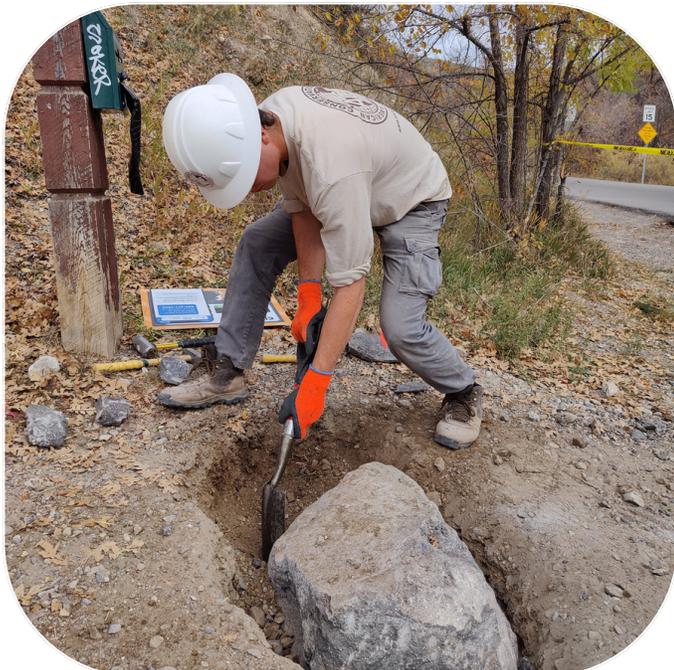
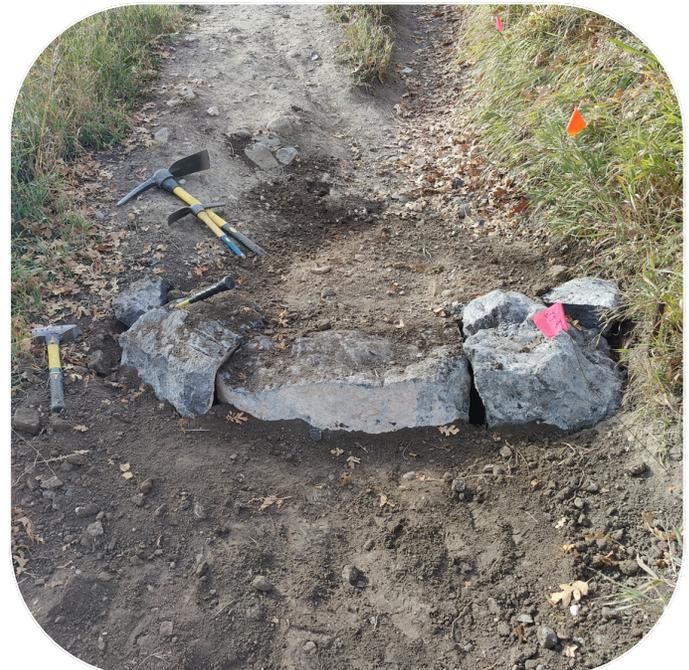
Before and After Set One: These pictures show the upper section of the staircase. In the before photo the trail trench can be seen along with the social trail being created to the left of the official trail. In the after photo the staircase can be seen filling up the trenched section. The stairs were spaced evenly and were each planned to be a 10 inch step.

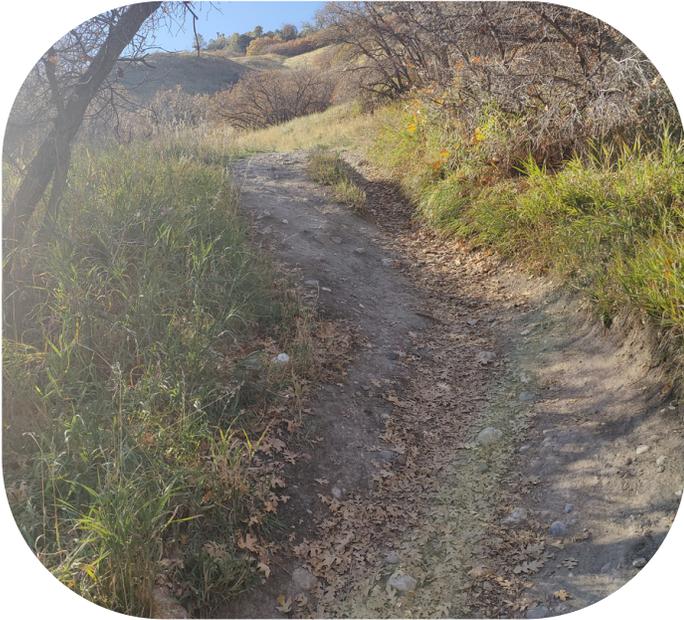
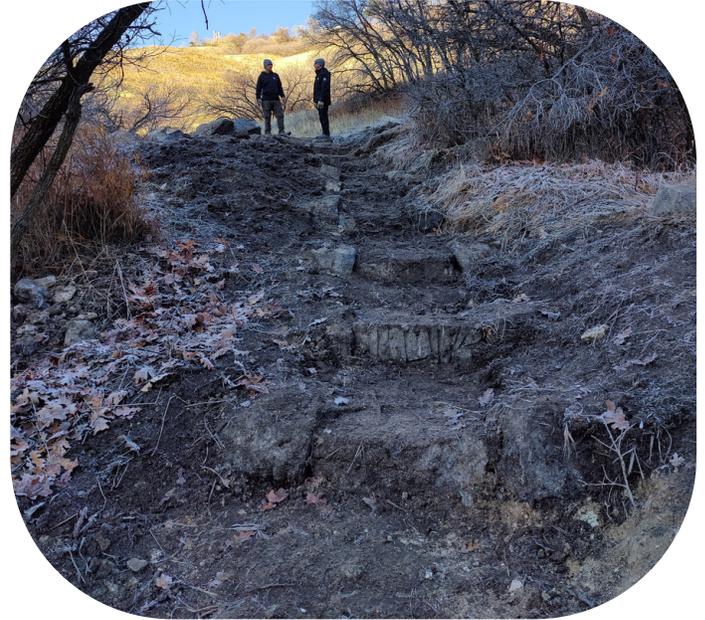
Before and After Set Two: This set focuses on one of the bottom portions of the trail. The crew started installing close to the road, which led to problems with digging. The soil had road infrastructure, but the crew used shaping tools to hammer through this tough layer.

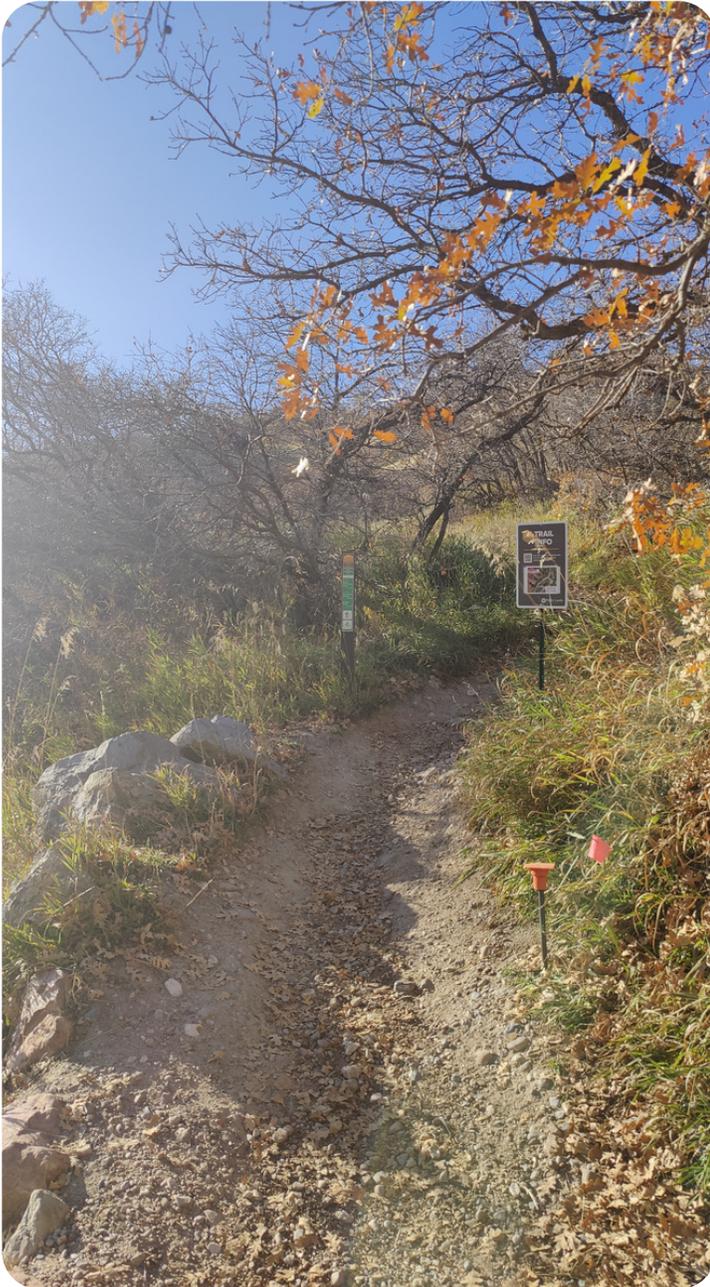
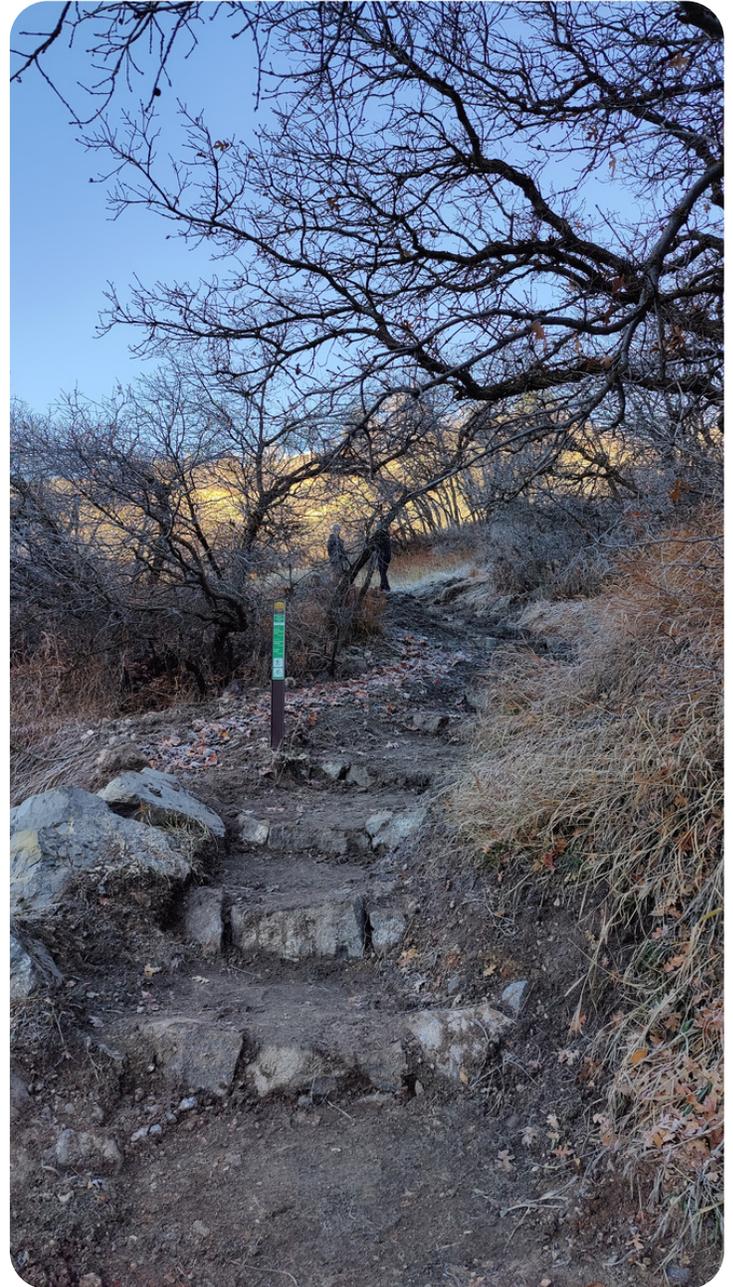
Before and After Set: This last set displays the middle section of the staircase. Again, the trenching can be seen in the before photo, which is caused by a combination of use and water erosion. The before photo also shows a survey stake on the right side of the picture. These stakes had string tied to them, which the members used with a line level to keep their step heights standardized at 10 inches.

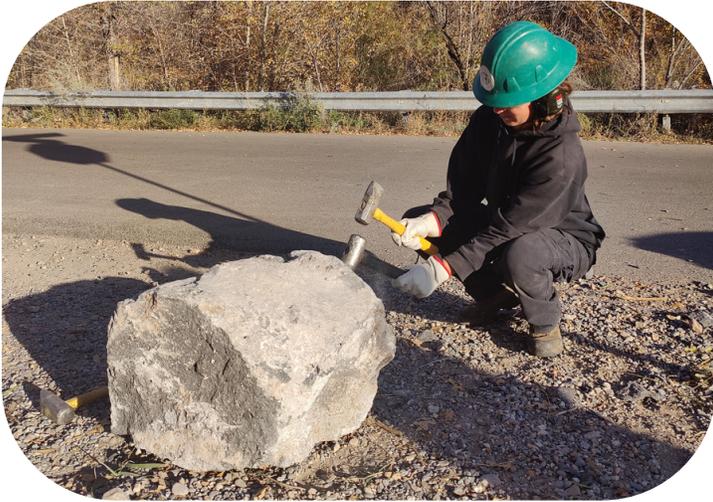
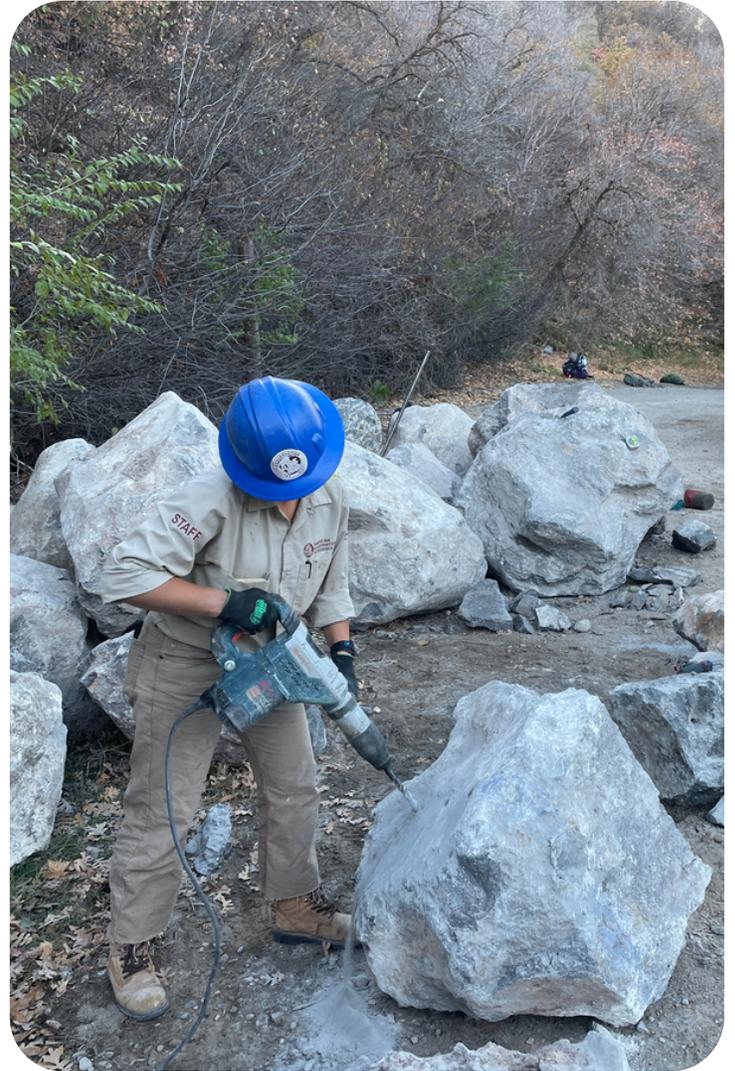
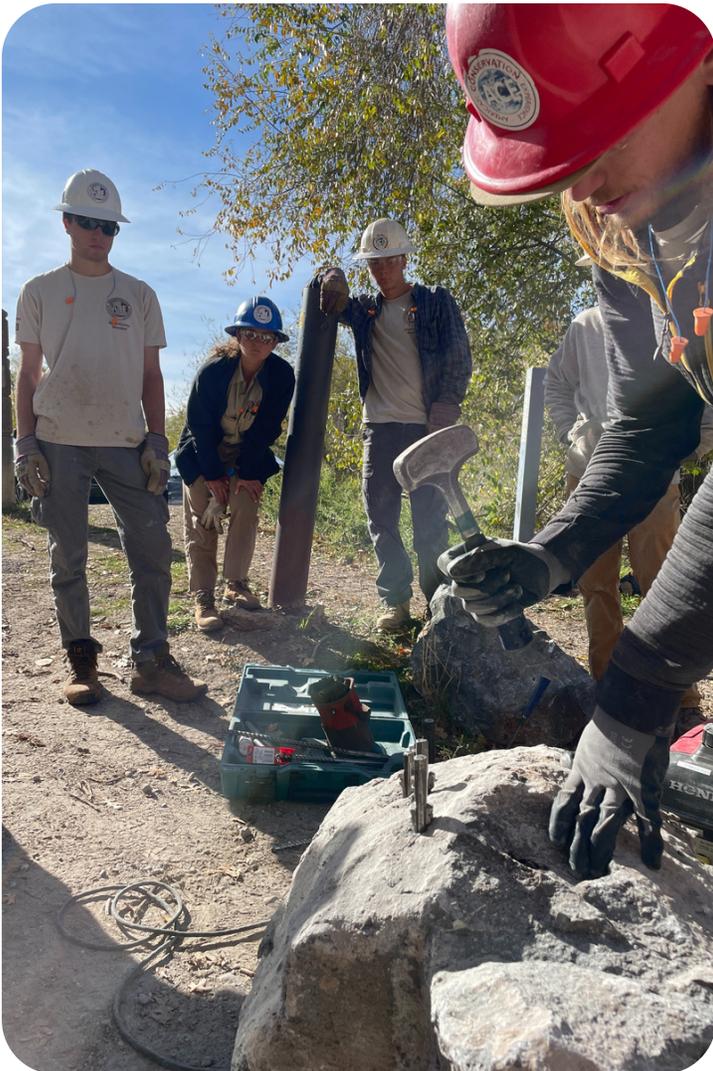
Top Left: Assistant Team Leader Brandi Marlett using shaping hammers to shape a step rock to better fit its hole.

Bottom Left: Jake Groth demonstrating shaping technics using feather and wedges to crew members and crew leader Casey Bainbridge.

Top Right: Crew Leader Casey Bainbridge using a rock drill to prepare a boulder for shaping into steps and gargoyles.

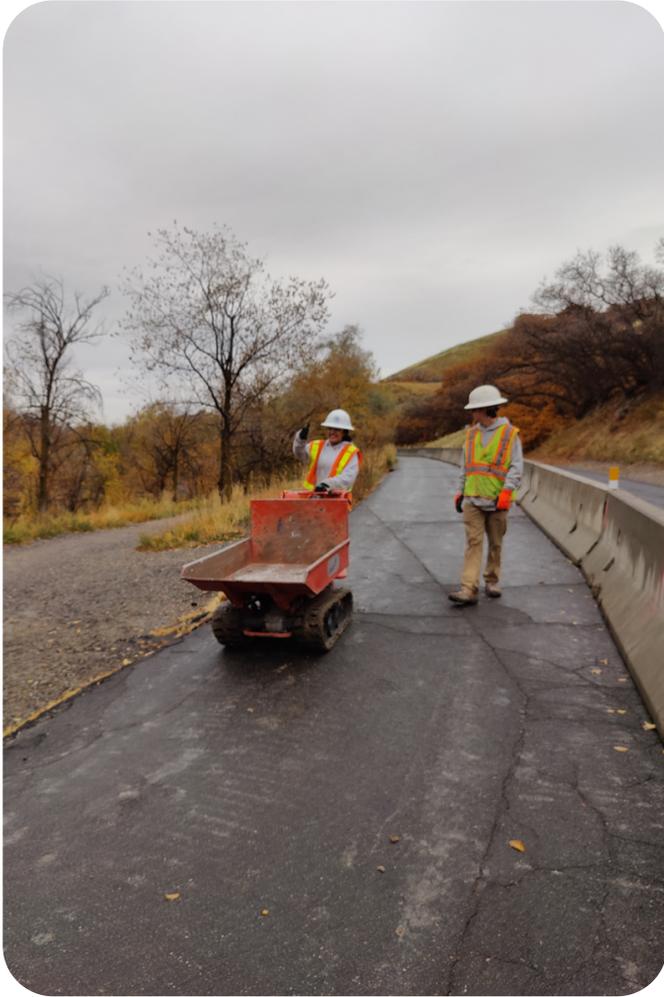
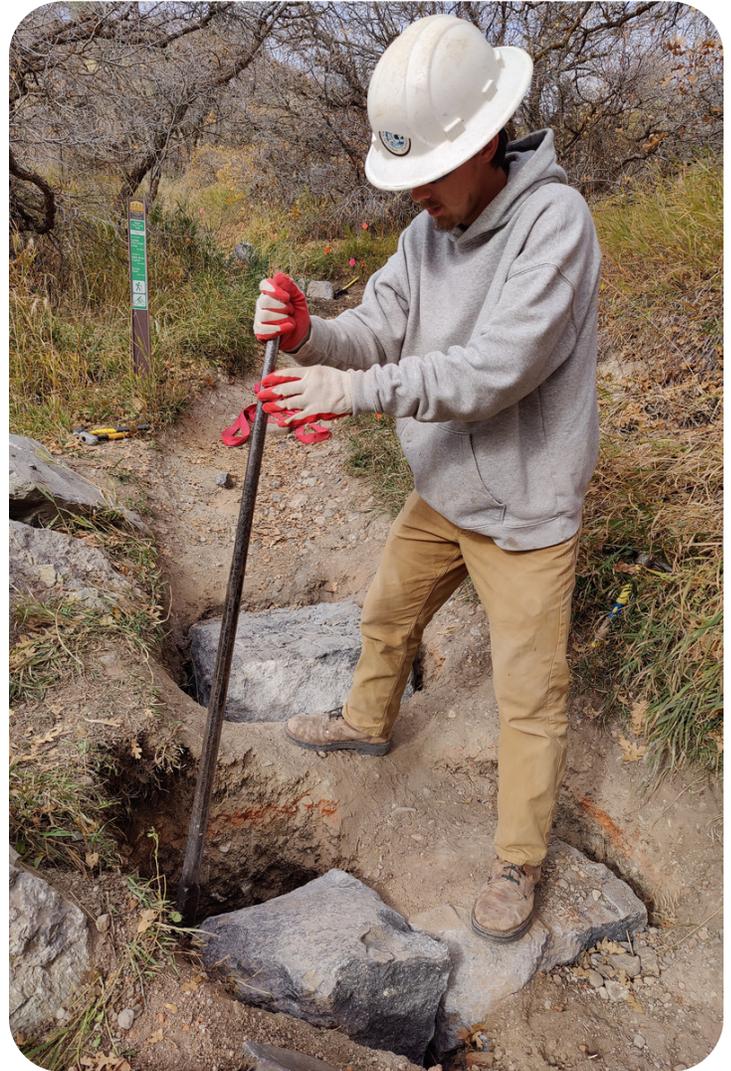
Top Left: Two crew members operating a power carrier. Members got specialized training and had to wear high visibility vests and have a spotter.

Bottom Left: Two crew members using survey stakes, line levels, and measuring tapes to assess the height of their step in relation to the rest of the staircase. This method ensured a standard step size and a uniform staircase.

Top Right: A crew member uses a rock bar to position a gargoye making sure to get good contact on the adjacent step.
