### 3.0 BASELINE ASSESSMENT RESULTS

#### Watershed Conditions

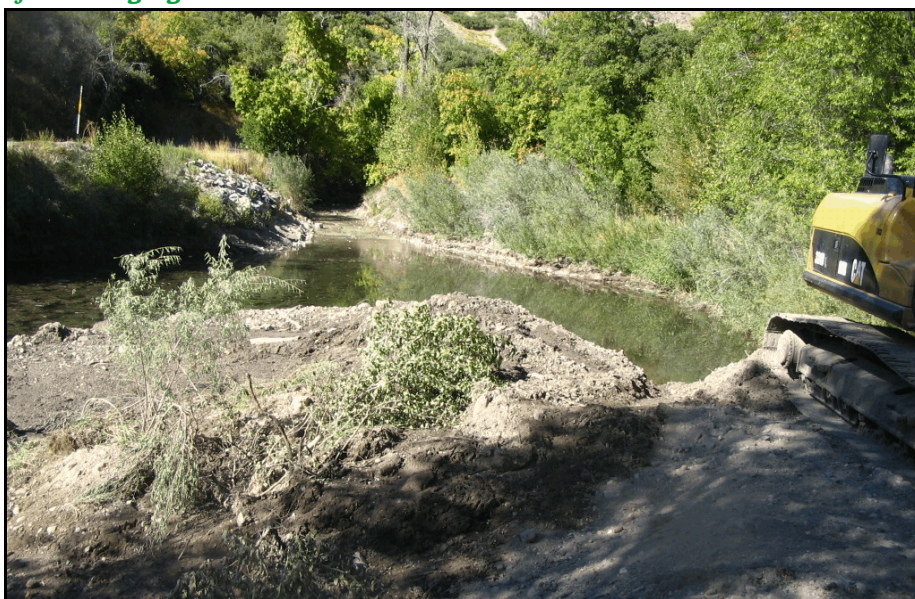
**Below: City Creek debris basin above Bonneville Boulevard shortly after dredging.**

No significant water storage reservoirs are currently present on City Creek, although historically reservoirs were constructed in the canyon to store water for municipal supply. Two debris basins located immediately above and below the Bonneville Boulevard crossing provide some degree of flow regulation and capture a significant portion of the creek’s coarse sediment loads. These debris basins are maintained by Salt Lake County and require dredging approximately every two to three years. Additionally, the formal portion of Memory Grove Park adjacent to study reach LCC\_R02B is designed to function as a flow regulation

basin that would control flood flows entering the downstream engineered conduits. This current system for flow and sediment regulation was constructed to prevent damages similar to those sustained during the major flood event in 1983.

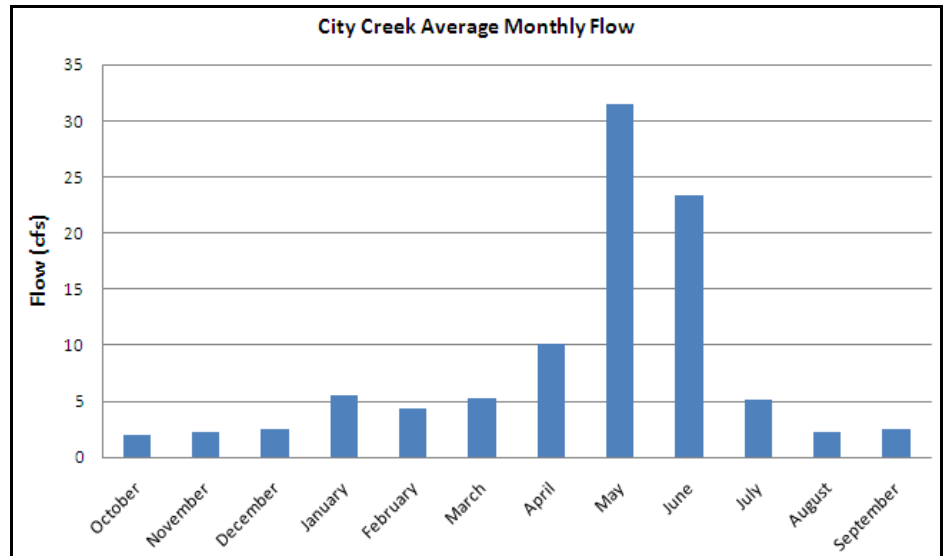
**Figure 3.2. Monthly flows at Salt Lake County’s gage at Memory Grove.**

City Creek’s hydrology is characterized by a distinct springtime peak typical of snowmelt-driven systems. Based on analysis of flow data recorded at the County gage in Memory Grove from 1980–2005, mean annual flow is 8.3 cfs, average monthly flow is highest in May (Figure 3.2 ), and base flows average about 3 cfs. Peak daily flow occurs on May 21st on average (SLCO 2009), and average annual high flow is 67 cfs based on analysis of the 1980–2005 time period.

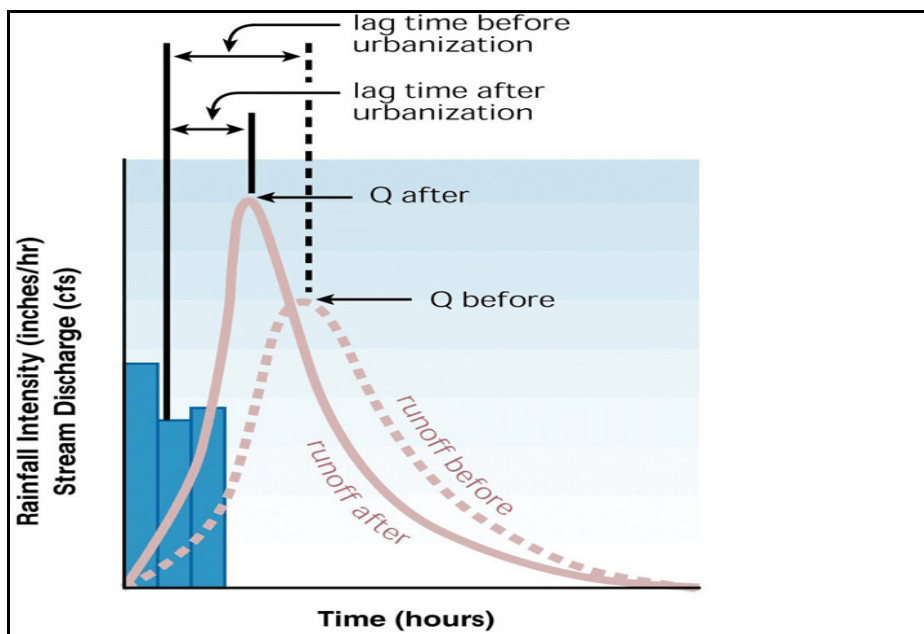
**Figure 3.4. A comparison of hydrographs before and after urbanization. The discharge curve is higher and steeper for urban streams than for natural streams. Diagram and caption text from FISRWG 1998.**

surface flow during storm events can also lead to a “flashy” hydrologic pattern with rapid, brief rises in flow during storms (Figure 3.4). On City Creek, however, these influences are limited only to the downstream-most study reaches because the majority of the contributing watershed area has been protected as undeveloped open space.

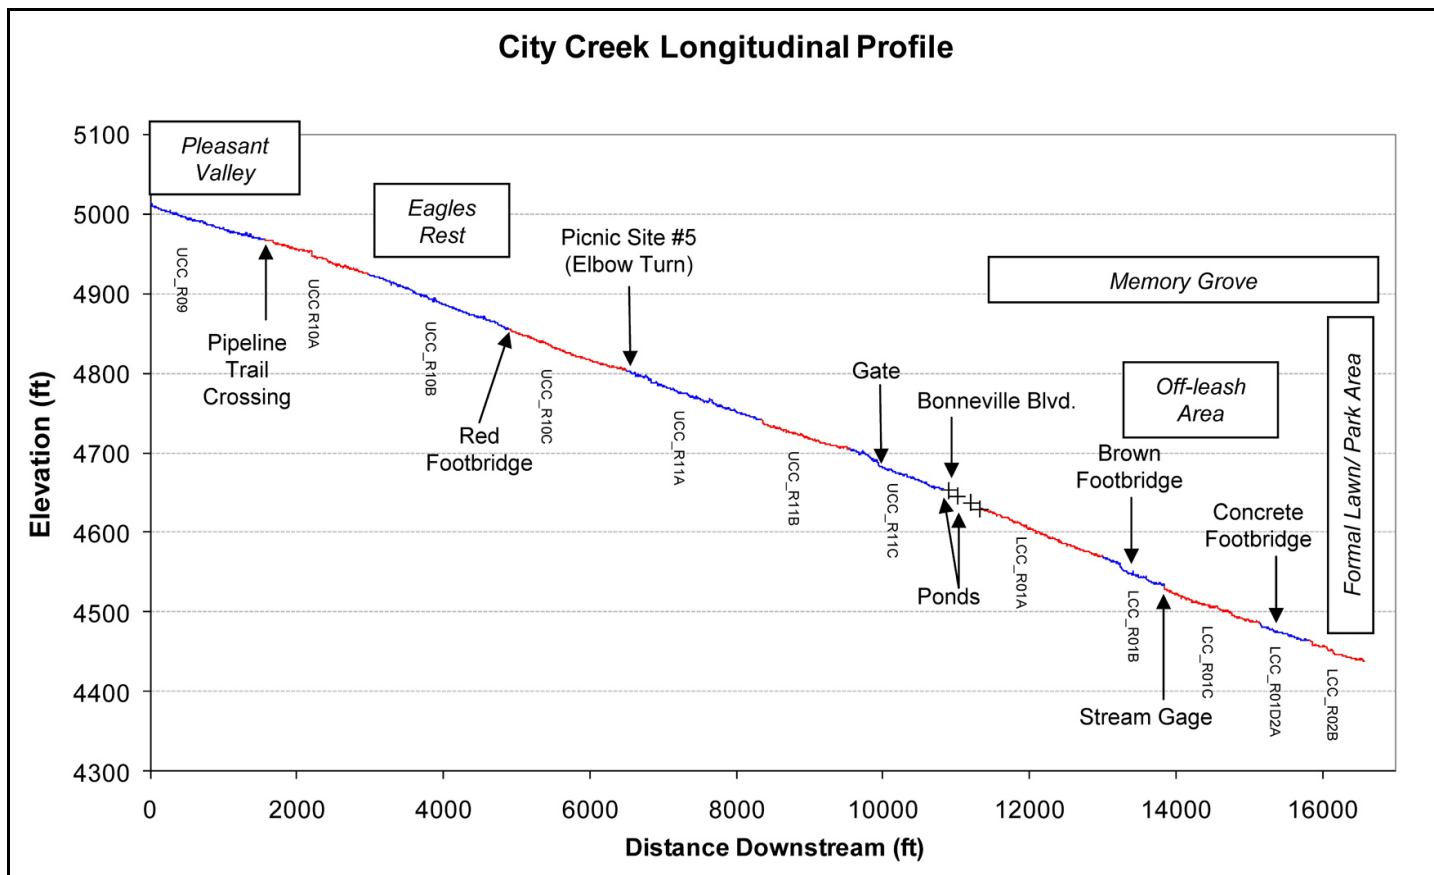
**Figure 3.8.** Longitudinal profile plot of City Creek streambed based on 2006 digital elevation data. Black cross marks indicate culvert inlets and outlets; red and blue lines indicate open channel stream sections.

Channel slope, as determined for each stream reach from digital elevation data, varies from 2.9% to 4.5% within the RCS study area, with an average value of 3% (Figure 3.8, Table 3.1). City Creek does not show any obvious consistent spatial trends in gradient through the study area. Historically, channel gradient would have shifted to a flatter, less confined, more sinuous channel type in the flatter valley area west of State Street; however, this portion of the creek is now piped underground in the North Temple conduit.

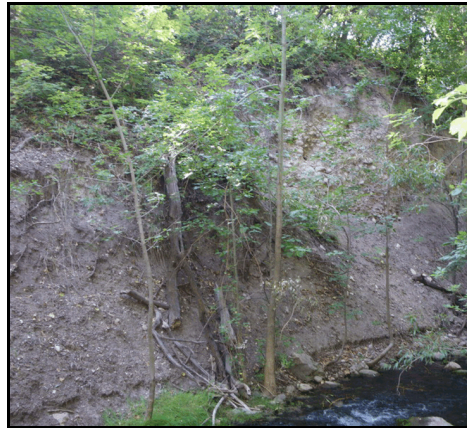
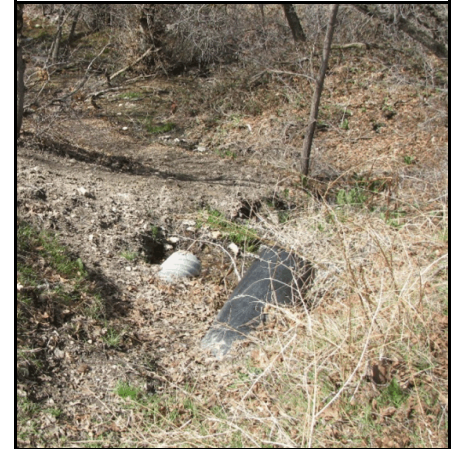
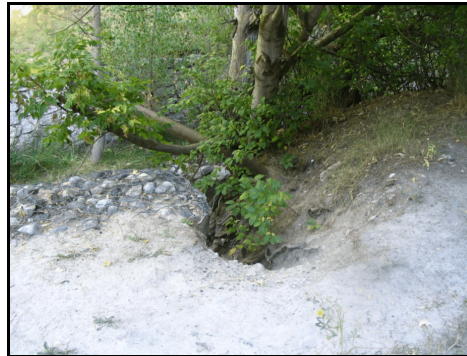
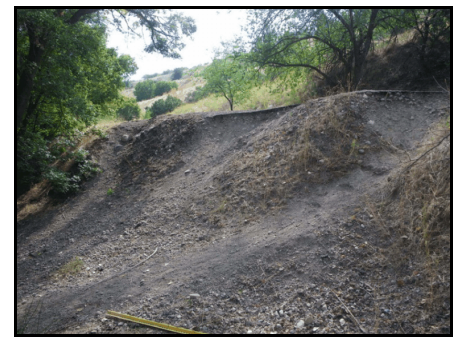
**Top left: Steep bare slope adjacent to Bonneville Boulevard in reach LCC\_R01A. Note trees, grass, and large rocks at base of slope indicating toe stability. Top right: Rill erosion below pipe outfalls. Bottom left: Rill erosion where road runoff concentrates at gabion/natural bank interface. Bottom right: Bare bank and compacted soil associated with heavy recreational foot traffic.**

Steep, poorly vegetated fill slopes associated with roads affect stability in portions of the lower reaches of City Creek and are particularly prevalent in reach LCC\_R01A. Because these slopes lack vegetation and the associated resistive strength it provides, they are vulnerable to erosion during flood events. Fill slopes also restrict floodplain width and laterally confine high flows, causing increased flow velocities and shear stress on streambanks. Fill encroachment also limits the ability of floodplain surfaces to act as sponges to absorb flood water.

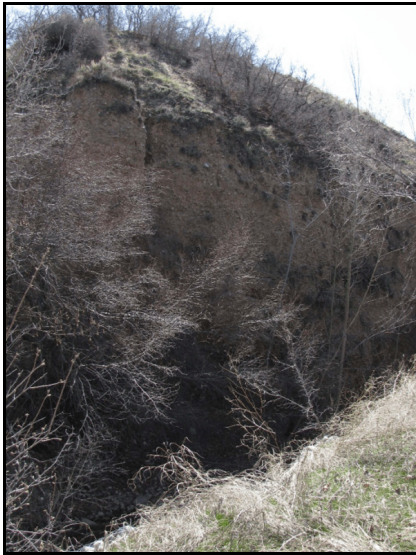
***Above: Steep vertical bank where stream has migrated laterally into a fine-grained geologic formation.***

Lateral erosion of streambanks is a natural process in stream channels, which are dynamic systems. Erosion and sediment transport are necessary for the creation and maintenance of important habitat features such as scour pools, undercut banks, and spawning gravels. Deposition of sediment on floodplain areas is also important, as it provides fresh substrate for the growth of willow and cottonwood seedlings that are needed to maintain native riparian forests. However, excessive amounts of erosion or deposition can degrade habitat and water quality and threaten infrastructure and homes.
