2.0 BASELINE ASSESSMENT METHODS

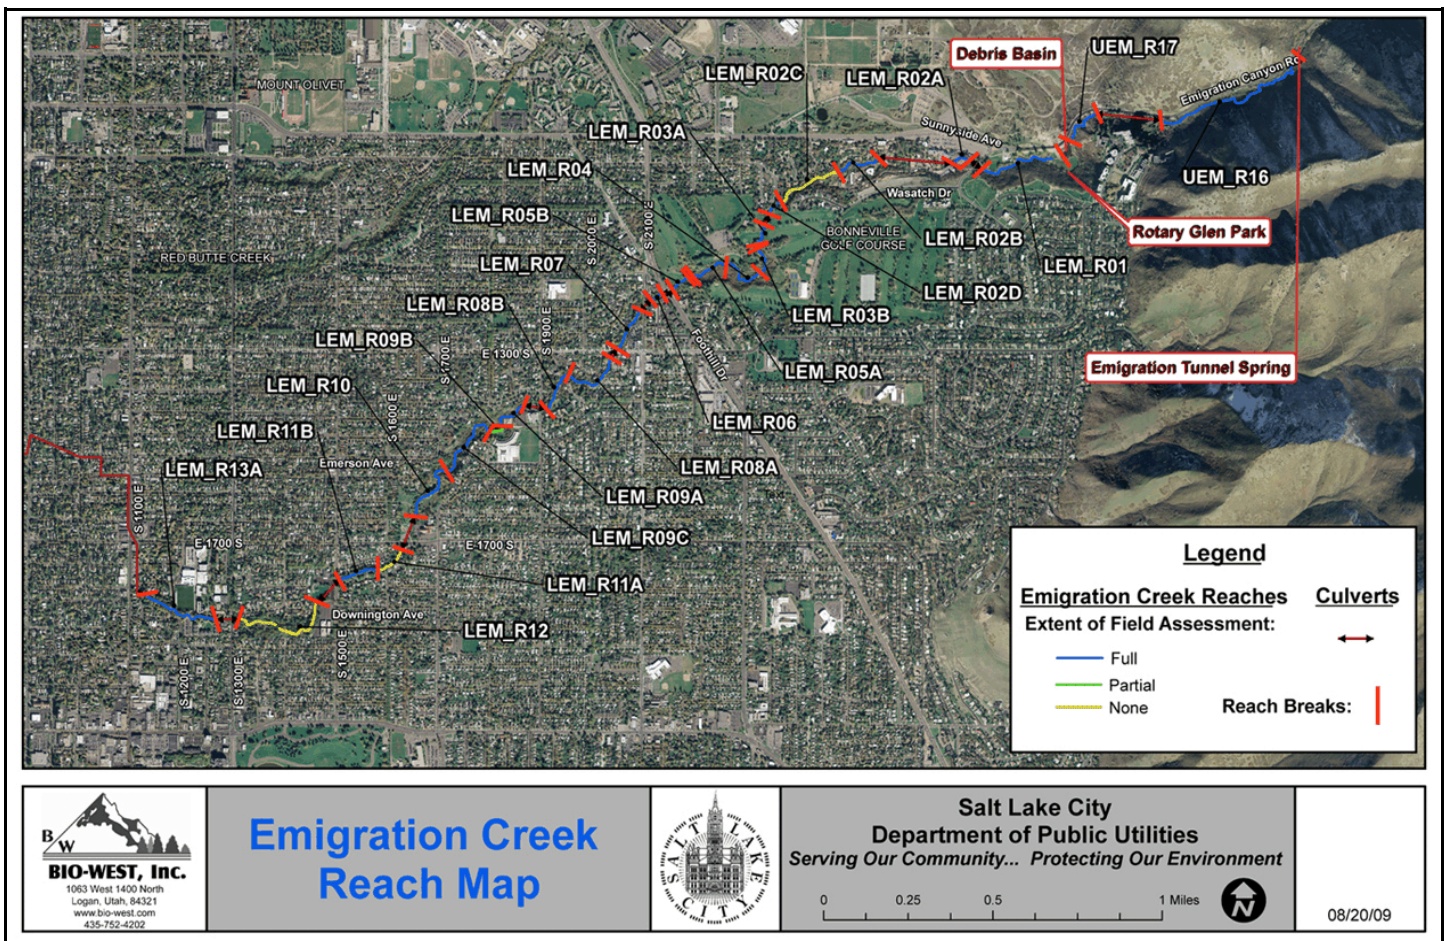
Figure 2.1. Emigration Creek reach map.

Conditions within the Emigration Creek corridor were assessed between Emigration Tunnel Spring and approximately 1100 East (Figure 2.1). Total above-ground channel length within the study area is approximately 3.8 miles. For assessment purposes, the stream was divided into individual reaches, with each reach generally between 300 to 1,400 feet in length. Reach

breaks were initially identified based on reaches previously established by Salt Lake County (the County); several of these County reaches were further subdivided at road crossings or where significant changes in stream condition occurred. Twenty-four study reaches were established within the overall Emigration Creek study area. Reach names and numbers were assigned based on established County watershed abbreviation

and stream numbering conventions (SLCO 2009). Emigration Creek includes the upper Emigration (UEM) and lower Emigration (LEM) subwatersheds, with the break occurring at the canyon mouth. Within each subwatershed, reach numbers are assigned consecutively in an upstream to downstream direction, resulting in reach numbers such as LEM_R01 (lower Emigration Creek Reach 1), LEM_R02, etc.

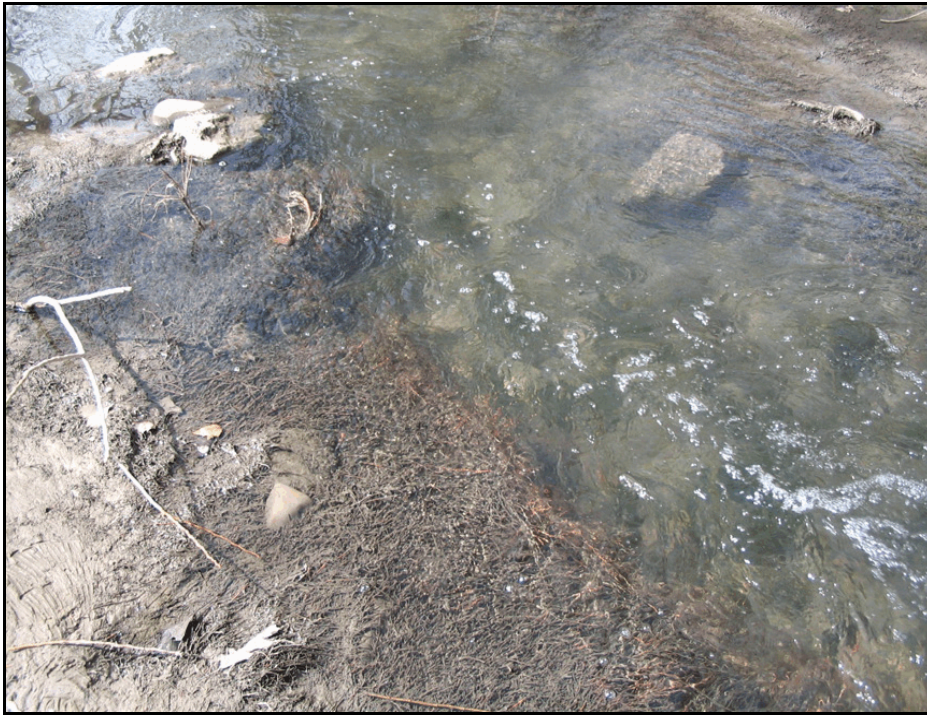
Figure 2.2. Clay/root mat “shelf” feature.

During reconnaissance visits to the creek prior to beginning detailed evaluations, it was noted that the streambed condition in some sections of the creek appears to be influenced by an unusual clay/root-mat feature (Figure 2.2). In these areas fine-grained bed material appears to become tightly bound together with dense, fine roots and moss, creating a smooth, resistant layer that can create a “shelf” within

the streambed. This “clay shelf” phenomenon is not well documented in the geomorphic literature and at this time is poorly understood; however, because it can have a significant influence on channel shape and roughness, its presence and extent of influence was noted on the data form for each study reach.

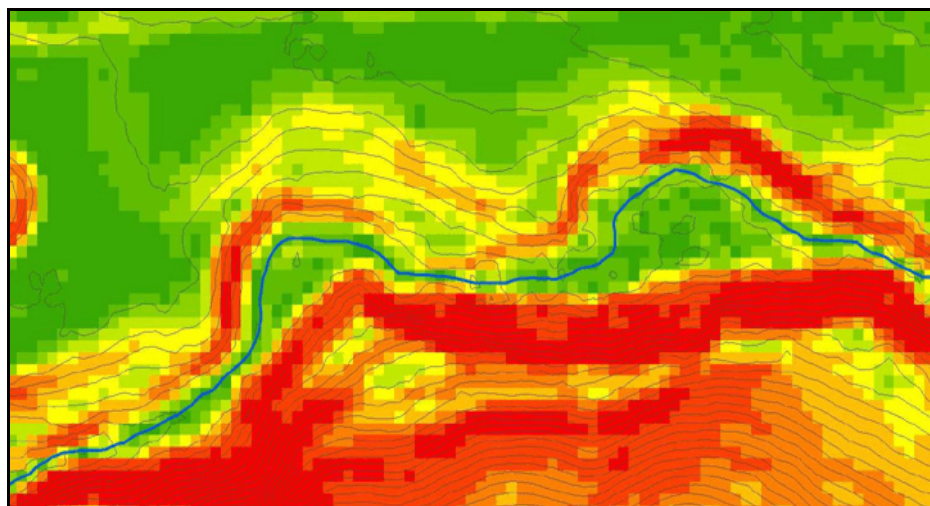
Figure 2.3. Using digital elevation data to draw the channel centerline.

To compliment the data collected in the field, several additional analyses were completed using 2006 LIDAR-based digital-elevation grid data (2-meter resolution) obtained from the City. Using slope and contour maps generated with ArcMap software to identify the low point of the channel, a new channel centerline alignment was digitized for the study area (Figure 2.3). Relative to previously available GIS stream-channel shapefiles, this new centerline file more closely follows the bends of the stream and provides more accurate information on total channel length. The digital contour maps were also used to identify more precise inlet and outlet locations of road-crossing culverts and update an existing “culverts” shapefile obtained from the County. Using the profile tool in ArcMap, a longitudinal profile of the channel centerline was extracted and plotted for each reach to determine total reach length and reach-averaged streambed slope. Culvert lengths were also determined, and a comprehensive longitudinal profile plot of the full study area was generated by combining the reach profile and culvert length data. The updated culvert shapefile was also attributed with data measured in the field (pipe diameter, outlet scour depth).

active channel and bank areas within and immediately beyond the AHWL; however, in most reaches, the stream is deeply entrenched below the surrounding terrain and it was not practical to field survey the entire upper portions of the slopes. Therefore, these upper-slope sections were extrapolated using the digital-elevation grid data. At each cross-section location in ArcMap, the profile tool was used to draw a line section (typically about 100 feet long) perpendicular to the channel and spanning its entire inset width. Because the accuracy of the GPS-based cross-section position data is only about 10 meters, the expanded portions of the cross-section plots may represent conditions slightly upstream or downstream of the actual field-surveyed cross section and, therefore, should be used only as a general indication of the overall shape and degree of entrenchment within a given steam reach.

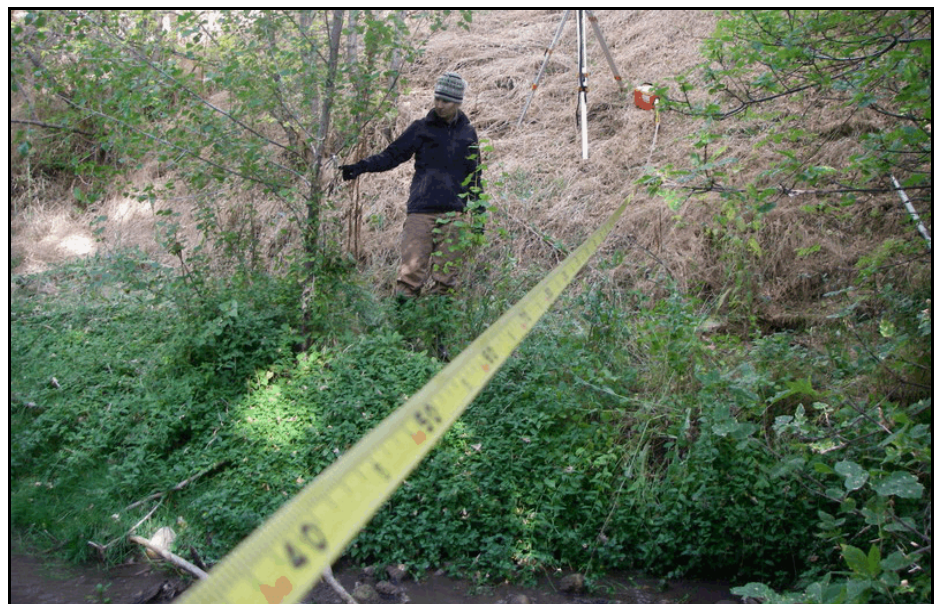
Information Recorded on the Vegetation Data Form:

- species composition of canopy, shrub, and understory layers
- relative amount of woody debris on banks/floodplain
- invasive species presence/dominance
- evidence of active recruitment of riparian willows/cottonwoods

Examples of Vegetation Community Associations:

- Box Elder/Redosier Dogwood Forest
- Gambel Oak Forest
- White Poplar Semi-natural Woodland
- Narrowleaf Cottonwood/
Narrowleaf Willow Woodland

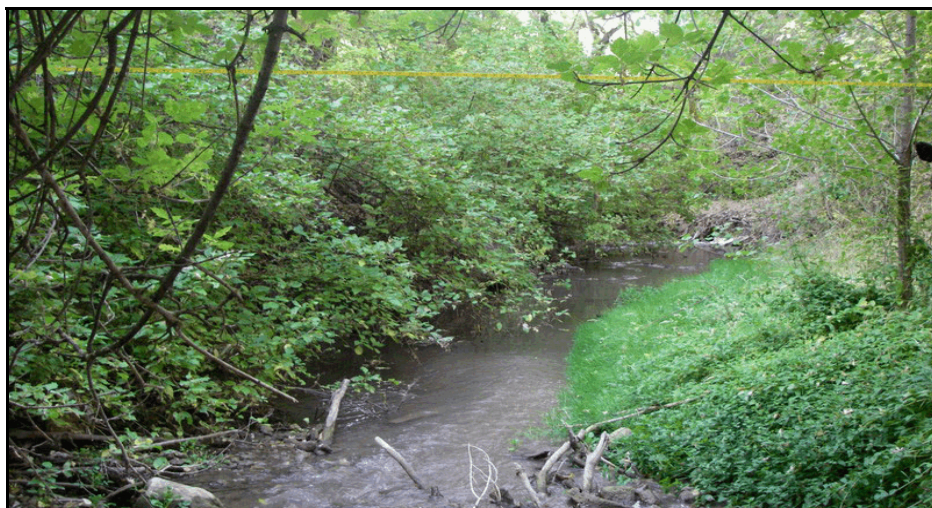
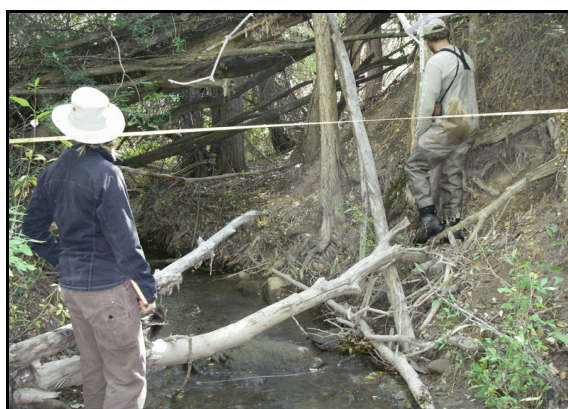
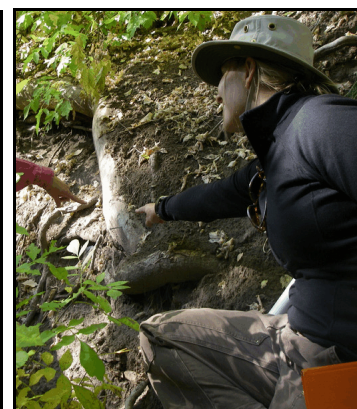
For each field-mapped vegetation polygon, species composition was recorded for all species that comprised 20% or more of the vegetation community. Species composition was recorded separately for each of the structural layers (canopy, shrub, understory). Each polygon was then classified as a specific vegetation community type based on the National Vegetation Classification for Utah, which is based on the National Vegetation

Classification Standard and the Standardized National Vegetation Classification System (SNVCS) (USDI 1994).

Communities were characterized to the association level. Associations are often named for the dominant canopy or tallest species and the dominant species in the ground layer or shrub layer. In many single-layer communities either a single species is used in the name or co-dominant species may be used in the name.
