### 3.0 BASELINE ASSESSMENT RESULTS

#### Watershed Conditions

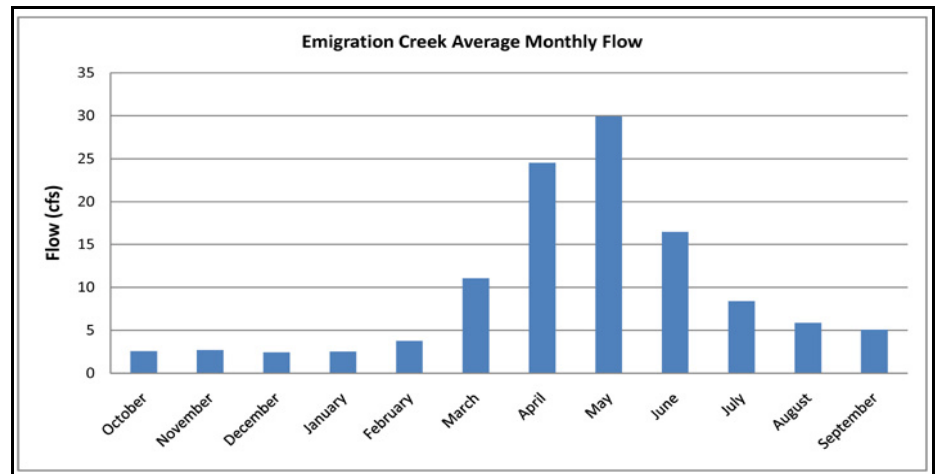
**Figure 3.3. Monthly flows at Salt Lake County's gage at Rotary Glen Park.**

Emigration Creek's hydrology is characterized by a distinct springtime peak typical of snowmelt-driven systems. Based on analysis of flow data recorded at the County gage in Rotary Glen Park from 1980–2005, average monthly flow is highest in May (Figure 3.3), and peak daily flow occurs on May 1 on average (SLCO 2009). Average annual high flow is 55 cubic feet per second (cfs), while typical base flows are on the order of 2.5 cfs. No streamflow gage exists at the downstream end of the study area, so no quantitative data are available to characterize hydrology after the creek flows through the most urbanized portion of watershed downstream from the Rotary Glen Park gage. However, field observations during storm events suggest that flows in the lower reaches of the creek are quite “flashy,” with rapid, brief rises in flow during storms. This is a

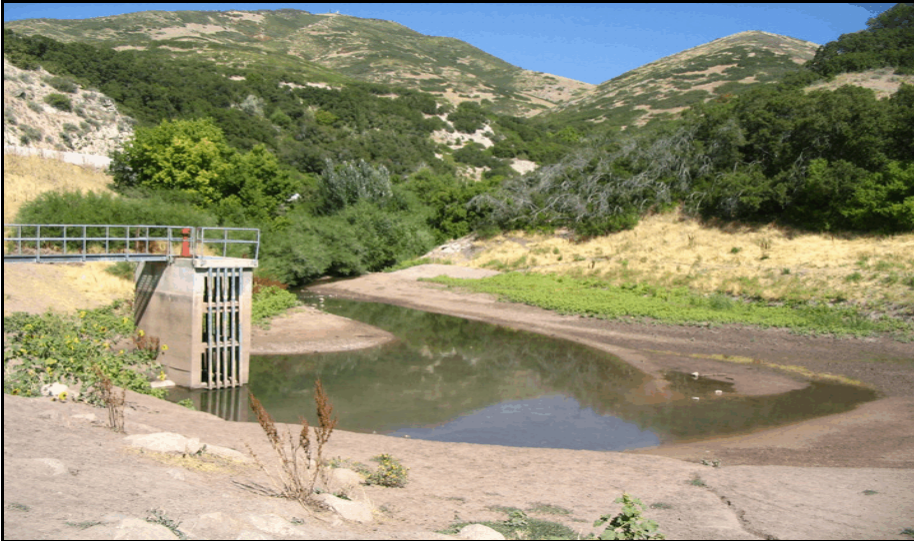
**Below: Emigration Creek debris basin in Rotary Glen Park.**

Emigration Creek, but sediment supply to the lower reaches is altered by the Emigration Creek debris basin, an on-stream facility located in Rotary Glen Park (Figure 2.1). The debris basin was originally constructed in 1985, and it is maintained by the County. The facility traps the

majority of coarse sediment loads and typically requires dredging to remove accumulated material about every 2 years.

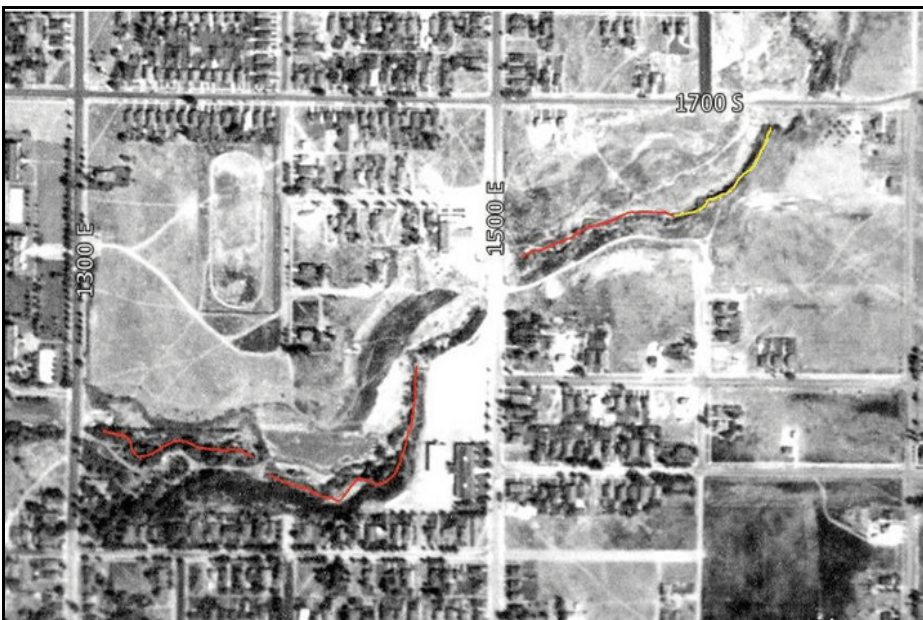
**Figure 3.7.** 1938 aerial photograph of Emigration Creek from 1700 South to 1300 East. The Photograph is overlaid with 2006 channel alignment in red and yellow; gaps in the line indicate underground culverts.

significant change is the increase in length and number of culvert pipes since 1938 (Figures 3.6 and 3.7). The 1938 photo shows a continuous open stream channel between 2100 East and what is now Hogle Zoo (Bowman and Beisner 2008); today this stretch of stream is interrupted by six different culvert crossings. The construction of culvert crossings and piping of portions of Emigration Creek facilitated urban growth but also reduced total channel length, resulting in greater channel slope and higher stream velocities. The culverts have also disrupted the connectivity of the riparian corridor by creating barriers to fish and wildlife migration. In some residential areas along the creek, it appears that tree canopy density has increased since 1938. This is most likely the result of landscaping and tree planting as dense residential neighborhoods were built along the creek. Based on the ages of homes in the corridor, much of the residential development within the RCS study area occurred between about 1940 and 1960.

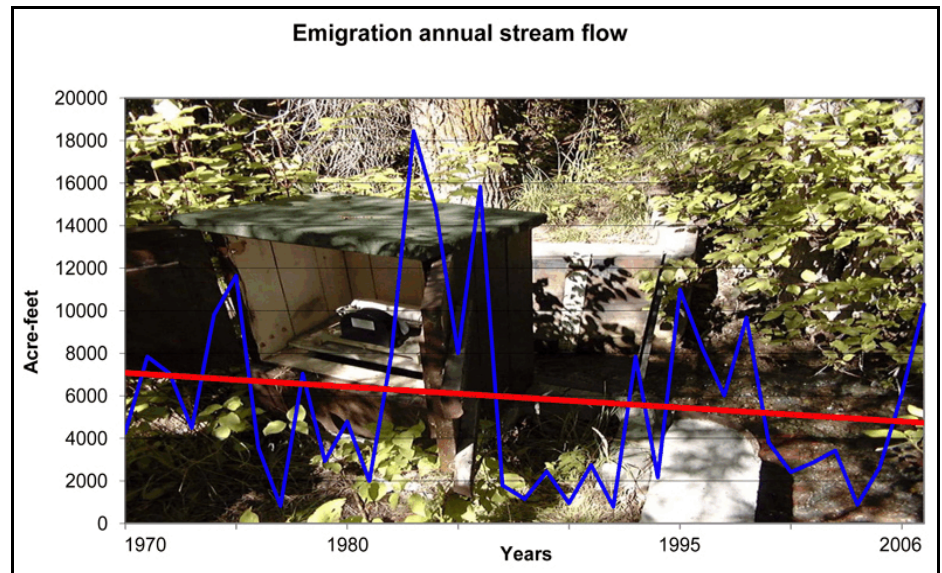
**Figure 3.9.** Plot of temporal trends in annual stream flow at Emigration Creek gage. Plot provided by the Salt Lake City Department of Public Utilities.

Climate change is another factor that can be anticipated to affect the Emigration Creek riparian corridor. Climate projections for the southwest region of the United States show increased temperatures, reduced mountain snowpack, a 10–20% decrease in annual runoff volume, reduced springtime precipitation amounts, and anticipated water supply shortages (Karl et al. 2009). The risk of drought, as well as the risk of flooding, are expected to increase. The changes in temperature will likely result in a shift in vegetation communities, and altered precipitation patterns will influence stream hydrology and channel conditions. The timing of snowmelt runoff is expected to occur earlier in the spring, with an anticipated reduction in summertime baseflows (Karl et al. 2009). It is difficult to predict specific changes to Emigration Creek with certainty, but recorded annual stream flow volumes on Emigration Creek show a declining trend between 1970 and 2006 (L. Alserda 2009, pers. comm., Figure 3.9). This trend is

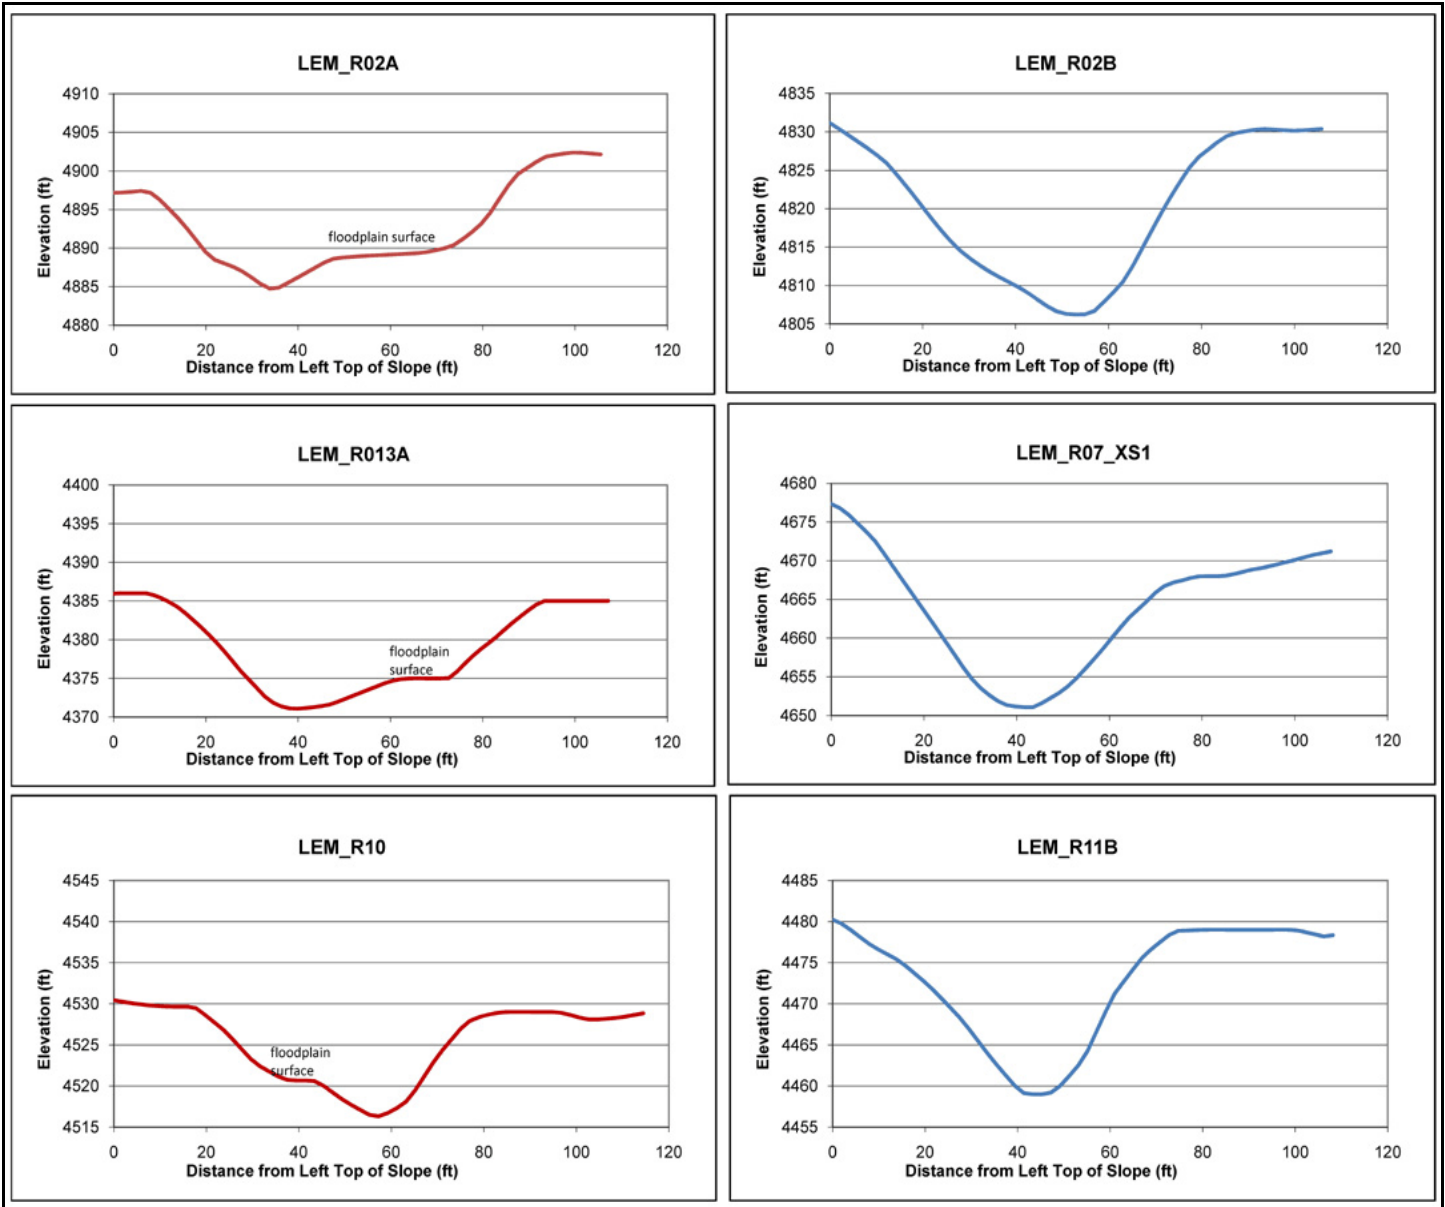
**Figure 3.10. Cross-section plots extrapolated from digital elevation data. Plots on left (in red) exhibit less vertical confinement and include relatively well-developed active floodplain surfaces. Plots on right (in blue) exhibit a greater degree of vertical confinement between tall, steep side slopes.**

“canyon.” The steep side slopes also make access to the creek challenging in many areas. However, the extent of vertical confinement varies, and in some locations the channel shape is wider and includes larger areas of flat, active floodplain surfaces (Figure 3.10). These surfaces are

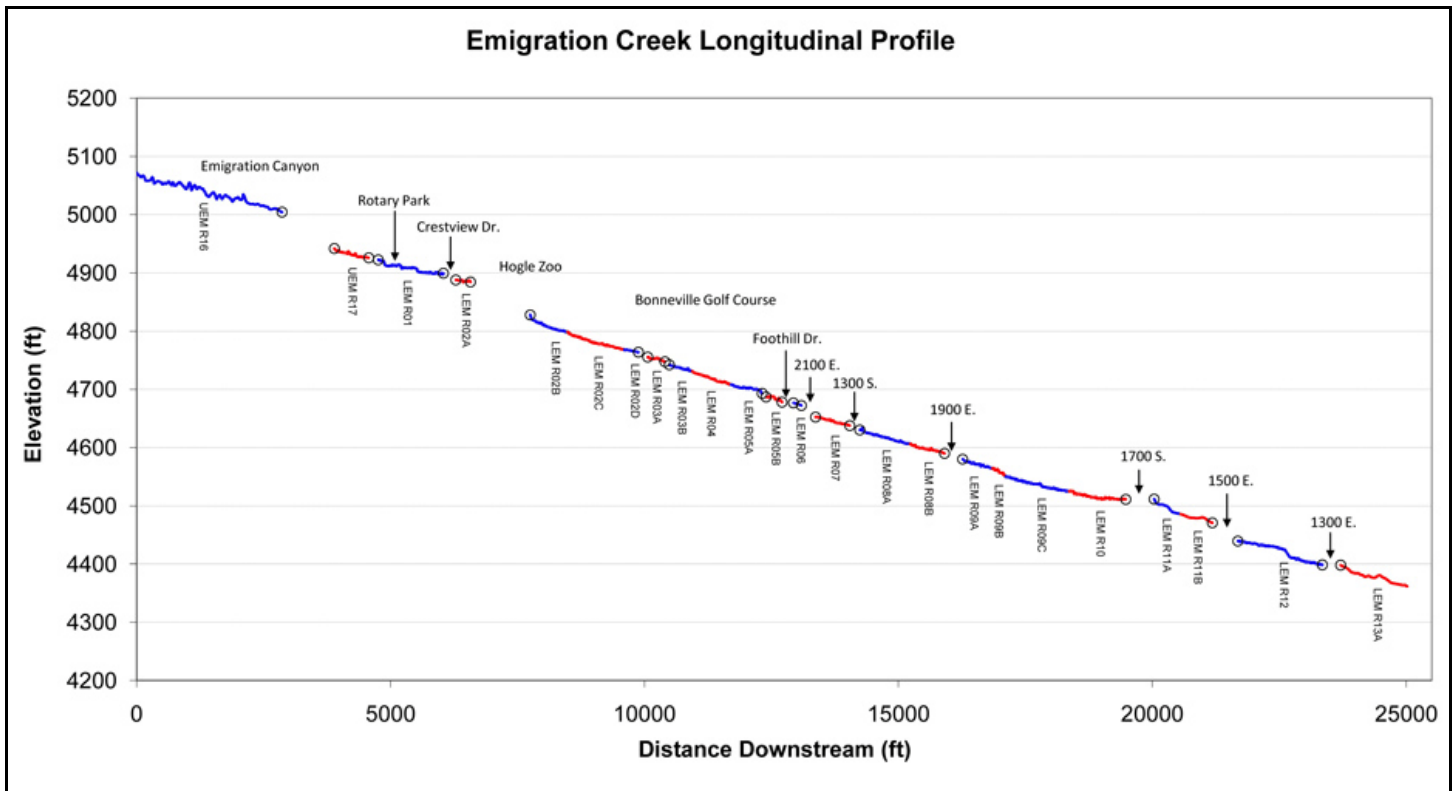
**Figure 3.11. Longitudinal profile plot of Emigration Creek streambed. Circles indicate culvert inlets or outlets; red and blue lines indicate open channel stream sections.**

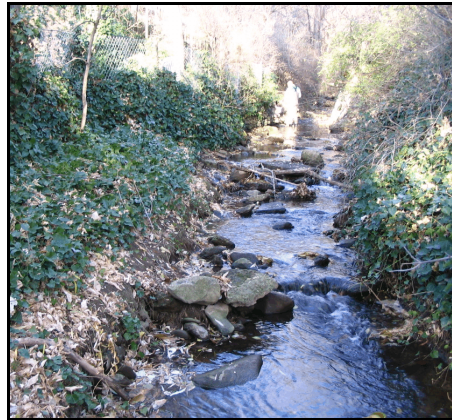
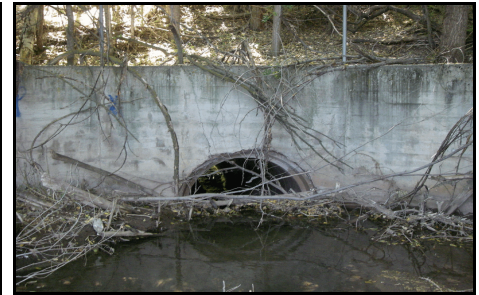
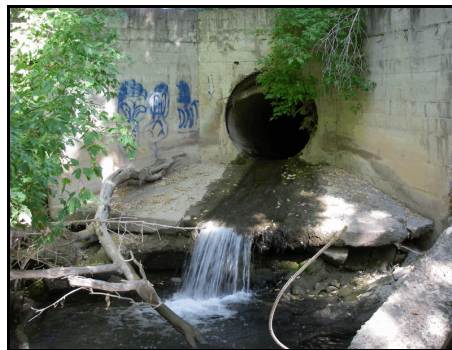
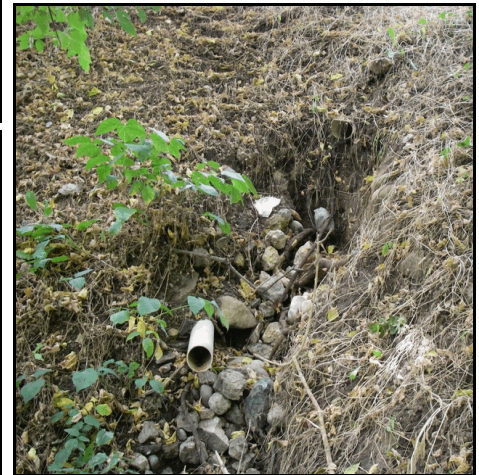
**Top left: Invasive vines on streambank. Top right: Debris and sediment accumulation at culvert inlet. Bottom left: Scour at culvert outlet. Bottom right: Erosion at storm drain outfall.**

blocked by debris and creating a stability and flooding concern. In between maintenance visits, inlets often become partially clogged, creating backwater pools and causing silt to drop out onto the affected streambanks. This silt buries existing plants and limits future vegetation establishment, leaving bare bank areas that are susceptible to erosion during storm events.

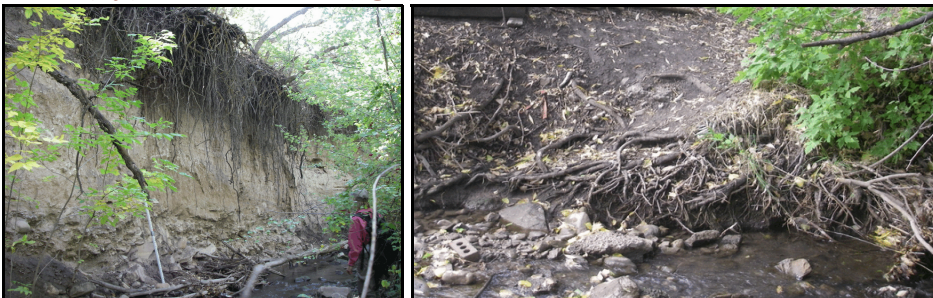
Several types of bank erosion were observed in the study area. Low bank erosion/root zone scour are evident in nearly all study reaches and are associated with the flashy urban hydrology that produces frequent, erosive runoff events during storms. In some areas, it appears that streambed lowering is also contributing to low-bank erosion by causing the toe of the slope to become undermined. In some reaches tall, vertical, bare banks are present where the creek has migrated laterally into a fine-grained Bonneville terrace deposit. This type of terrace erosion at the outside of bends is a natural process, but it is a concern where it poses a risk to infrastructure. Localized bank erosion caused by direct channel alterations is another type of erosion problem observed in the study area. Several RCS workshop attendees described bank erosion problems on their property that began after fill-placement or bank-hardening projects on adjacent properties altered streamflow patterns. This type of problem can occur when bank-stabilization efforts are not implemented comprehensively throughout a reach, because measures taken to fix erosion in one location may alter channel shape and flow hydraulics and inadvertently create erosion in a different location.

**Below: (left) Terrace erosion; (right) Low bank/root zone erosion.**
