2.0 BASELINE ASSESSMENT METHODS

Conditions within the Parleys Creek corridor were assessed between Suicide Rock and Hidden Hollow (Figure 2.1). As discussed previously, the eastern portion of the study area extends beyond the Salt Lake City municipal boundary. This area was included because of City ownership and interests within these portions of the riparian

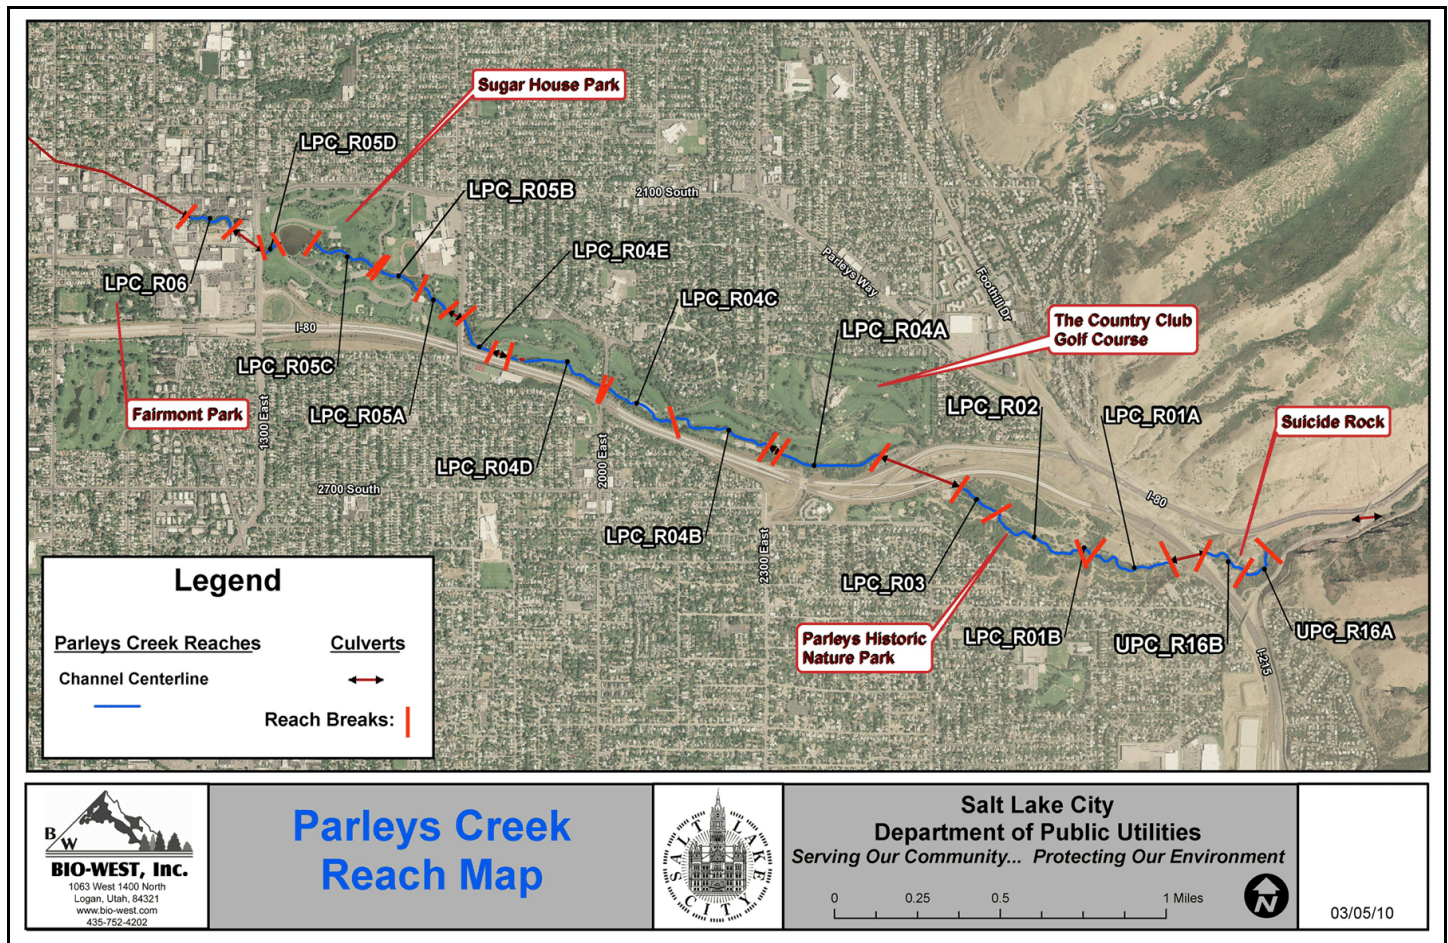
Figure 2.1. Parleys Creek reach map.

subdivided at road crossings or where significant changes in stream conditions occurred. Sixteen study reaches were established within the overall Parleys Creek study area. Reach names and numbers were assigned based on established County watershed abbreviation and stream numbering conventions (SLCO 2009). Parleys Creek includes the upper Parleys (UPC) and lower Parleys (LPC) subwatersheds, with the break occurring at the canyon mouth. Within each subwatershed, reach numbers are assigned consecutively in an upstream to downstream direction, resulting in reach numbers such as LPC_R01 (lower Parleys Creek Reach 1), LPC_R02, etc.

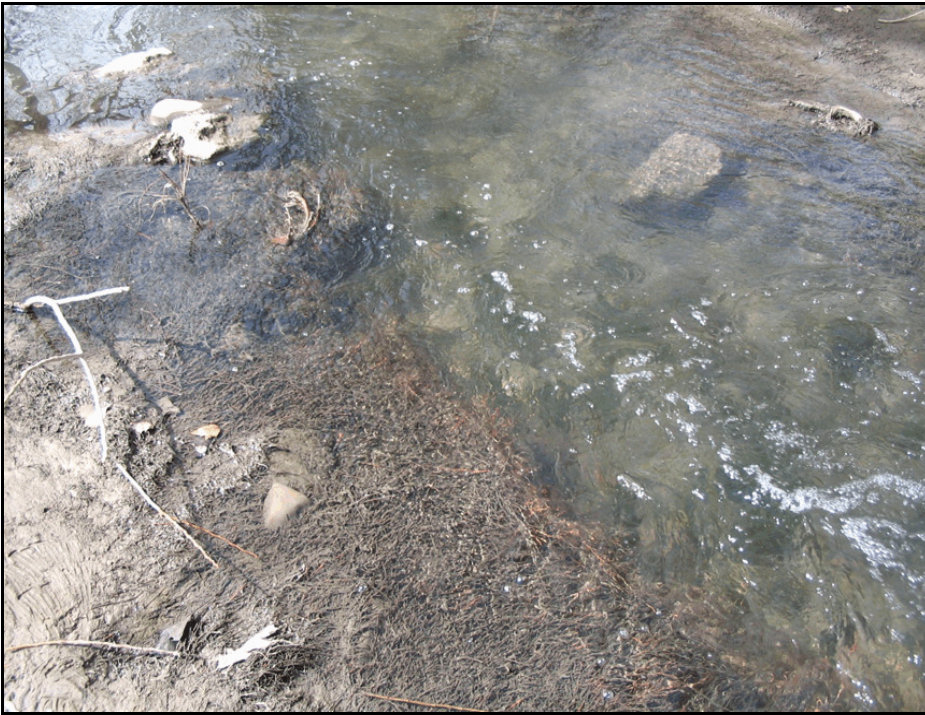
Figure 2.2. Clay/root mat “shelf” feature.

During reconnaissance visits to the creek prior to beginning detailed evaluations, it was noted that the streambed condition in some sections of the creek appears to be influenced by an unusual clay/root-mat feature (Figure 2.2). In these areas fine-grained bed material appears to become tightly bound together with dense, fine roots and moss, creating a smooth, resistant layer that can create a “shelf” within the streambed. This “clay shelf” phenomenon is not well documented in the geomorphic literature and at this time is poorly understood; however, because it can have a significant influence on channel shape and roughness, its presence and extent of influence was noted on the data form for each study reach.

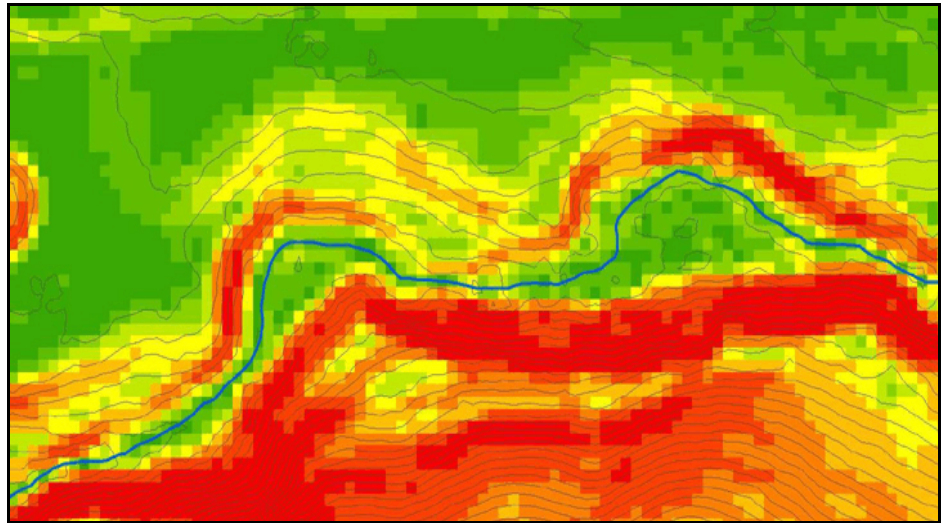
Figure 2.3. Using digital elevation data to draw the channel centerline.

To compliment the data collected in the field, several additional analyses were completed using 2006 LIDAR-based digital-elevation grid data (2-meter resolution) obtained from the City. Using slope and contour maps generated with ArcMap software to identify the low point of the channel, a new channel centerline alignment was digitized for the study area (Figure 2.3). Relative to previously available GIS stream-channel shapefiles, this new centerline file more closely follows the bends of the stream and provides more accurate information on total channel length. Using the profile tool in ArcMap, a longitudinal profile of the channel centerline was extracted and plotted for each reach to determine total reach length and reach-averaged streambed slope. Culvert lengths were also determined, and a comprehensive longitudinal profile plot of the full study area was generated by combining the reach profile and culvert length data.

reaches, the stream is entrenched below the surrounding terrain and it was not practical to field survey the entire upper portions of the slopes. Therefore, these upper-slope sections were extrapolated using the digital-elevation grid data. At each cross-section location in ArcMap, the profile tool was used to draw a line section (typically about 100 feet long) perpendicular to the channel and spanning its entire inset width. Because the accuracy of the GPS-based cross-section position data is only about 10 meters, the expanded portions of the cross-section plots may represent conditions slightly upstream or downstream of the actual field-surveyed cross section and, therefore, should be used only as a general indication of the overall shape and degree
