Hydrology

Water Quality

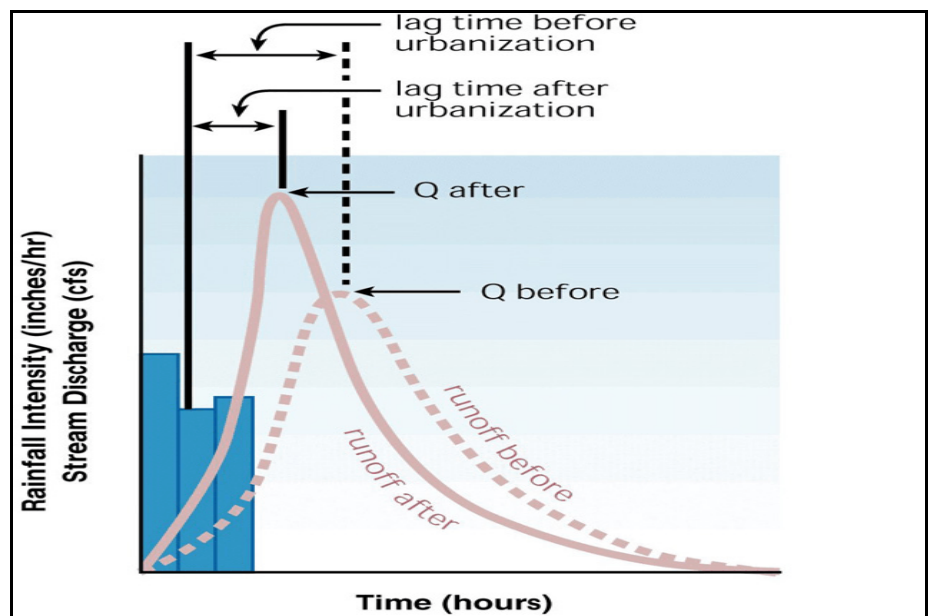
Figure 3.4. A comparison of hydrographs before and after urbanization. The discharge curve is higher and steeper for urban streams than for natural streams. Diagram and caption text from FISRWG 1998.

Urbanization and development throughout the watershed have affected surface water-groundwater patterns. As more of the watershed has been converted to impervious surfaces, a greater proportion of storm water runs off as surface flow rather than infiltrating into the ground, leaving less groundwater available to supply baseflow to the creek during the summer dry period (Figure 3.3). No streamflow gage exists at the downstream end of the study area, so no quantitative data are available to characterize hydrology after the creek flows through the most urbanized portion of watershed downstream from the Suicide Rock gage. However, field observations during storm events suggest that flows in the lower reaches of the creek can be quite “flashy”, with rapid, brief rises in flow during storms. This is a common hydrologic pattern in urbanized systems (Figure 3.4).

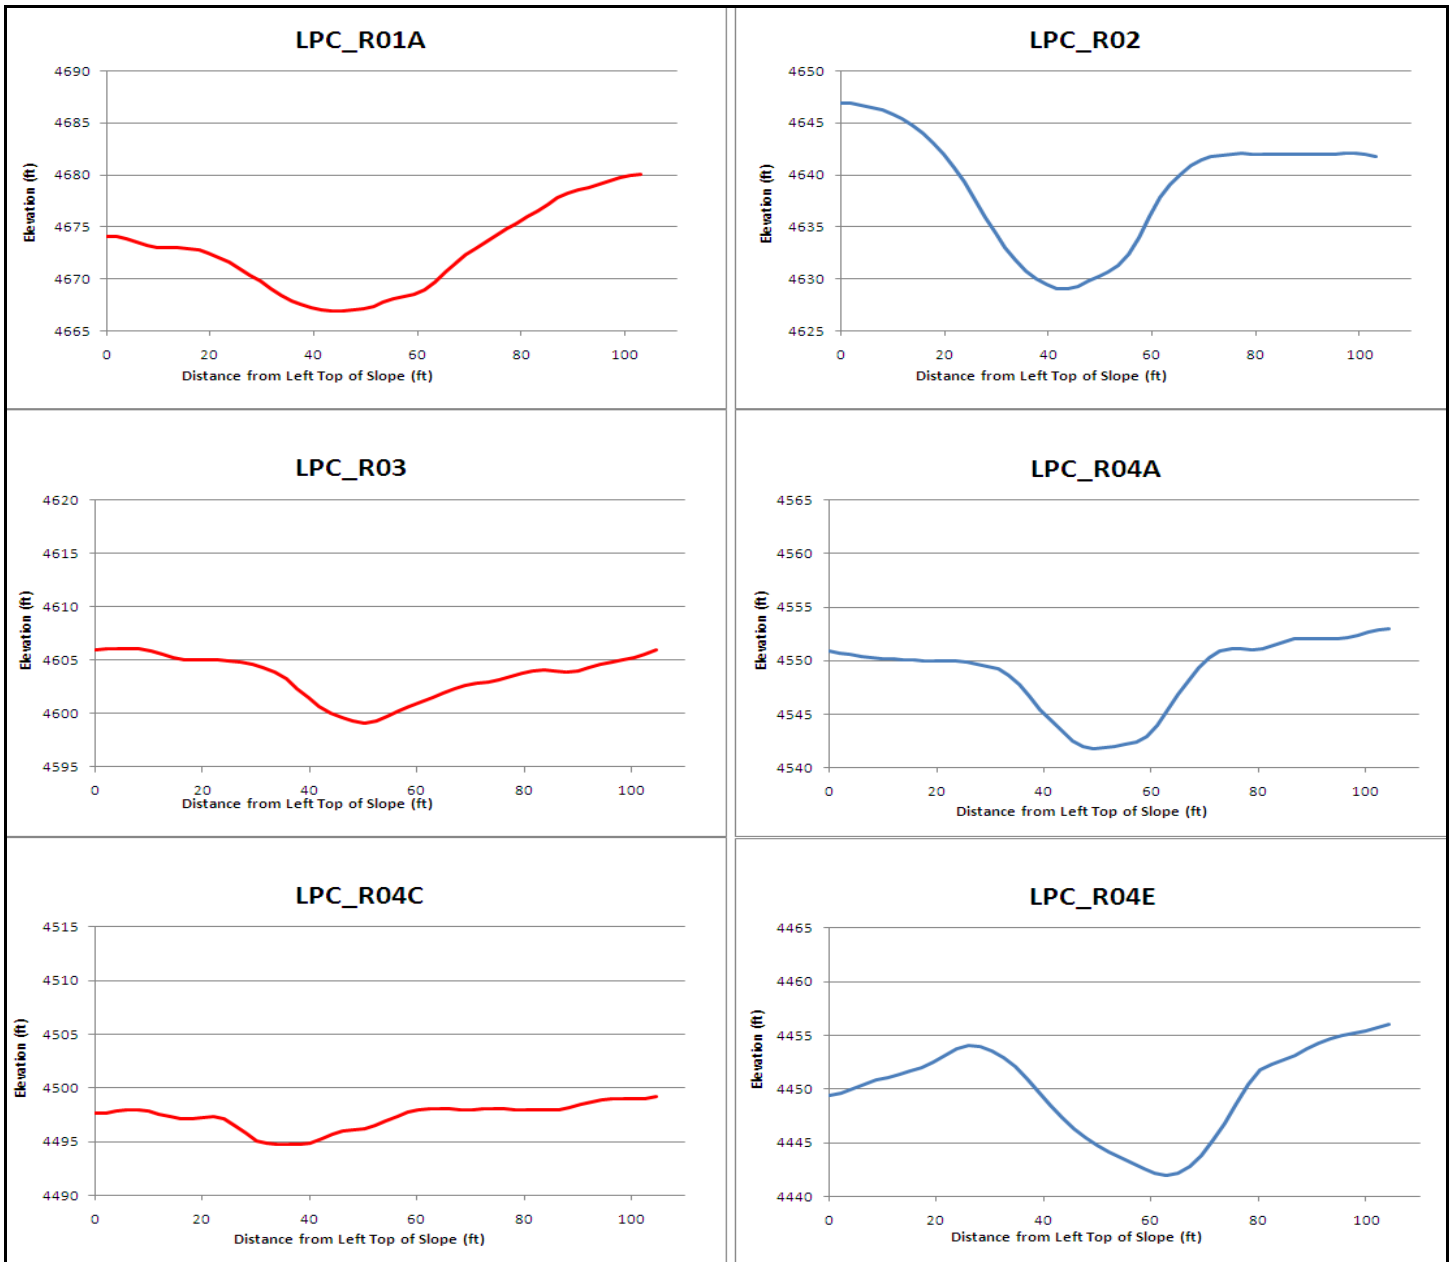
Figure 3.11. Cross-section plots extrapolated from digital elevation data. Plots on left (in red) exhibit less vertical confinement and include relatively well-developed active floodplain surfaces. Plots on right (in blue) exhibit a greater degree of vertical confinement between tall, steep side slopes.

fact that the Parleys Creek channel is moderately entrenched and in some areas inset between tall, steep slopes (Figure 3.11). However, the extent of vertical confinement

varies, and in some locations the channel shape is wider and includes broader, flatter bank and floodplain surfaces (Figure 3.11). These areas are important because they allow water to

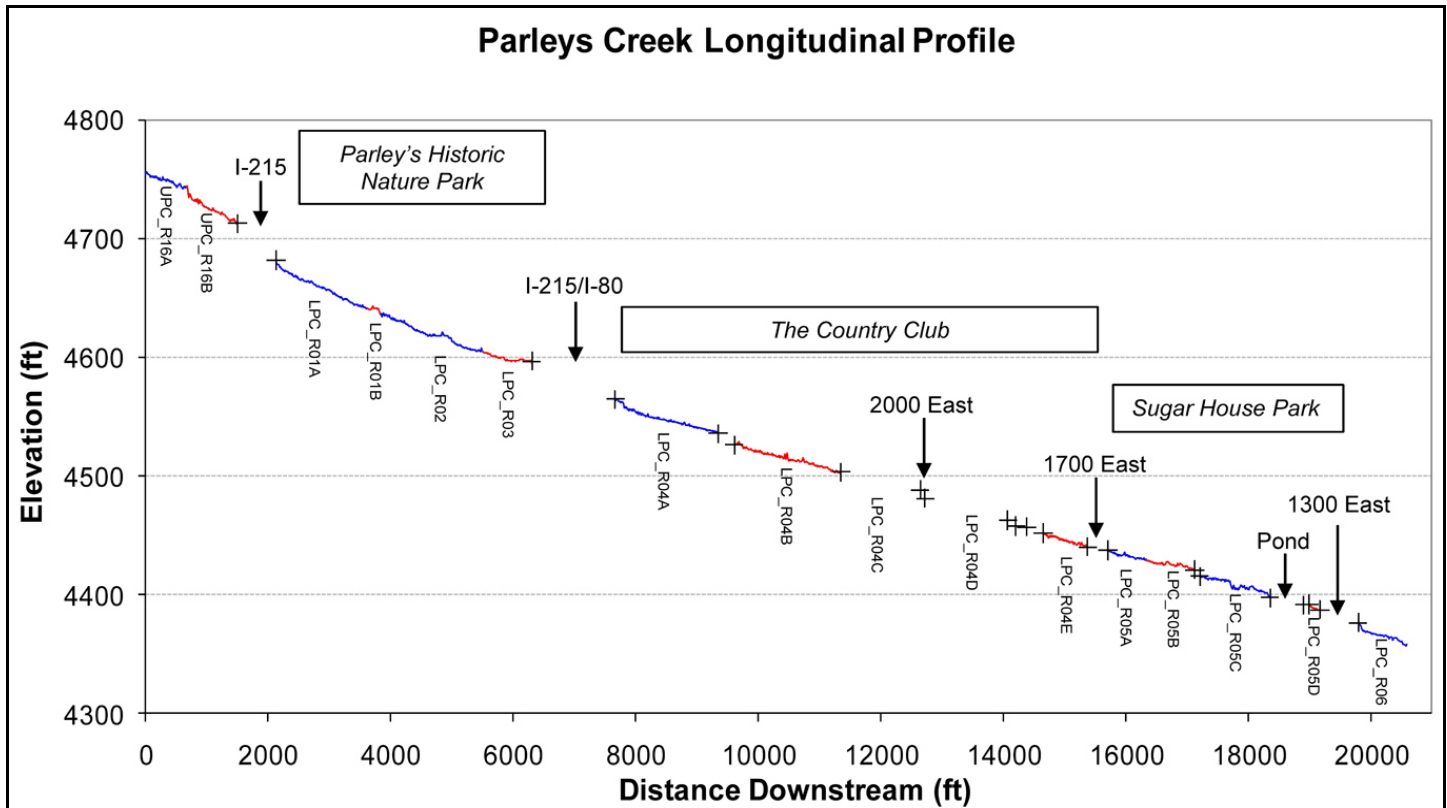
Figure 3.12. Longitudinal profile plot of Parleys Creek streambed based on 2006 digital elevation data. Black cross marks indicate culvert inlets and outlets; red and blue lines indicate open channel stream sections. Data are not shown for reaches LPC_R04C or LPC_R04D because they have been altered by post-2006 channel modifications.

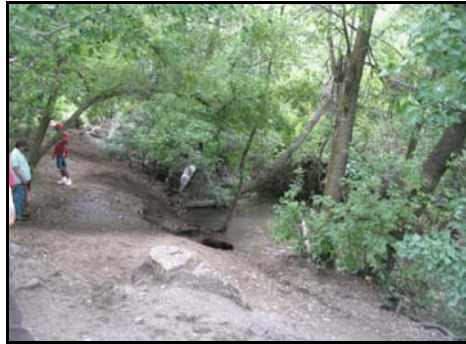
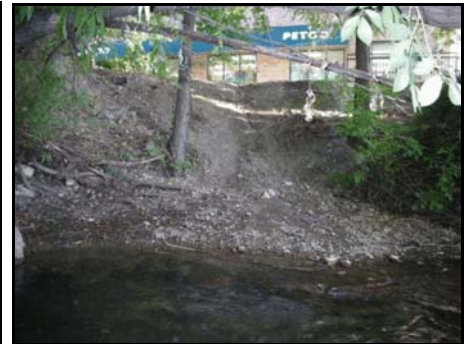
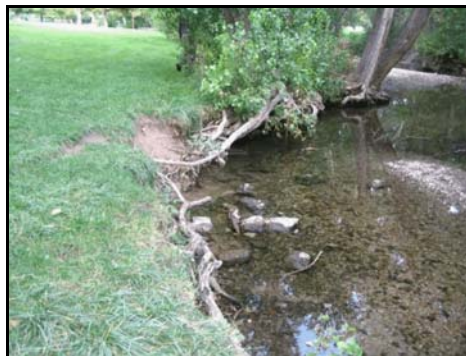
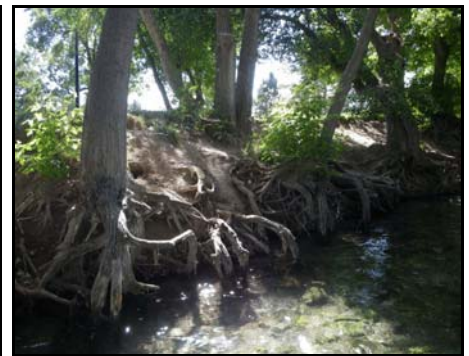
Top left: Soil compaction from heavy foot traffic in Parleys Park. Top right: Unprotected fill slope in Hidden Hollow. Bottom left: Bank scalloping from lack of woody riparian vegetation in Sugar House Park. Bottom right: Low bank/root zone erosion in Sugar House Park.

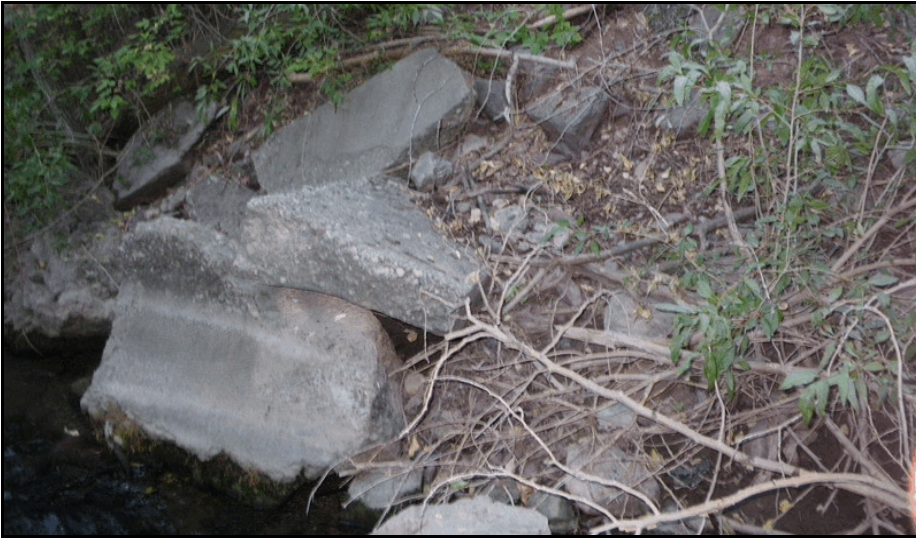
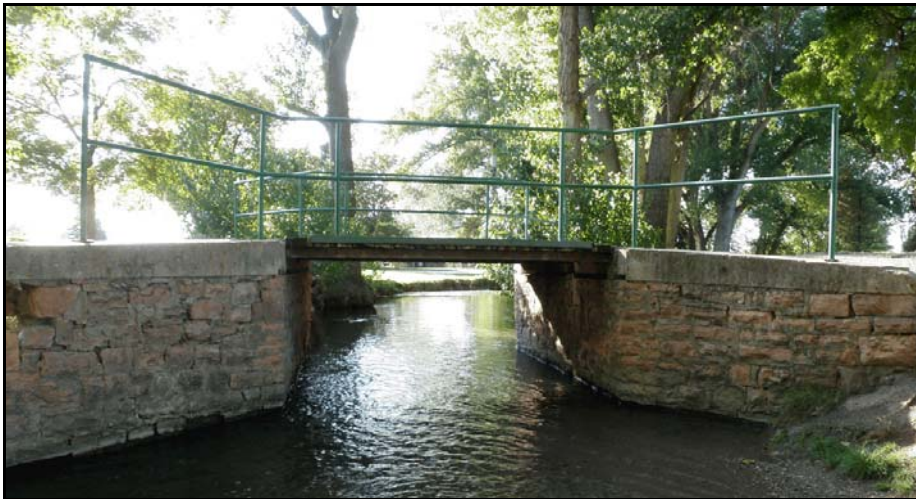
Several types of bank erosion were observed in the study area. Low bank erosion/root zone scour is particularly evident in the

downstream half of the study area below reach LPC_R04B. This type of erosion is associated with high impervious cover and the resulting flashy urban hydrology that produces frequent, erosive runoff events during storms. In some areas, it appears that streambed lowering may also be contributing to low bank erosion by causing the toe of the slope to become undermined. In some reaches, tall, vertical bare banks are present where the creek has migrated laterally into historic or more recent fill material. Bank “scallop” is another type of erosion observed in the Parleys Creek corridor; this type of erosion involves the development of widened sections of bank where woody shrubs or trees are lacking, and is common in park areas where grass is mowed to the edge of the streambank.
