## 3.0 BASELINE ASSESSMENT RESULTS

### Watershed Conditions

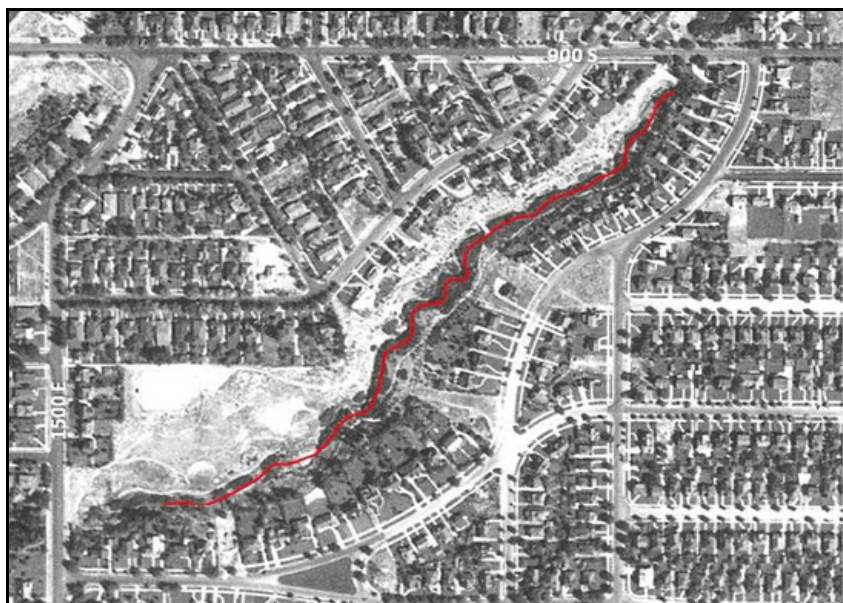
**Figure 3.7.** 1938 aerial photograph of Red Butte Creek from 900 South to 1500 East. Photograph is overlaid with 2006 channel alignment in red; gaps in line indicate underground culverts.

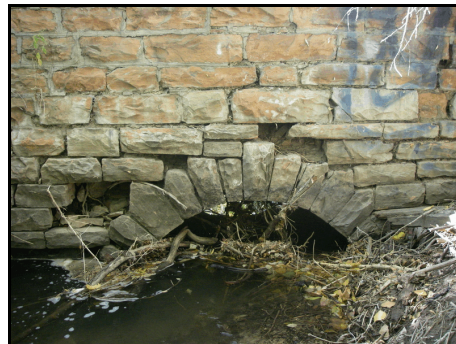
Localized erosion and deposition problems were noted at several of the stream crossing culverts within the study area. Most of the culverts have diameters of 3 to 7 feet (Table 3.5), which is significantly smaller than the 13-foot average bankfull channel width. Because of this width discrepancy, a hydraulic constriction occurs at culvert inlets, slowing flow velocities and leading to deposition and accumulation of sediment and debris. At three crossings within the study area, the size of the openings at the culvert inlets and the conveyance capacities of the structures have been substantially reduced as a result of this deposition process. During RCS public workshops and stakeholder meetings, no one reported experiencing any flooding problems on Red Butte Creek since the 1983 floods; however, problems may occur in the future unless measures are taken to restore the conveyance capacities of these crossing structures.

**Top left: Debris and sediment accumulation at culvert inlet. Top right: Erosion at storm drain outfall. Bottom left: Invasive vines on streambank. Bottom right: Scour at culvert outlet.**

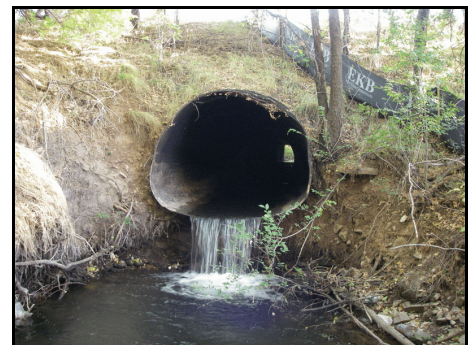
the longer culverts are accelerated because of width constriction and a lack of bed roughness within the smooth concrete pipe material. Scour problems and vertical drops were noted at three of the assessed crossing outlets within the study area (Table 3.5).

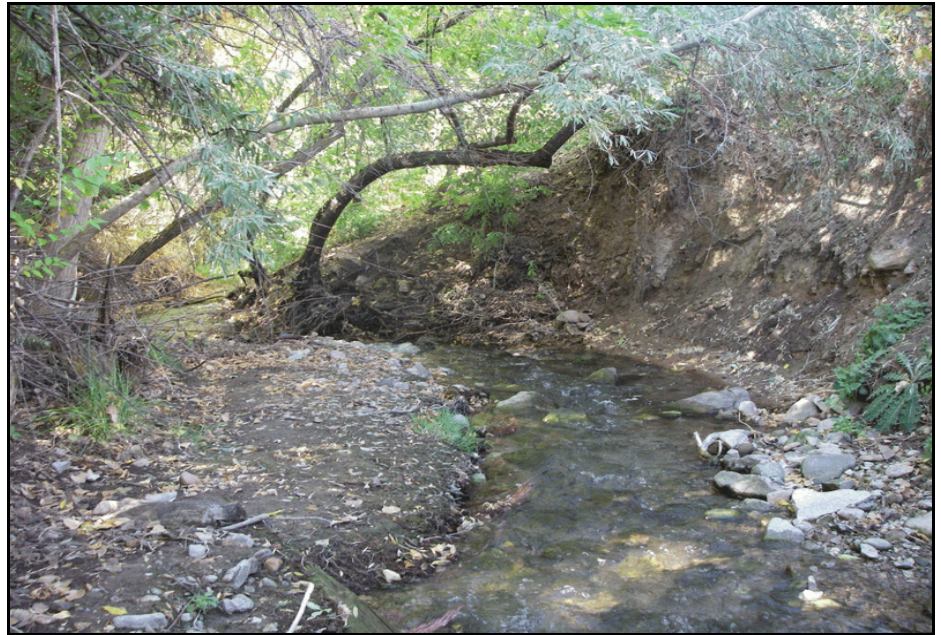
Several types of bank erosion were observed in the study area. Low bank erosion/root zone scour are evident in nearly all study reaches and are associated with the flashy urban hydrology that produces frequent, erosive runoff events during storms. In some areas, it appears that streambed lowering is also contributing to low bank erosion by causing the toe of the slope to become undermined. In some reaches tall, vertical, bare banks are present where the creek has migrated laterally into a fine-grained Bonneville terrace deposit. This type of terrace erosion at the outside of bends is a natural process, but it is a concern where it poses a risk to infrastructure. Localized bank erosion caused by direct channel alterations is another type of

**Top: Terrace erosion at outside of bend. Bottom: Low bank/root zone erosion.**
