Public
Utilities

City Property Water Use Efficiency EXECUTIVE REPORT

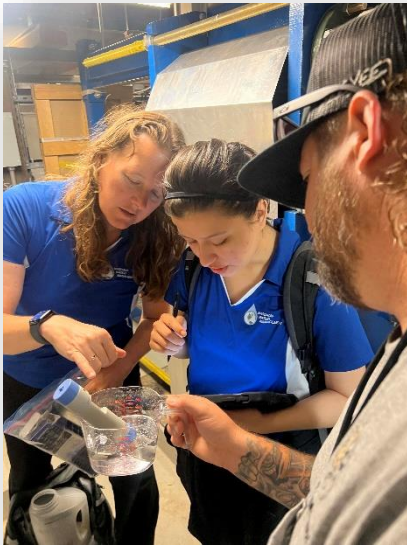
MWM and Facilities Staff measure water quality for a cooling tower.

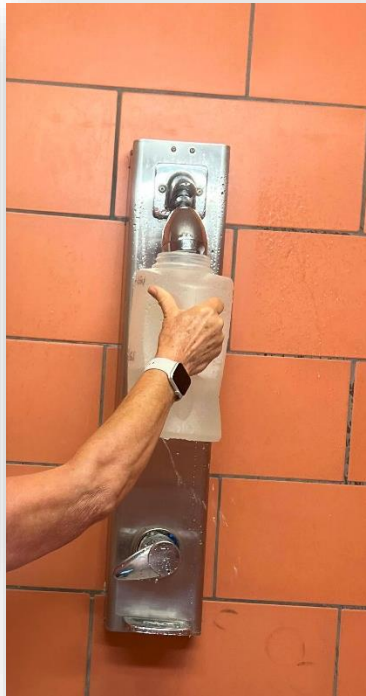
City staff measuring flow rate of shower at Salt Lake City Sports Complex.

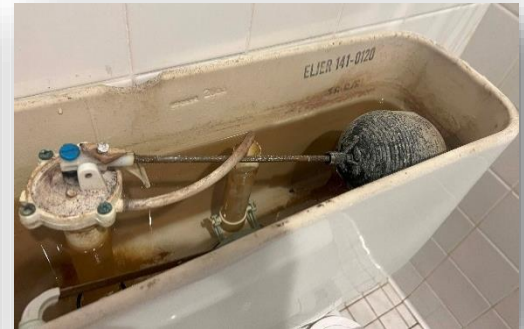
Checking the refill and overflow tubes in toilet tanks for proper settings.

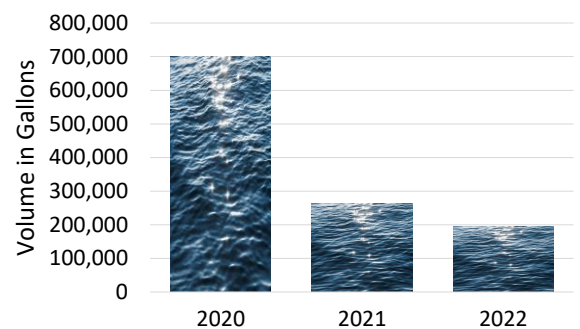
Figure 7 Concord Lift Station Annual Water Use

A comparison of water use data, and pre-and post-transformation Water Check and WaterMAPS™ assessments of Concord LS demonstrate measurable, sustainable water savings and supports continued efforts to identify other SLCDPU and City properties for similar landscape transformation opportunities.

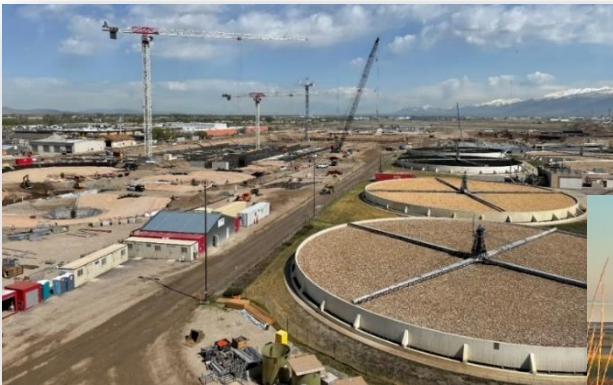
Construction continues at the SLC Water Reclamation Facility.

The new WRF will replace the majority of the existing facility and is one of the largest infrastructure improvements in the history of the City, second only to the expansion of the airport. The WRF is being designed and built as an exemplary facility with advanced treatment of wastewater, a focus on sustainability, thoughtful investment of rate payers' money, public involvement, and inclusion of educational elements to better accommodate the tours provided to school children and the public each year. Traditional culinary uses in bathrooms, kitchen and showers will be designed to optimize efficiency, and the addition of submetering of culinary water lines will ensure timely monitoring and management.

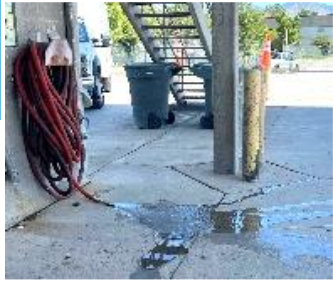
Large vehicle wash station

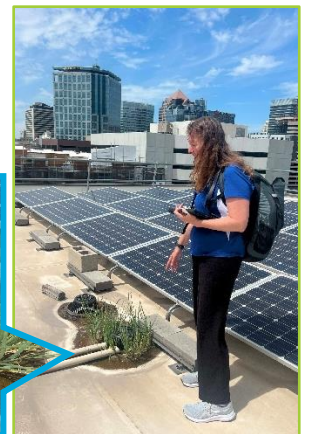
Cooling tower leak at the Main Library.

Multiple City properties use cooling towers, especially through the summer months. Issues in cooling towers can result in large levels of water loss that are not often apparent because few people have access to the area and the large, complicated, machinery requires extra training to understand and repair. Leaking or potentially problematic cooling towers were found at Fleet (where staff rely on 7 makeup air units, 3 indirect evaporative cooling units, and 10 large portable evaporative coolers), the Main Library (where the cooling tower is slated for replacement in winter 2023/24), Plaza 349 (where continued water indicative of a leak is shown at right), and the Public Safety Building. The Public Safety Building had a leak in the overflow pipe (above) that reportedly “could have been leaking at least a year.”

When measured, the leak was 1.875 gallons per minute. At this rate this leak accounted for nearly **ONE MILLION GALLONS per year.**

MWM staff inspecting cooling tower at SLC Public Safety Building (with close-up).

MWM recommends a comprehensive assessment of City operated cooling towers with regular maintenance, leak repair, and a capital replacement program for those that are not operating at peak efficiency for the intended use.

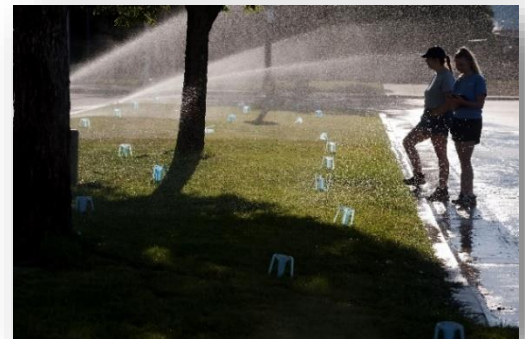
USU-CWEL conducting a Water Check at the SLC Sports Complex.
