# HISTORIC LANDMARK COMMISSION STAFF REPORT

Drayton Condominiums  
Major Alterations  
PLNHLC2011-00112  
1121 E. First Avenue  
April 6, 2011

# THE DRAYTON CONDOMINIUM PROJECT

WINDOW  
CONDITION  
SUMMARY

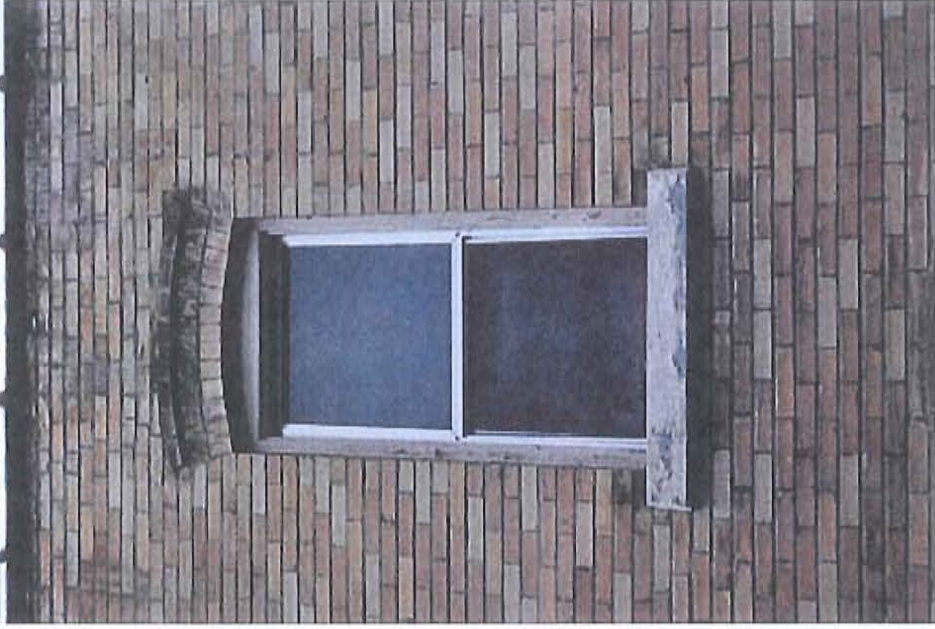
11 LEVEL 02-WEST	REPLACE UNIT W/ SIERRA PACIFIC CLAD DOUBLE HUNG	NO COUNTER WEIGHT	34
	12 LEVEL 02-WEST	REPLACE UNIT W/ SIERRA PACIFIC CLAD DOUBLE HUNG	PAINTED SHUT, NO COUNTER WEIGHT	35
	13 LEVEL 02-WEST	REPLACE UNIT W/ SIERRA PACIFIC CLAD DOUBLE HUNG	NO COUNTER WEIGHT, WOOD DETERIORATION	36, 79
	14 LEVEL 02-WEST	REPLACE UNIT W/ SIERRA PACIFIC CLAD DOUBLE HUNG	FRAME DETERIORATION	37, 80
	15 LEVEL 02-COURTYARD EAST	REPLACE UNIT W/ SIERRA PACIFIC CLAD DOUBLE HUNG	FIXED SHUT, BROKEN FRAME & GLAZING	40, 81
	16 LEVEL 02-COURTYARD EAST	REPLACE UNIT W/ SIERRA PACIFIC CLAD DOUBLE HUNG	WOOD DETERIORATION	41, 82
	17 LEVEL 02-COURTYARD WEST	REPLACE UNIT W/ SIERRA PACIFIC CLAD DOUBLE HUNG	VINYL WINDOW-NOT ORIGINAL	42, 83
	18 LEVEL 02-COURTYARD WEST	REPLACE UNIT W/ SIERRA PACIFIC CLAD DOUBLE HUNG	NO COUNTER WEIGHT	43, 84
LEVEL 03	NUMBER/LEVEL/ELEVATION	CONSTRUCTION INTENT	CONDITION	IMAGE APPENDIX-NUMBER
	01 LEVEL 03-EAST	REPLACE UNIT W/ SIERRA PACIFIC CLAD DOUBLE HUNG	ALUMINUM-NOT ORIGINAL	44

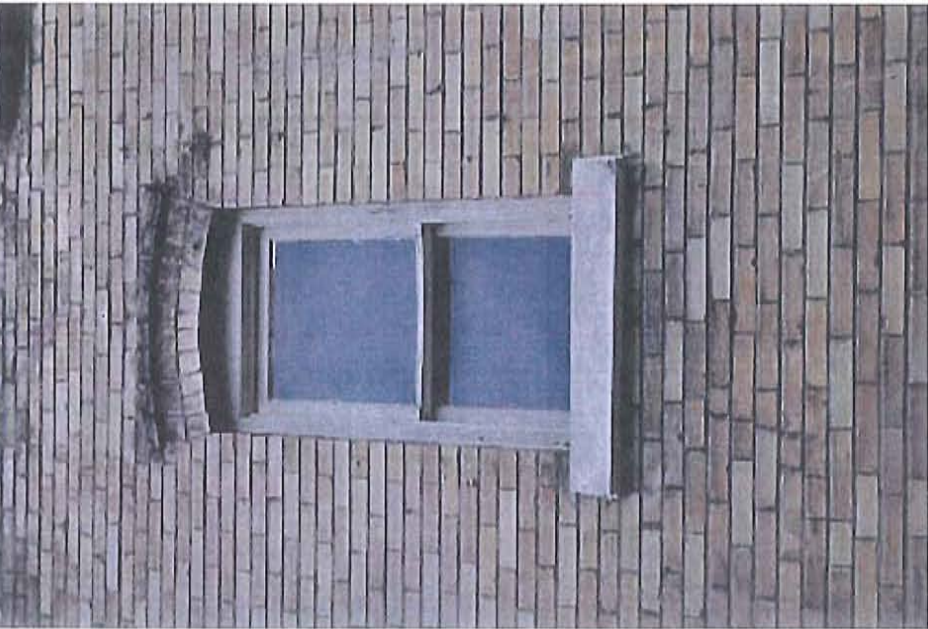
45

02 LEVEL 03-EAST	REPLACE UNIT W/ SIERRA PACIFIC CLAD DOUBLE HUNG	PAINTED SHUT	45, 61
	03 LEVEL 03-EAST	REPLACE UNIT W/ SIERRA PACIFIC CLAD DOUBLE HUNG	NO COUNTER WEIGHT	46, 63
	04 LEVEL 03-EAST	REPLACE UNIT W/ SIERRA PACIFIC CLAD DOUBLE HUNG	NO COUNTER WEIGHT	46, 62, 63
	05 LEVEL 03-SOUTH	RETAIN AND REPAIR	COUNTER WEIGHT, PAINT & GLAZING PUTTY TO BE REPAIRED	47, 64
	06 LEVEL 03-SOUTH	RETAIN AND REPAIR	COUNTER WEIGHT, PAINT & GLAZING PUTTY TO BE REPAIRED	47, 65
	07 LEVEL 03-SOUTH	RETAIN AND REPAIR	COUNTER WEIGHT, PAINT & GLAZING PUTTY TO BE REPAIRED	47, 66
	08 LEVEL 03-SOUTH	REPLACE UNIT W/ SIERRA PACIFIC CLAD DOUBLE HUNG	ALUMINUM-NOT ORIGINAL	48
	09 LEVEL 03-SOUTH	RETAIN AND REPAIR	COUNTER WEIGHT, PAINT & GLAZING PUTTY TO BE REPAIRED	48, 67
	10 LEVEL 03-SOUTH	REPLACE UNIT W/ SIERRA PACIFIC CLAD DOUBLE HUNG	ALUMINUM-NOT ORIGINAL	48
	11 LEVEL 03-WEST	REPLACE UNIT W/ SIERRA PACIFIC CLAD DOUBLE HUNG	PAINTED SHUT, NO COUNTER WEIGHT	49, 68

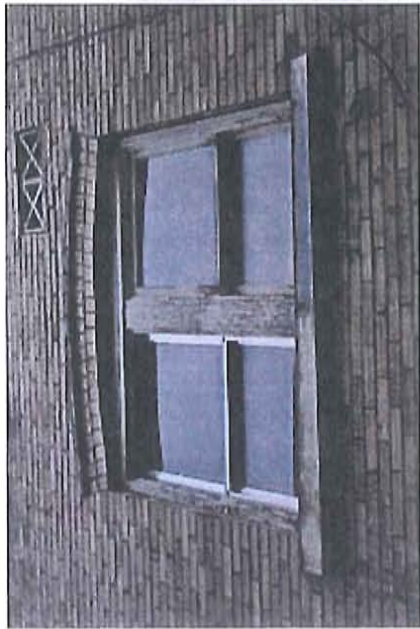
12 LEVEL 03-WEST	REPLACE UNIT W/ SIERRA PACIFIC CLAD DOUBLE HUNG	ALUMINUM-NOT ORIGINAL	49
	13 LEVEL 03-WEST	REPLACE UNIT W/ SIERRA PACIFIC CLAD DOUBLE HUNG	PAINTED SHUT	50, 69

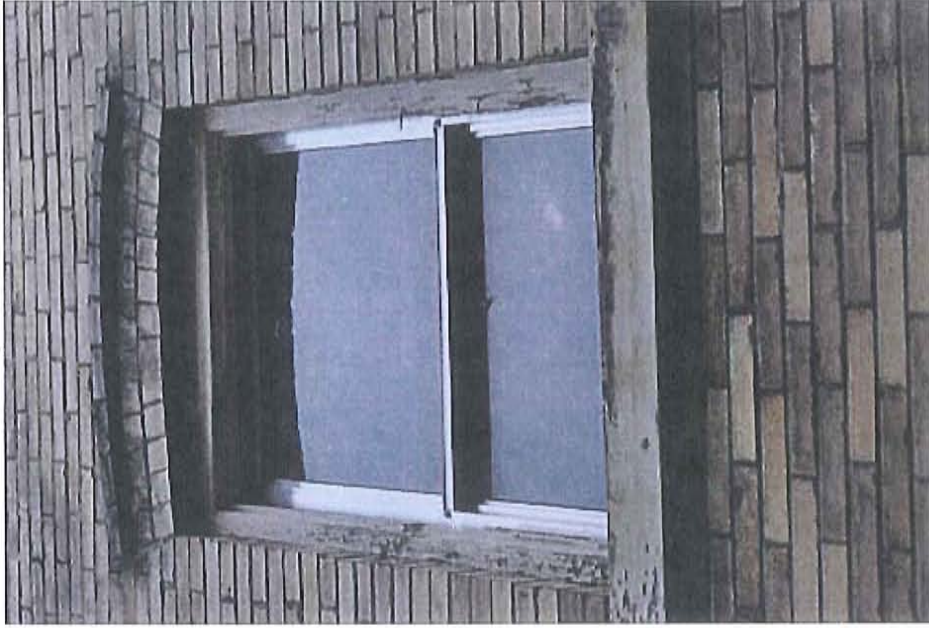
51

14 LEVEL 03-WEST	REPLACE UNIT W/ SIERRA PACIFIC CLAD DOUBLE HUNG	ALUMINUM-NOT ORIGINAL	51, 70
15 LEVEL 03-COURTYARD EAST	REPLACE UNIT W/ SIERRA PACIFIC CLAD DOUBLE HUNG	VINYL-NOT ORIGINAL	56
16 LEVEL 03-COURTYARD EAST	REPLACE UNIT W/ SIERRA PACIFIC CLAD DOUBLE HUNG	NO COUNTER WEIGHT	57
17 LEVEL 03-COURTYARD WEST	REPLACE UNIT W/ SIERRA PACIFIC CLAD DOUBLE HUNG	NO COUNTER WEIGHT, WOOD DECAY	58
18 LEVEL 03-COURTYARD WEST	REPLACE UNIT W/ SIERRA PACIFIC CLAD DOUBLE HUNG	ALUMINUM-NOT ORIGINAL	59, 60

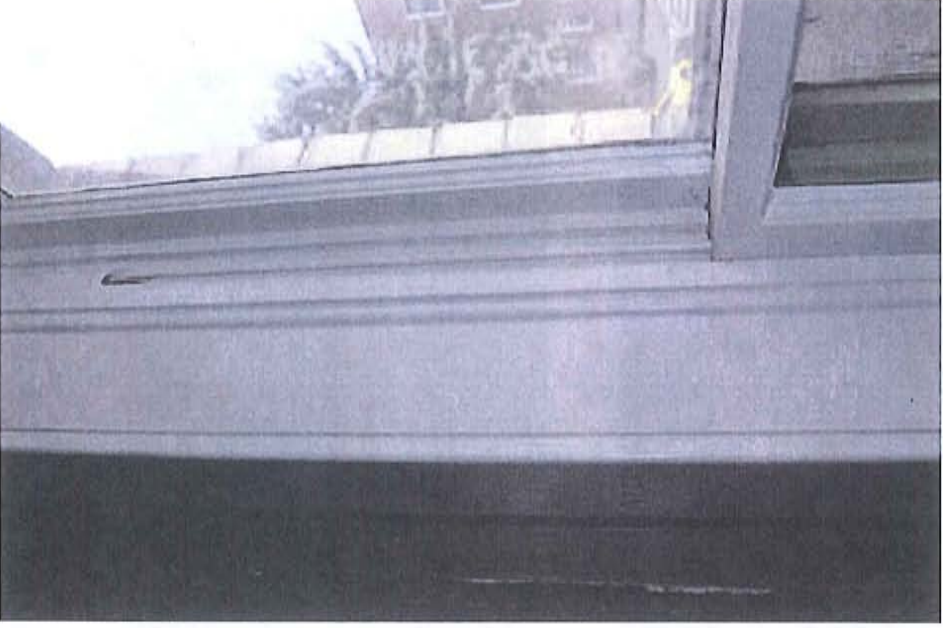
01 LEVEL 02-EAST	REPLACE UNIT W/ SIERRA PACIFIC CLAD DOUBLE HUNG	PAINTED SHUT, NO COUNTER WEIGHT	24, 71
	02 LEVEL 02-EAST	REPLACE UNIT W/ SIERRA PACIFIC CLAD DOUBLE HUNG	PAINTED SHUT	25, 72
	03 LEVEL 02-EAST	REPLACE UNIT W/ SIERRA PACIFIC CLAD DOUBLE HUNG	PAINTED SHUT, NO COUNTER WEIGHT	26, 73
	04 LEVEL 02-EAST	REPLACE UNIT W/ SIERRA PACIFIC CLAD DOUBLE HUNG	PAINTED SHUT, NO COUNTER WEIGHT, WOOD DETERIORATION	27, 74
	05 LEVEL 02-SOUTH	RETAIN AND REPAIR	COUNTER WEIGHT, PAINT & GLAZING PUTTY TO BE REPAIRED	28, 75
	06 LEVEL 02-SOUTH	RETAIN AND REPAIR	COUNTER WEIGHT, PAINT & GLAZING PUTTY TO BE REPAIRED	29
	07 LEVEL 02-SOUTH	RETAIN AND REPAIR	COUNTER WEIGHT, PAINT & GLAZING PUTTY TO BE REPAIRED	30
	08 LEVEL 02-SOUTH	RETAIN AND REPAIR	COUNTER WEIGHT, PAINT & GLAZING PUTTY TO BE REPAIRED	31, 76
	09 LEVEL 02-SOUTH	RETAIN AND REPAIR	COUNTER WEIGHT, PAINT & GLAZING PUTTY TO BE REPAIRED	32, 77
	10 LEVEL 02-SOUTH	RETAIN AND REPAIR	COUNTER WEIGHT, PAINT & GLAZING PUTTY TO BE REPAIRED	33, 78
