Salt Lake City Historic Landmarks Commission
451 S. State St.
Salt Lake City, UT 84111

MEMORIAL HOUSE SUSTAINABILITY PLAN

90% DRAFT

SEPTEMBER 26, 2012

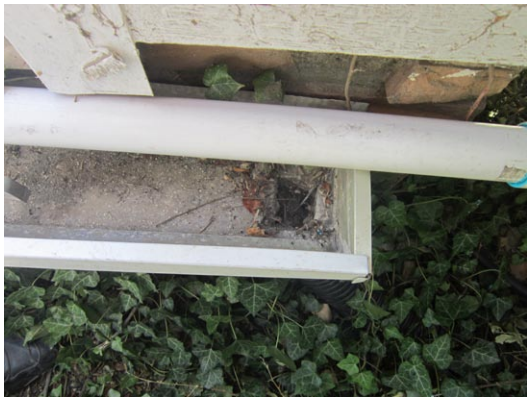
The Main Hall roof drains out of a gutter onto this low sloped roof and is directed to the west edge. There are flexible pipes directing the water into the landscaping. A concrete gutter has been constructed to capture the water from the roof and direct it to the south to the end of the building. The larger issue, though, is that the gutter is consistently filled with weeds, trash, dirt, and general debris and the water is not effectively directed away from the stone retaining wall below. Based on visual observation, it appears there is some puddling that occurs in these areas and likely the water

seeps below grade, affecting the integrity of the wall below. The wall is experiencing serious structural integrity issues, which are discussed further in the following section.

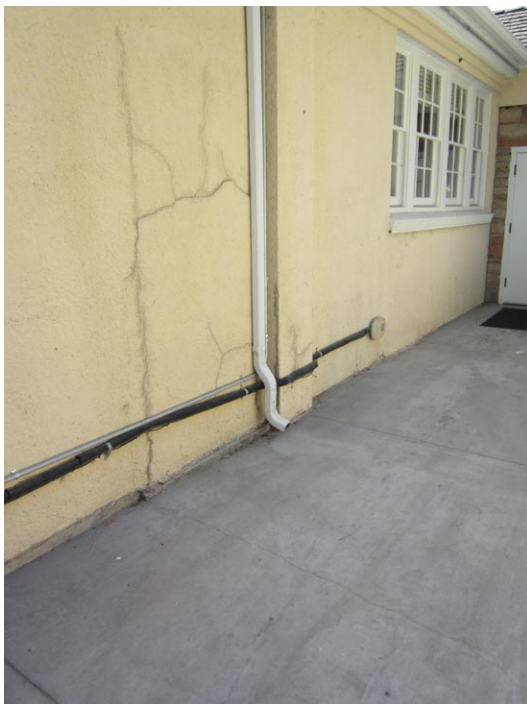
The two-story section is comprised of a painted, stucco-covered brick masonry exterior. The stucco is generally in good condition, with a few areas of cracking. The condition of the mortar and underlying masonry is unknown, due to the stucco. The exterior walls of the main structure do not have any insulation. The relatively thick wall assembly consists of a masonry core with stucco on the outside and a heavy coat of plaster on the inside. Having a high masonry content, the assembly is, thus, an effective thermal mass and acts as one of the components in the passive heating/cooling system of the building.

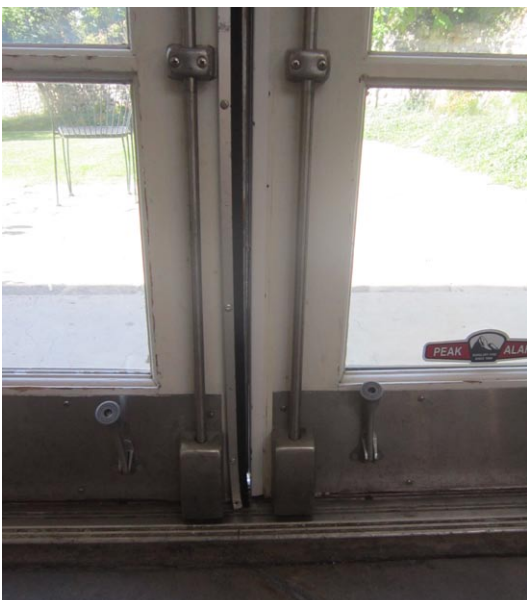
Seven pairs of French doors comprise the remainder of the windows in the main event hall. Three sets lead to the garden room addition to the west and four sets lead to the patio on the east side of the building. Each of the doors contains 2x5 divided lights. The glass is single paned.

Three single wood doors with divided lights on the upper portion have been installed where French doors were previously located. One door is on the east wall, leading to the patio. The other two are on each end of the west wall leading to the garden room.

While all the doors are far from air tight, the newer doors actually have the largest gaps around their edges.

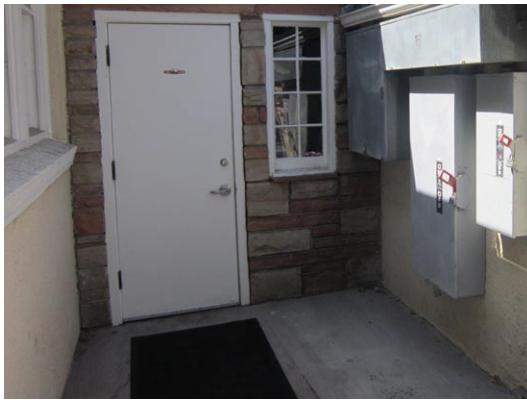
2 x 8 divided lights. The glass is one single pane, with exterior applied muntins. One section of the muntins is missing on the interior of the window. The glass is single-pane.

No door is located in the opening between the kitchen and mudroom. The mudroom has an exterior door that is solid wood, with no window. Some gaps occur along the top, side, and bottom of the opening edge, with the most noticeable gap along the top where an alarm fixture has been installed. The door is in need of paint and the closure bar is currently not connected/operable. This door is used for transporting tables and chairs into the Main Hall for catered events, thus needs to stay open often.

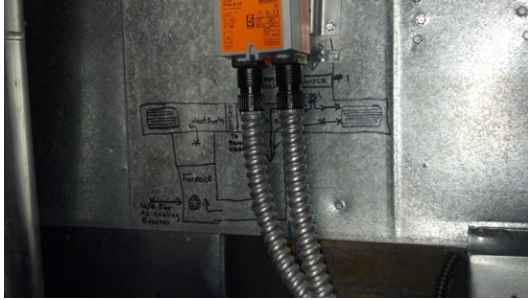
Air flow diagram for Garden Room Coolerado unit and furnace
