HISTORIC LANDMARK COMMISSION STAFF REPORT

1120 E 400 S Major Alterations PLNHLC2014-00884 University Historic District 1120 E 400 South January 15, 2014

This is a request by Andrew Nielson for major alterations to the property located at approximately 1120 E. 400 South, in the University Historic District, and within the R-2 (Single and Two Family Residential) zoning district.

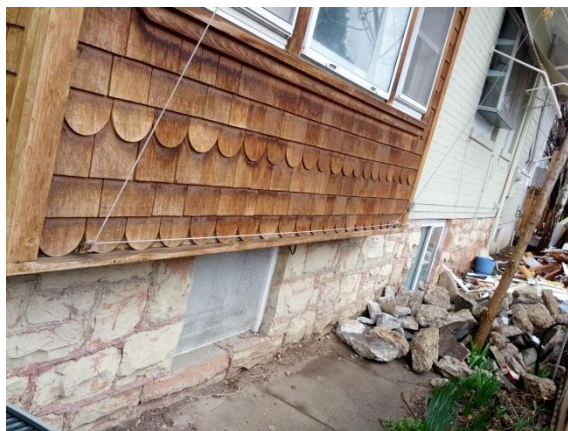
Basement windows before alterations

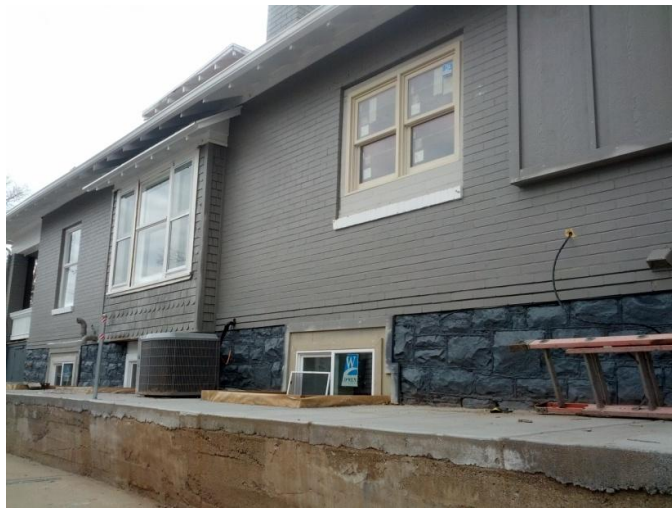
The applicant is asking for approval for a replacement of a metal garden box window along the west side of the home that was replaced with double hung beige wood windows. The new windows do not fit the original window opening. The area between the windows and the original window opening is trimmed with a smooth hardie board.

New kitchen window and covered window on west elevation

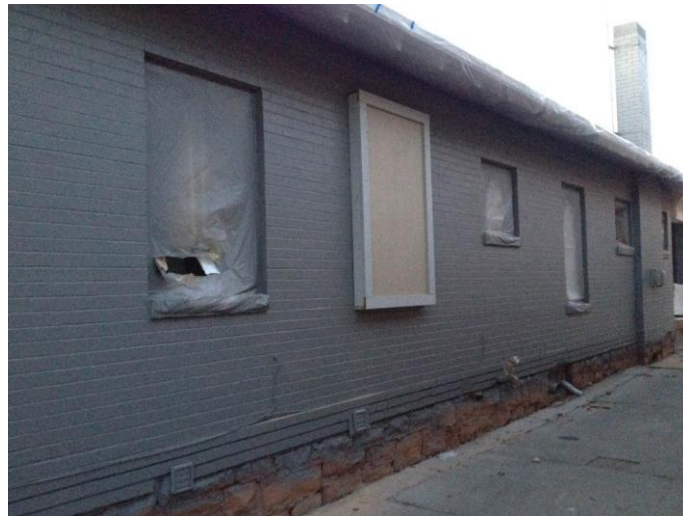
Covered window on east elevation

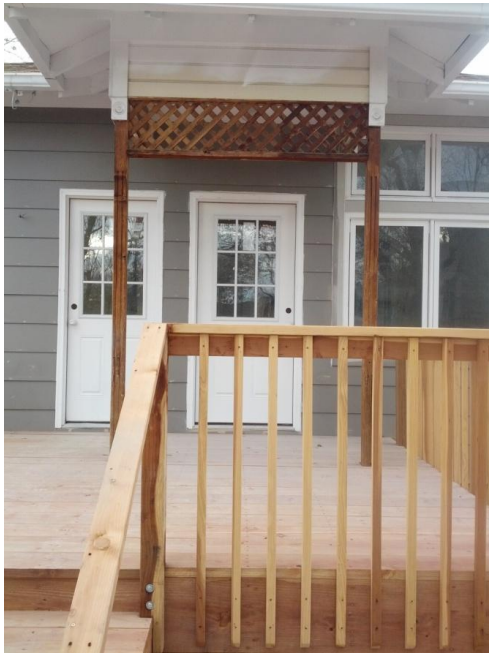
The applicant is requesting approval to legalize the removal of the former deck that measured approximately 6' by 4' and the building of a larger deck with stairs located at the center of the deck leading towards the rear of the property. The requested deck measures 10' by 15' and is made of redwood. The balusters are 37" tall and are spaced 3.75". The top railing on the deck is constructed of 2x4s and the design of the new deck railing is a simple stick design in which the stick balusters are nailed to the exterior of the top railing and then nailed to the base of the deck. The handrails for the stairs contain a top hand rail and no balusters.

New deck railing and balusters

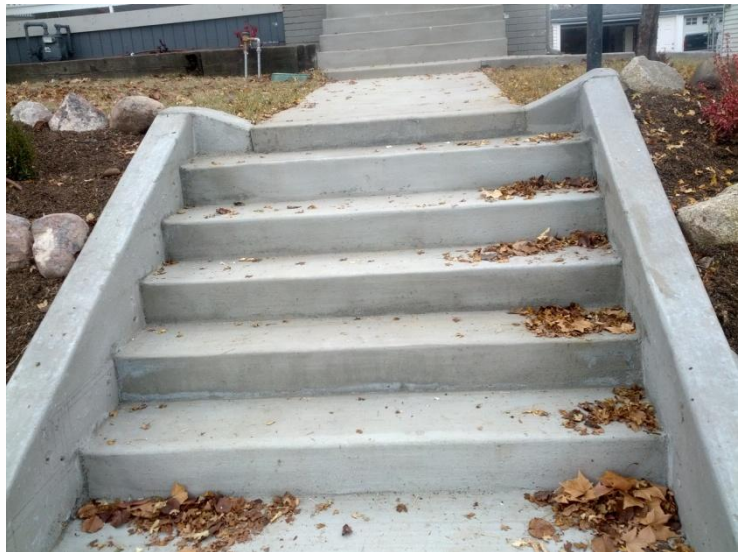
The applicant is seeking approval for concrete work that was completed on the stairs in the front yard, the porch stairs, the walkway connecting the two sets of stairs, and the walkway along the western edge of the home leading towards the back of the home. The shape of the stairway in the front yard was changed from a curved design to a straight design. The set of porch stairs was repaired with a new layer of cement and the concrete work was continued from the front walkway to the west side of the property to the back of the property.

New design of front stairs

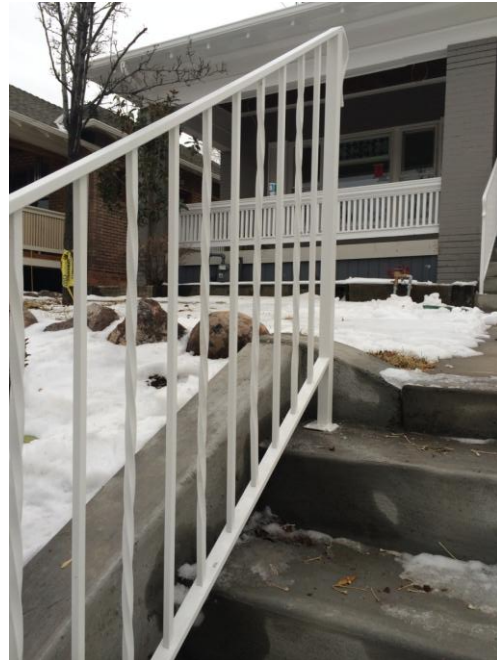
The applicant is seeking approval for the removal of the front metal railings along the west side of the stairs and proposes to replace them with similar metal railings. The proposed new metal railings mimic the design of the previously unoriginal and inappropriate metal railings. Although a stop work order is currently in place on the property, new metal railings have been installed without approval.

Newly installed handrails

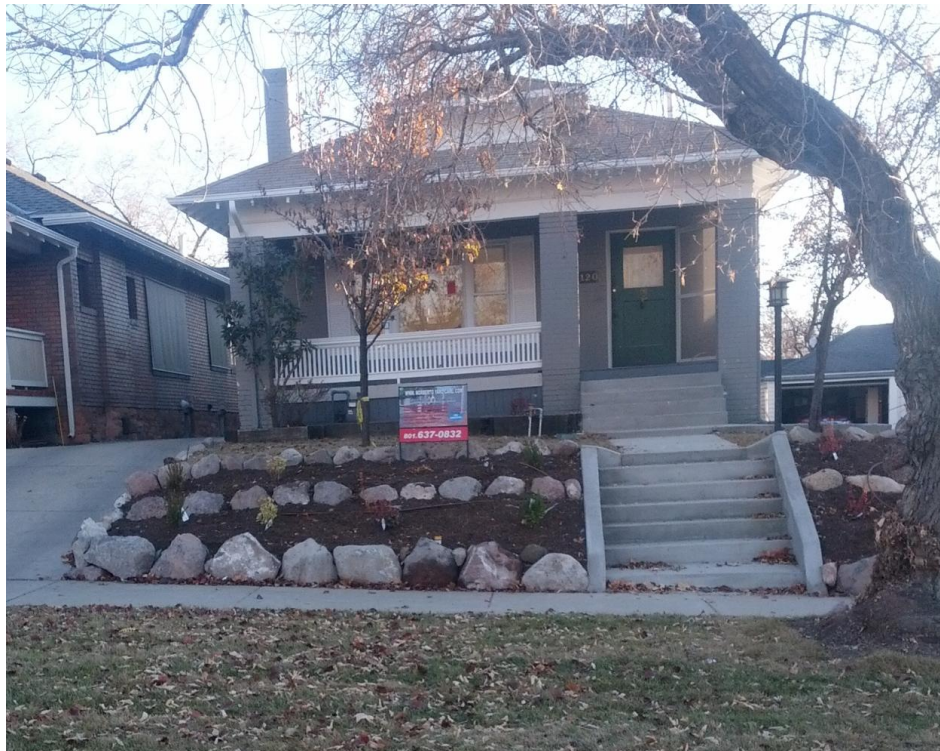
Front of home after concrete work

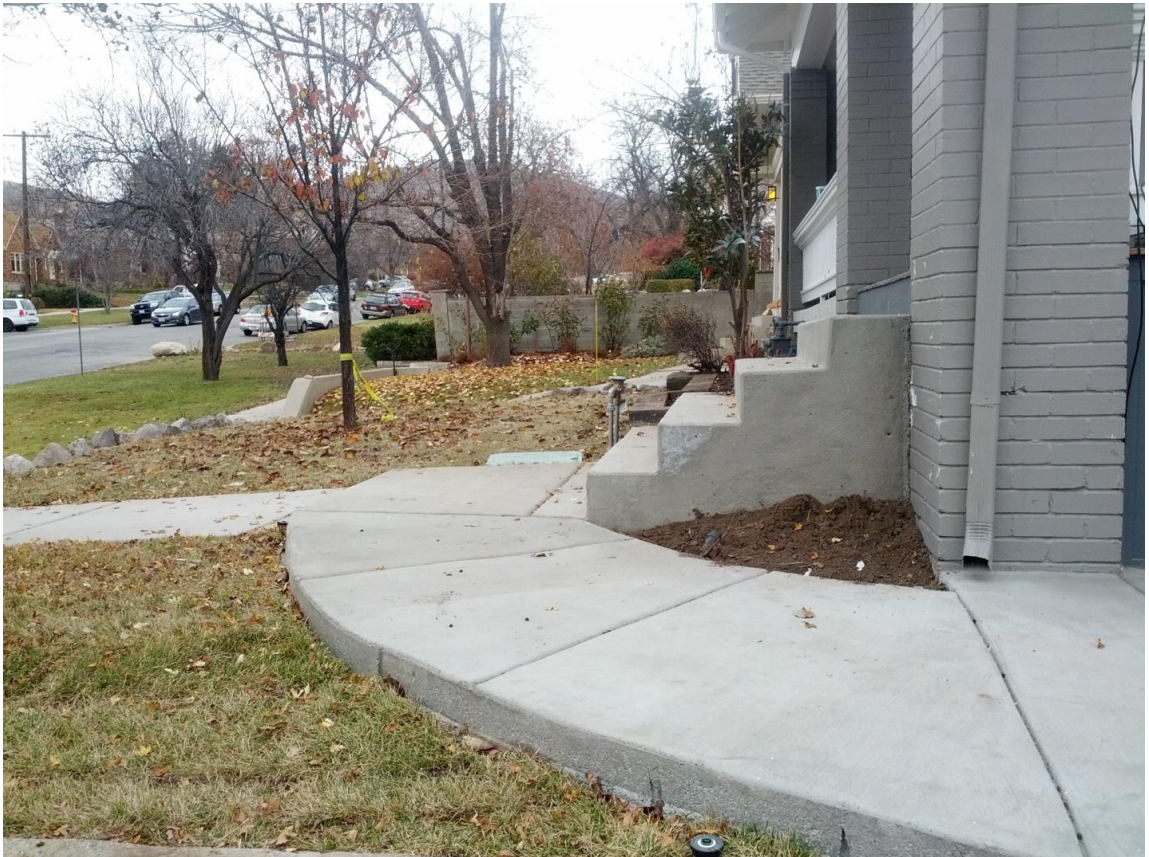
Concrete work and repairs on walkway

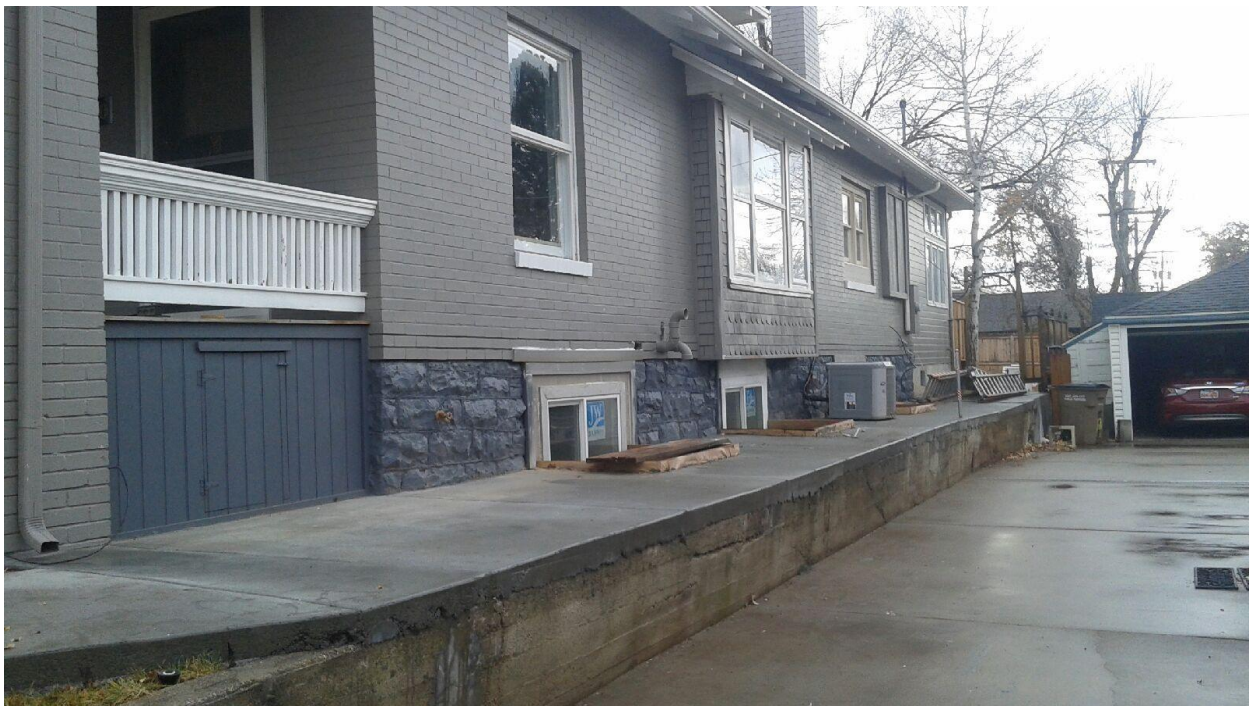
Concrete work along western edge of property

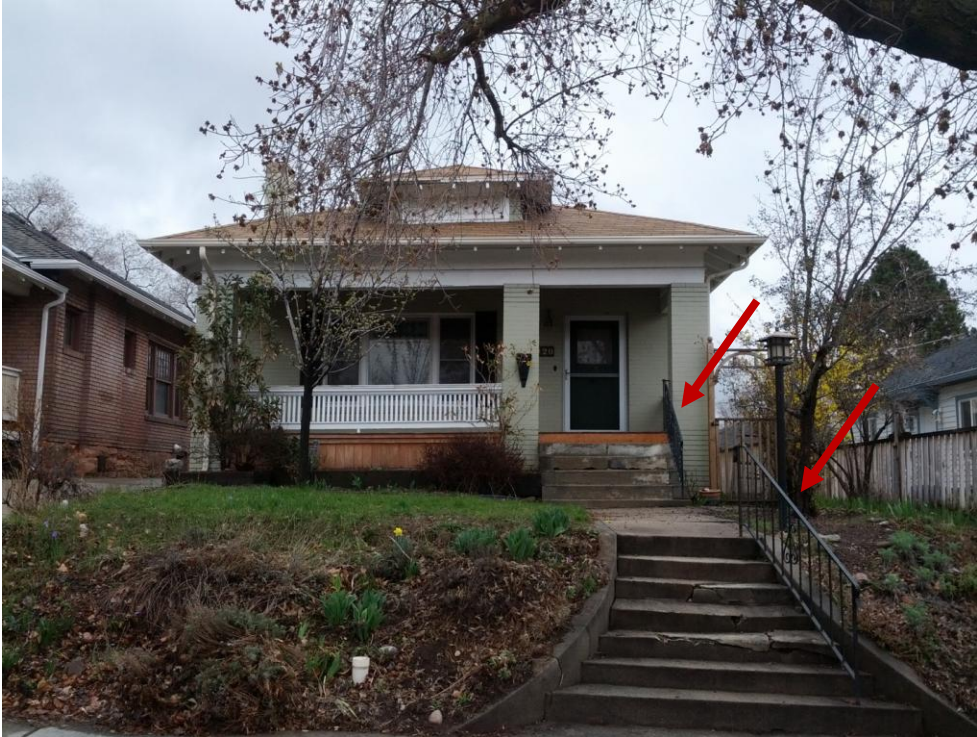
Former front metal handrails along front porch and front yard (above)

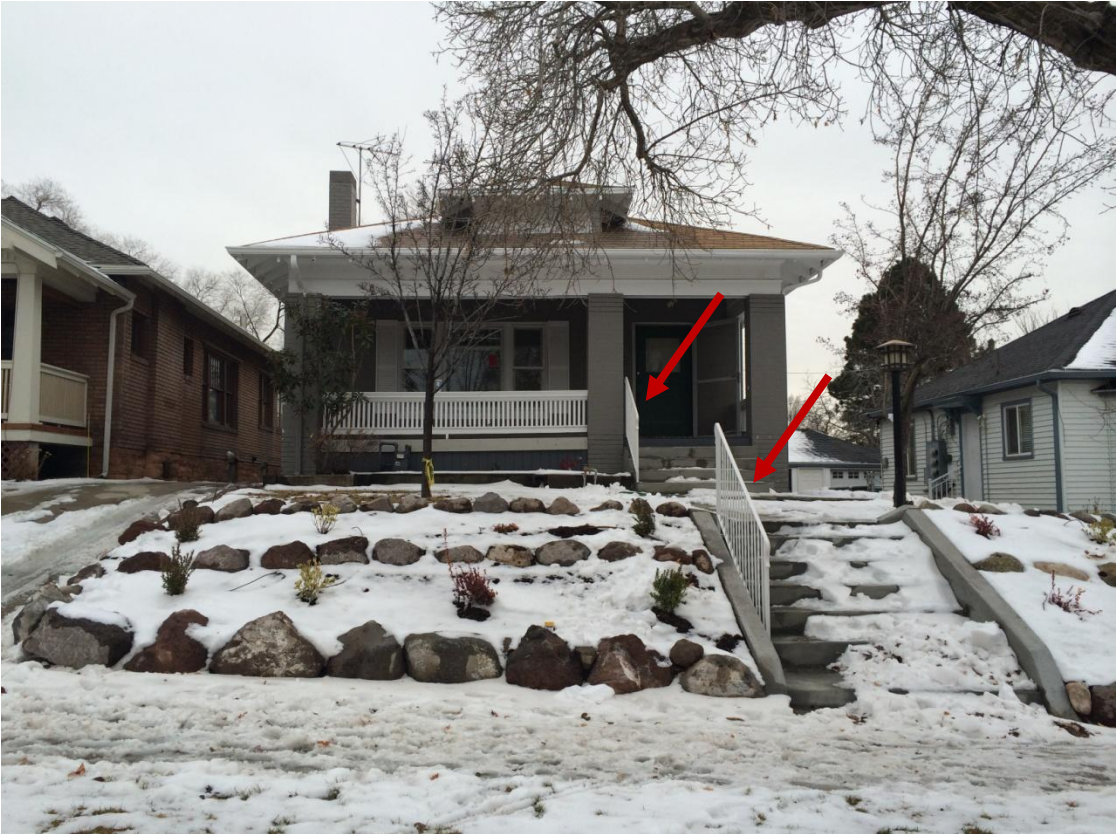
New front painted metal handrails (below)

New painted front metal handrails – front yard handrail does not extend the whole length of stairs
