## APPENDIX C: STUDY REACH MAPS, SUMMARIES, AND RECOMMENDATIONS

## REACH UCC\_R09: PLEASANT VALLEY

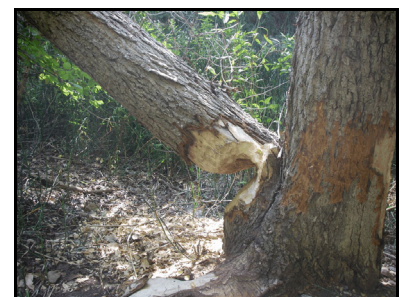
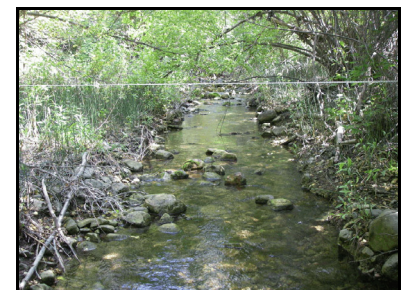
### Issues affecting riparian function:

- minimal infrastructure
- channel/floodplain not confined by road

RECOMMENDATIONS	
IMPROVEMENT MEASURE	LOCATION
Invasive plant removal/control	within vegetation type(s)
Access control/trail reclamation	point 1 on map

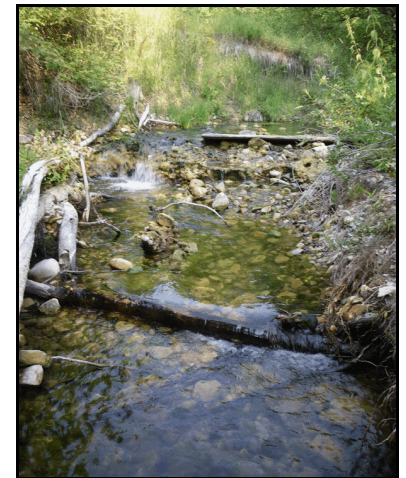
This reach includes two developed picnic sites. Beaver activity is evident in this reach, which contains many woody debris piles and a diverse mix of native canopy, shrub, and understory vegetation. Well-developed undercut banks provide excellent fish habitat, and more than 10 trout were observed during the field assessment of this reach. Several significant areas of erosion are evident where the stream has migrated into the steep hillside.

- trash (minor)
- invasive species (thistle, burdock, goatgrass, cheatgrass, toadflax, Dyer's woad)
- eroded access trails (minor)

RECOMMENDATIONS	
IMPROVEMENT MEASURE	LOCATION
Invasive plant removal/control	within vegetation type(s)
Monitor terrace erosion	point 4 on map
Stream cleanup	points 1, 2, and 3 on map
Mechanized trash removal	point 5 on map
Picnic site improvements/access stabilization	points 5 and 6 on map

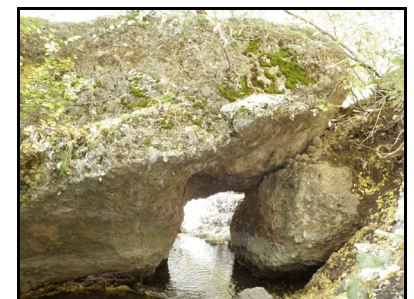
Within this reach, the northern bank has been stabilized with gabion baskets in several locations. The channel passes through a conglomerate geologic formation in this reach, and bedrock is exposed in portions of the banks. Areas of steep, bare banks are common, but appear to be associated with natural processes typical of a steep canyon setting. The downstream boundary of the reach is at the red footbridge/water line crossing. Fish were observed in this reach.

- invasive species (burdock)
- gabions
- bank erosion

RECOMMENDATIONS	
IMPROVEMENT MEASURE	LOCATION
Invasive plant removal/control	within vegetation type(s)
Gabion basket retrofit	points 1, 2, 3, 4, 5 on map
Stabilize erosion/rills at ends of gabions	points 3 and 6 on map
Access trail stabilization	points 7, 9, and 10 on map
Picnic site improvements/access stabilization	point 8 on map

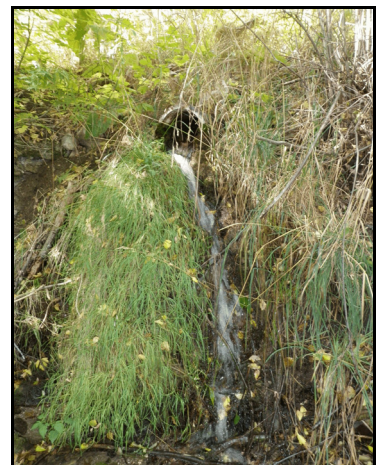
Starting at this reach, the alignment of City Creek shifts and begins to flow to the south. Several seeps/springs enter from the west bank. Fish were observed in this reach, which includes abundant undercut banks. Vegetative cover and floodplain width are limited by the proximity of the road and gabion basket protection on the west bank in several locations. Two picnic sites are present near the stream in this reach.

- invasive species (burdock, toadflax)
- eroded access trails
- gabions

RECOMMENDATIONS	
IMPROVEMENT MEASURE	LOCATION
Invasive plant removal/control	within vegetation type(s)
Gabion basket retrofit	points 1, 2, 3, 4, 5 on map
Picnic site improvements	points 3 and 5 on map
Outfall improvements	points 2 and 6 on map
Access trail stabilization/reclamation	points 5, 7, 8, 9 on map

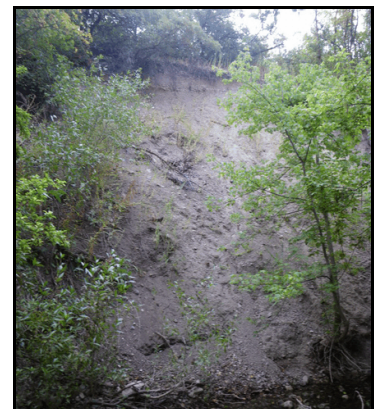
The upstream boundary of this reach is at the Elbow Turn picnic site; the reach also includes three other picnic sites. The stream channel flows very close to the road in some areas, and has meandered into some steep hillslope/rock outcrops on the east bank. Several relatively small areas of rip rap and gabion bank protection are present on the west bank. Fish were observed in this reach.

- invasive species (burdock, toadflax, Dyer's woad, thistle, houndstongue, cheatgrass)
- eroded trails/picnic site access
- gabions
- road proximity/repair practices
- hillslope erosion

RECOMMENDATIONS	
IMPROVEMENT MEASURE	LOCATION
Invasive plant removal/control	within vegetation types
Picnic site improvements	near points 3, 4 and 6 on map
Gabion basket retrofit	points 1, 2, 3, 4, 5 on map
Stabilize erosion/rills at ends of gabions	points 3 and 5 on map
Access trail stabilization/reclamation	points 1, 4, 6, 8 on map
Stream cleanup	point 7 on map
Mechanized trash removal	near point 5 on map
Protect stream from asphalt/road debris	point 8 on map
Outfall improvement	point 9 on map
Road maintenance/runoff management	reach-scale

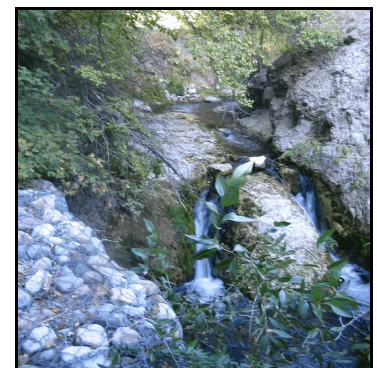
This reach begins at a natural bedrock outcrop/waterfall feature near the Hidden Falls picnic site. Near-stream vegetation (including dense stands of horsetail) is thick through much of this reach, but limited by the proximity of the road in other areas. Fish were observed, and a spring/seep was also noted. A broken wood plank footbridge crosses the channel at the downstream end of the reach. A small footpath parallels the stream along the east bank.

- invasive species (burdock, toadflax)
- eroded trails/picnic site access
- gabions
- trash (minor)
- road proximity/repair practices

RECOMMENDATIONS	
IMPROVEMENT MEASURE	LOCATION
Invasive plant removal/control	within vegetation type(s)
Stream cleanup	points 2 and 7 on map
Gabion basket retrofit	points 1, 2, 3 on map
Picnic site access controls	point 4 on map
Access trail stabilization/reclamation	point 6 on map and at picnic sites
Remove or repair footbridge	point 5 on map
Mechanized trash removal	point 2 on map
Protect stream from asphalt/road debris	reach-scale

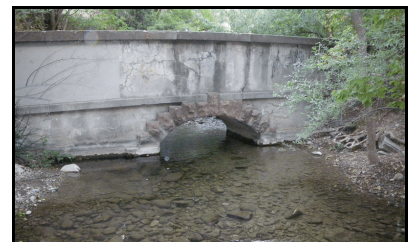
- high level of recreational use
- multiple utility crossings
- excellent interpretive opportunities

RECOMMENDATIONS	
IMPROVEMENT MEASURE	LOCATION
Invasive plant removal/control	within vegetation type(s)
Revegetation (understory)	within vegetation type(s)
Mechanized trash removal	point 1 on map
Storm drain improvement	point 2 on map
Identify and remedy source of "milky," foamy discharge	point 3 on map
Restore/protect tributary drainage	point 1 on map
Gabion basket retrofit	near points 2 and 4 on map
Access control/trail stabilization	reach-scale
Add interpretive displays	reach-scale
Replace arch culvert with wider-span structure	point 5 on map
Replace concrete footbridge with wider-span structure	point 6 on map

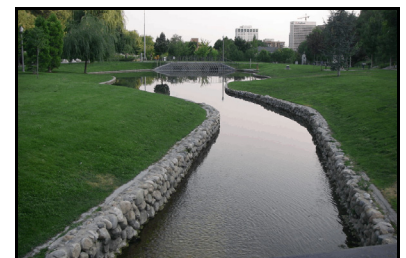
- designed/managed landscape limits potential for natural riparian functions

RECOMMENDATIONS	
IMPROVEMENT MEASURE	LOCATION
Invasive plant removal/control	within vegetation type(s)
Revegetation (canopy)	within vegetation type(s)
Revegetation (shrub)	within vegetation type(s)
Restoration of native understory plants	within vegetation type(s)
Stream cleanup	near points 1, 2, and 3 on map
Establish "no-mow" buffer at edge of turf	downstream half of reach
Access control/trail stabilization	upstream half of reach
