APPENDIX C: STUDY REACH MAPS, SUMMARIES, AND RECOMMENDATIONS

This appendix provides summary information and maps for each of the fully-assessed study reaches. Maps include vegetation community types and locations of features such as litter areas, storm drain outfalls, culvert crossings, access trails, artificial bank treatments, and erosion areas. A brief description and selected photographs are also provided, along with tables summarizing stream channel data and vegetation characteristics. For each study reach, a table is also provided that lists appropriate types of improvement measures for the reach and describes where within the reach the measures should be applied. Measures identified for implementation at the reach-scale will typically require additional detailed site-level design work and engineering to determine specific locations and combinations of treatment techniques.

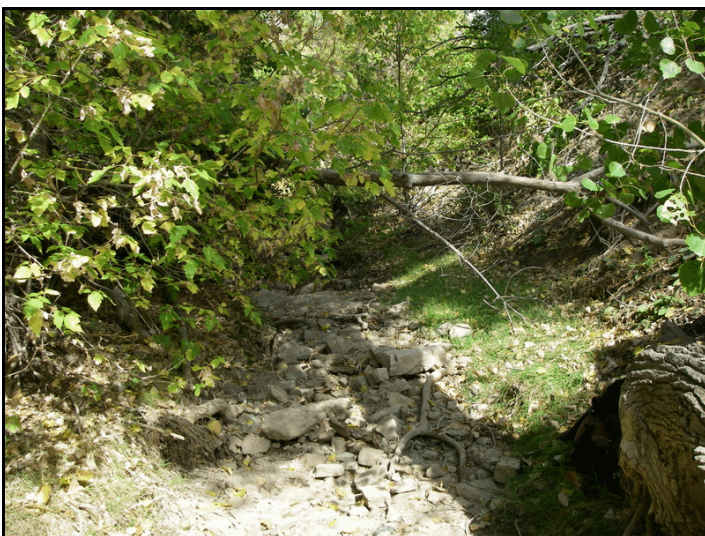
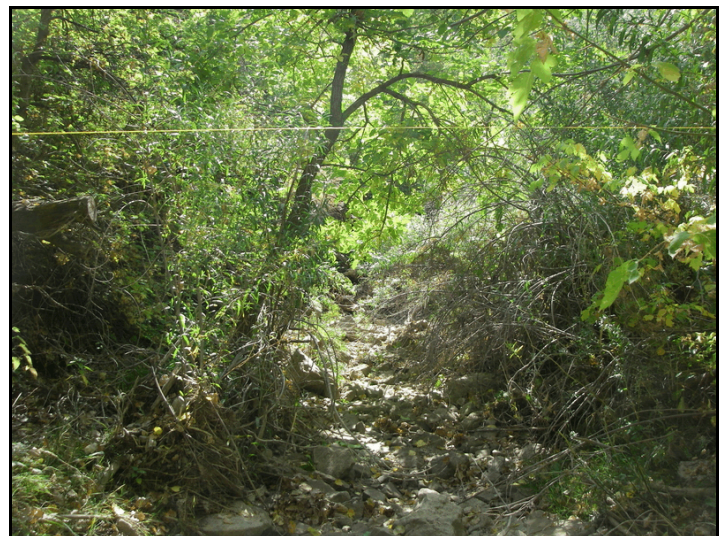
The reach, in Emigration Canyon, is in relatively natural condition. Lateral width is confined by the steep hillside to the south and the road to the north. Some low floodplain surfaces are present; however, root zone scour may indicate some degree of bed incision. The stream was dry at the time the reach was assessed. Vegetative structure is excellent in this reach, with native canopy, shrub, and understory layers present.

RECOMMENDATIONS	
IMPROVEMENT MEASURE	LOCATION
Explore instream flow opportunities ^a	watershed-scale
Invasive plant removal ^a	within vegetation type(s)
Revegetation - shrub layer	within vegetation type(s)
Revegetation - understory layer	within vegetation type(s)
No-trespassing signage	reach-scale
Grade control	reach-scale
Bank stabilization	reach-scale

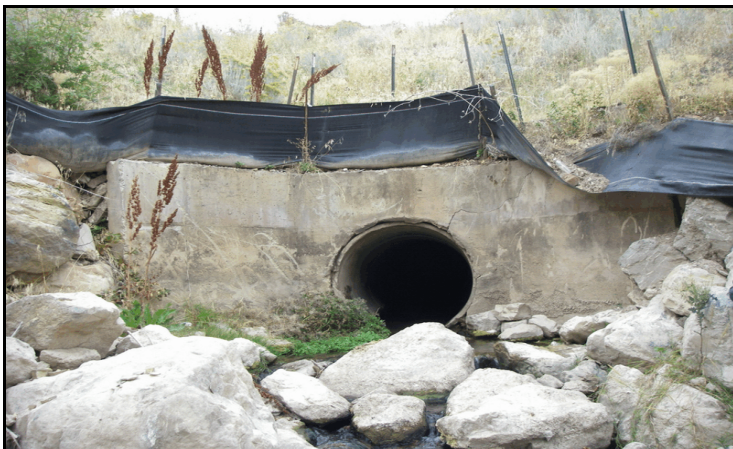
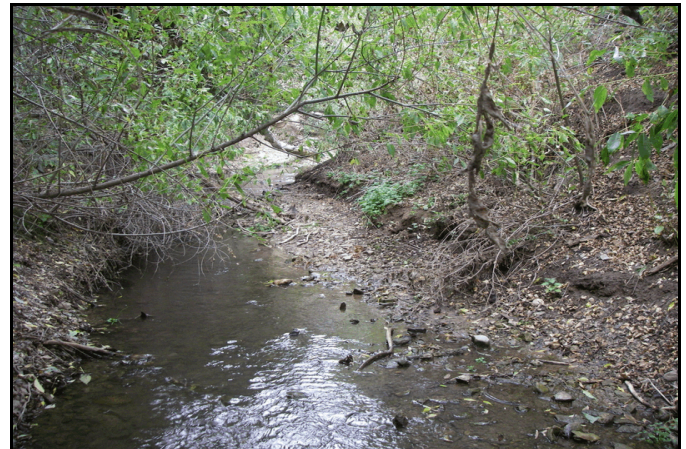
- Issues affecting riparian function:**
- eroded access trails
 - dog use
 - backwater effect/ sedimentation limits understory vegetation
 - trash (minor)
 - limited understory cover

RECOMMENDATIONS	
IMPROVEMENT MEASURE	LOCATION
Revegetation - understory layer ^a	within vegetation type(s)
Access control/ trail stabilization ^a	point 3 on map
Stream cleanup ^a	points 1 and 2 on map
Invasive plant removal	within vegetation type(s)
Revegetation - shrub layer	within vegetation type(s)
Grade control	reach-scale
Bank stabilization	reach-scale
Culvert replacement/outlet protection	point 1 on map

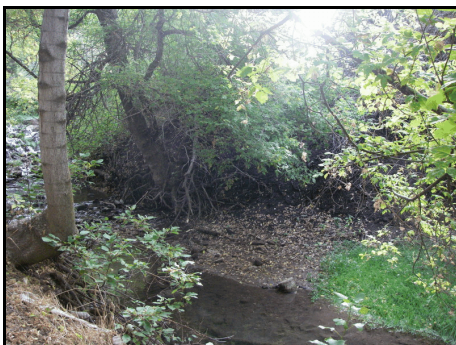
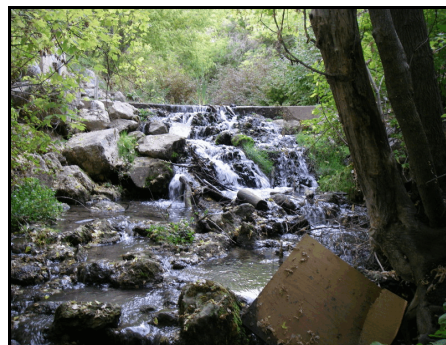
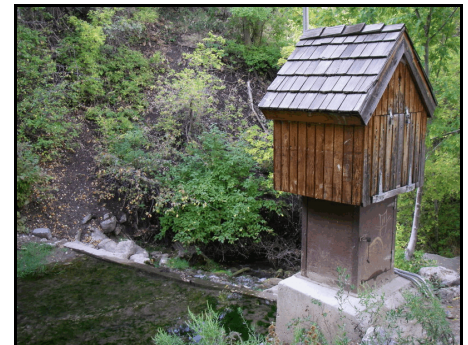
This reach, located in Rotary Glen Park below the debris basin, is in generally good condition. The reach includes rip-rap grade control structures and a stream gaging weir. Some low bank erosion/root zone scour is evident. Vegetation cover in the understory, shrub, and canopy layers is generally good, but in one area the understory is comprised of nonnative invasive species.

RECOMMENDATIONS	
IMPROVEMENT MEASURE	LOCATION
Silt removal from debris basin pipe outlet	point 1 on map
Mechanized trash removal ^a	points 2 and 3 on map
Stream cleanup ^a	reach-scale
Invasive plant removal ^a	within vegetation type(s)
Restoration of native understory plants ^a	within vegetation type(s)
Bank stabilization	reach-scale
Grade control	reach-scale
Access Control ^a	reach-scale

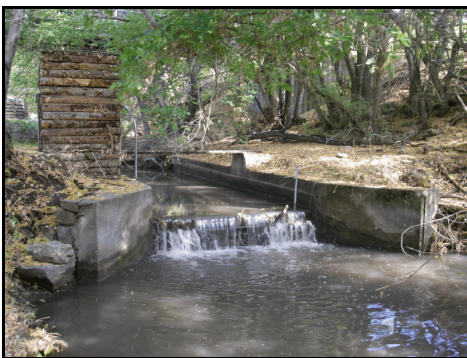
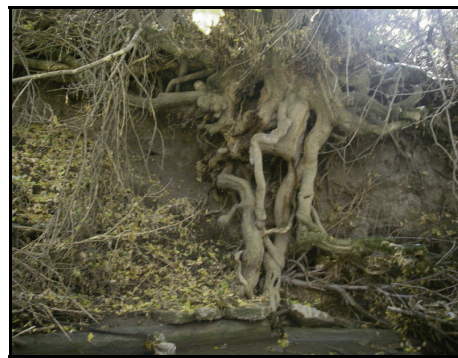
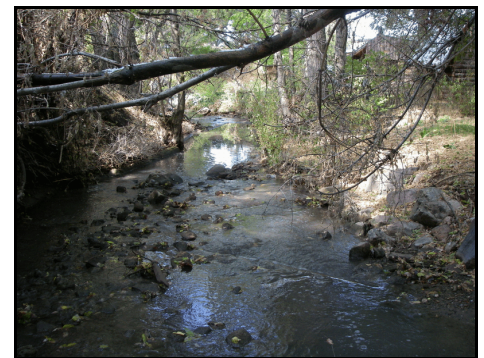
- scour/erosion at culvert outlet
- bed incision
- failing bank revetment
- low bank/root zone erosion
- lack of shrub cover
- understory dominated by nonnative species
- invasive species (periwinkle, lesser burdock)

RECOMMENDATIONS	
IMPROVEMENT MEASURE	LOCATION
Culvert replacement/outlet protection ^a	point 1 on map
Bank stabilization ^a	reach-scale
Grade control ^a	reach-scale
Revegetation - shrub layer	within vegetation type(s)
Invasive plant removal ^a	within vegetation type(s)
Restoration of native understory plants ^a	within vegetation type(s)
Storm drain improvement ^a	point 2 on map

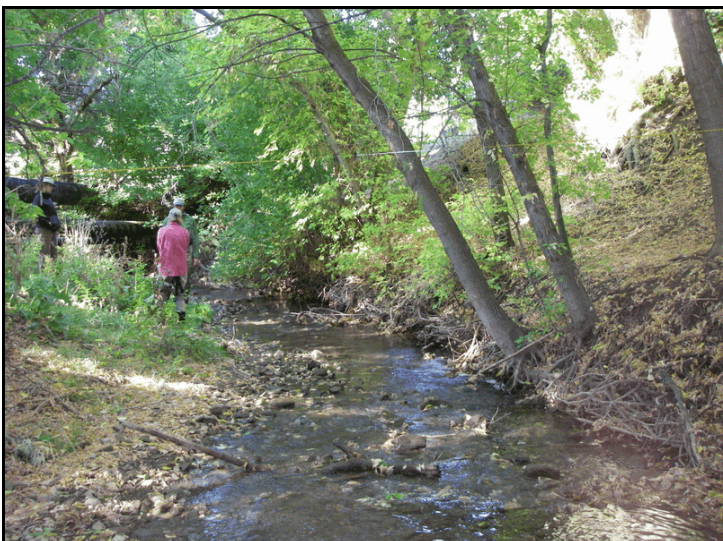
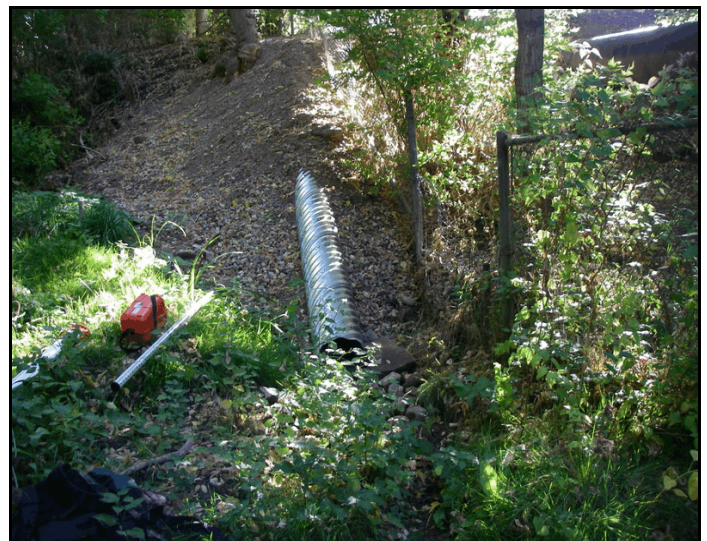
This is a short reach that has many pools and contains some low floodplain surfaces. A wide span open-bottom arch culvert is present at a pathway crossing in the middle of this reach and is in good condition. Backfill around an apparently new storm drain outlet is bare and unvegetated. Elevated exposed utility pipes cross the channel within this reach.

- poor revegetation/stabilization practices
- low bank/root zone erosion
- failing bank revetment
- invasive species (Siberian elm, lesser burdock)
- lack of understory cover
- lack of shrub cover

RECOMMENDATIONS	
IMPROVEMENT MEASURE	LOCATION
Storm drain outfall improvement ^a	point 1 on map
Revegetation of bare fill ^a	point 1 on map
Revegetation - understory/shrub ^a	within vegetation type(s)
Mechanized trash removal ^a	point 2 on map
No-trespassing signage	point 3 on map
Invasive plant removal/control ^a	within vegetation type(s)

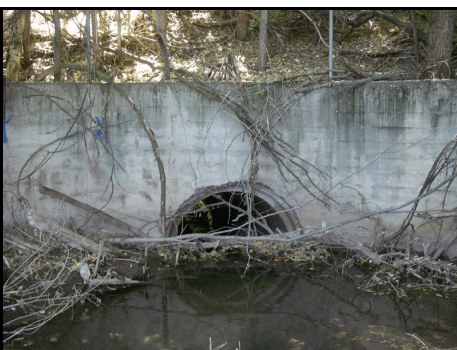
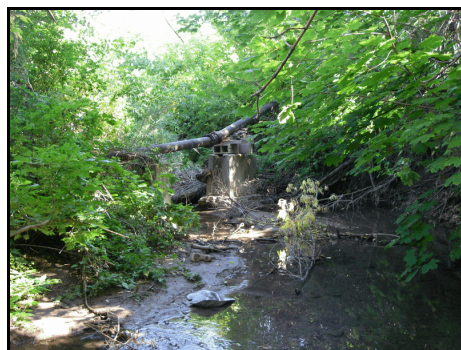
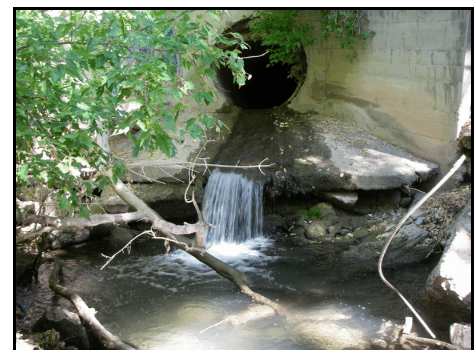
This reach contains a high amount of large woody debris and subsequently the potential for debris jams is high. There are a number of pipes and irrigation-related items in the channel. The culvert outlet at the top of the reach is in poor condition, and the inlet at the bottom of the reach shows evidence of deposition/debris accumulation. Tree cover is lacking in the central portion of the reach.

RECOMMENDATIONS	
IMPROVEMENT MEASURE	LOCATION
Culvert replacement/outlet protection ^a	point 1 on map
Culvert replacement ^a	point 2 on map
Redesign of irrigation pipe system/ removal of in-channel pier ^a	point 3 on map
Revegetation - understory/ shrub/ canopy ^a	within vegetation type(s)
Removal of invasive plants ^a	within vegetation type(s)
Grade control	reach-scale
Bank stabilization (general)	reach-scale

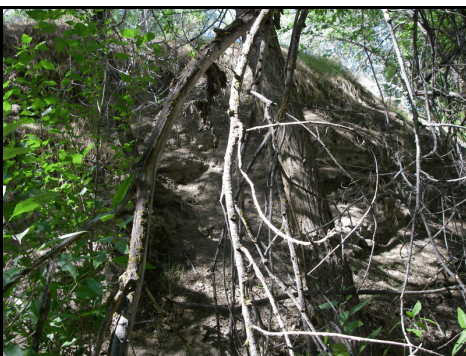
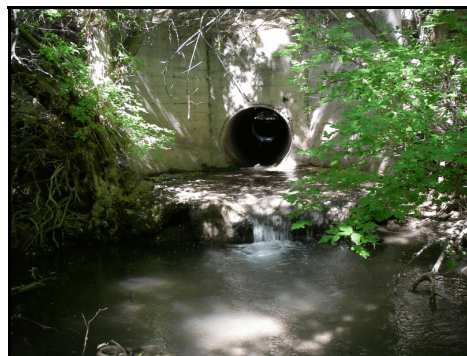
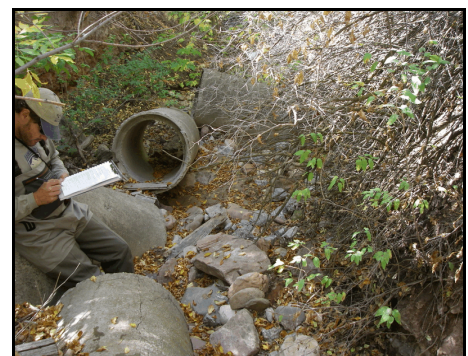
This reach is affected by an actively head-cutting storm outfall gully that enters from the east. Broken concrete pipe is present in the gully. The culvert outlet at the top of the reach is in poor condition, with scour and bank erosion evident. The streambed is noticeably silty, likely from the sediment generated in the eroding gully. A suspension bridge for golf carts crosses high above the channel in this reach. Channel width is relatively narrow.

RECOMMENDATIONS	
IMPROVEMENT MEASURE	LOCATION
Culvert replacement/outlet protection ^a	point 1 on map
Stabilization/ grade control in storm outfall gully ^a	points 2 and 3 on map
Mechanized trash removal ^a	points 4 and 5 on map
Invasive plant removal ^a	within vegetation type(s)
Revegetation - understory/shrub ^a	within vegetation type(s)
Barrier installation to contain sand trap sand ^a	point 6 on map
Bank stabilization (general)	reach-scale

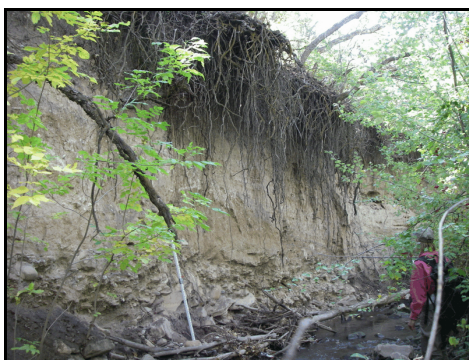
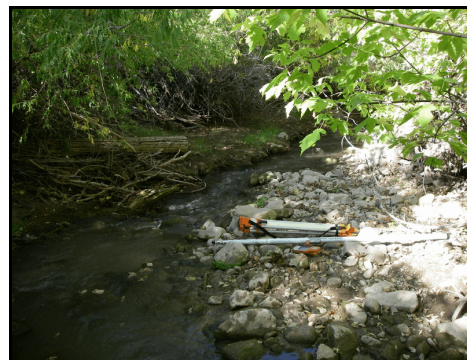
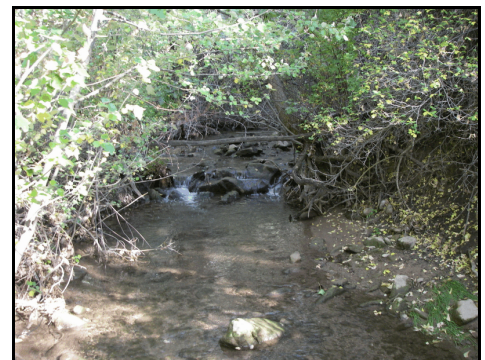
This reach is in a relatively natural condition, with no culverts and no noted in-channel structures. Tall, vertical, bare banks are present in several locations where the stream has eroded into high terraces associated with Lake Bonneville deposits. A second actively head-cutting storm outfall gully enters the stream at the top of this reach. Some active, low floodplain areas are present.

RECOMMENDATIONS	
IMPROVEMENT MEASURE	LOCATION
Stabilization/ grade control in storm outfall gully ^a	point 1 on map
Invasive plant removal ^a	within vegetation type(s)
Revegetation - understory/shrub ^a	within vegetation type(s)
Bank stabilization (general)	reach-scale

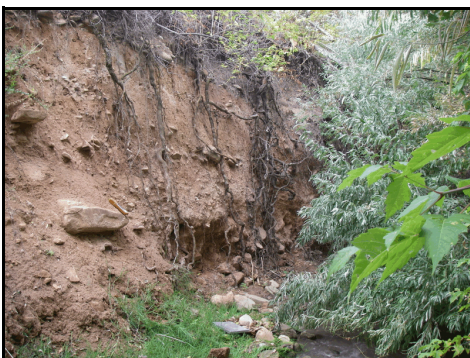
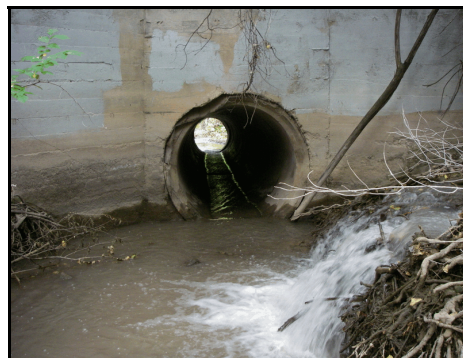
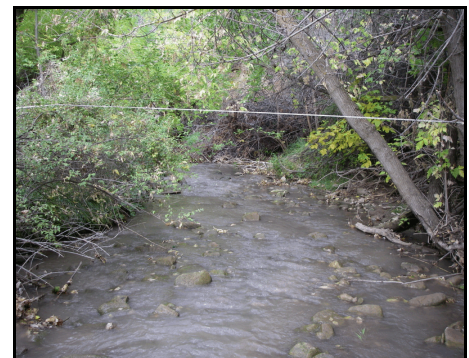
- Issues affecting riparian function:**
- terrace erosion
 - low bank/root zone erosion
 - debris jam at culvert inlet
 - lack of understory cover
 - invasive species (Siberian elm, Russian olive, myrtle spurge)

RECOMMENDATIONS	
IMPROVEMENT MEASURE	LOCATION
Culvert replacement ^a	point 1 on map
Invasive plant removal ^a	within vegetation type(s)
Revegetation - understory ^a	within vegetation type(s)
Revegetation - shrub	within vegetation type(s)
Bank stabilization (general)	reach-scale

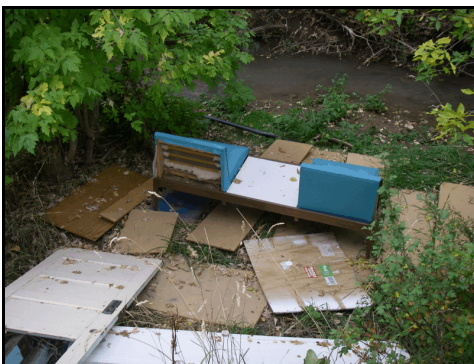
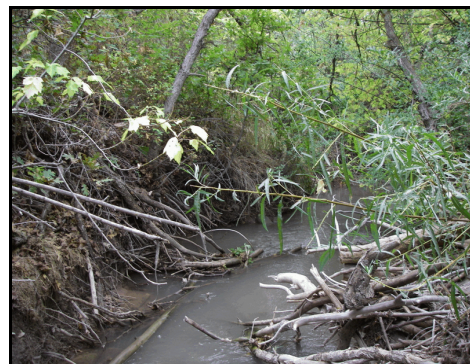
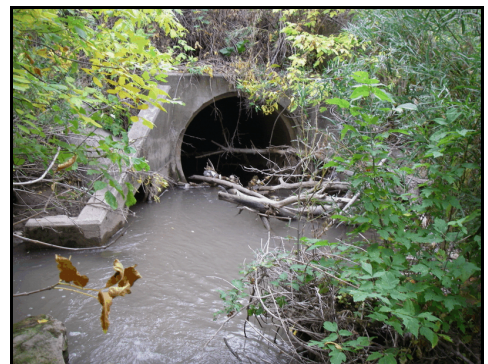
In this reach, the stream is no longer confined by Bonneville terrace deposits, and terrace erosion is not evident. Woody debris continues to be abundant in the channel and on the banks. Trash, including an old couch, was observed in this reach. The culvert outlet at the top of the reach has a cracked headwall and the concrete apron is being scoured/undercut. An elevated exposed utility pipe crosses the channel in this reach.

- Issues affecting riparian function:**
- scour/erosion at culvert outlet
 - low bank/root zone erosion
 - invasive species (Siberian elm)
 - trash
 - storm drain outfall erosion (minor)
 - limited understory cover

RECOMMENDATIONS	
IMPROVEMENT MEASURE	LOCATION
Culvert replacement/outlet protection ^a	point 1 on map
Revegetation - understory ^a	within vegetation type(s)
Invasive plant removal ^a	within vegetation type(s)
Stream cleanup ^a	point 2 on map
Bank stabilization (general)	reach-scale
Storm drain outlet protection ^a	point 3 on map

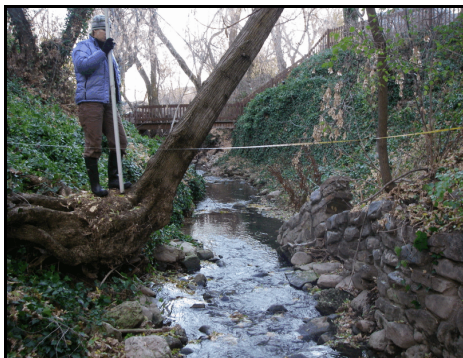
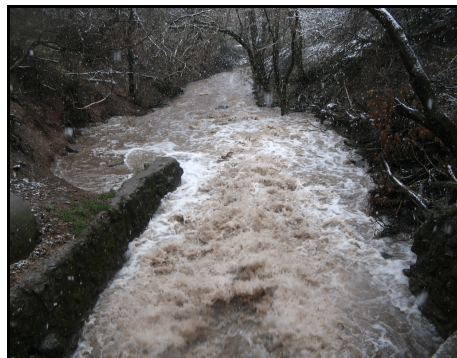
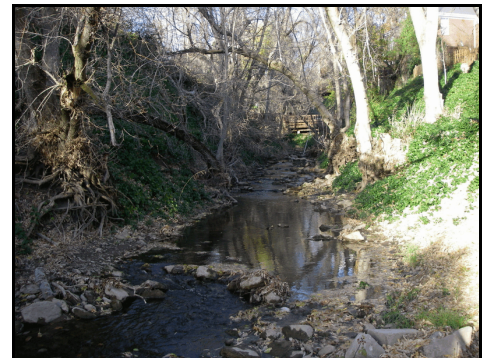
Channel and bank conditions in this reach are affected by landscaping and bank stabilization features (terracing, rock walls, etc.) constructed on individual nearby residential properties; many of the features are in disrepair due to continued erosion. English ivy and periwinkle vines dominate the understory vegetation. Severe bank erosion and scour are evident at the 2100 East culvert outlet; during storms the flow velocities exiting the culvert are extremely high.

- Issues affecting riparian function:**
- scour/erosion at culvert outlet (severe)
 - storm drain outfall erosion
 - bed incision
 - failing bank revetment
 - low bank/root zone erosion
 - eroded access trails
 - understory dominated by nonnative species
 - invasive species (periwinkle, English ivy)
 - terrace erosion

RECOMMENDATIONS	
IMPROVEMENT MEASURE	LOCATION
Culvert replacement/outlet protection ^a	point 1 on map
Comprehensive bank stabilization ^a	reach-scale
Comprehensive grade control ^a	reach-scale
Biotechnical slope stabilization ^a	point 2 on map
Access control/trail stabilization ^a	point 3 on map
Storm drain improvement ^a	points 4, 5, and 6 on map
Invasive plant removal ^a	within vegetation type(s)
Revegetation - canopy layer	within vegetation type(s)
Revegetation - shrub layer ^a	within vegetation type(s)
Restoration of native understory plants ^a	within vegetation type(s)
No trespassing signage ^a	near 1300 South

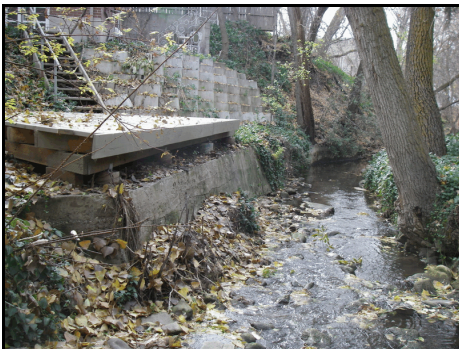
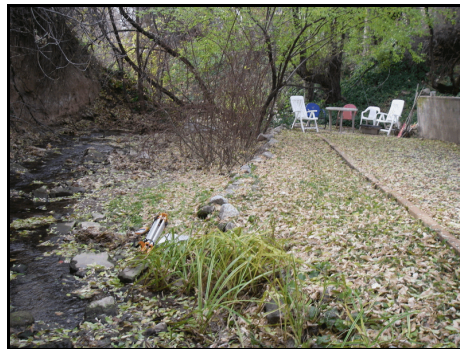
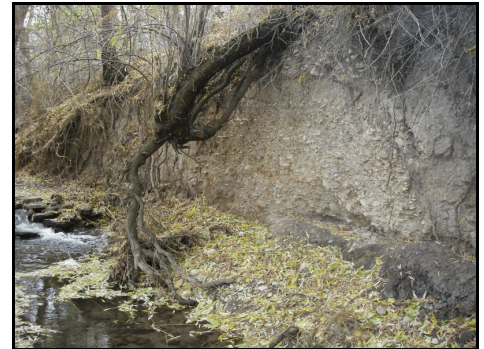
Emigration Creek continues through a residential area in this reach. Channel and floodplain conditions have been altered by development and structures (patios, rock walls, decks, etc.). Continued bank erosion poses a risk to fences, sheds, and other infrastructure. There have been various attempts at bank stabilization, but many of the revetment features are failing.

- Issues affecting riparian function:**
- storm drain outfall erosion
 - bed incision
 - terrace erosion
 - failing bank revetment
 - low bank/root zone erosion
 - eroded access trails
 - invasive species (Rampion bellflower, Tree of heaven, periwinkle, houndstongue)
 - scour/erosion at culvert outlet
 - understory dominated by nonnative species

RECOMMENDATIONS	
IMPROVEMENT MEASURE	LOCATION
Comprehensive bank stabilization ^a	reach-scale
Comprehensive grade control ^a	reach-scale
Invasive plant removal ^a	within vegetation type(s)
Restoration of native understory plants ^a	within vegetation type(s)
Storm drain improvement ^a	point 3 on map
Stream cleanup ^a	points 2 and 5 on map
Mechanized trash removal ^a	points 2 and 5 on map
Culvert replacement/outlet protection ^a	point 1 on map
Access trail stabilization ^a	point 4 on map
Revegetation - understory layer	within vegetation type(s)
No trespassing signage ^a	near 1300 South

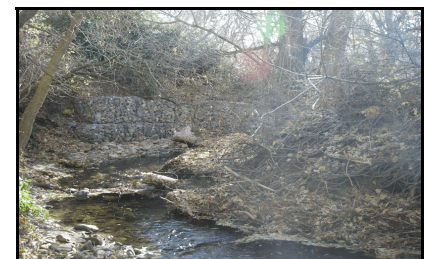
Much of this reach is influenced by a clay/root mass layer that confines low flow into a small and deeper channel. The culvert inlet at the bottom of the reach appears to clog occasionally, leading to some sediment deposition and flooding concerns. As with the reach upstream, residential development and bank stabilization attempts have altered channel and bank conditions. Terrace erosion and low bank/root scour are present. Nonnative plants dominate the understory vegetation.

- low bank/root zone erosion
- bed incision
- invasive species (Rampion bellflower, periwinkle, ivy, burdock)
- failing bank revetment
- terrace erosion
- eroded access trails
- storm outfall erosion
- deposition/clogging at culvert inlet
- limited shrub cover

RECOMMENDATIONS	
IMPROVEMENT MEASURE	LOCATION
Stream cleanup ^a	point 4 on map
Invasive plant removal ^a	within vegetation type(s)
Restoration of native understory plants ^a	within vegetation type(s)
Storm drain improvement ^a	point 5 on map
Comprehensive bank stabilization ^a	reach-scale
Comprehensive grade control ^a	reach-scale
Access stabilization ^a	points 1, 2, and 3 on map
Culvert replacement ^a	point 5 on map
No trespassing signage ^a	near 1900 East

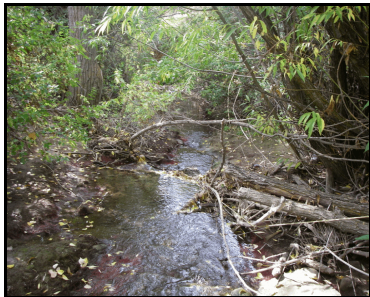
In this reach, development has encroached into portions of the south side floodplain. The channel contains a lot of silty material, and some streamside trees have a silt layer at the base of their trunks. A clay/ root mat layer affects channel and bank conditions through most of the reach, and appears to inhibit understory growth. Trout were observed in the reach, which historically included a meander bend to the east that has been culverted (Figure 3.6).

- Issues affecting riparian function:**
- terrace erosion
 - invasive species (myrtle spurge, Russian olive)
 - trash and yard waste
 - lack of understory cover

RECOMMENDATIONS	
IMPROVEMENT MEASURE	LOCATION
Revegetation - understory layer ^a	within vegetation type(s)
Invasive plant removal ^a	within vegetation type(s)
Storm drain improvement ^a	point 1 on map
Stream cleanup ^a	points 2 and 4 on map
Mechanized trash removal ^a	point 3 on map
Culvert replacement/outlet protection ^a	point 1 on map
Revegetation - shrub layer	within vegetation type(s)
Bank stabilization	reach-scale
Grade control	reach-scale

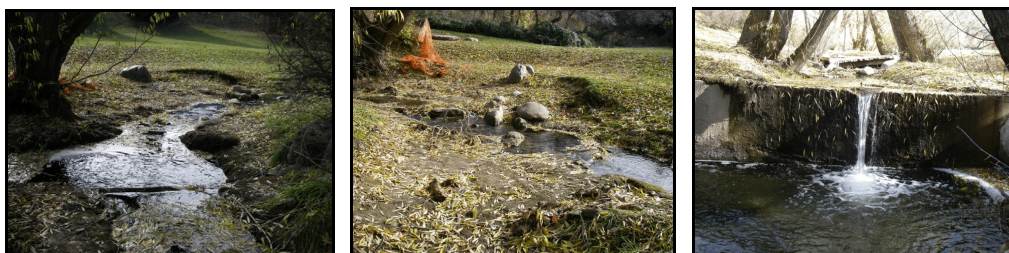
Several concrete in-channel drop structures trap debris and create pools in this reach. The purpose of these structures is unclear and they are in generally poor condition. The lawn area of the school extends all the way to the channel, stream banks have been compacted from heavy foot traffic, and understory and shrub cover are correspondingly poor. Historically the channel followed a longer meander closer to the current school building location (Figure 3.6).

- Issues affecting riparian function:**
- failing in-channel structures
 - eroded access trails
 - compaction from foot traffic
 - lack of understory cover
 - invasive species (Russian olive, myrtle spurge)
 - trash

RECOMMENDATIONS	
IMPROVEMENT MEASURE	LOCATION
Revegetation - understory layer ^a	within vegetation type(s)
Access control ^a	point 2 on map
Storm drain improvement ^a	point 5 on map
No-trespassing signage ^a	point 6 on map
Stream cleanup ^a	reach-scale
Removal/improvements to in-channel concrete structures ^a	points 1, 3, and 4 on map
Invasive plant removal ^a	within vegetation type(s)
Revegetation (shrub layer)/buffer creation ^a	within vegetation type(s)
Bank stabilization	reach-scale
Grade control	reach-scale

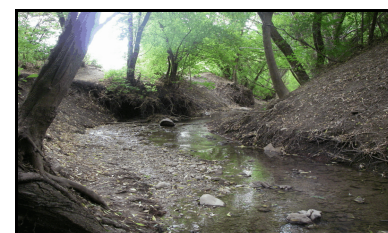
This reach is heavily used for recreation by people and dogs, which has affected bank stability and understory vegetation growth. Understory vegetation is further limited by sediment deposition that occurs when the downstream culvert inlet clogs. Failing bank revetment is present in some areas of the reach, as is root zone scour. Fill material has encroached into portions of the floodplain. Russian olive is a dominant species in the upper part of the reach.

- invasive species (Russian olive, Siberian elm, various noxious weeds)
- eroded access trails
- heavy dog use
- failing bank revetment
- low bank/root zone erosion
- terrace erosion
- backwater effect/ sedimentation limits understory vegetation
- lack of understory cover
- limited shrub cover

RECOMMENDATIONS	
IMPROVEMENT MEASURE	LOCATION
Stream cleanup ^a	points 1, 2, and 3 on map
Mechanized trash removal ^a	points 2 and 3 on map
Invasive plant removal ^a	within vegetation type(s)
Culvert replacement ^a	point 4 on map
Access control/ trail stabilization ^a	reach-scale
Revegetation - understory layer ^a	within vegetation type(s)
No-trespassing signage ^a	reach-scale
Revegetation - shrub layer ^a	within vegetation type(s)
Bank stabilization ^a	reach-scale
Grade control	reach-scale
Floodplain re-establishment ^a	reach-scale

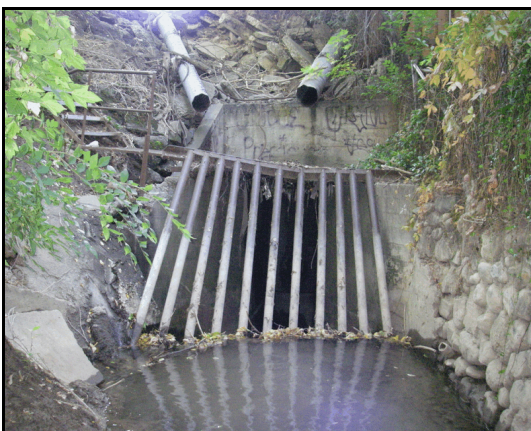
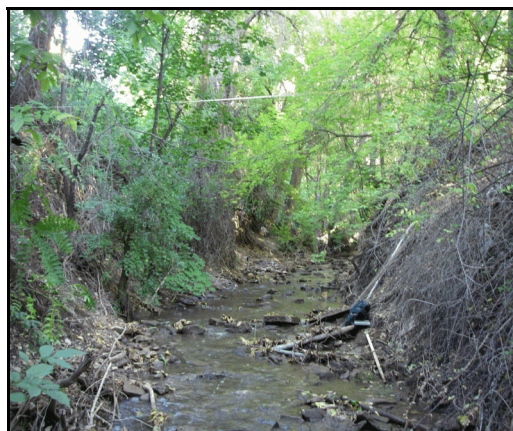
- storm outfall erosion
- bed incision
- low bank/root zone erosion
- failing bank revetment
- low bank/root zone erosion
- terrace erosion
- eroded access trails
- lack of shrub cover
- invasive species (Siberian elm)
- trash

RECOMMENDATIONS	
IMPROVEMENT MEASURE	LOCATION
Stream cleanup ^a	points 1, 3, 4, and 5 on map
Mechanized trash removal ^a	points 4, 5, and 7 on map
Revegetation - shrub layer ^a	within vegetation type(s)
Storm drain improvement ^a	point 8 on map
Invasive plant removal ^a	within vegetation type(s)
Revegetation - understory layer ^a	within vegetation type(s)
Grade control ^a	reach-scale
Bank stabilization ^a	reach-scale
Access control/ trail stabilization ^a	points 2, 6, and 8 on map
Culvert replacement ^a	point 8 on map
No-trespassing signage	reach-scale
