APPENDIX C: STUDY REACH MAPS, SUMMARIES, AND RECOMMENDATIONS

This appendix provides summary information and maps for each of the fully-assessed study reaches. These summaries are not intended to comprehensively provide all the information collected for each reach; rather, they are meant as a reference that provides a brief characterization and overview of existing conditions, issues, and recommendations for each assessed reach. The maps in this appendix include vegetation community types and locations of features such as litter areas, storm drain outfalls, culvert crossings, access trails, artificial bank treatments, and erosion areas. A brief description and selected photos are also provided, along with tables summarizing stream channel data and vegetation characteristics. For each reach, a table is also provided that lists appropriate types of improvement measures for the reach and describes where within the reach the measures should be applied. Measures identified for implementation at the reach-scale will typically require additional detailed site-level design work and engineering to determine specific locations and combinations of treatment techniques.

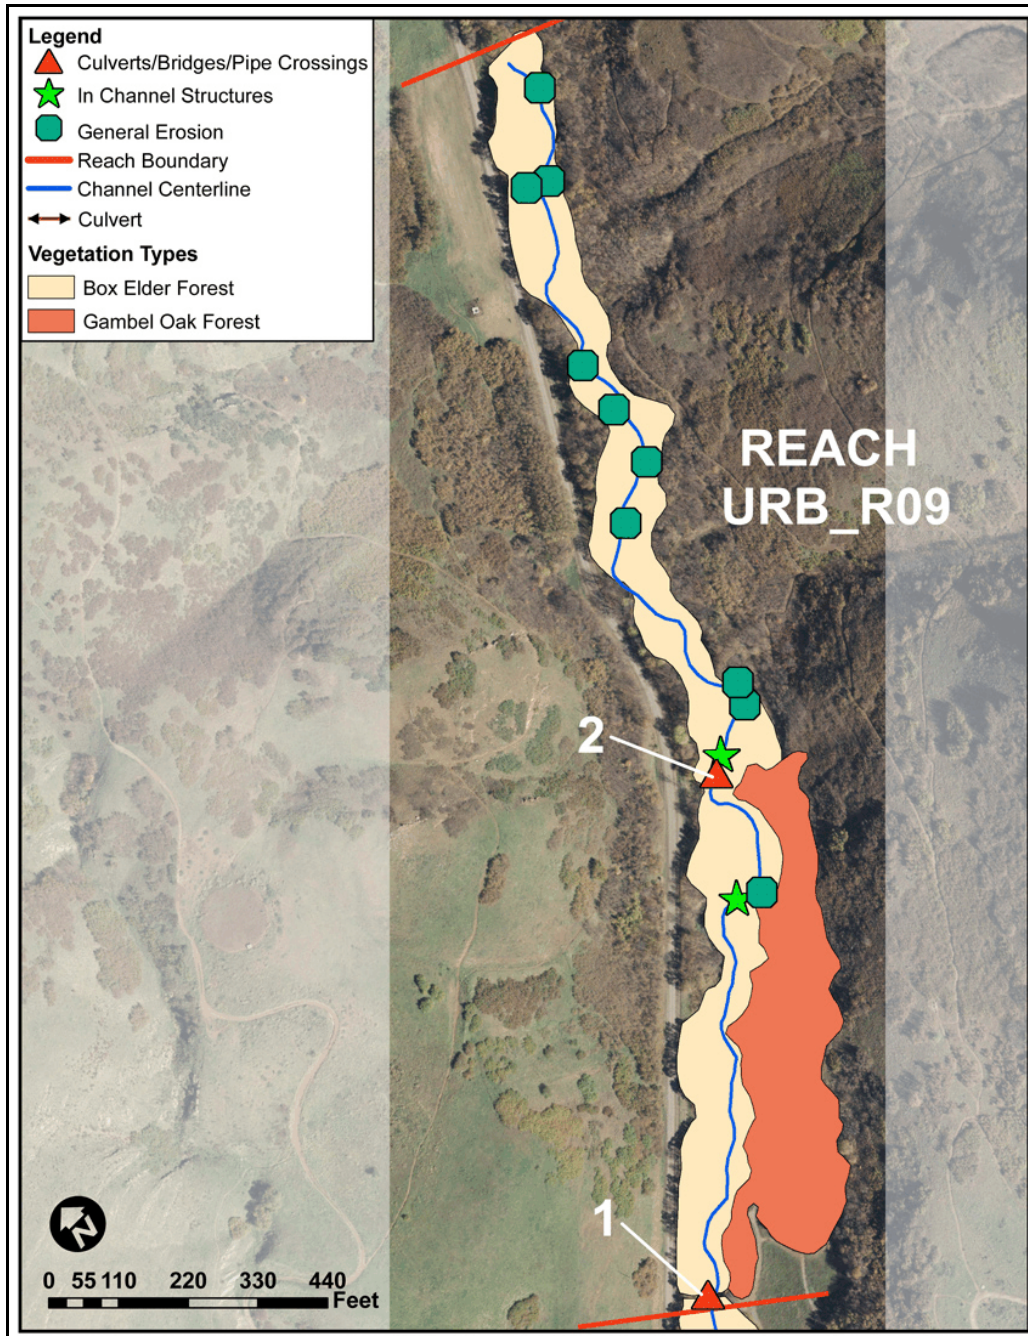
REACH URB_R09: UPPER RED BUTTE GARDEN

This reach flows through the downstream portion of Red Butte Canyon, and the channel is confined by steep hillslopes. The reach is in relatively natural condition, and although some trail and picnic facilities are present, recreational use does not appear to be negatively affecting riparian condition. Channel and bank slopes are steep, and the reach shows evidence of low bank/root scour, terrace/high bank erosion, hillslope slumping, and apparent bed incision. Vegetative structure and cover are generally excellent in this reach.

- low bank/root zone erosion
- terrace erosion
- eroded access trails (minor)
- invasive species (whiteweed, lesser burdock, Siberian elm)
- bed incision

RECOMMENDATIONS	
IMPROVEMENT MEASURE ^a	LOCATION
Invasive plant removal	within vegetation type(s)
Removal of concrete/asphalt on bank	point 1 on map
Biotechnical slope stabilization	point 1 on map
Revegetation of low bank at picnic area	point 2 on map

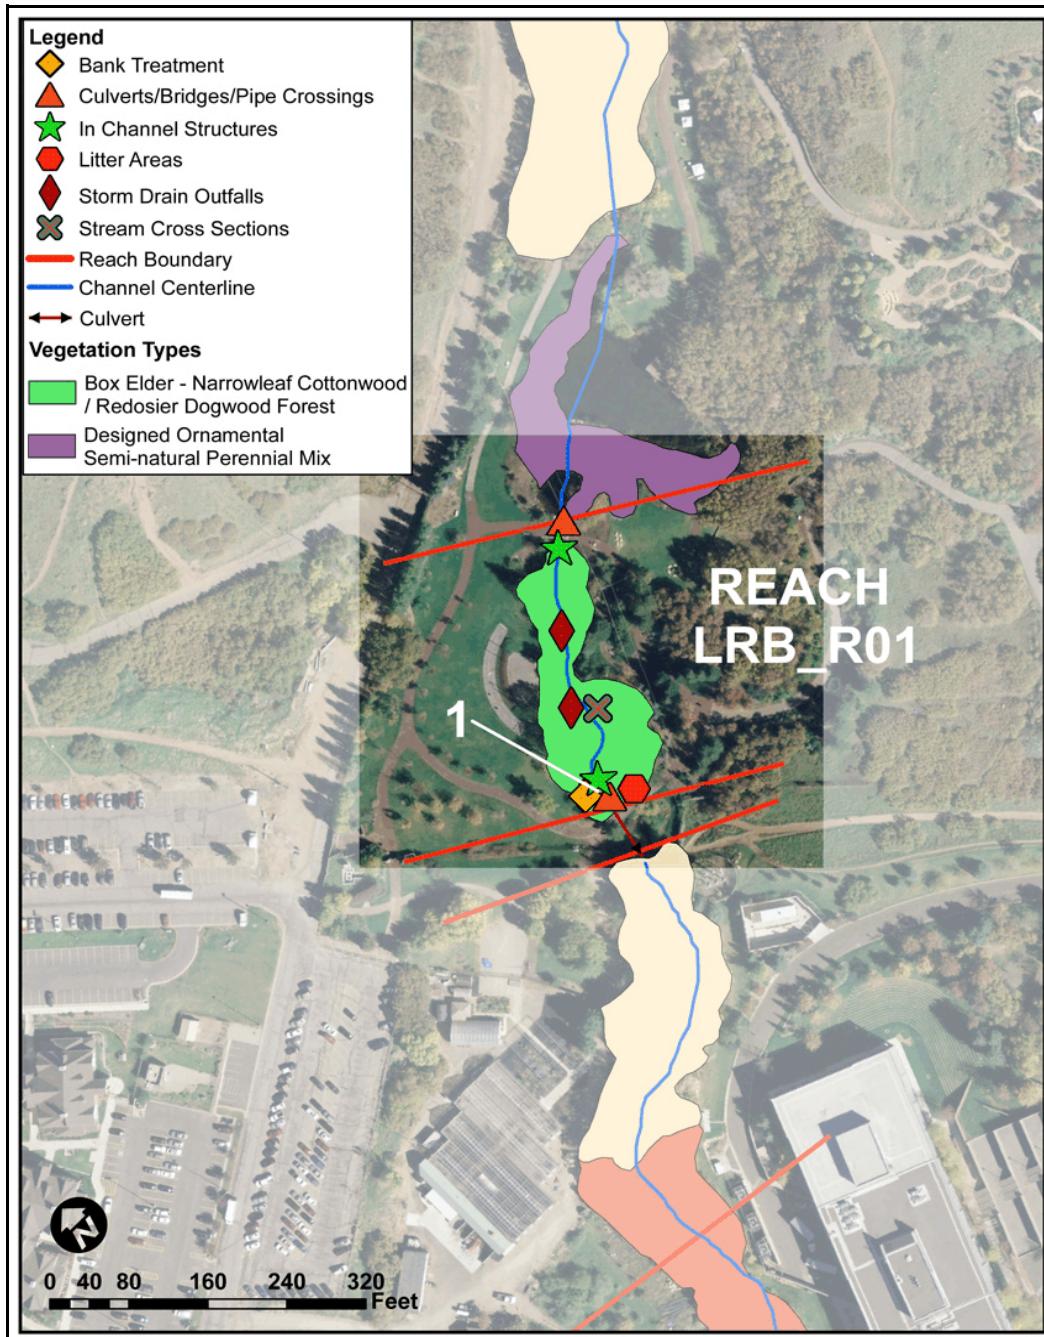
REACH LRB_R01: LOWER RED BUTTE GARDEN

This is a short reach downstream of the ponds in Red Butte Garden. At the time of field assessment, the riparian corridor was affected by construction activities associated with renovation of the Red Butte Garden concert venue. The banks through this reach are much lower and less confining than in Reach URB_R09, and several grade control structures are present. A narrow but thick buffer of riparian vegetation with excellent shrub density limits direct access to the stream. No invasive plant species were noted in this reach.

- affected by active construction at time of assessment

RECOMMENDATIONS	
IMPROVEMENT MEASURE ^a	LOCATION
Stream cleanup	point 1 on map
Monitor/protect riparian corridor	reach-scale

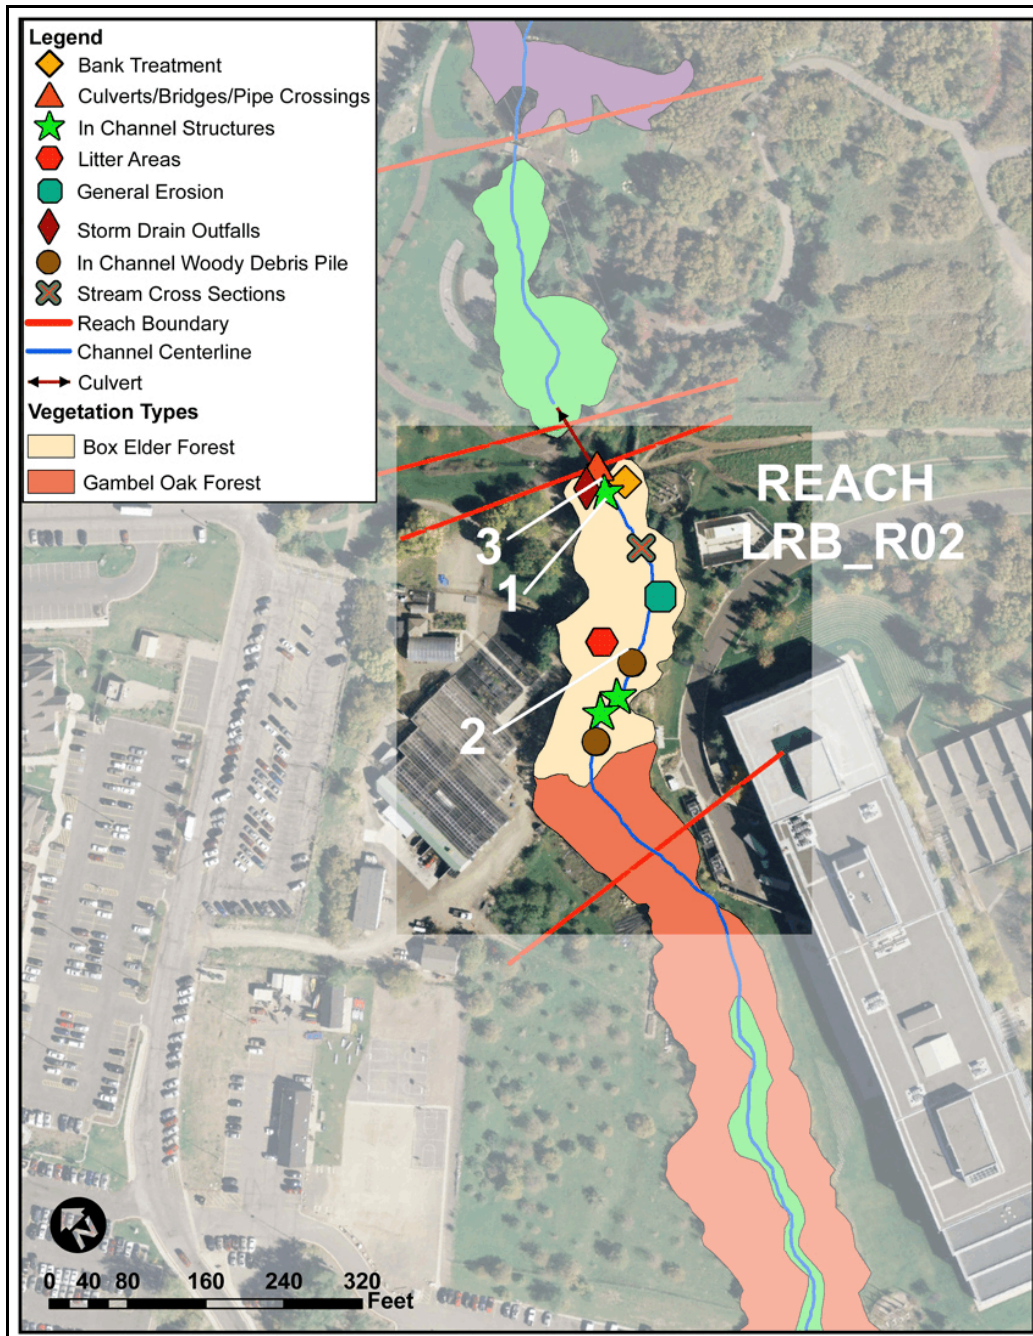
REACH LRB_R02: UNIVERSITY - BELOW RED BUTTE GARDEN

On the southeast side in this reach, the channel is confined by a tall bank that in some areas appears to have been affected by fill placement. The riparian area is impacted by heavy foot traffic that has compacted the soil and reduced understory vegetation cover. Rock and concrete pieces have been placed in several bank and in-channel areas; otherwise, bed material is dominantly sand and small gravel. Vegetation diversity is generally poor in this reach.

- Issues affecting riparian function:**
- heavy foot traffic/soil compaction
 - lack of shrub cover
 - lack of understory cover
 - low bank/root zone erosion
 - trash (minor)

RECOMMENDATIONS	
IMPROVEMENT MEASURE ^a	LOCATION
Access control	reach-scale
Revegetation - understory layer	within vegetation type(s)
Biotechnical slope stabilization	reach-scale
Revegetation - shrub layer	within vegetation type(s)
Bank stabilization	reach-scale
Mechanized trash removal (concrete pieces)	point 1 on map
Stream cleanup	point 2 on map
Invasive plant removal/control	within vegetation type(s)
Culvert replacement with bridge	point 3 on map

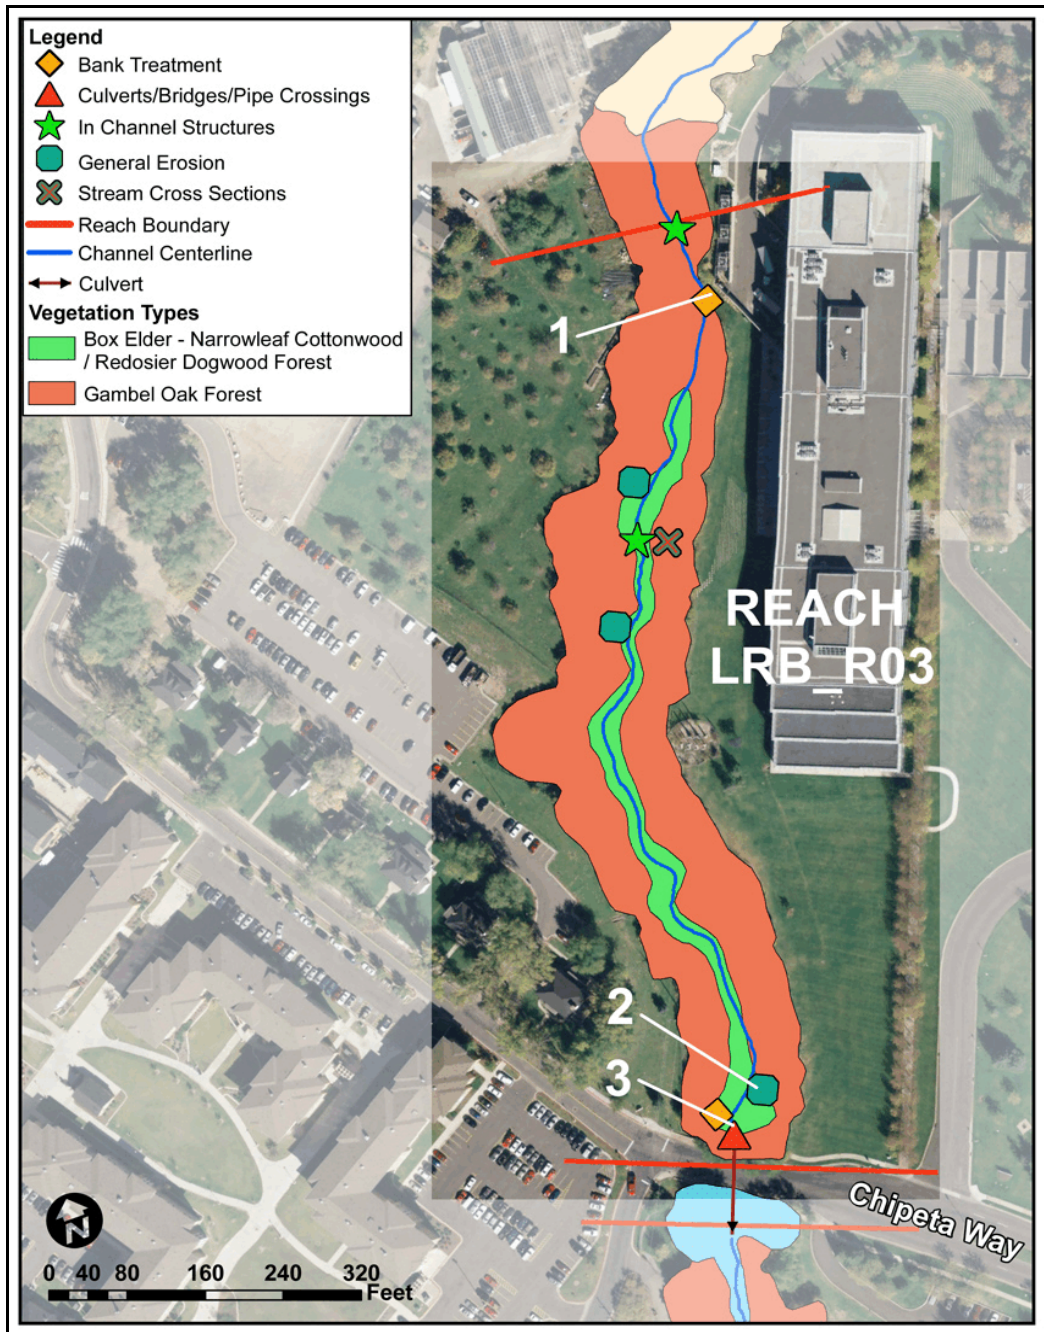
REACH LRB_R03: UNIVERSITY - ABOVE CHIPETA WAY

Although this reach is generally steep, rock grade control structures have created small sections with flat, slow-moving water and wetland vegetation. Tree cover is poor on the east bank at the upstream end of the reach where a building/access road extends to within 16 feet of the channel centerline. The channel is confined by tall, steep banks through much of the reach. Poorly designed gravel and concrete brick wall bank protection features are contributing to erosion on adjacent/opposite banks.

- Issues affecting riparian function:**
- invasive species (Russian olive, lesser burdock)
 - terrace erosion
 - low bank/root zone erosion
 - deposition/clogging at culvert inlet
 - failing bank revetment
 - limited tree cover

RECOMMENDATIONS	
IMPROVEMENT MEASURE ^a	LOCATION
Invasive plant removal	within vegetation type(s)
Removal/improvements to gravel bank protection	point 1 on map
Revegetation - canopy layer	point 1 on map
Removal/improvements to concrete brick wall	point 2 on map
Avoid placing yard waste on banks/leave "no-mow" buffer at edge of turf	reach-scale
Bank stabilization	reach-scale
Grade control	reach-scale
Culvert replacement/improvement	point 3 on map

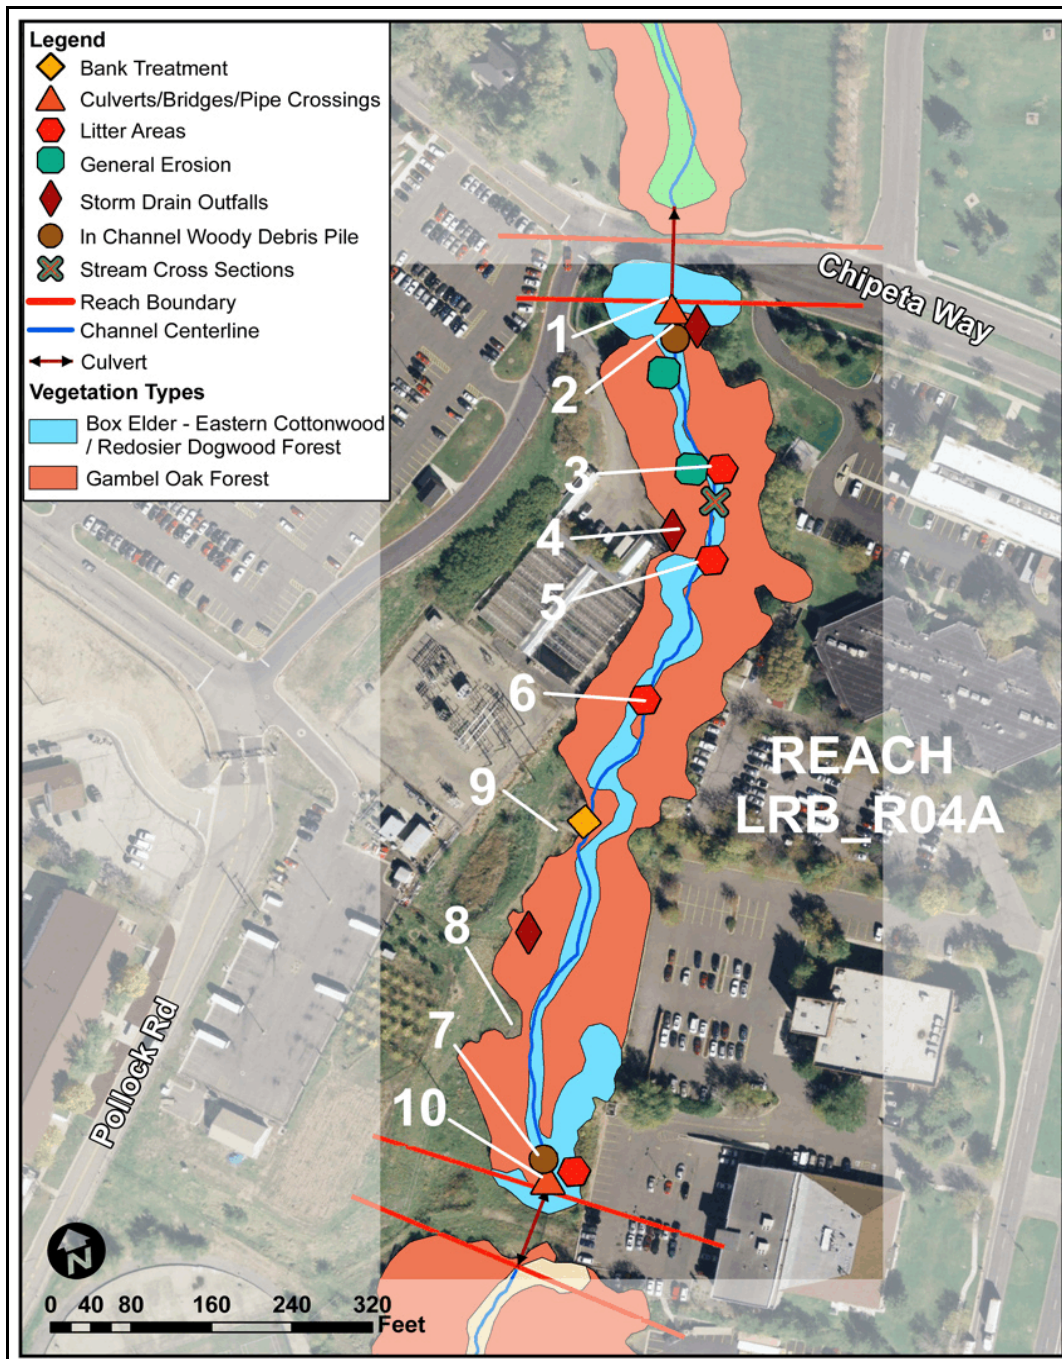
REACH LRB_R04A: UNIVERSITY - BELOW CHIPETA WAY

Banks are generally steep and tall in this reach, which flows between University parking lots and maintenance facilities. Significant amounts of trash were noted in the reach. Vegetative structure is relatively good; however, total forested width is limited in some areas. Poison ivy dominates the understory cover. Heavy root scour and significant bank erosion are prevalent within the reach.

- terrace erosion
- storm drain outfall erosion
- low bank/root zone erosion
- trash
- invasive species (Siberian elm)
- narrow forested corridor
- bed incision

RECOMMENDATIONS	
IMPROVEMENT MEASURE ^a	LOCATION
Stream cleanup	points 2, 3, 5, 6, and 7 on map
Mechanized trash removal	points 3 and 6 on map
Storm drain improvement	point 4 on map
Culvert replacement/improvement/removal	points 1 and 10 on map
Revegetation to increase total forested width	points 8 and 9 on map
Invasive plant removal	within vegetation type(s)
Bank stabilization	reach-scale
Grade control	reach-scale

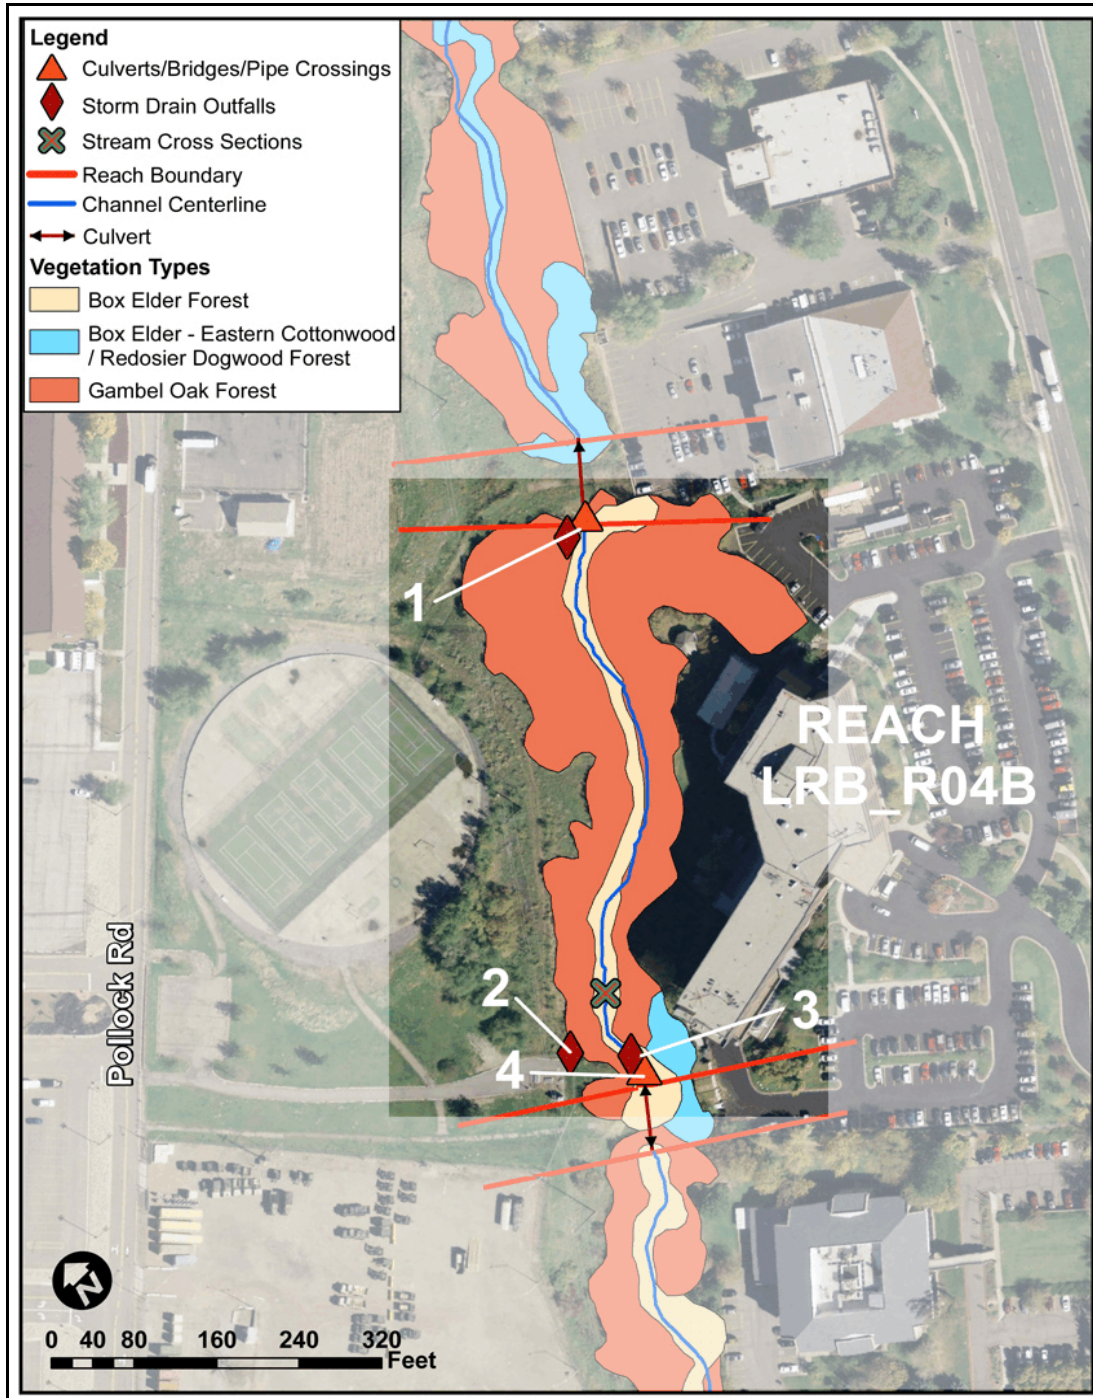
REACH LRB_R04B: UNIVERSITY - NEAR TENNIS COURTS

This reach is located between tennis courts on the west and a hotel building on the east. As with the upstream reaches, banks are generally tall and steep and terrace erosion is prevalent. Several storm drain outfalls are causing erosion within the reach. Understory cover and species diversity are somewhat limited, with poison ivy dominant.

- terrace erosion
- storm drain outfall erosion
- limited understory cover
- deposition/clogging at culvert inlet

RECOMMENDATIONS	
IMPROVEMENT MEASURE ^a	LOCATION
Storm drain improvement	points 2 and 3 on map
Culvert removal	points 1 and 4 on map
Revegetation - understory layer	within vegetation type(s)
Biotechnical slope stabilization	reach-scale
Bank stabilization	reach-scale
Grade control	reach-scale

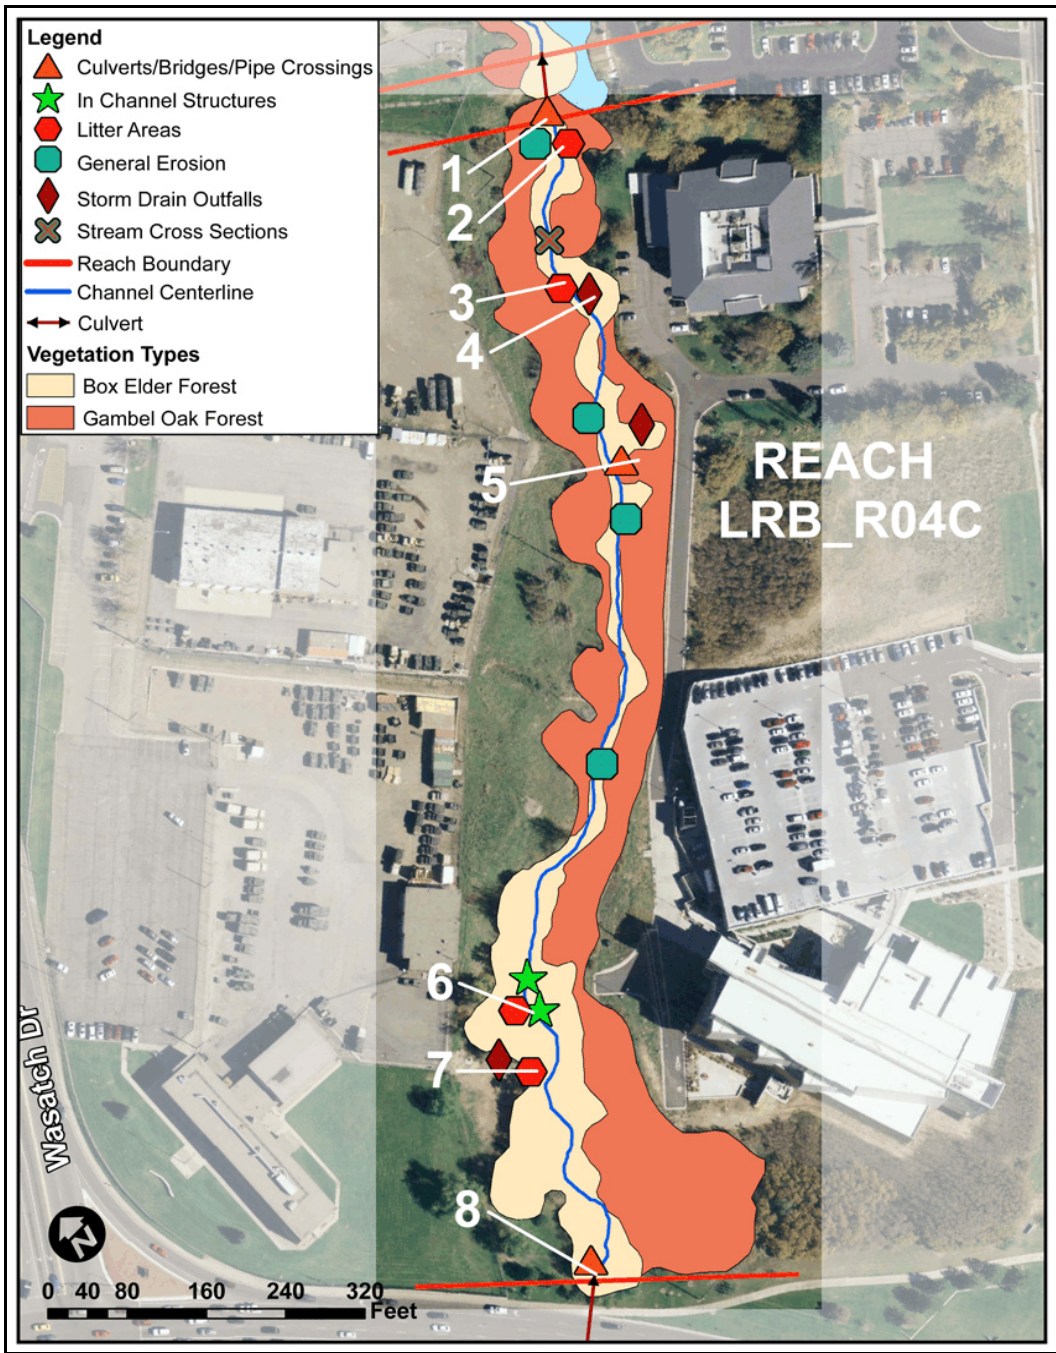
REACH LRB_R04C: UNIVERSITY - ABOVE FOOTHILL DRIVE

This reach flows between U.S. Army facilities on the west and University of Utah research park buildings on the east. Several litter areas including broken pieces of concrete, pipe, chain link fence, and silt fence are present. Bank erosion is evident primarily in the upper and lower portions of the reach. This reach contains several storm drain outfalls and a wooden grade control structure. Forested width and canopy cover are limited in some areas.

- trash
- storm drain outfall erosion
- terrace erosion
- invasive species (whiteweed, quackgrass)
- low bank/root zone erosion
- narrow forested corridor
- understory dominated by nonnative species
- bed incision
- limited shrub

RECOMMENDATIONS	
IMPROVEMENT MEASURE ^a	LOCATION
Restoration of native understory plants	within vegetation type(s)
Invasive plant removal	within vegetation type(s)
Mechanized trash removal	points 3 and 6 on map
Stream cleanup	points 2, 3, and 7 on map
Revegetation - canopy layer	within vegetation type(s)
Storm drain improvement	points 4 and 5 on map
Culvert removal	point 1 on map
Biotechnical slope stabilization	point 8 on map
Bank stabilization	reach-scale
Grade control	reach-scale

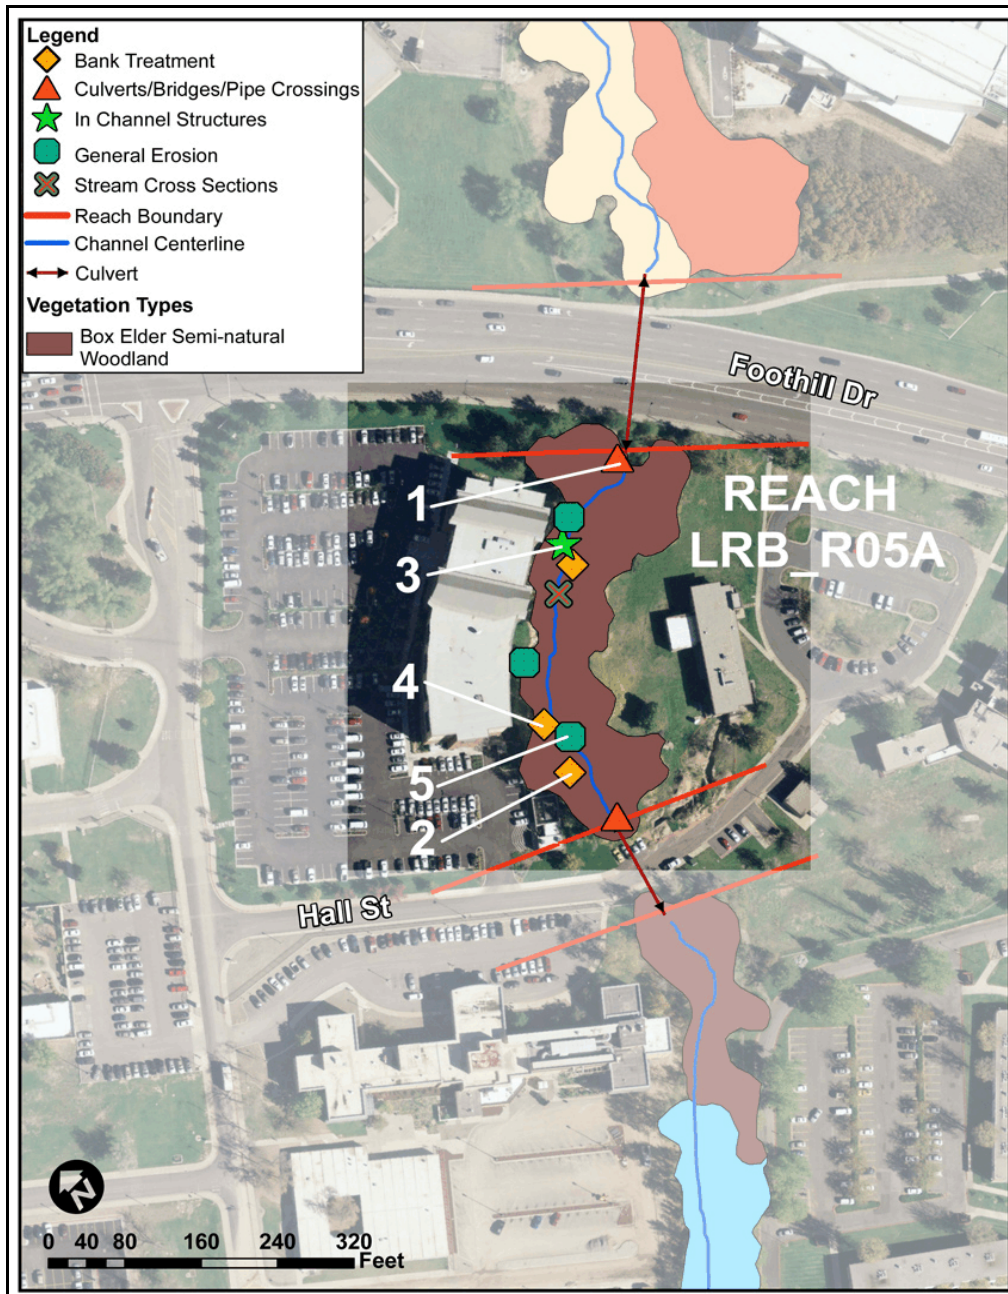
REACH LRB_R05A: VA MEDICAL CENTER - BELOW FOOTHILL DRIVE

This is a steep, short reach that is heavily impacted by development. Bank areas contain significant amounts of asphalt and concrete pieces that have failed to stabilize the banks and currently degrade aesthetics and limit vegetation establishment. The reach contains a concrete wall/weir/outfall structure that contributes to erosion and appears to be obsolete. Bed incision, root scour, and bank erosion are also ubiquitous through the reach. Shrub cover is lacking.

- Issues affecting riparian function:**
- scour/erosion at culvert outlet
 - storm drain outfall erosion
 - poor revegetation/stabilization practices
 - bed incision
 - failing in-channel infrastructure
 - failing bank revetment
 - low bank/root zone erosion
 - terrace erosion
 - trash
 - invasive species (Siberian elm)
 - lack of shrub cover

RECOMMENDATIONS	
IMPROVEMENT MEASURE ^a	LOCATION
Invasive plant removal	within vegetation type(s)
Revegetation - shrub layer	within vegetation type(s)
Culvert replacement/outlet protection	point 1 on map
Stream cleanup	point 5 on map; reach-scale
Mechanized trash removal	points 2 and 4 on map; reach-scale
Replace/improve obsolete concrete structure	point 3 on map
Bank stabilization	reach-scale
Grade control	reach-scale

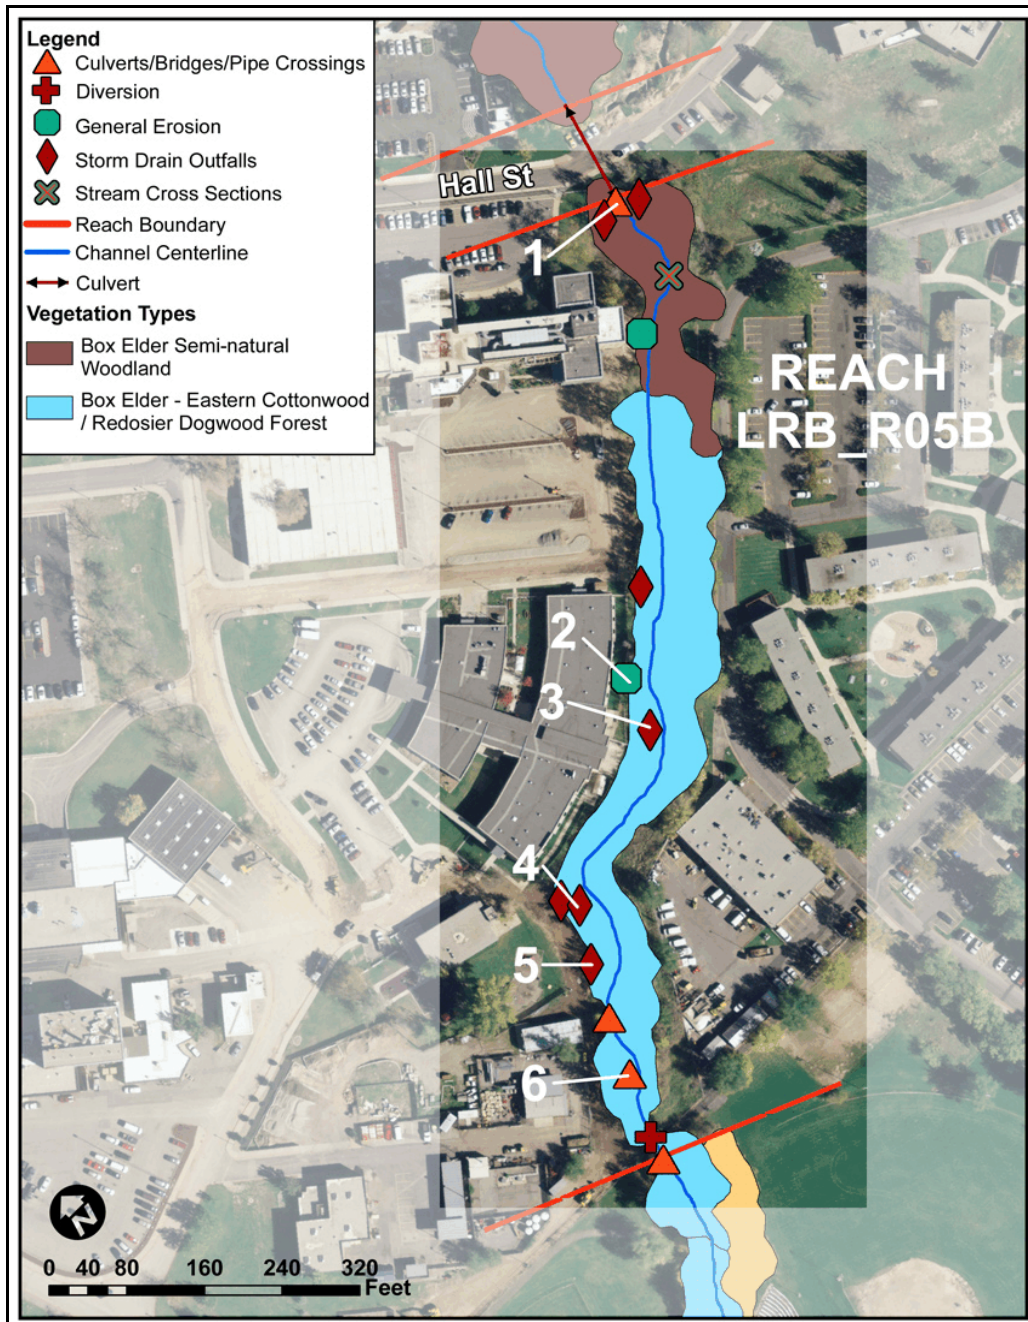
REACH LRB_R05B: VA MEDICAL CENTER - ABOVE SUNNYSIDE PARK

This reach flows between Veteran’s Administration and University of Utah facilities, ending at a diversion structure and bridge at the upstream end of Sunnyside Park. The reach contains seven storm drain outfalls, a utility pipe crossing, and a nearly clogged culvert at a trail crossing that does not appear to receive much use. Portions of the reach are in good condition.

- Issues affecting riparian function:**
- deposition/clogging at culvert
 - bed incision
 - terrace erosion
 - storm drain outfall erosion
 - limited shrub cover
 - limited understory cover
 - invasive species (Siberian elm, Russian olive)
 - low bank/root zone erosion

RECOMMENDATIONS	
IMPROVEMENT MEASURE ^a	LOCATION
Culvert replacement/outlet protection	point 1 on map
Culvert removal	point 6 on map
Storm drain improvement	points 3, 4, and 5 on map
Revegetation - shrub layer	within vegetation type(s)
Revegetation - understory layer	within vegetation type(s)
Invasive plant removal	within vegetation type(s)
Bank stabilization	reach-scale
Grade control	reach-scale
Biotechnical slope stabilization	point 2 on map

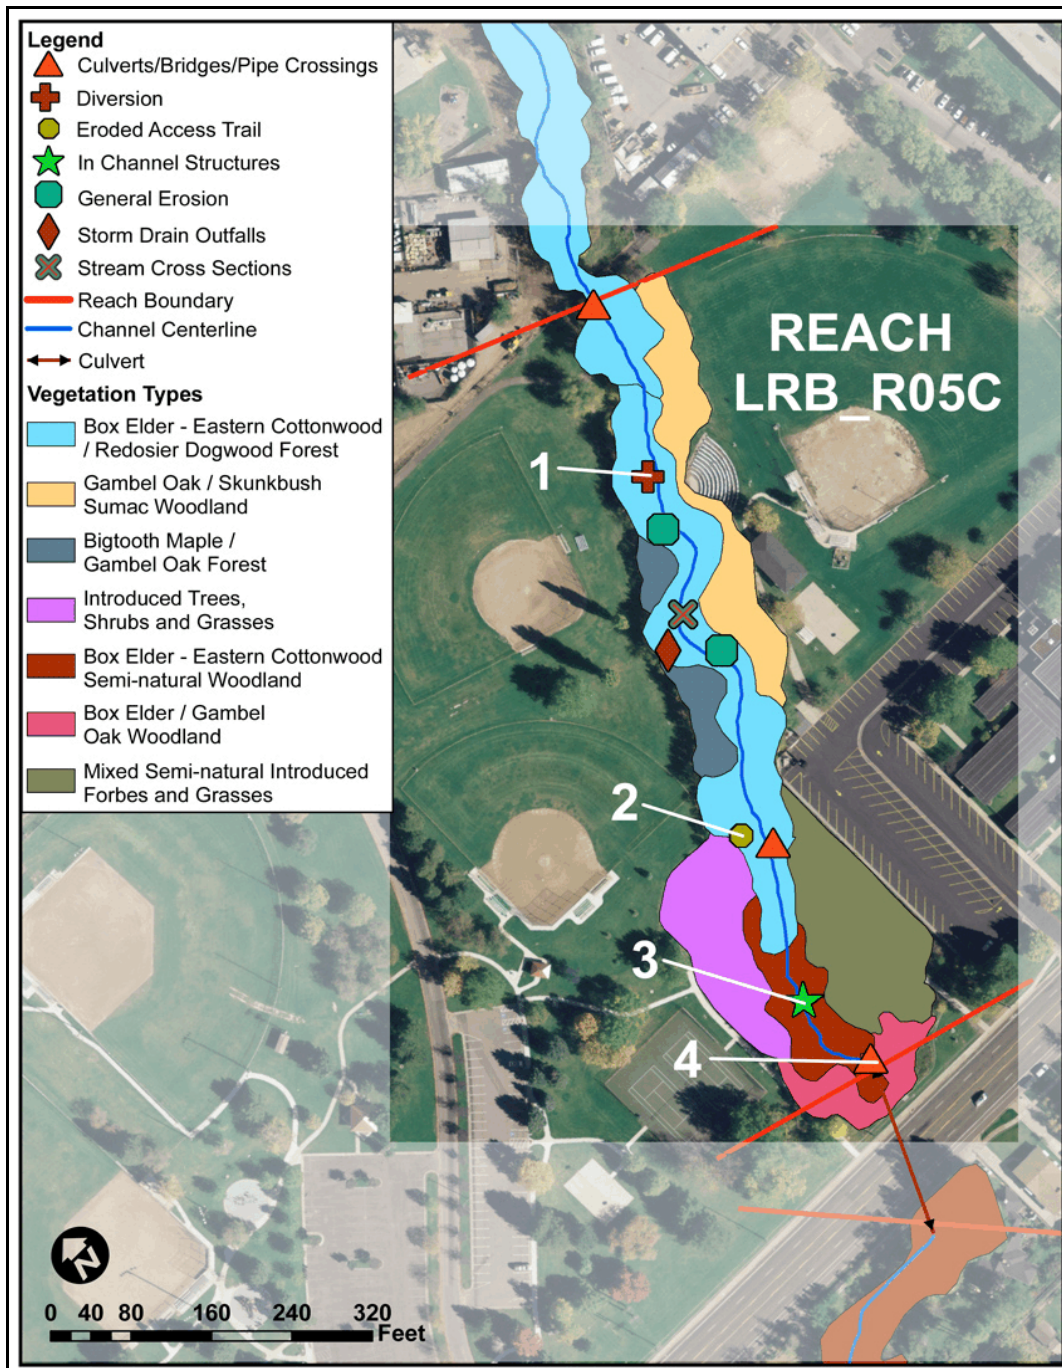
REACH LRB_R05C: SUNNYSIDE PARK

This reach contains a number of in-channel structures including a concrete diversion/weir structure and broken trash grate. The reach also contains several pedestrian access trails. Root zone scour and bank erosion are evident, particularly in the lower portions of the reach. Banks become less steep in the lower portion of the reach. Minimal understory vegetation cover is present.

- Issues affecting riparian function:**
- scour/erosion below concrete diversion weir
 - low bank/root zone erosion
 - eroded access trail
 - bed incision
 - invasive species (Russian olive, Siberian elm, houndstongue, whitetop)
 - lack of understory cover
 - failing in-channel infrastructure

RECOMMENDATIONS	
IMPROVEMENT MEASURE ^a	LOCATION
Scour protection at diversion weir	point 1 on map
Revegetation - understory layer	within vegetation type(s)
Access trail stabilization	point 2 on map
Invasive plant removal	within vegetation type(s)
Remove/repair trash grate	point 3 on map
Bank stabilization	reach-scale
Grade control	reach-scale
Establish "no-mow" buffer at edge of turf	reach-scale
Culvert replacement	point 4 on map

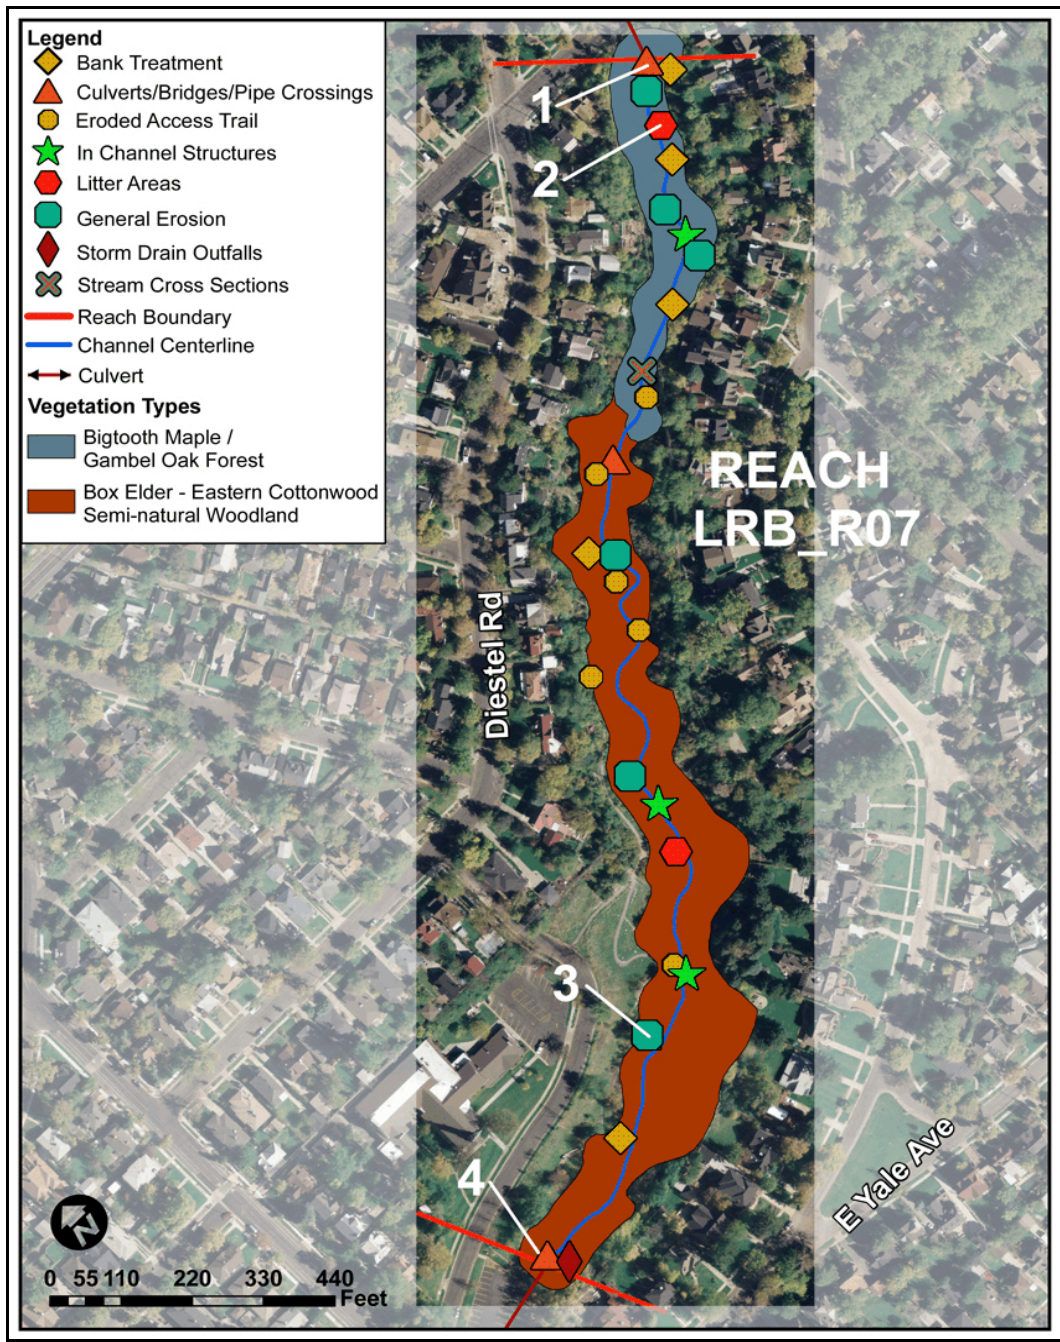
REACH LRB_R07: MILLER PARK/BONNEVILLE GLEN

This reach encompasses Miller Park and Bonneville Glen, a church-owned park area. Bank erosion and bed incision are issues within the reach. Various rock and concrete bank/ bed hardening structures are present in the reach, but in some areas the structures are failing or causing erosion on opposite/ adjacent banks. Established and user-created trails are prevalent throughout the reach, limiting shrub and understory cover and contributing to erosion. Invasive periwinkle and English ivy comprise much of the understory vegetation.

- Issues affecting riparian function:**
- bed incision
 - failing in-channel infrastructure
 - failing bank revetment
 - invasive species (English ivy, periwinkle, Scotch thistle, cheatgrass, Siberian elm, tree of heaven)
 - low bank/root zone erosion
 - scour/erosion at culvert outlet
 - eroded access trails
 - heavy foot traffic/soil compaction from dogs and people
 - understory dominated by nonnative species
 - lack of shrub cover

RECOMMENDATIONS	
IMPROVEMENT MEASURE ^a	LOCATION
Invasive plant removal	within vegetation type(s)
Restoration of native understory plants	within vegetation type(s)
Revegetation - shrub layer	within vegetation type(s)
Access control	reach-scale
Access trail stabilization	reach-scale
Bank stabilization	reach-scale
Grade control	reach-scale
Culvert replacement/outlet protection	points 1 and 4 on map
Mechanized trash removal	point 2 on map
Remove partial rock wall	point 3 on map
