**.HISTORIC LANDMARK COMMISSION
STAFF REPORT**

Roof Alteration,
Ellerback House Minor Alteration &
PLNHLC2008-00528
210 North State Street
December 3, 2008

The request is for a change to the roofline and the installation of new gutters. In addition, the project includes the repair of brick and stucco and the replacement of the roofing membrane of the upper deck of the porch. Although the proposed project is a minor alteration, staff chose to bring the project to the Commission since it does not meet the ordinance and the applicant is concerned that to repair the structure following the ordinance will not insure the longevity of the building.

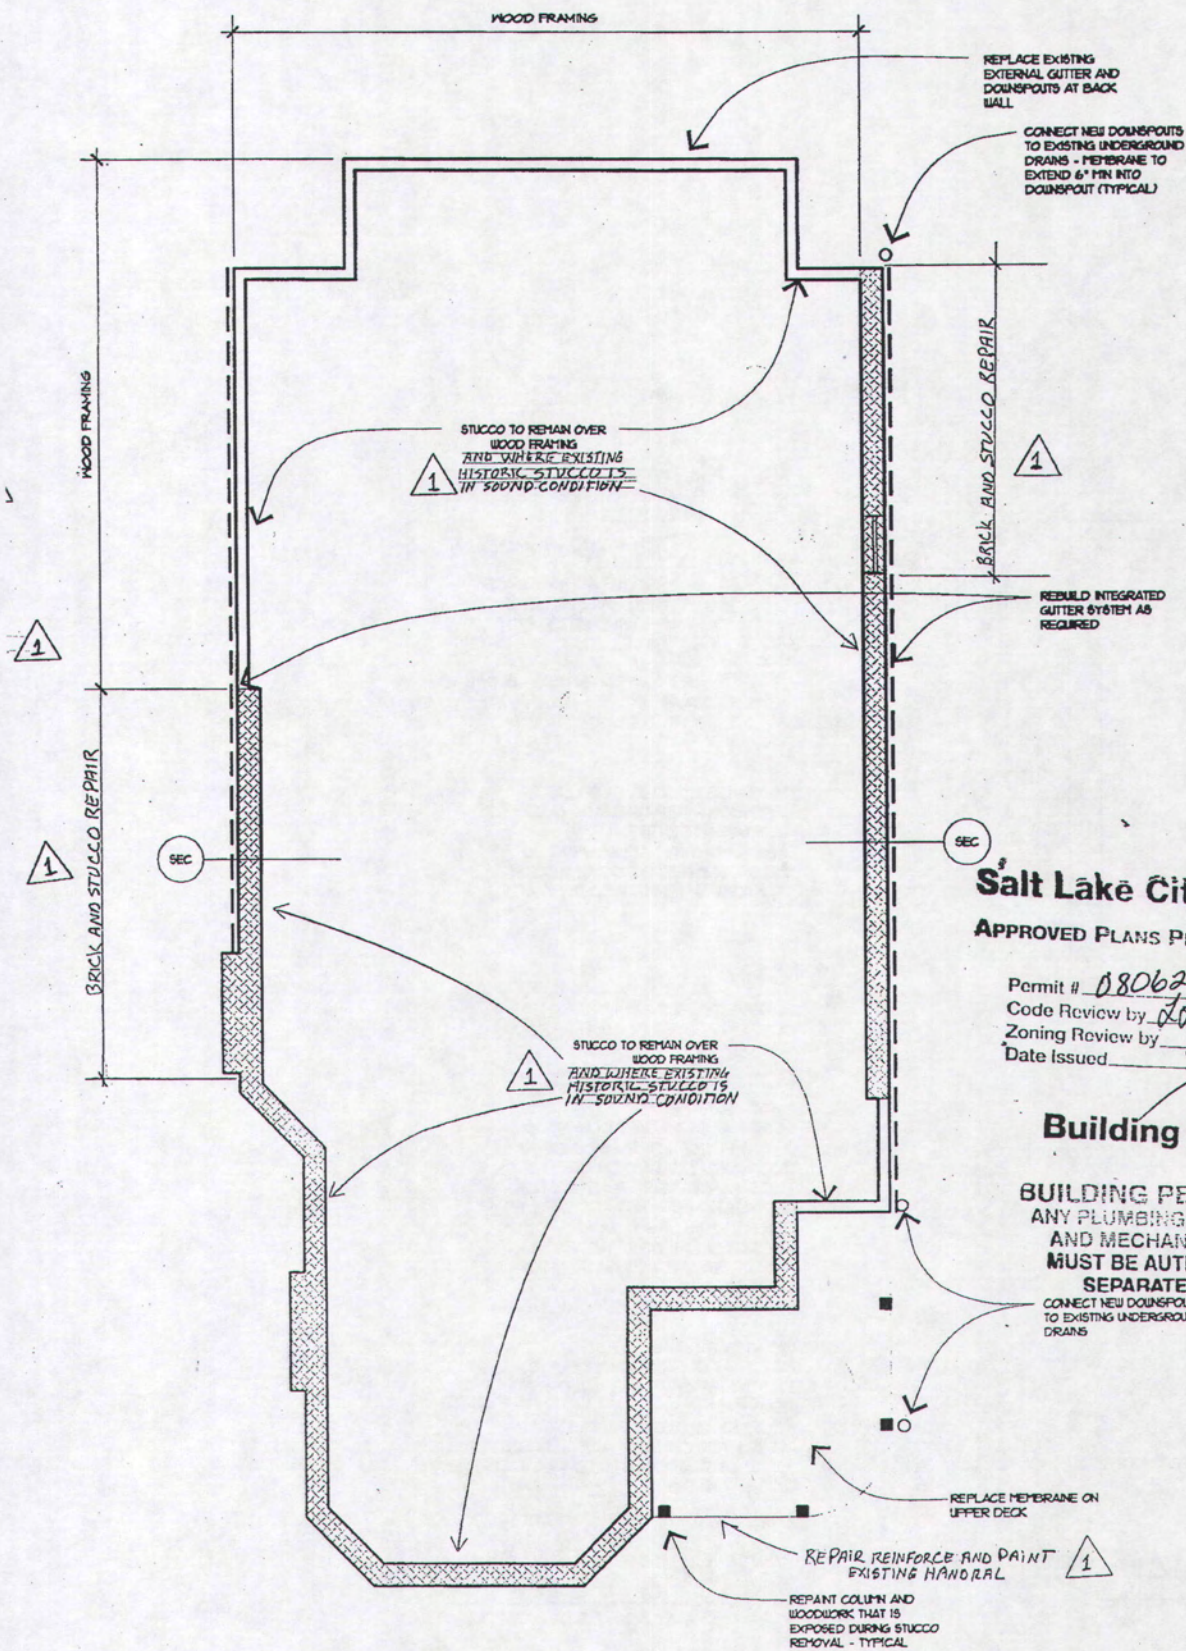
REPAINT COLUMN AND
 WOODWORK THAT IS
 EXPOSED DURING STUCCO
 REMOVAL - TYPICAL

3/16" = 1'-0"

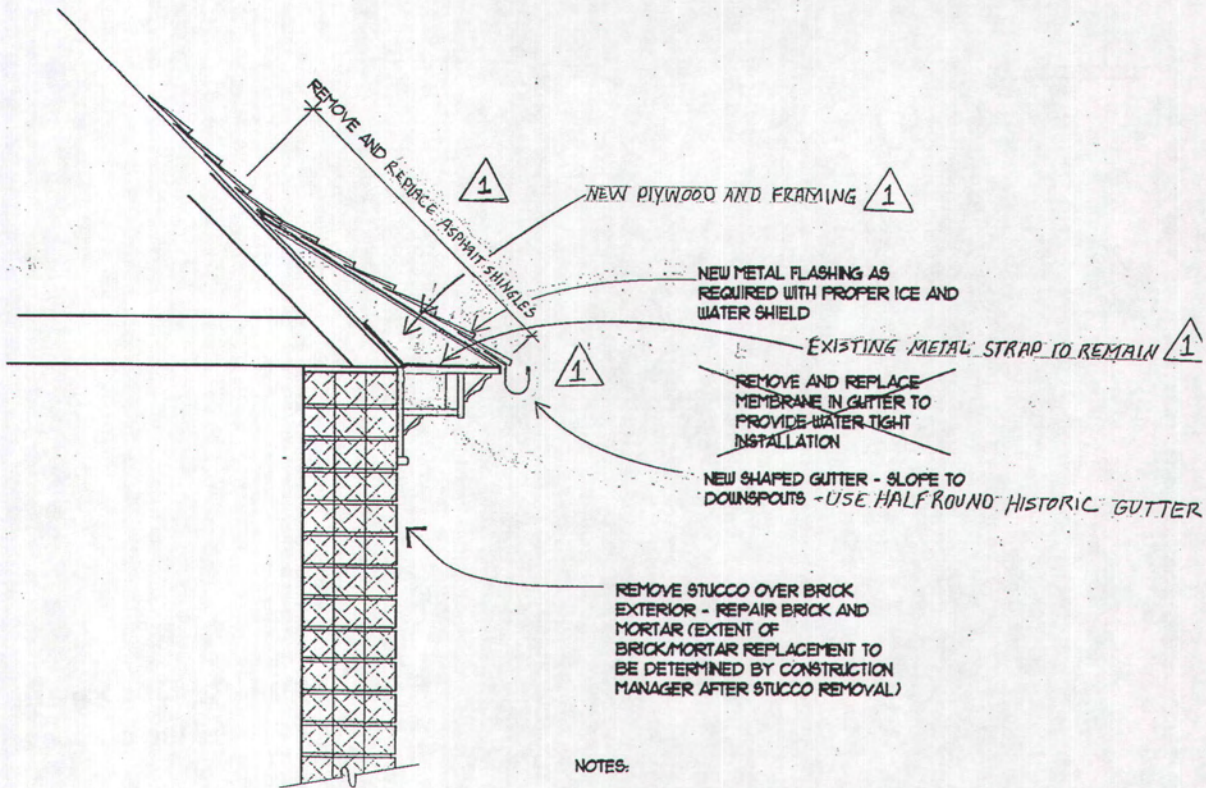
1. REMOVE TEMPORARY MEMBRANE COVERING LOWER PORTION OF ROOF AND GUTTER
2. REPLACE / REBUILD SOFIT AND FASCIA GUTTER SYSTEM AS NEEDED - MATCH EXISTING
3. VERIFY ROOF TO WALL CONNECTION. IF CONNECTION APPEARS TO BE DEGRADED CONTACT ENGINEER OF RECORD FOR FURTHER INSTRUCTION (CONNECTION WAS NOT ACCESSIBLE DURING INITIAL INSPECTION)
4. REPAINT ENTIRE SOFIT AND FACIA - APPLY SEALANT AS REQUIRED FOR TIGHT JOINTS.
5. USE TYPE "O" HIGH LIME CONTENT MORTAR.
6. USE HISTORIC SALVAGED BRICK TO MATCH AS CLOSE AS POSSIBLE TO EXISTING BRICK IN SIZE, COLOR AND TEXTURE.
7. PROVIDE ALL NEW DOWNSPOUTS
8. INSTALL NEW CAULKING & SEALANTS AT JOINTS OF DISSIMILAR MATERIALS & AT DOORS & WINDOWS.
9. INSTALL NEW PORTLAND CEMENT BASED STUCCO OVER REPAIRED BRICK TO MATCH EXISTING HISTORIC FINISH IN SAME LOCATION AS STUCCO BEING REMOVED

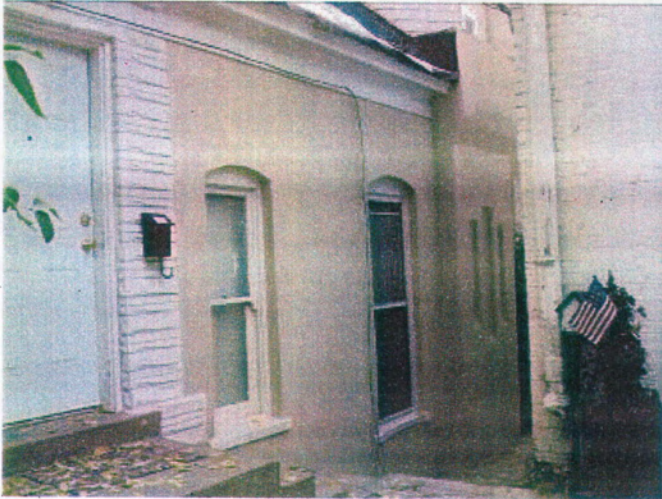
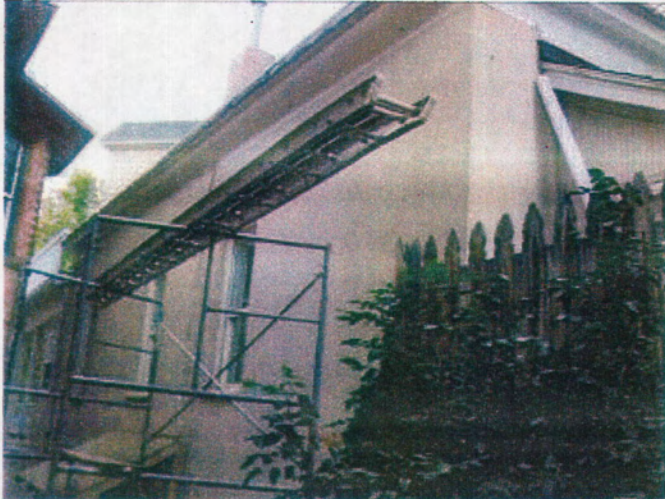
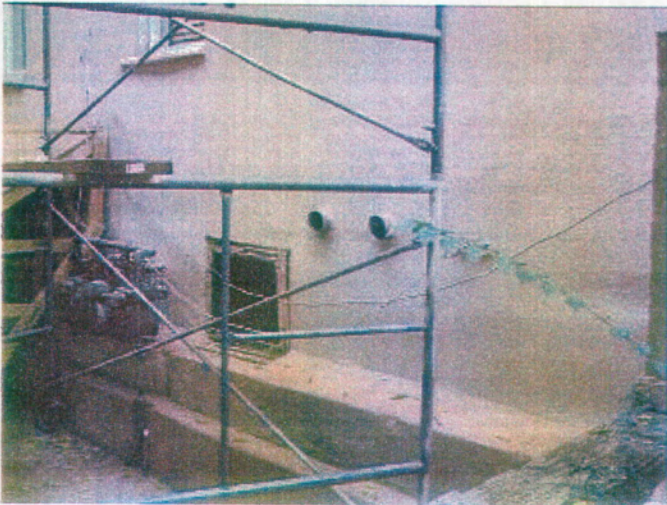
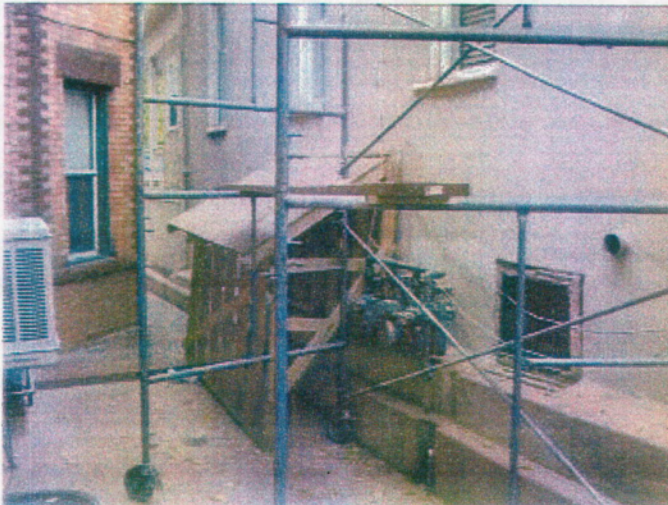
October 31 2008

210 N STATB- EVIDENCE OF DAMAGE- INTERNAL GUT

Leaking gutters that were never repaired or properly maintained have caused serious damage to the walls of the 210 North State Street and water runoff issues for the neighbors. The wall damage was first reported to code enforcement on April 2, 2008. The enforcement officer contacted the property owners who stated that they were aware of the damage and would get it repaired. They were informed at that time of the need of a permit. The property owners were contacted again on April 10, 2008 and provided a deficiency list outlining repairs required and the need for a structural engineer and certificate of appropriateness.
