HISTORIC LANDMARK COMMISSION  
STAFF REPORT

**Mensink House**

Legalization/Appeal PLNHLC2008-227931  
623 East First Avenue in the Avenues Historic District  
September 3, 2008

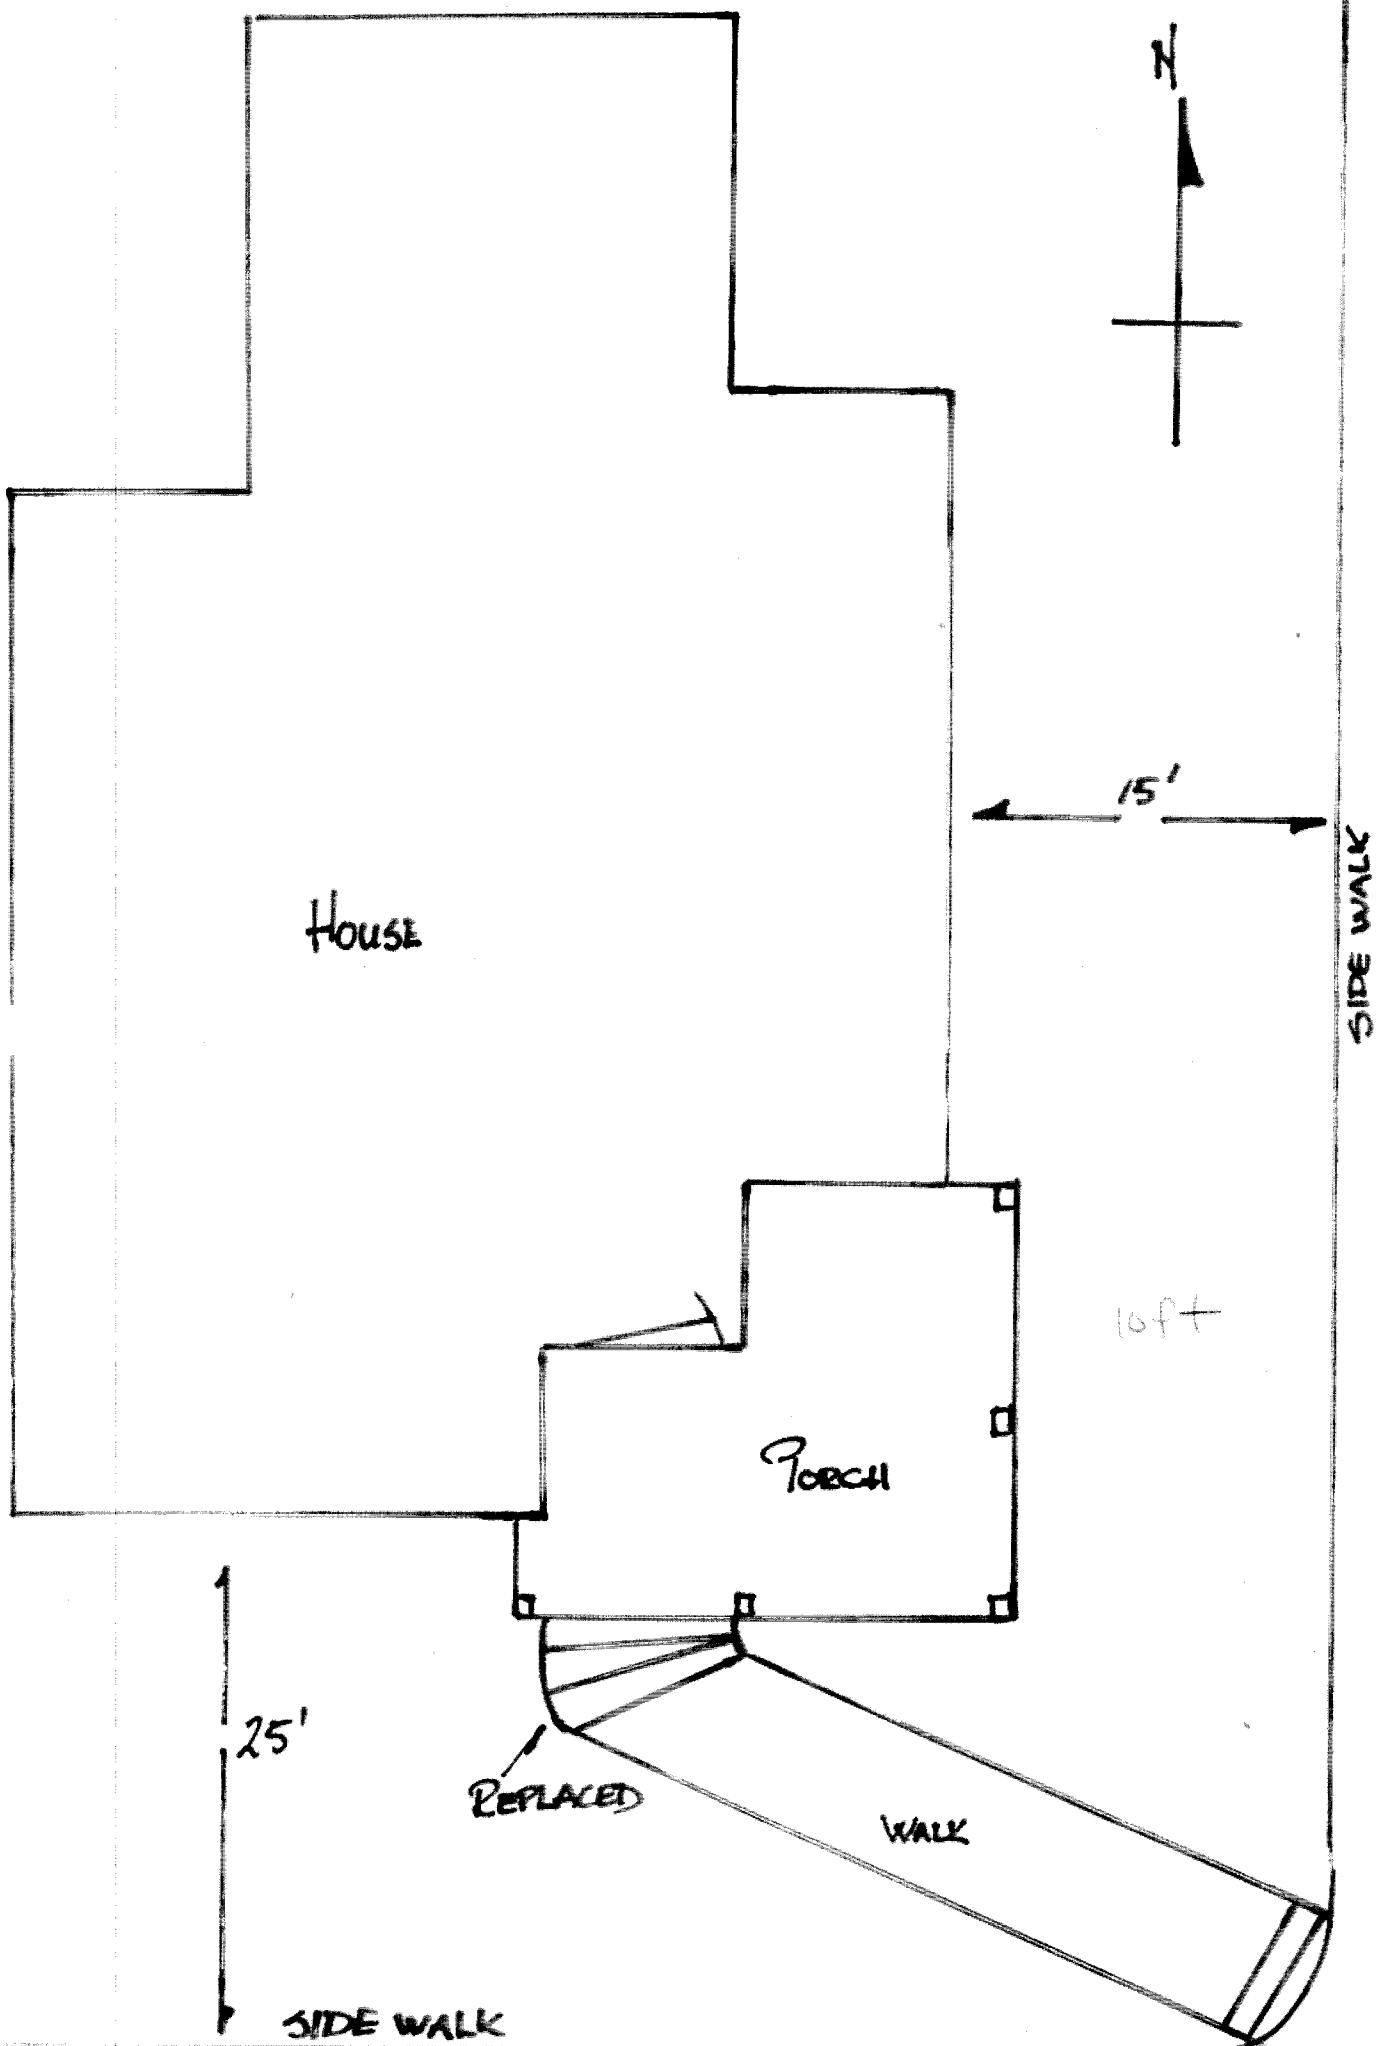
STAIR DETAIL  
AT CENTER  
OF  
STEPS

DECK

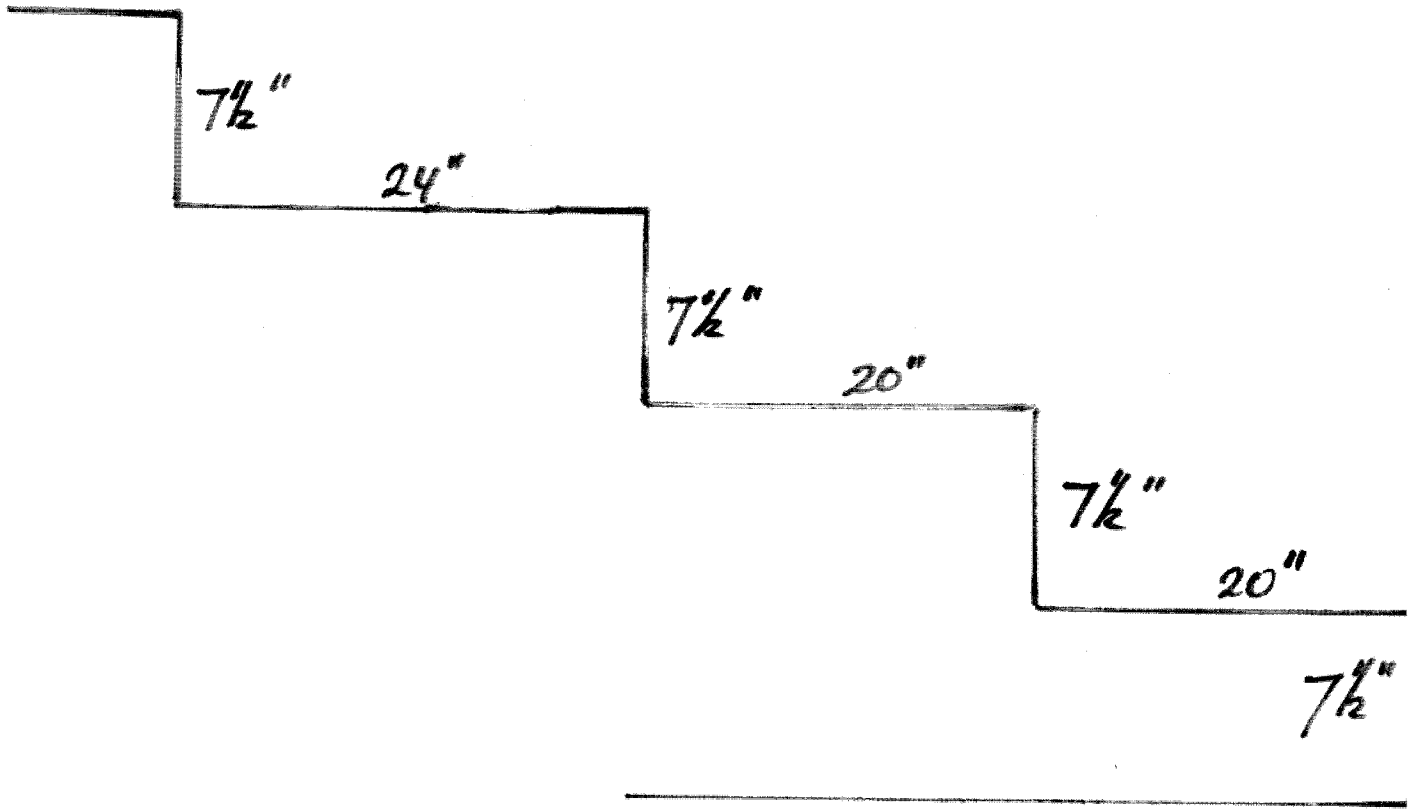
THE STEPS REMOVED WERE WAY TO STEEP AND VERY UNSAFE WE'VE HAD MULTIPLE PEOPLE FALL FROM THEM. THEY WERE LIKELY NOT TO CODE

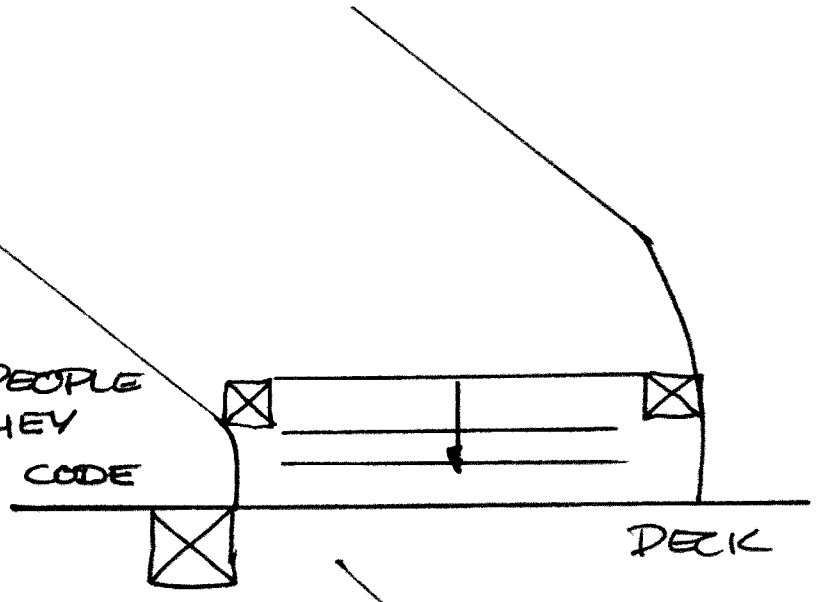
IF WE WOULD HAVE EXTENDED THE STEPS IN SAME FASHION, ON TOP OF CURRENT PATH, IT WOULD NOT HAVE MET UP WITH PATH

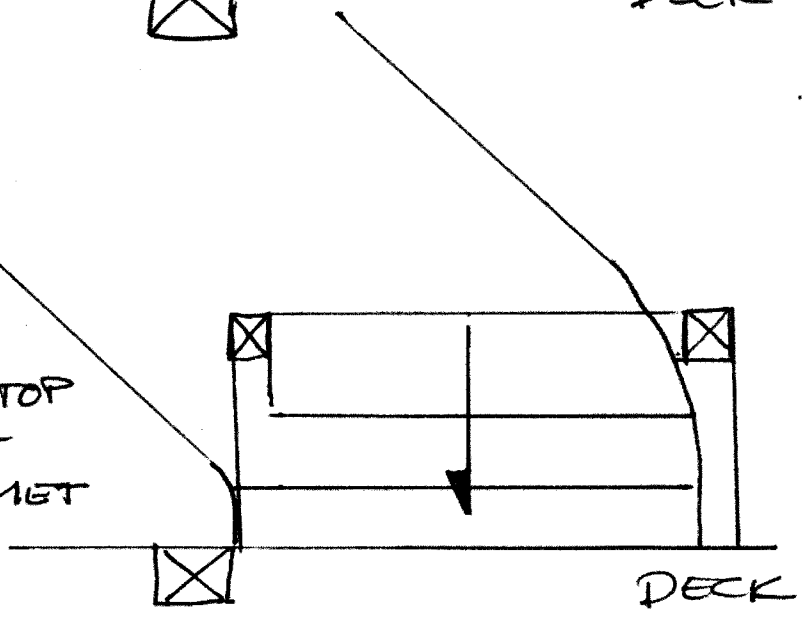
THE PATH TO FRONT DOOR HAS NOT BEEN ALTERED IN OVER 100 YRS. THE DECK IN CA 192 WAS CLOSER TO THE HOUSE THUS LEAVING ENOUGH ROOM FOR SAFE STEPS.

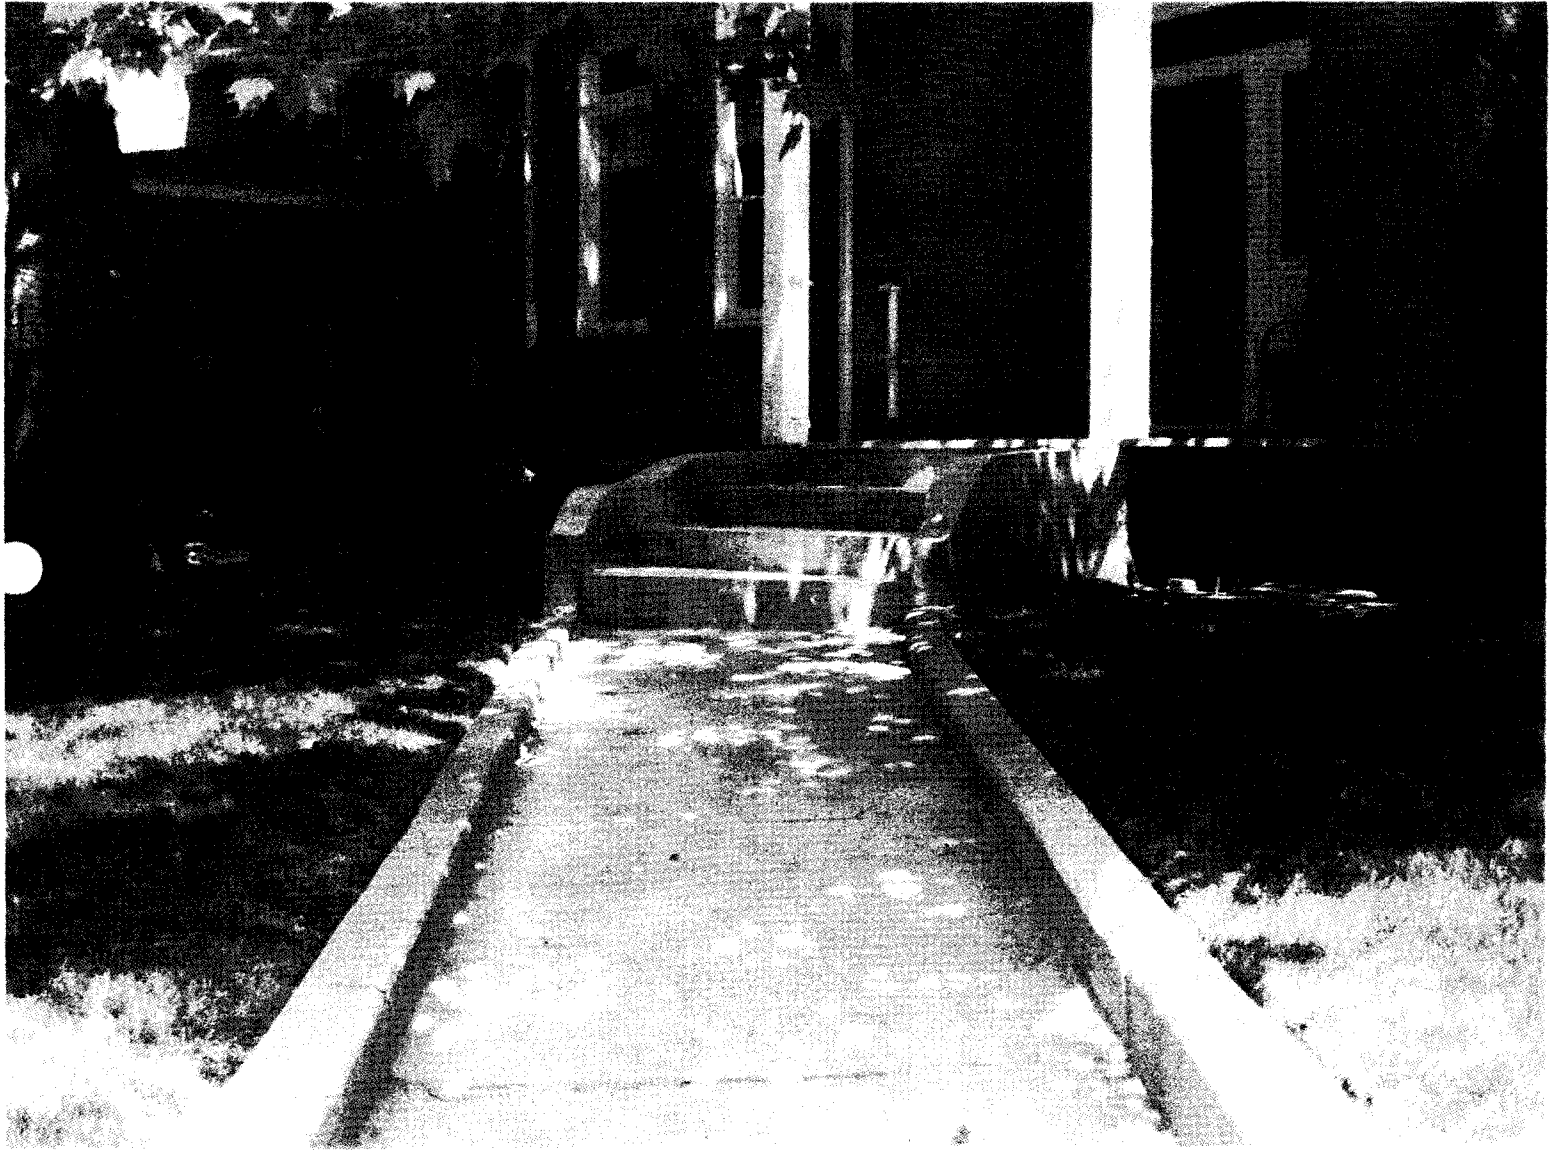
Will pave walkway and steps  
with red brick.

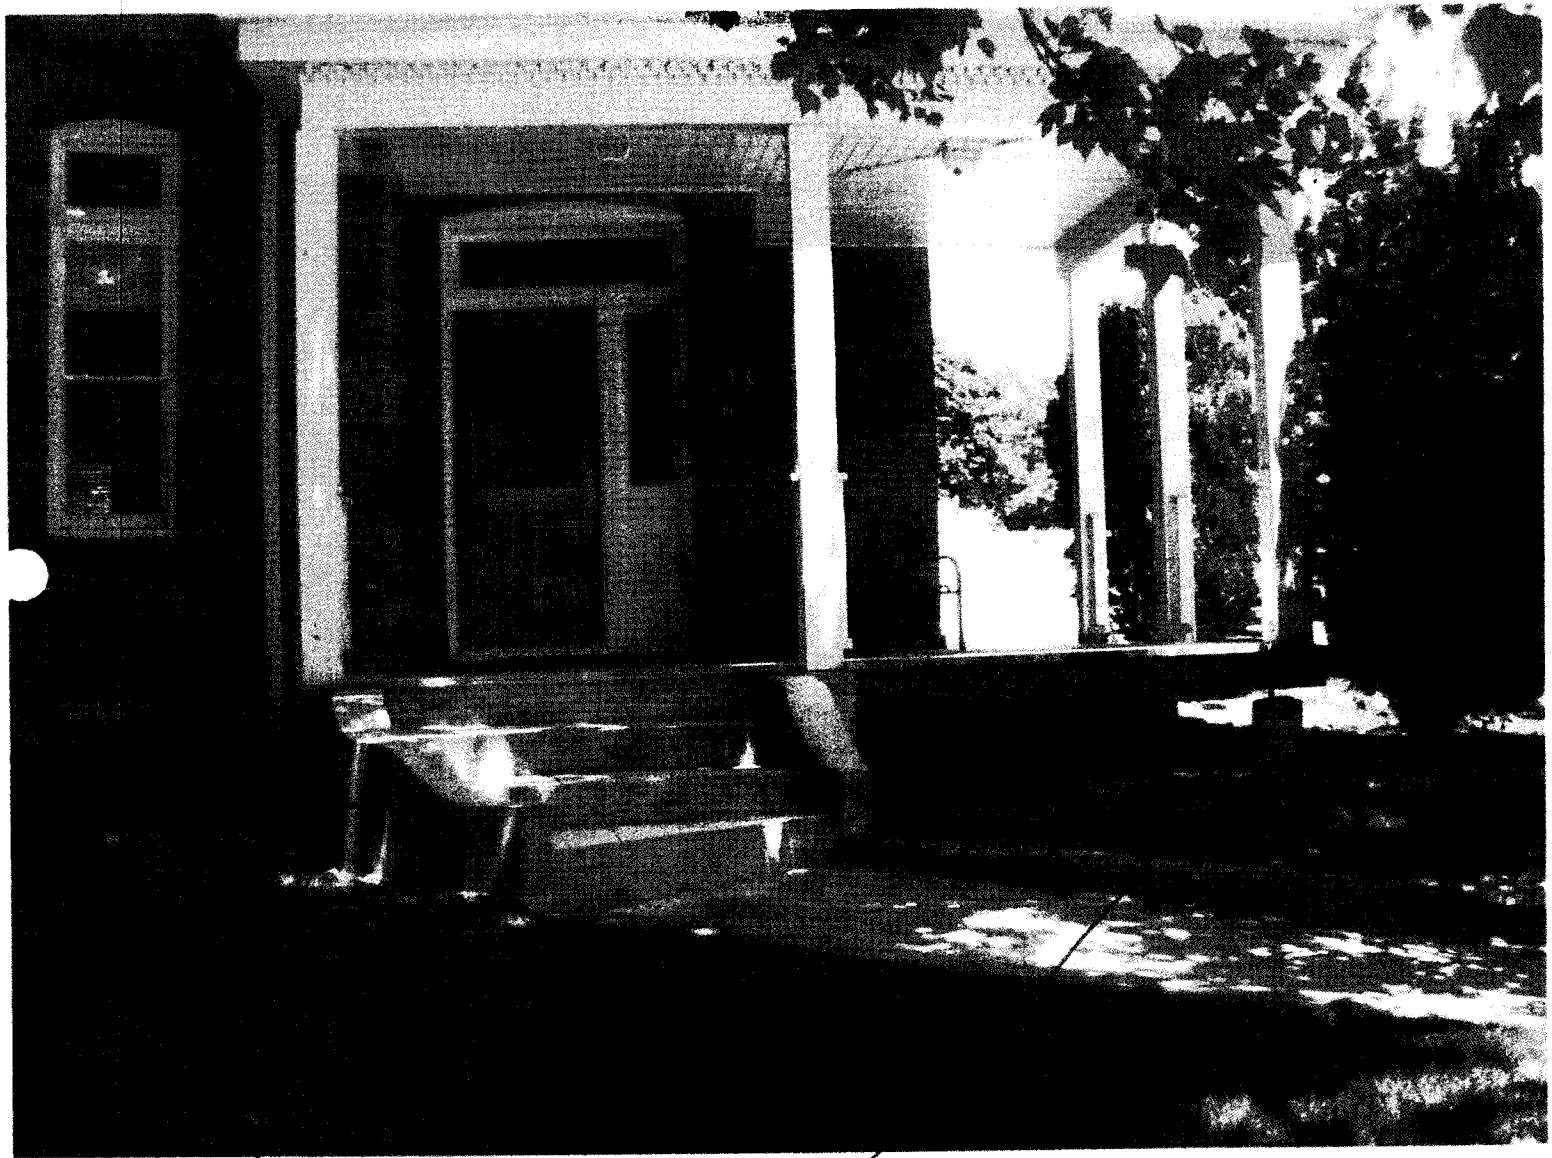
BOTTOM PART OF DECK WILL  
BE FINISHED WITH ZION SANDSTONE  
LEDGESTONE. THIS WILL GIVE IT A  
UNIFORM LOOK WITH CURRENT FOUNDATION.  
SIDE WALLS OF STEPS WILL BE FINISHED  
WITH THIS SAME STONE AS WELL.

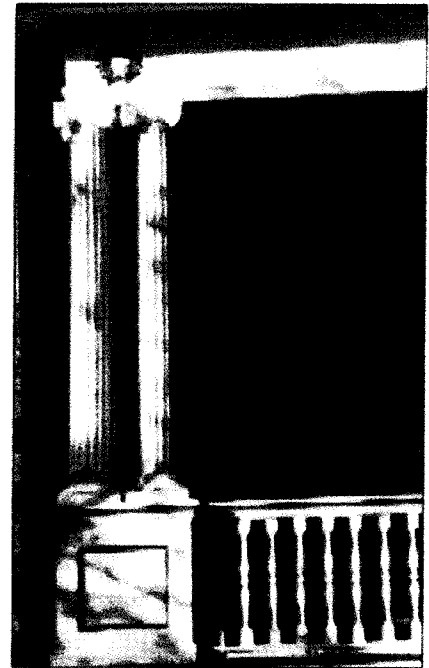
*Paired fluted columns support an architrave with dentil molding on this porch. These are distinct features that should be preserved.*

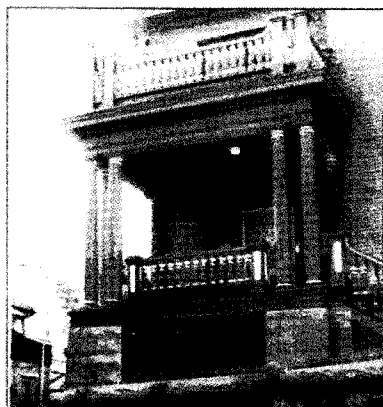
*This classical detail porch includes paired Doric columns.*

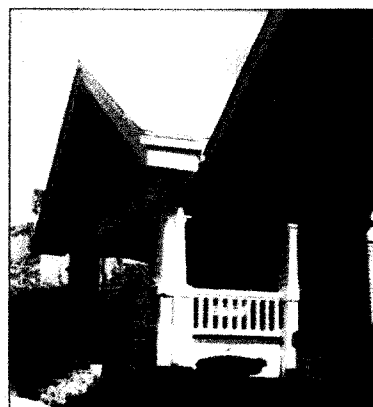
*Supports for bungalow porches often have a sloped or "battered" design, which is a key feature.*

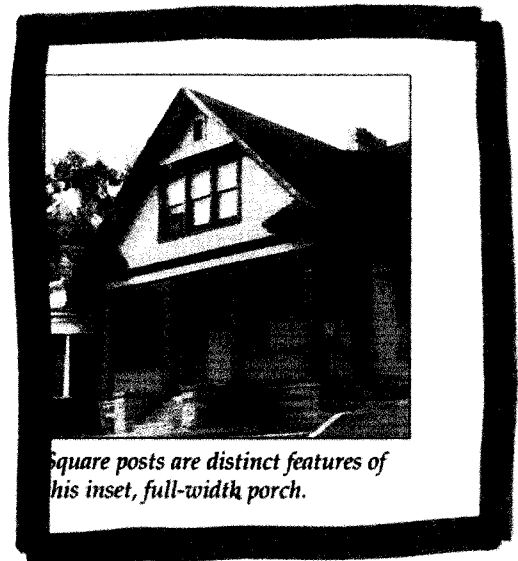
*Square posts are distinct features of this inset, full-width porch.*

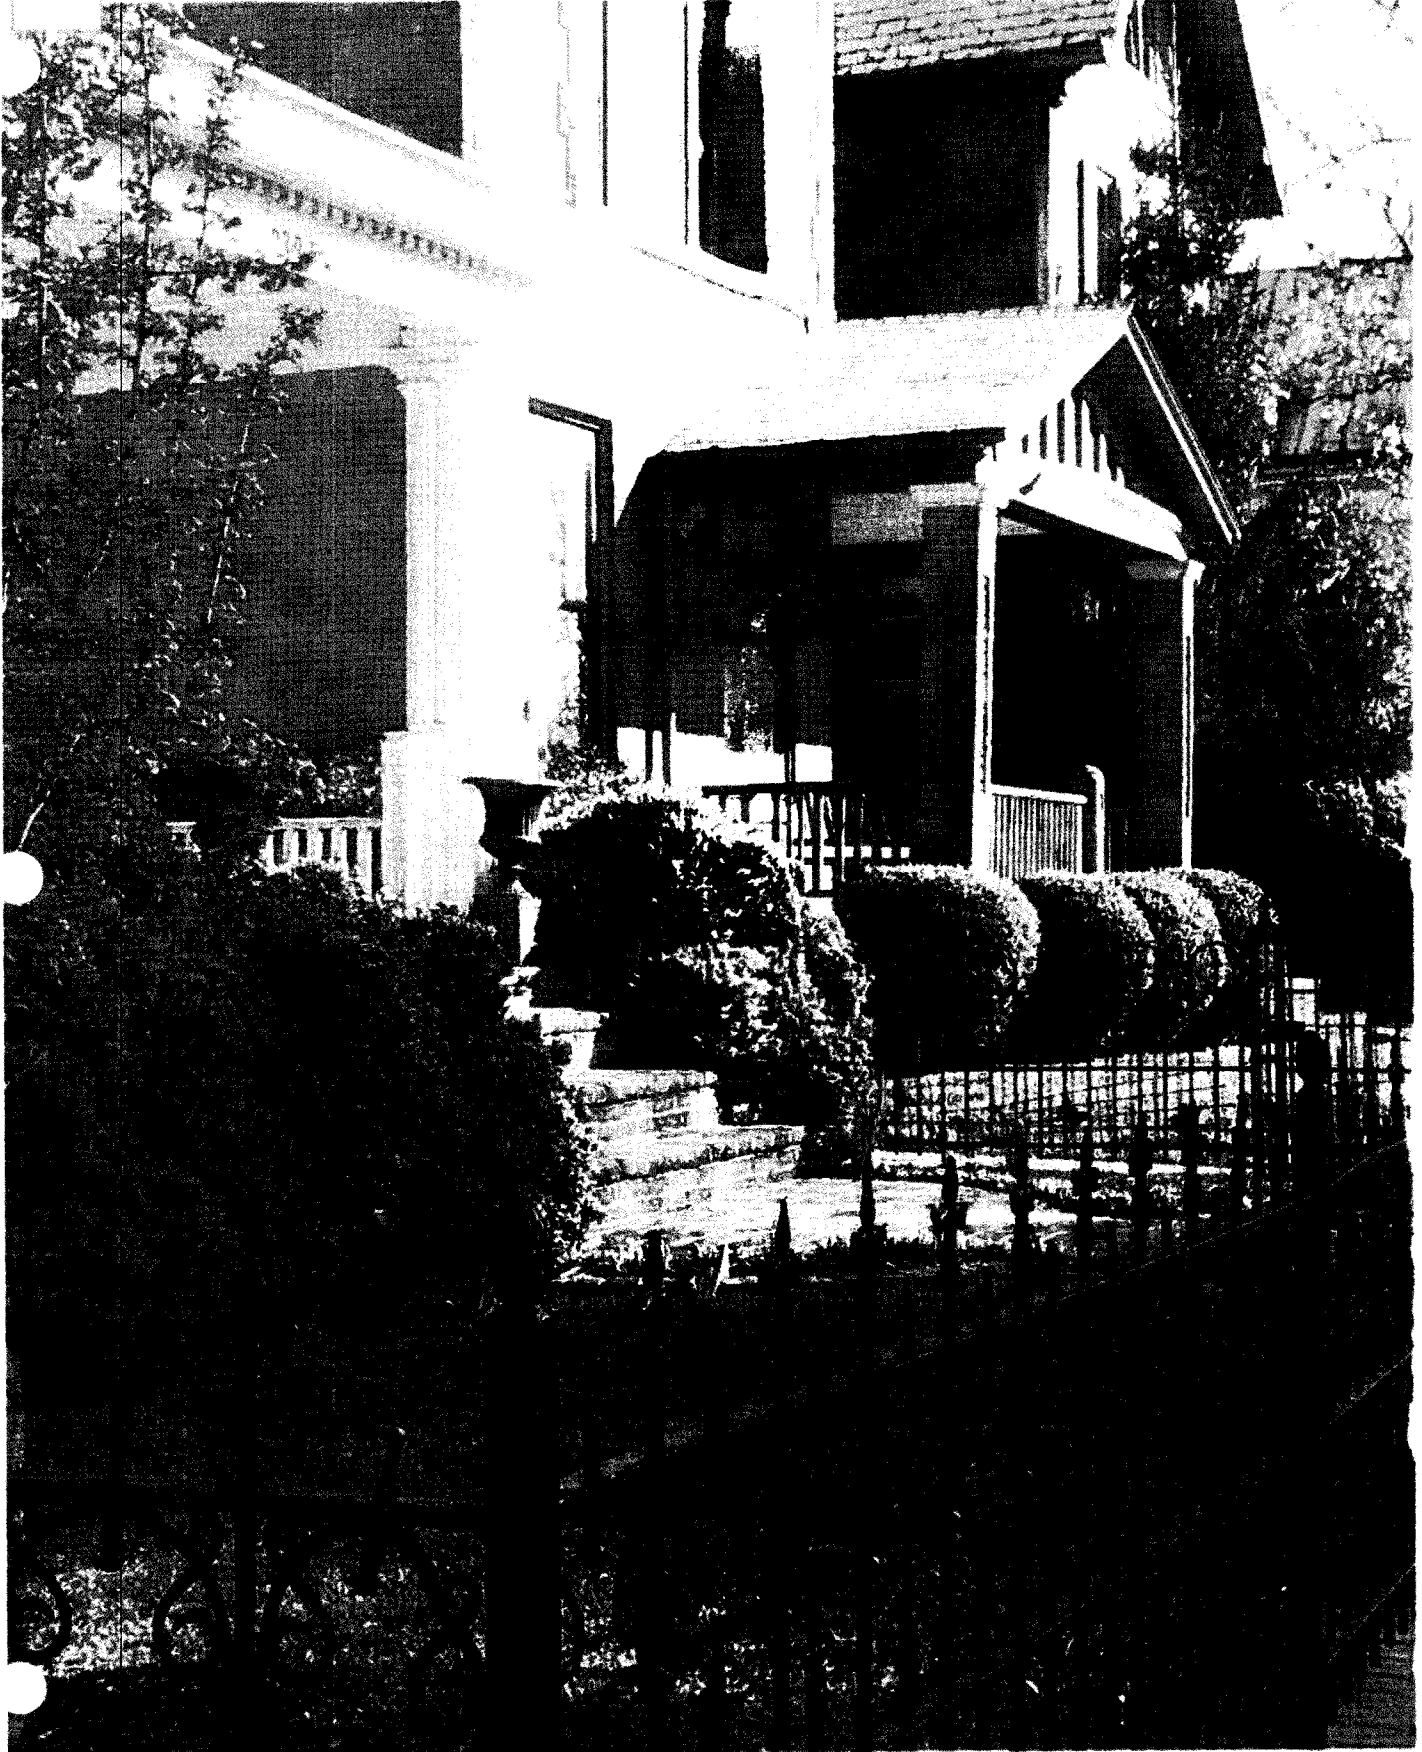
WE PLAN ON SURFACING CONCRETE STEPS  
WITH BRICK. ALSO WALK TO STEPS WILL  
BE RESURFACED WITH BRICK

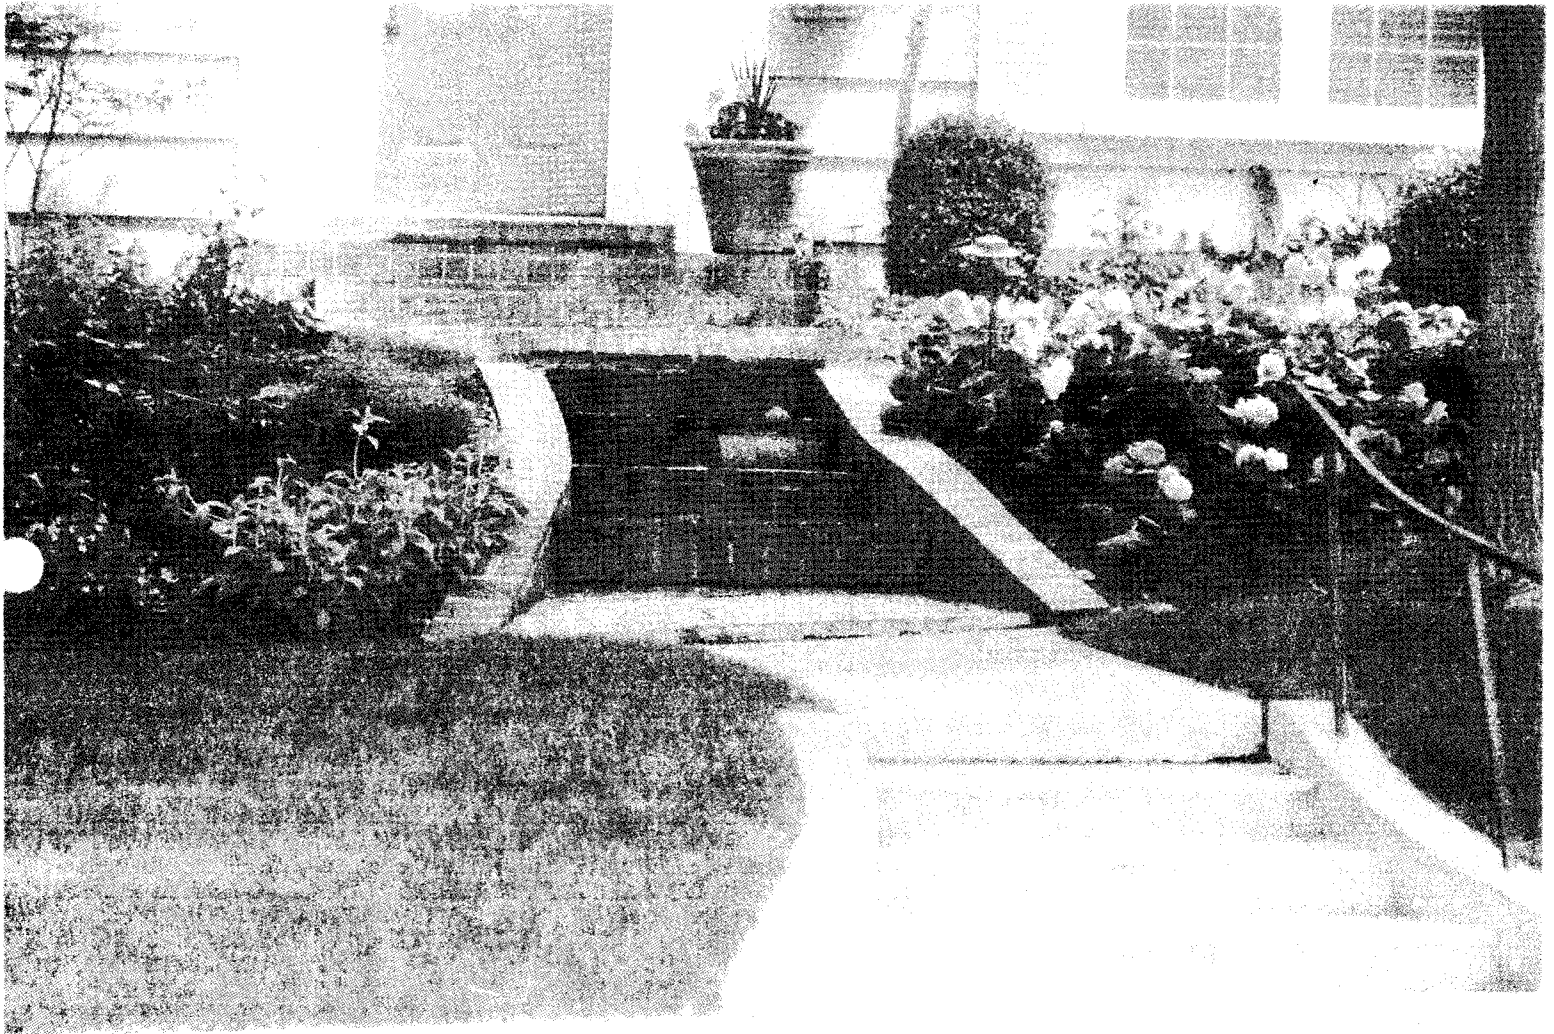
(Example)  
of  
curved steps  
and  
stone sides

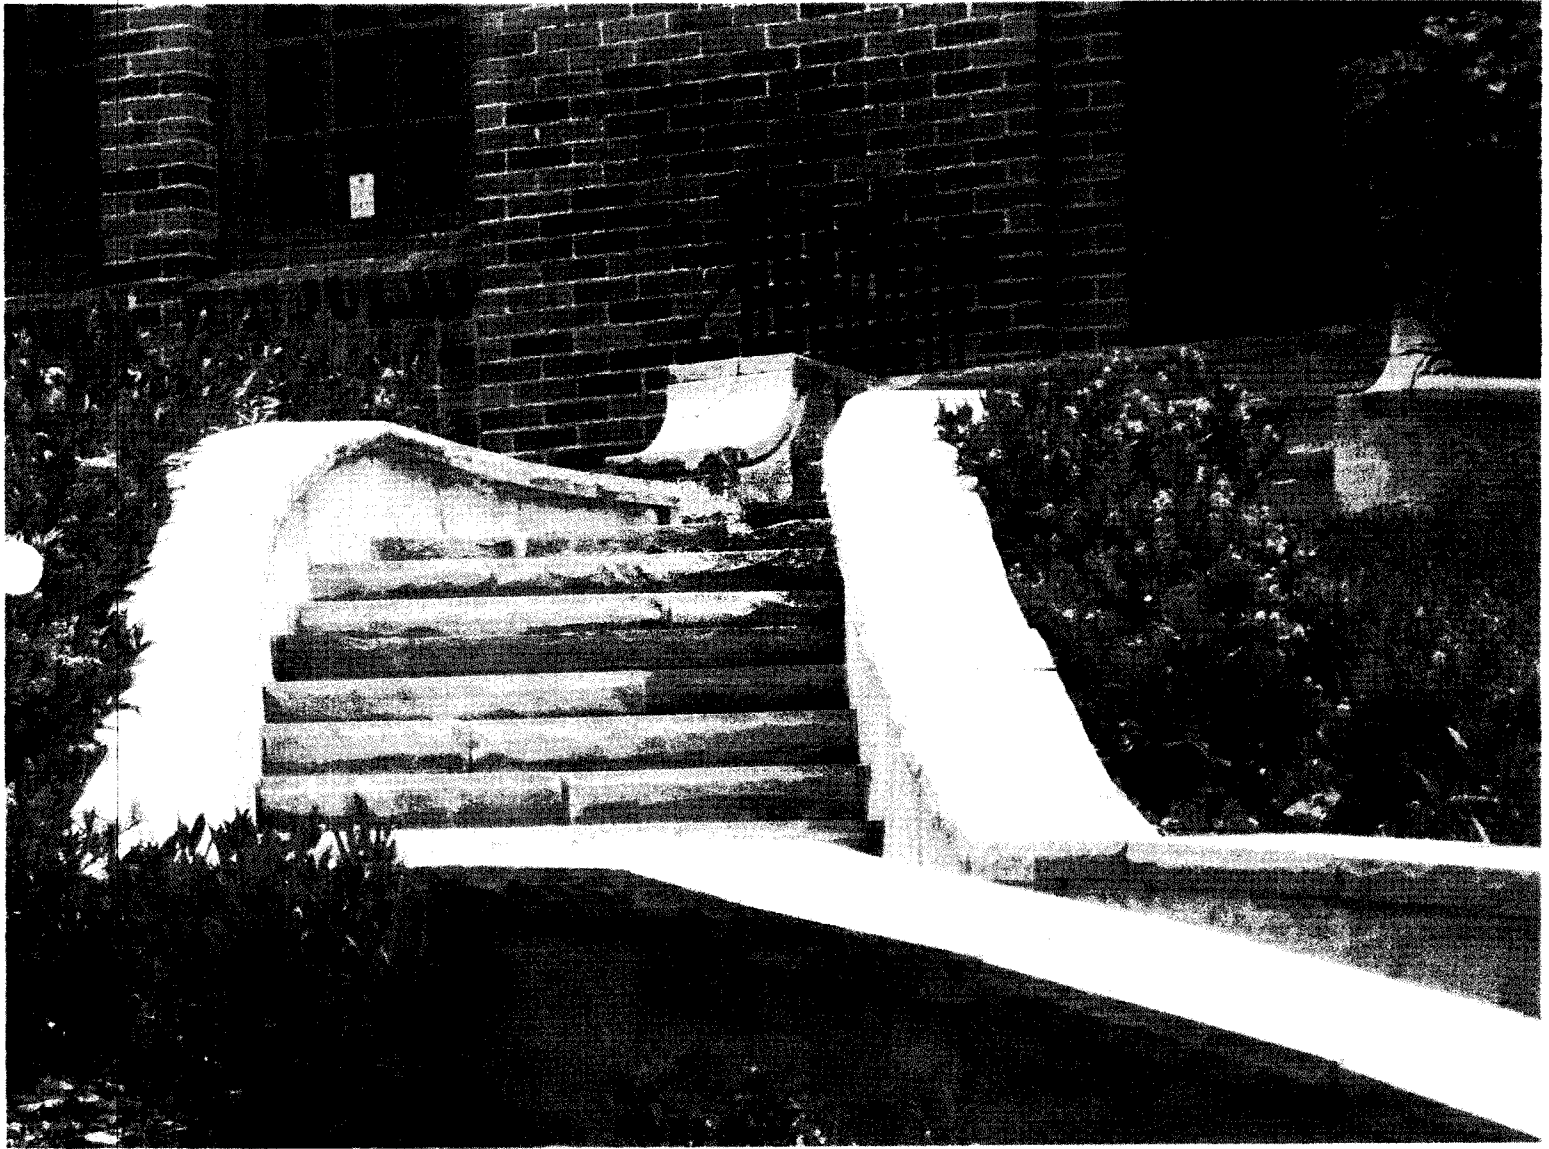
(Example of  
Stone siding)
