# HISTORIC LANDMARK COMMISSION STAFF REPORT

Planning Division  
Department of Community and  
Economic Development

## Phillips Residence Minor Alterations and Replacement Windows 565 E Sixth Avenue PLNHLC2010-00095 May 19, 2010

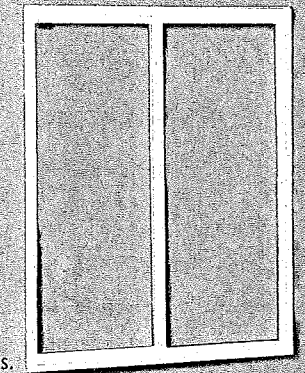
### Model 170 Sliding Patio Door

- **Sturdy 4-1/2" frame depth.**
- **1" wide integral nailing fin** with 1-3/8" fin set-back.
- **Adjustable dual tandem rollers** on a stainless steel track for years of trouble free operation.
- **Integral full length interlock** enhances strength and security while reducing air infiltration.
- **Steel reinforced meeting rail and sash** for strength and durability.
- Available in **White, Almond, or White interior with Bronze exterior.**
- Available with **keyed handle lock and/or foot lock** options.
- **Three panel configurations** also available on 9' and 12' units.

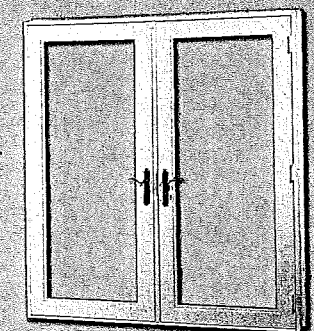
### Model 190 Hinged Patio Door

- **Available 4-9/16" or 6-9/16" frame depth.**
- **1" wide integral nailing fin.**
- **Brass hardware with adjustable white hinges.**
- **Three point locking system** for high security and a tighter seal.
- **Self-weeping sloped sill** for smooth water drainage.
- **Heavy-duty stiffener in all frame and panel members** for added strength.
- Available in **White.**
- **Single, Double or French** style doors available.
