THE UTAH GUIDE FOR THE SEISMIC IMPROVEMENT OF UNREINFORCED MASONRY DWELLINGS

**Utah Seismic Safety Commission
Existing Buildings Committee
Second Edition
2016**

THE UTAH GUIDE FOR THE SEISMIC IMPROVEMENT OF **UNREINFORCED MASONRY DWELLINGS**

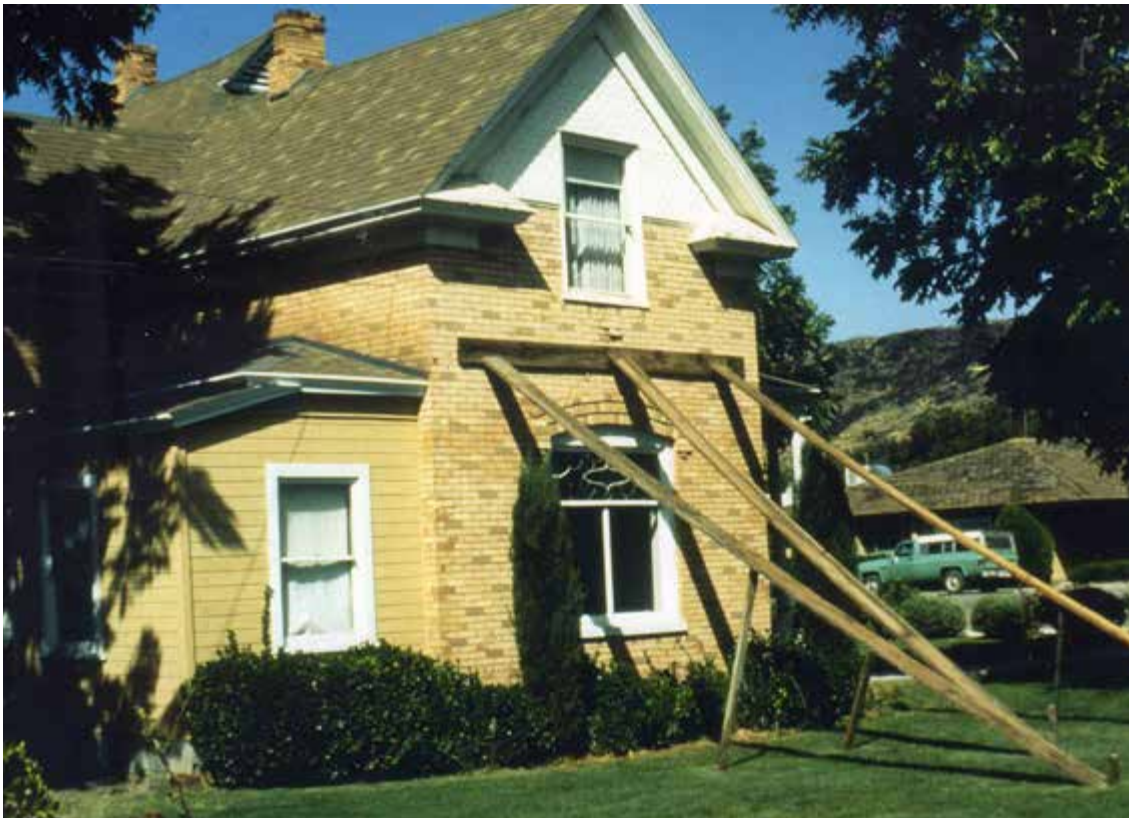
Figure 1. Braced exterior wall of a URM dwelling after an earthquake.

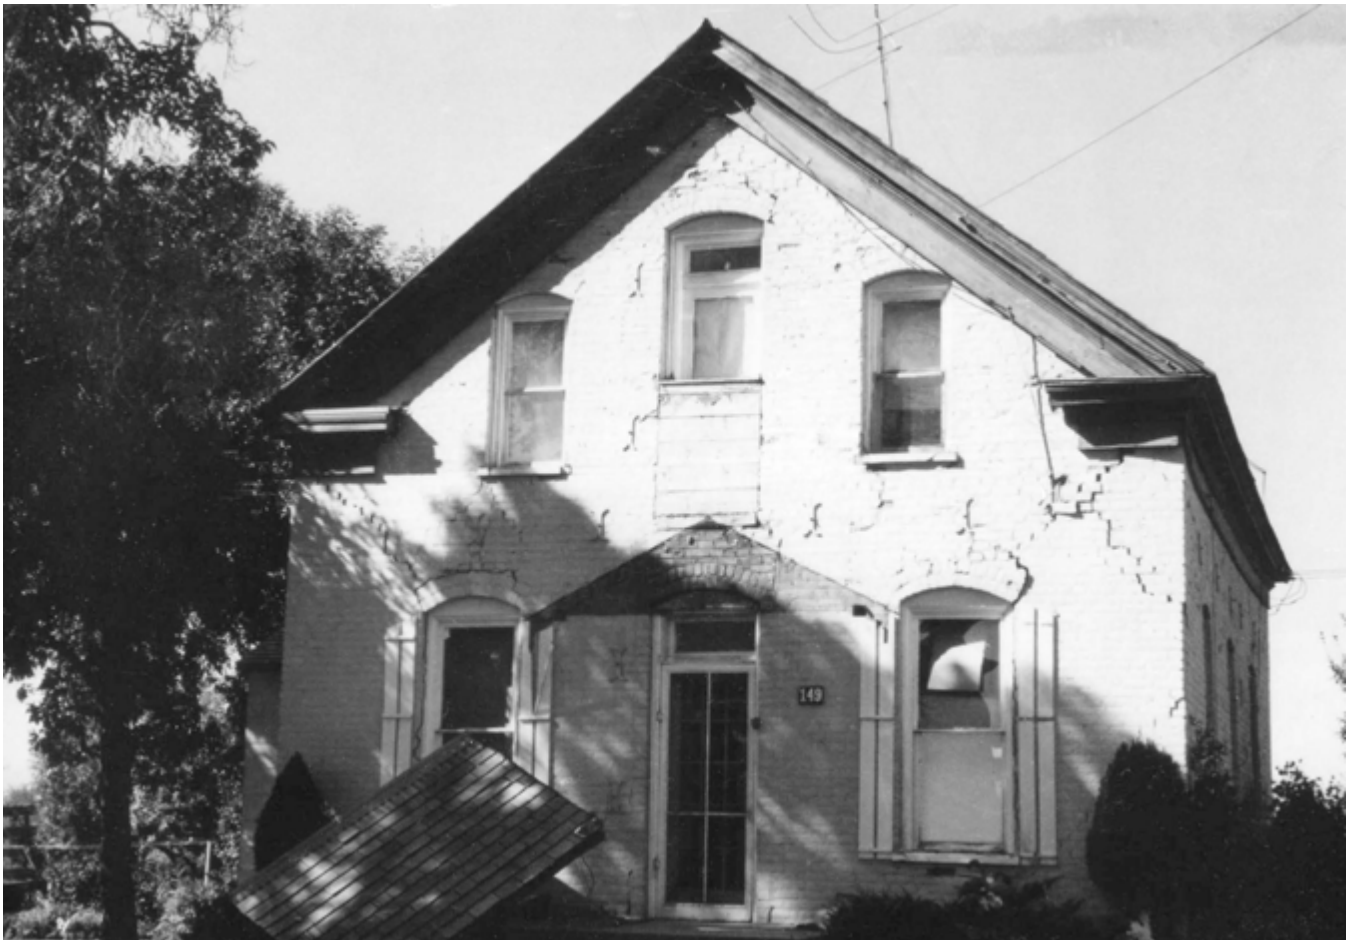
Figure 2. Cracks and failure due to an earthquake. Photo: Ariel Benson.

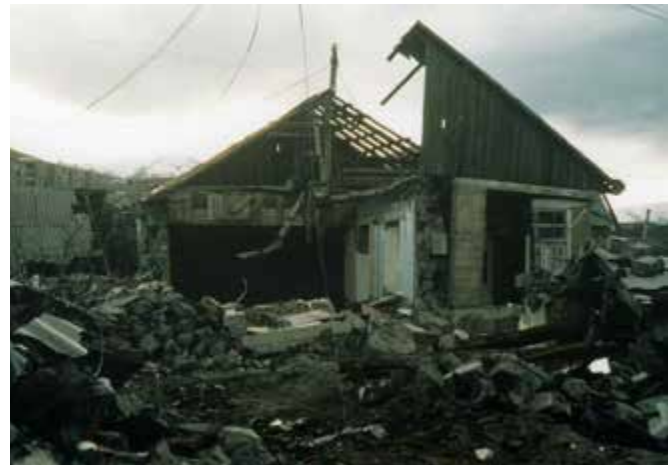
Figure 3. URM structure collapse.

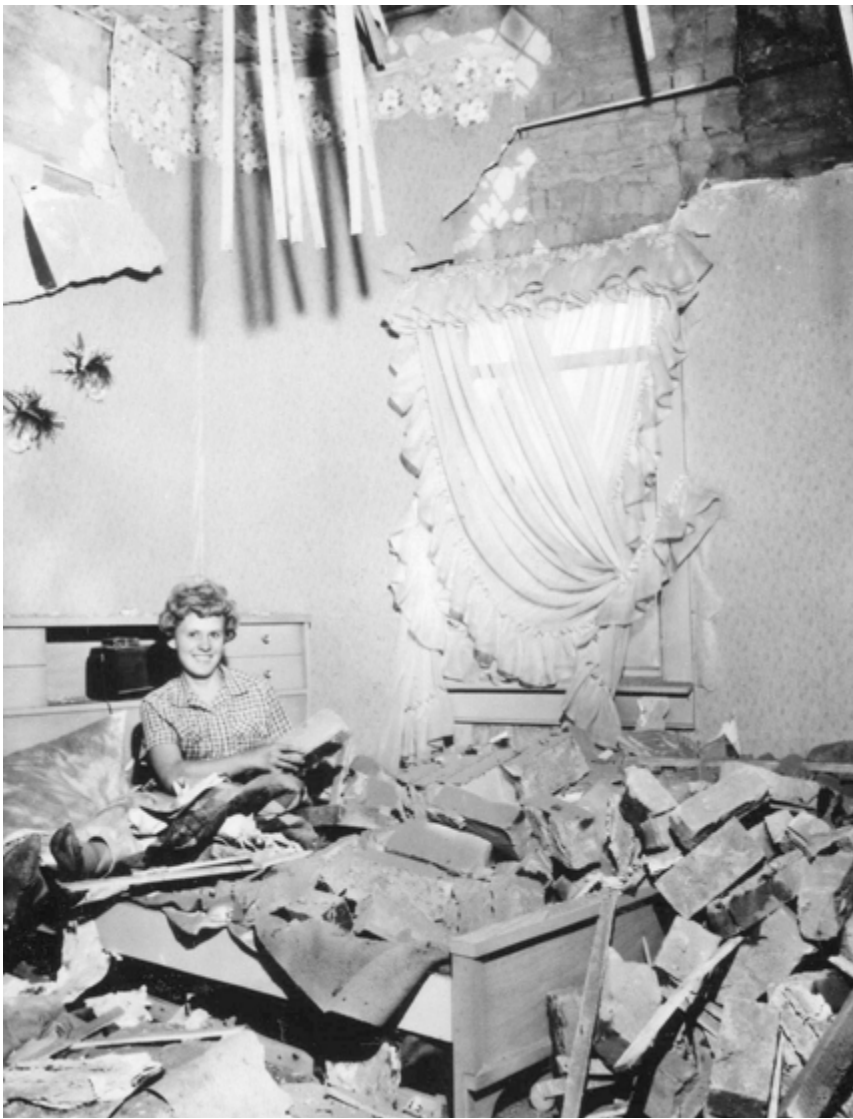
Figure 4. Interior URM wall collapse. Photo: Ariel Benson

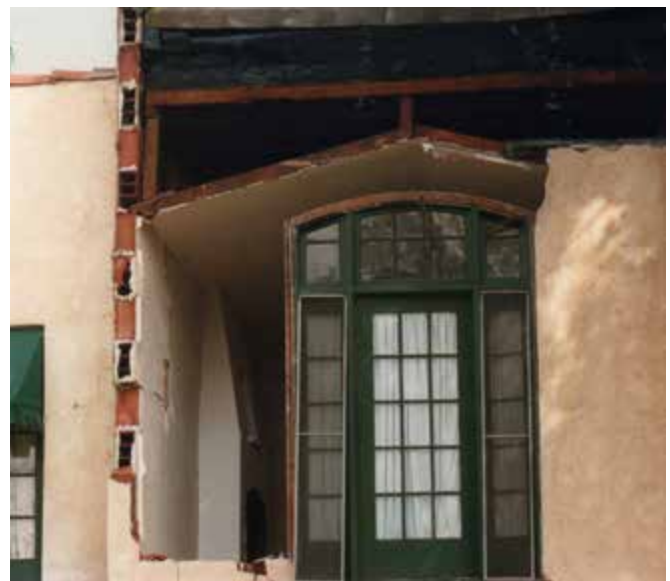
Figure 5. URM wall (hollow clay units) collapse due to earthquake.

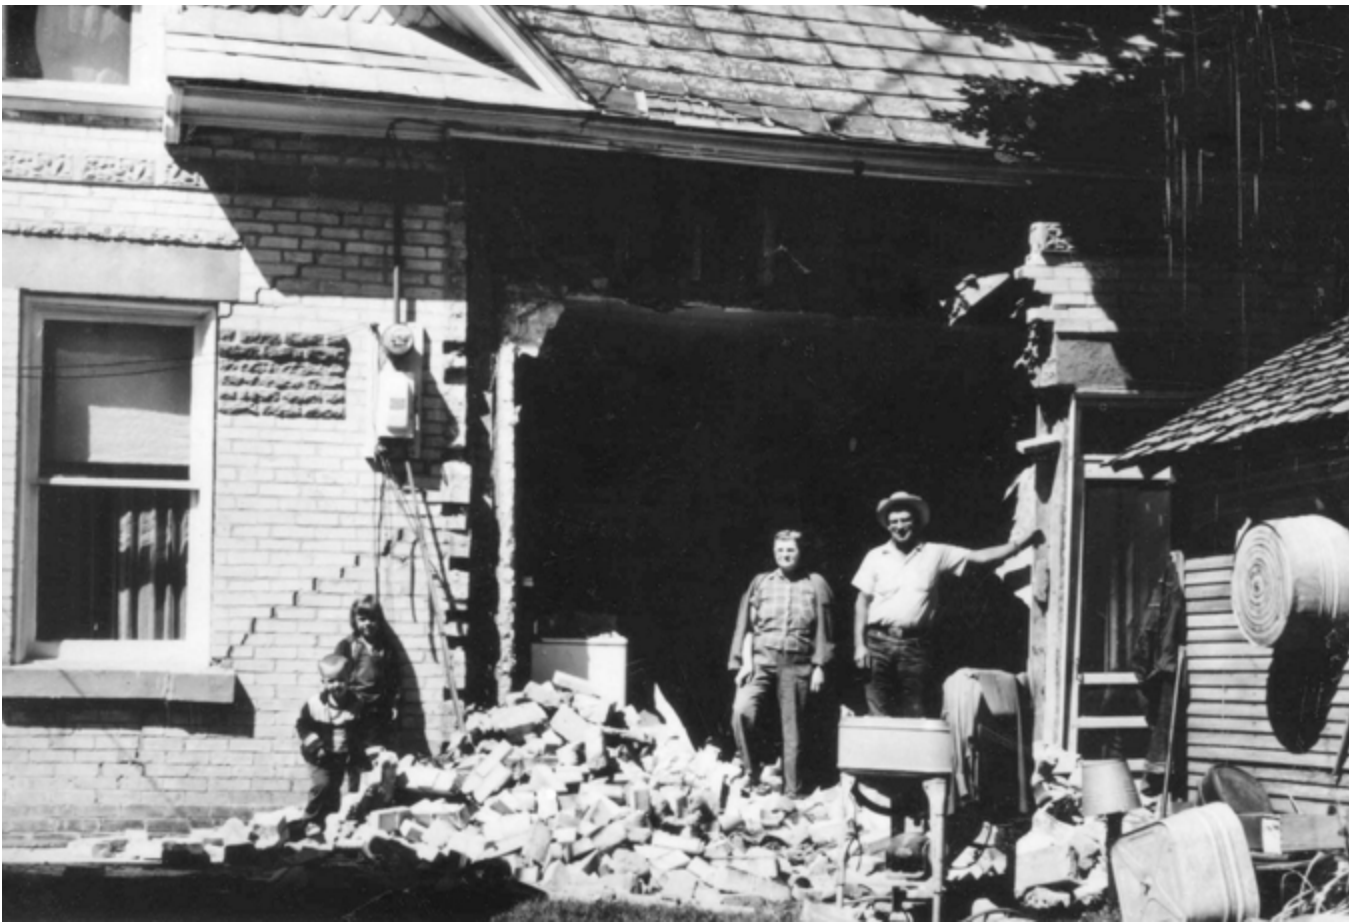
Figure 6. URM wall collapse from earthquake damage. Photo: Ariel Benson

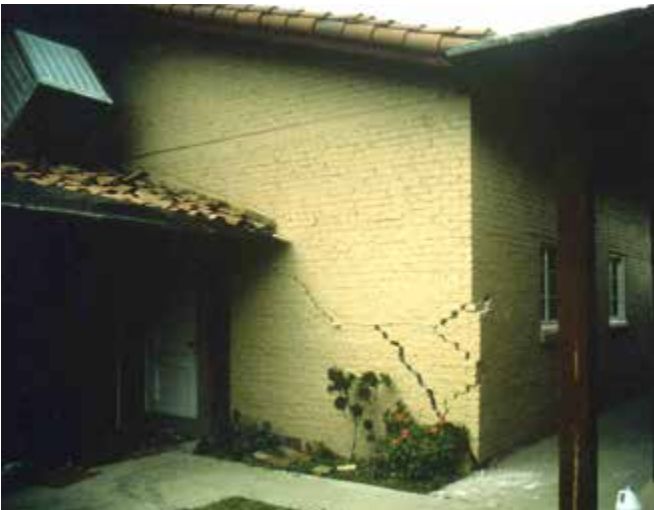
Figure 7. Earthquake damage to an URM wall and displacement of mechanical equipment on roof.

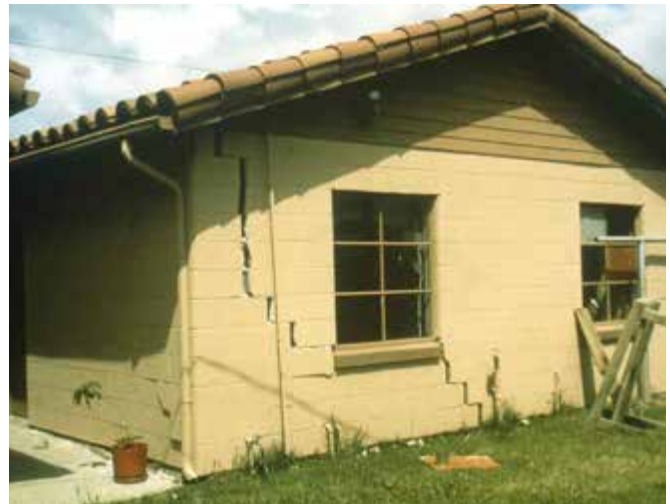
Figure 8. URM wall failure from an earthquake.

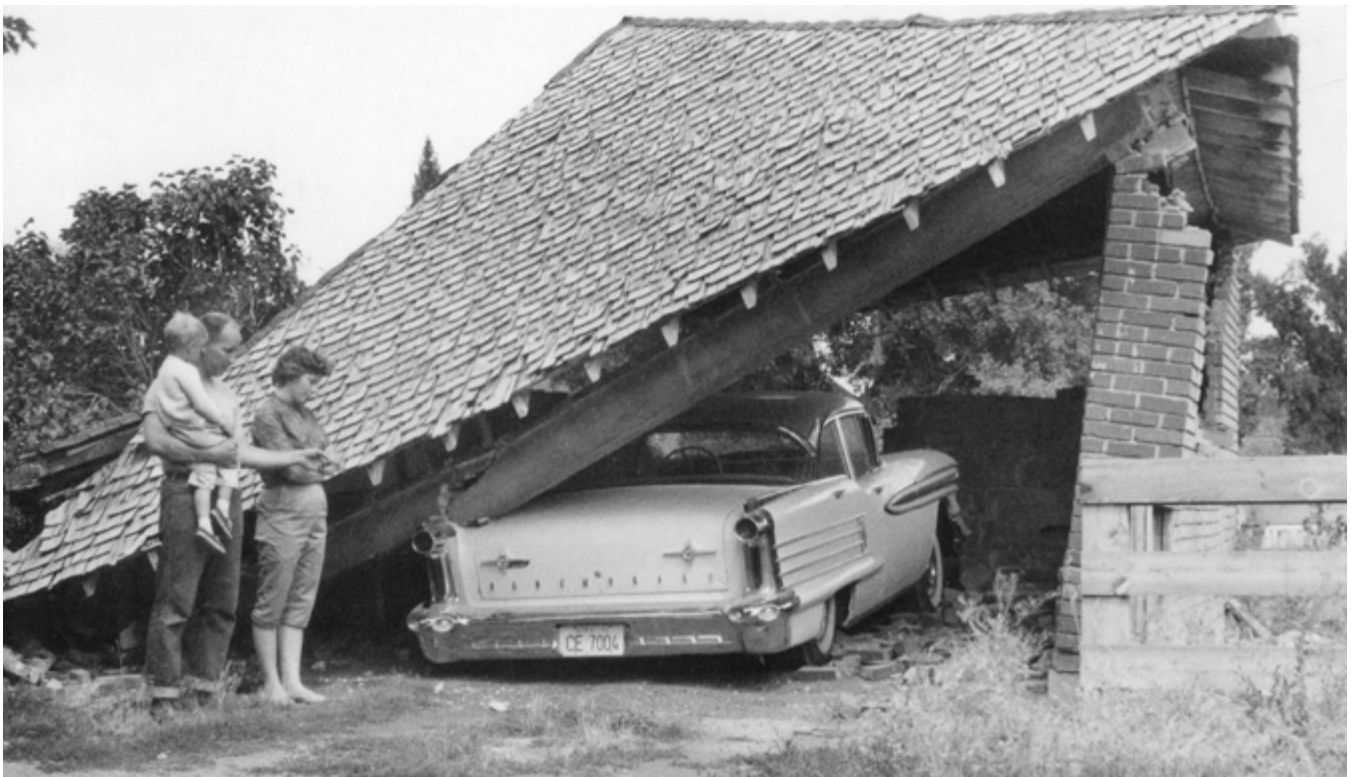
Figure 9. URM pier failure. Photo: Ariel Benson

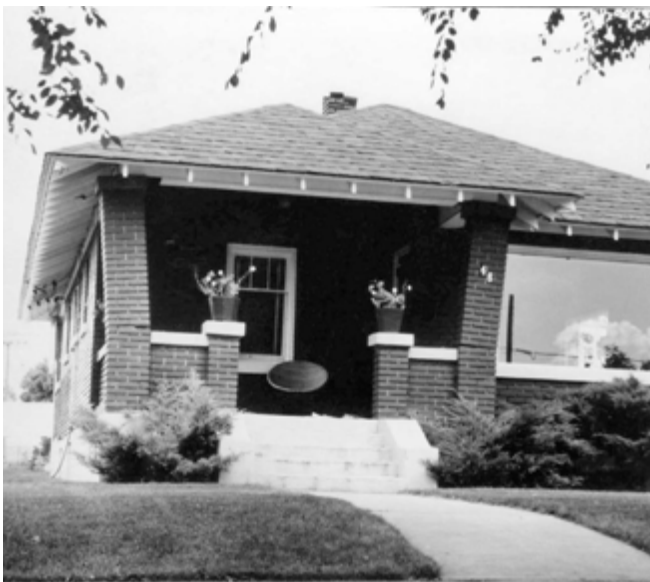
Figure 10. URM pier failure. Photo: Ariel Benson

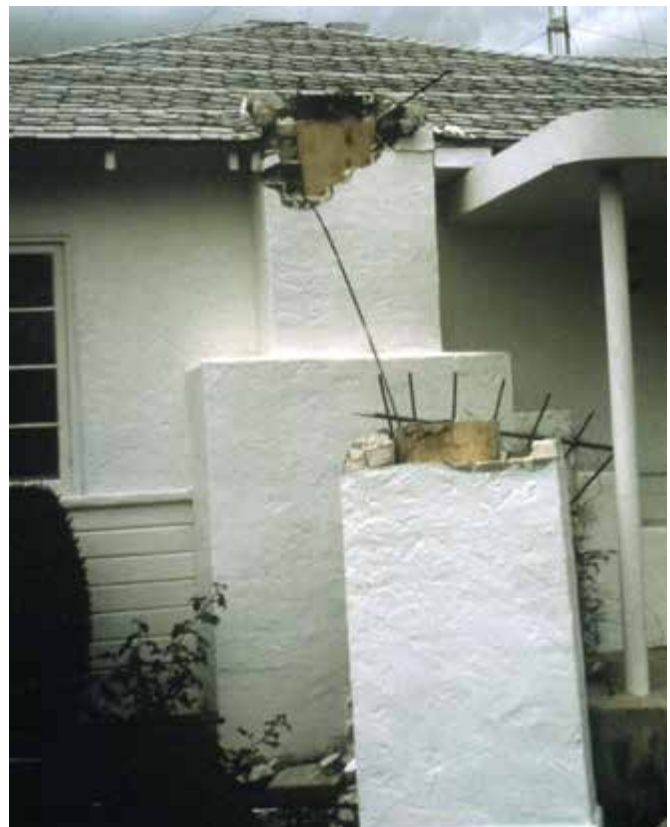
Figure 11. Chimney failure due to inadequate reinforcement.

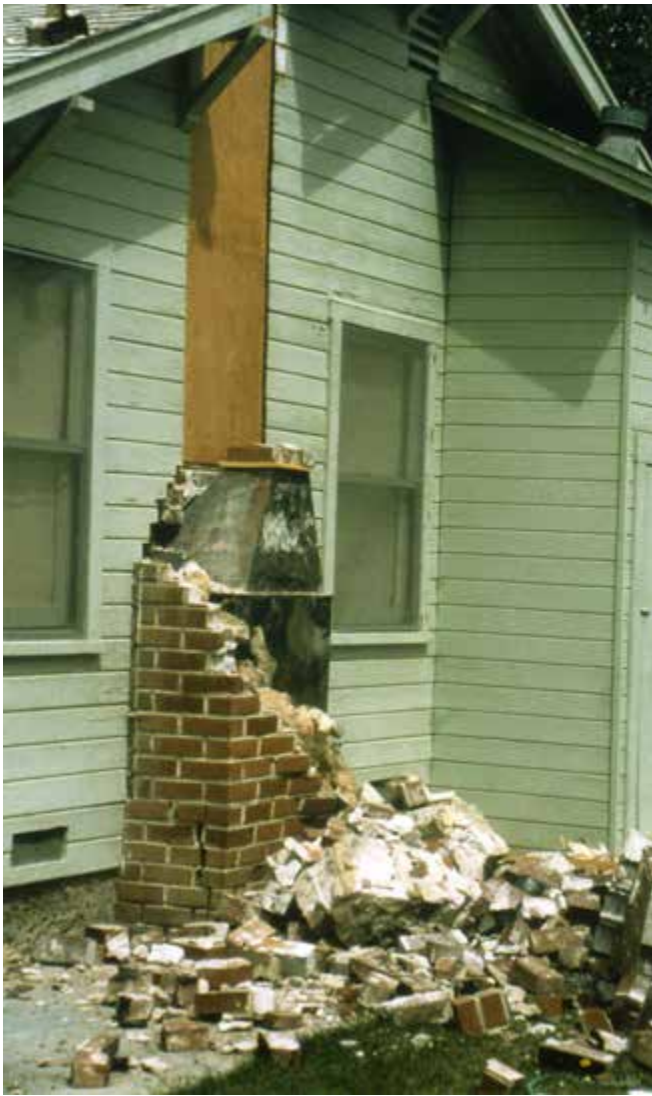
Figure 12. Chimney collapse.

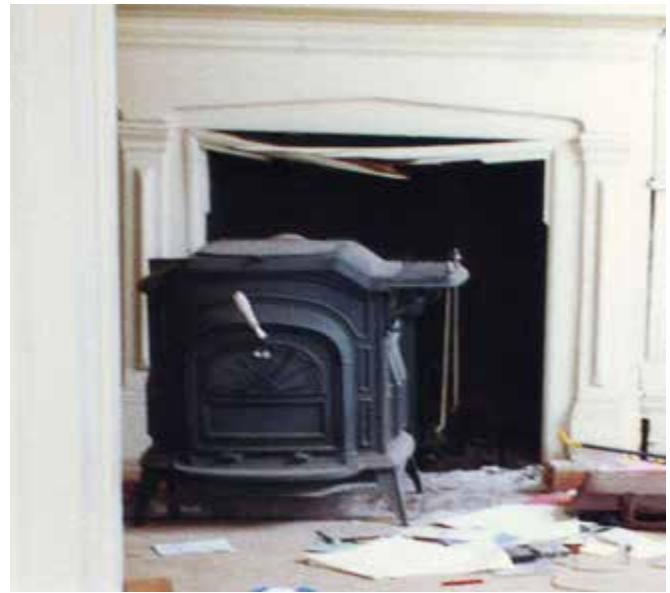
Figure 13. Displacement of wood burning stove.

Chapter 7 includes general details for upgrading (bracing, anchoring, etc.) non-structural seismic hazards. These are typically elements and dwelling contents that are not part of or are not anchored to the dwelling structure (figure 13).

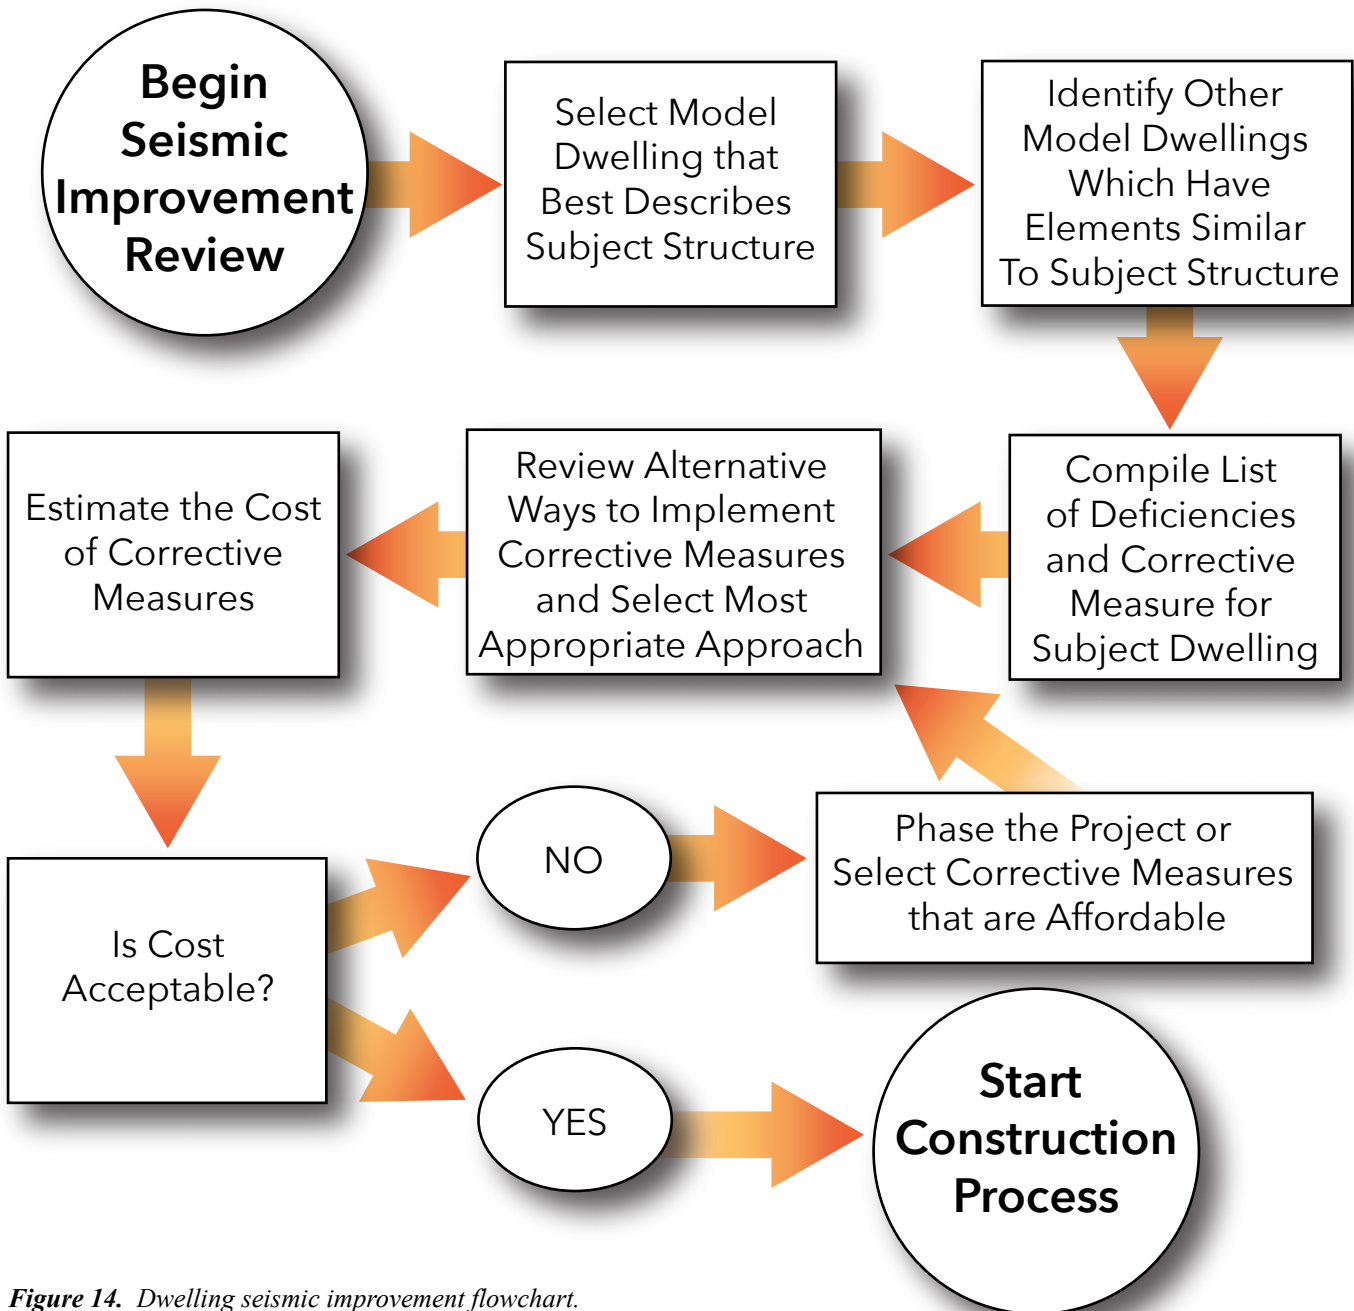
Figure 14. Dwelling seismic improvement flowchart.

Chapter 2 provides directions for using this guide, including how to select the most important areas for improvement and how to implement the actual fix. A flow chart (figure 11) has been included to aid in the use of this guide.

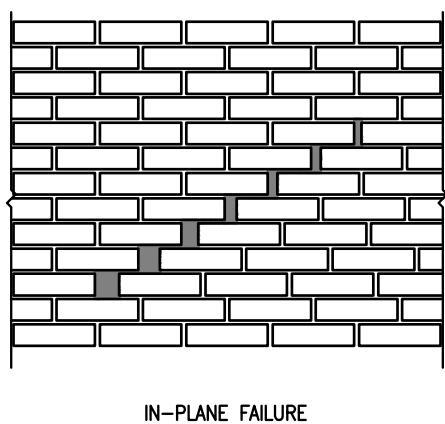
Figure 20. In-plane failure.

Figure 19 illustrates three types of URM walls described in this guide. Failure of these walls can happen in several different ways. In-plane failure occurs when seismic forces from an earthquake are introduced parallel to the wall causing the wall to be displaced horizontally within the plane of the wall (figure 20). Out-of-plane failure occurs when seismic forces are introduced perpendicular to the wall and the wall either falls away from the floor(s) and/or roof, or buckles between the floor(s) and roof (figure

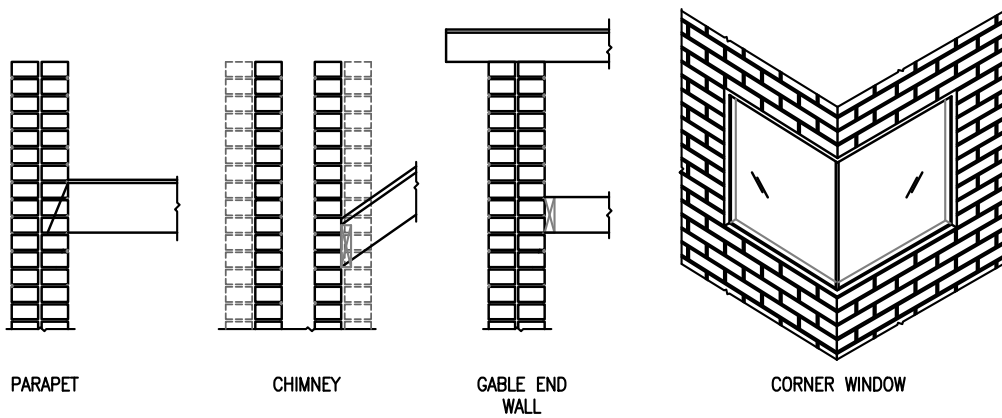
Figure 25. Examples of a parapet, chimney gable end wall, and corner window.

The special features covered in this guide include URM parapets, masonry gable end walls, chimneys, and corner windows (figure 25). There are other special features found on URM dwellings, however these are the most common. A description of each of these items, their deficiencies, and references to the appropriate corrective measures are included at the end of Chapter 5.

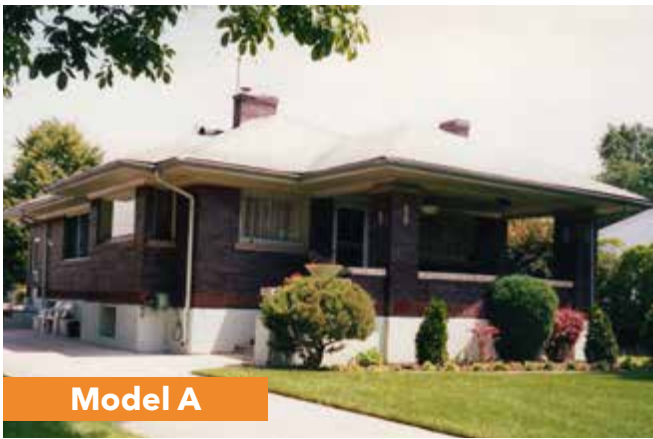
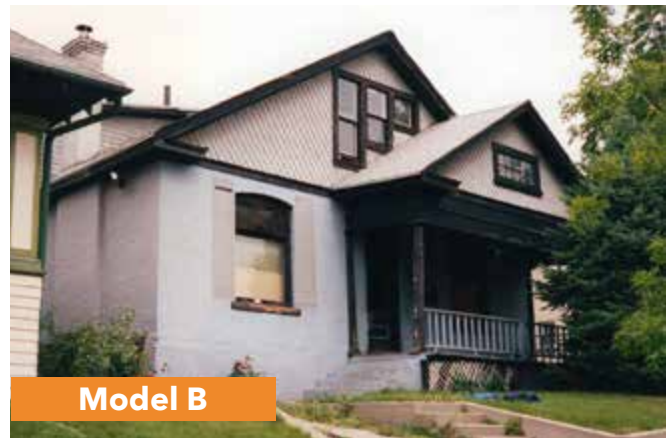
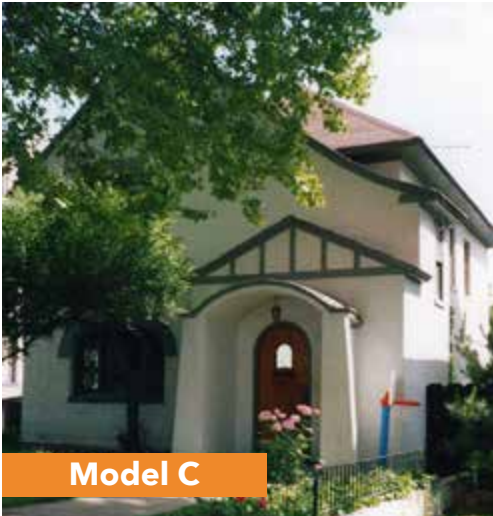
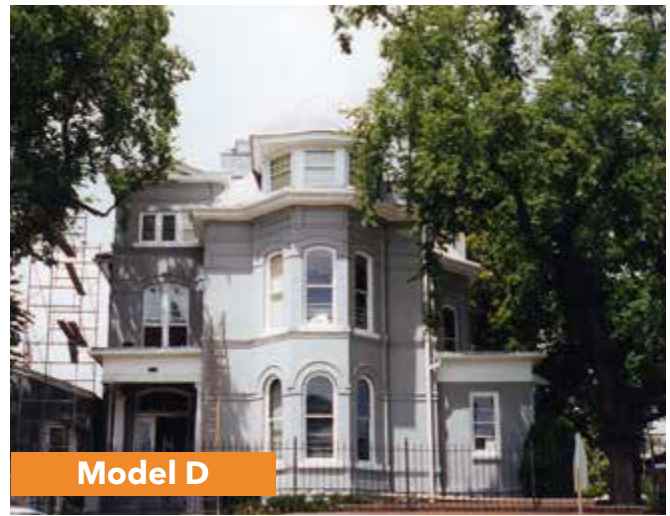
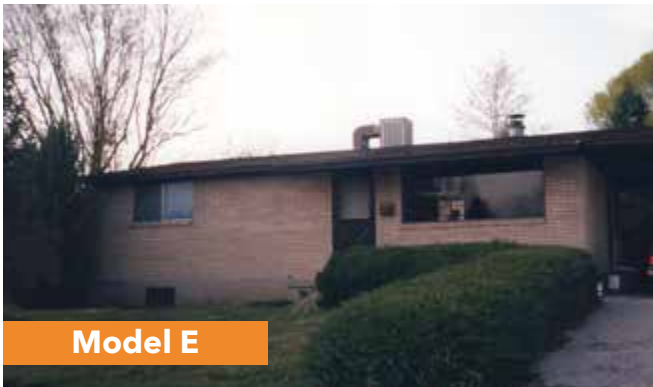
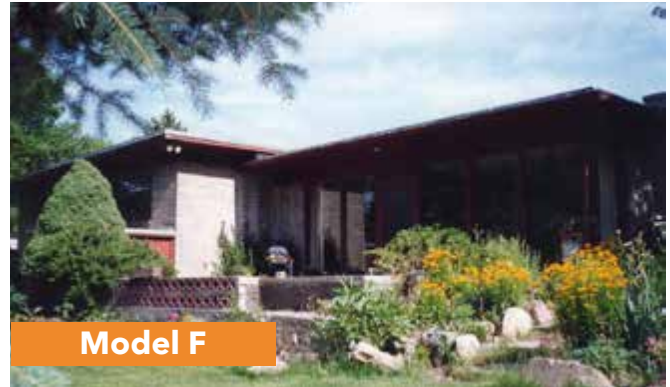
Figure 26. Representative model dwelling types.

This chapter includes descriptions of seven model dwellings with distinct architectural styles, variations in construction, and different structural configurations typical of URM dwellings found in Utah (figure 26). Photographs of exterior walls and details of typical wall sections are included for each model and can be used to compare the homeowner’s dwelling with the different model dwellings. The objective is to find the typical model dwelling that is most similar to the homeowner’s dwelling. It may be that the homeowner’s dwelling is a combination of two or more of these models. Careful study of the specific conditions at a dwelling will lead to identification of which exterior wall details best match the subject dwelling. Also included with each model dwelling description is a list of its typical seismic deficiencies.

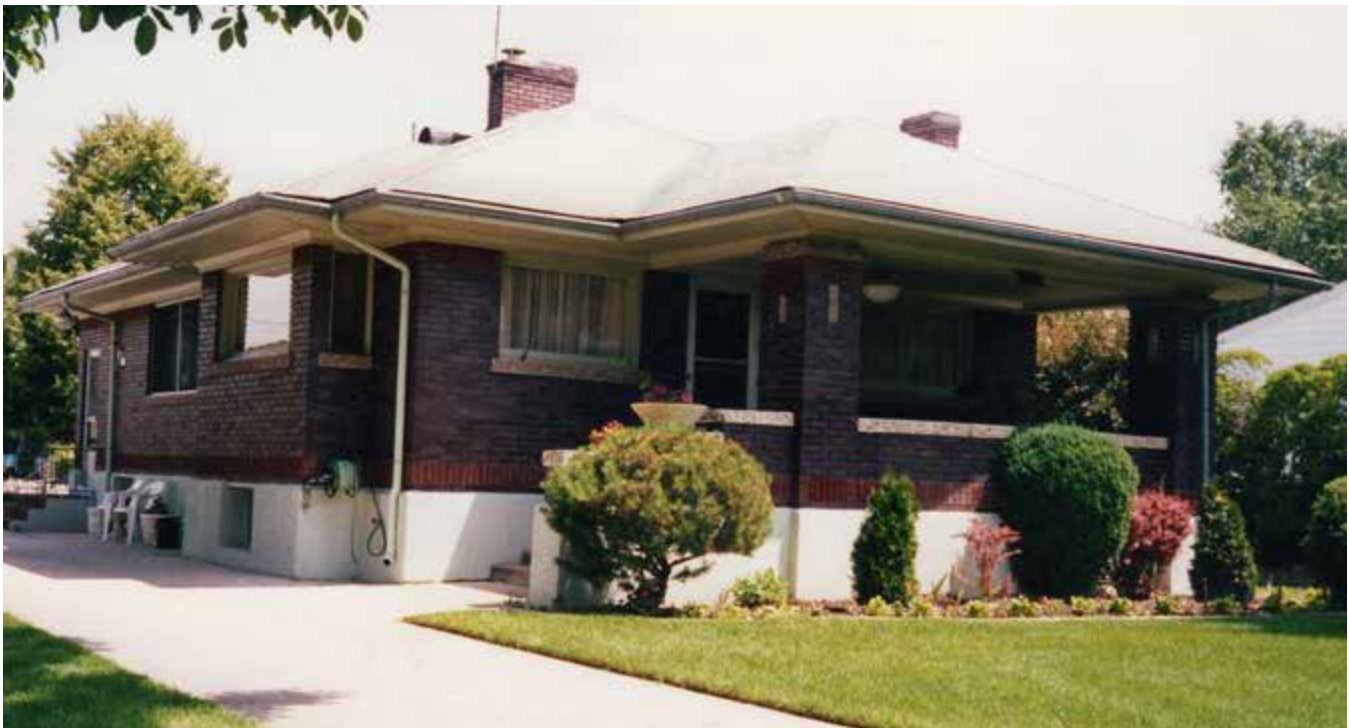
Figure 27. Model A front view.

Model A was built in approximately 1906 and is a single-story dwelling with a full basement (figures 27 and 28). The construction consists of double wythe URM exterior walls, concrete foundation walls supporting a wood floor and roof/ceiling joists around the exterior, and wood stud bearing walls within the dwelling. It has two chimneys, one exterior and one interior, and a porch with tall masonry piers supporting the roof.

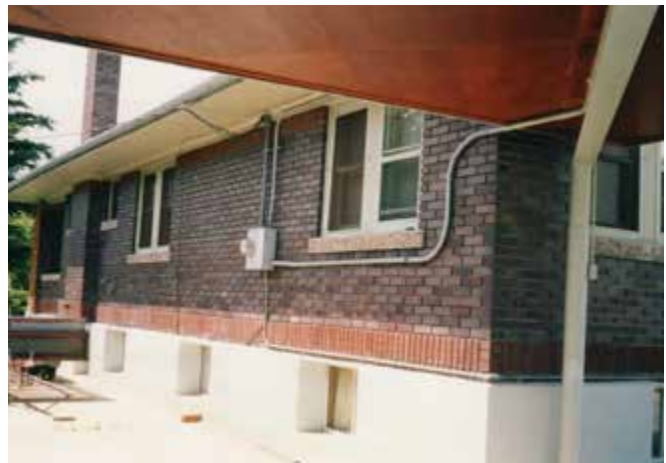
Figure 28. Model A rear view.

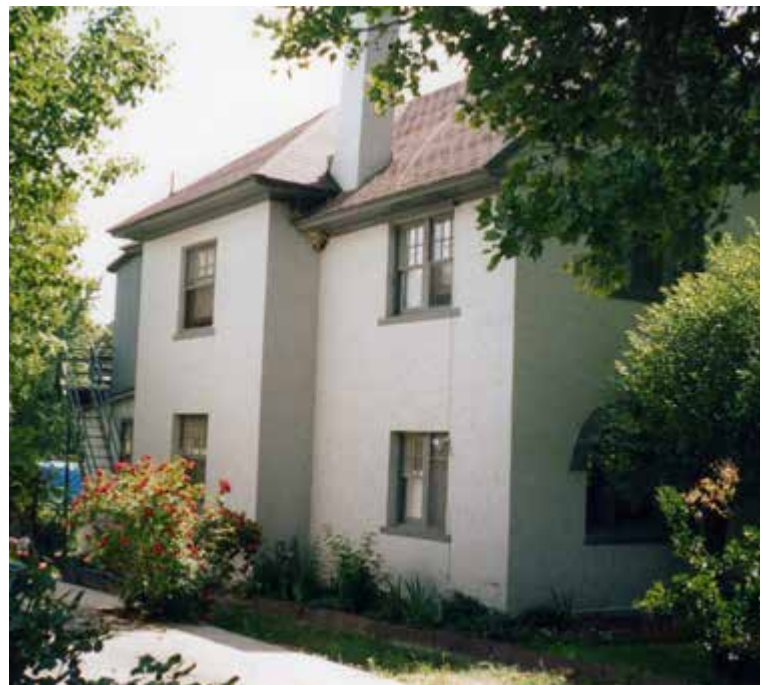
Figure 32. Model C rear view.

Model C was built in the 1900s, and is a two-story home with a concrete shelf basement (figures 31 and 32). The construction consists of double wythe URM exterior walls covered with stucco, masonry/rock foundation walls supporting a wood floor and roof/ceiling joists around the exterior. A wood beam on masonry piers or wood posts supports the floor, while a wood stud wall supports the roof. It has two exterior chimneys and several small roof areas built into the dwelling.

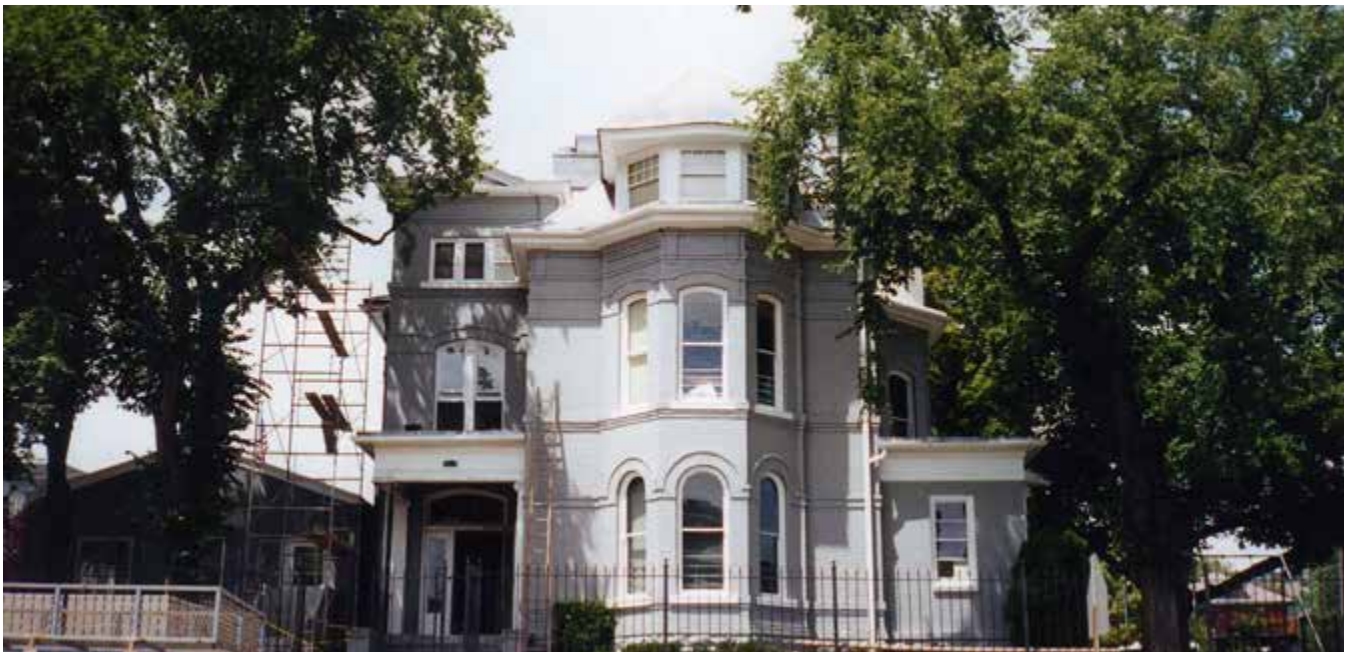
Figure 33. Model D front view.

Model D was built in the early 1900s and is a two-story home with living space built into the attic area and a partial shelf basement (figures 33 and 34). The construction consists of double wythe URM exterior walls and masonry/rock foundation walls supporting a wood floor and roof/ceiling joists around the exterior. A wood beam supported by masonry piers support the floor, while an interior wood stud wall supports the ceiling/floor joists. It usually has one exterior chimney and may have low roof areas at any elevated the floor levels.

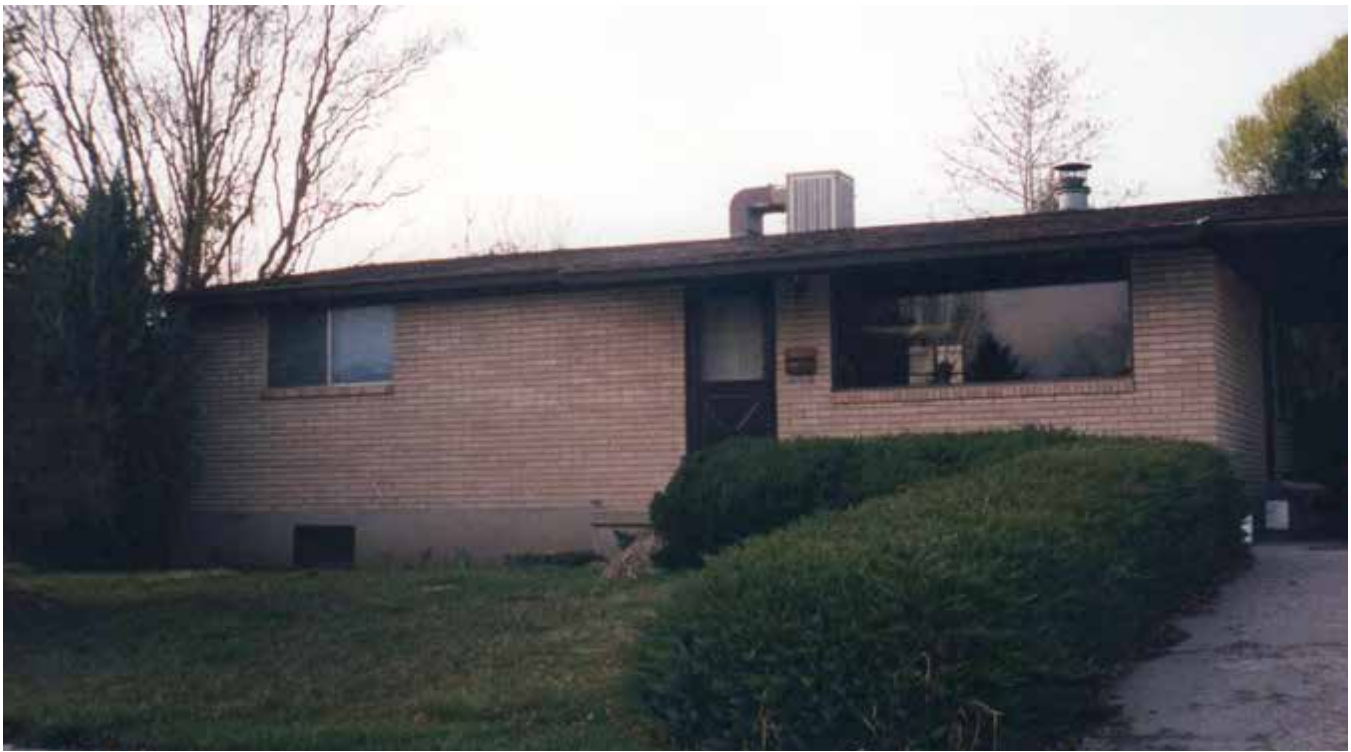
Figure 35. Model E front view.

Model E was built in approximately 1966, and is single-story home with a full basement and a low slope roof (figures 35 and 36). The construction consists of single wythe URM exterior walls and concrete foundation walls supporting wood floor joists and roof trusses around the exterior with wood stud bearing walls supporting the interior. The roof structure extends over the carport and changes from trusses to sloped joists supported by wood beams at the ridge and ends. The end beams are carried by steel or wood columns.

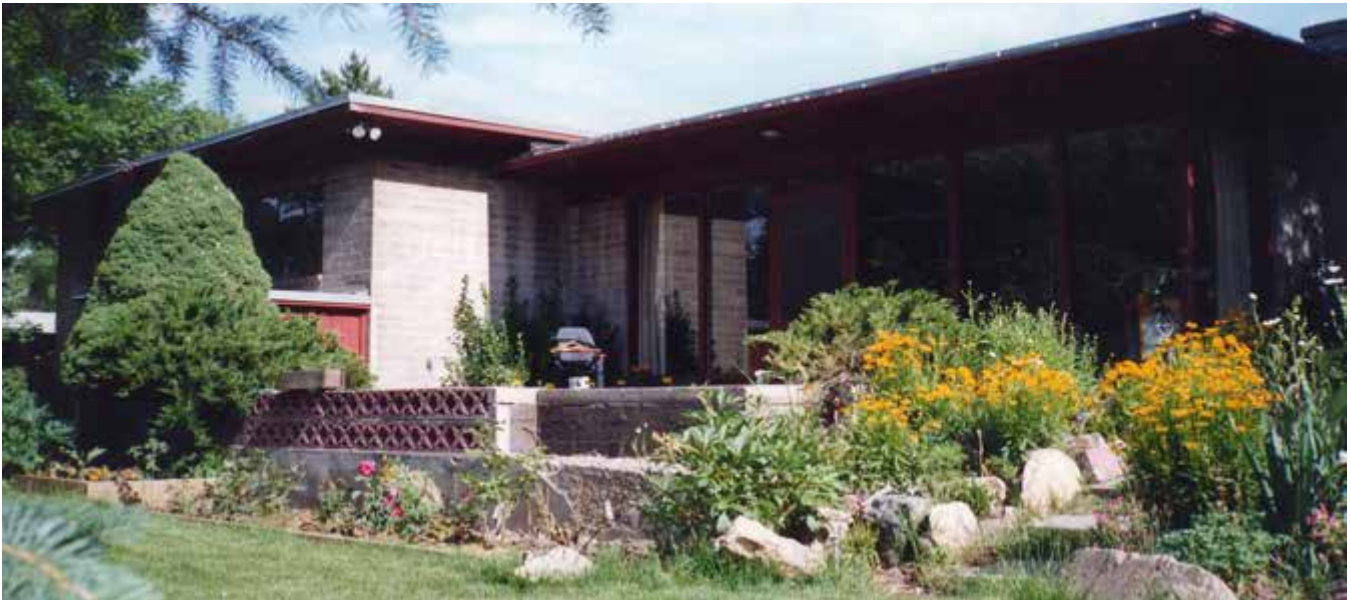
Figure 37. Model F front view.

Model F was built in 1954, and is a single-story home with a partial basement and flat roof (figure 37). The construction consists of a concrete/cinder block walls, referred as concrete masonry units (CMU), and concrete foundation walls supporting wood floor and roof/ceiling joists around the exterior with wood stud bearing walls supporting the interior. It has one low chimney with a metal flue that extends up. The roof over the front porch is supported by slender wood posts.

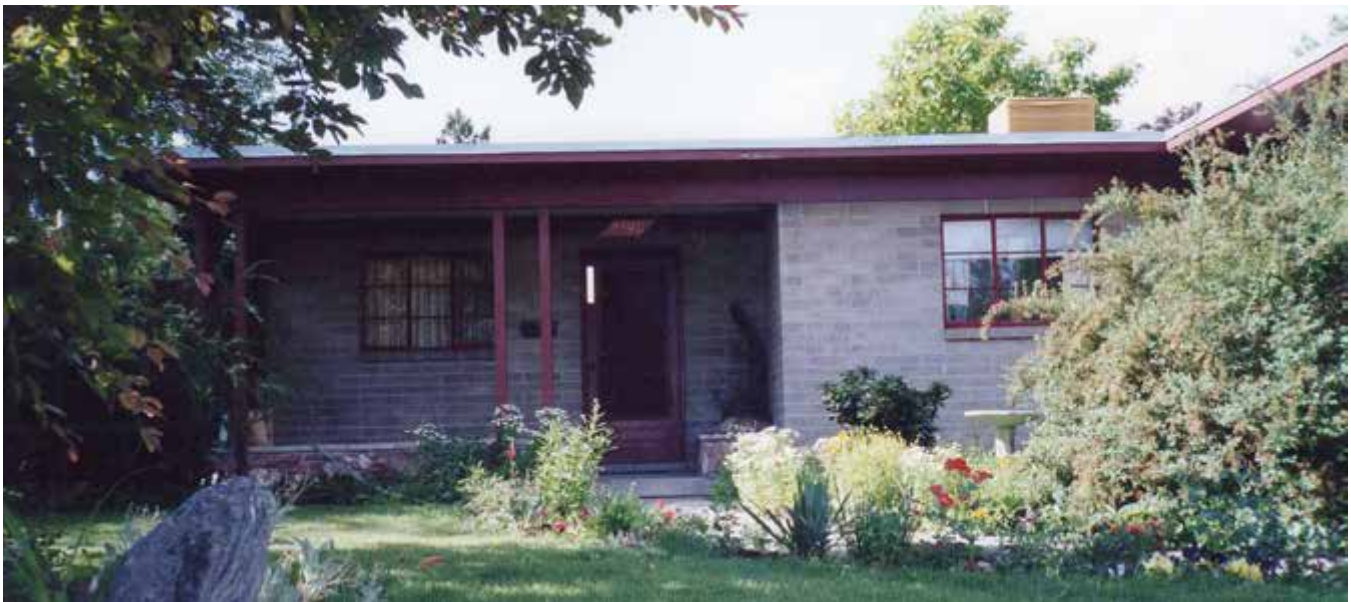
Figure 38. Model G front view.

Model G is a single-story home with a basement and was a common building type constructed in the 1940s and 1950s (figure 38). The construction consists of CMU walls with exterior brick veneer and concrete foundation walls with the concrete/cinder block portion of the exterior walls supporting wood floor and roof/ceiling joists around the exterior with wood stud bearing walls supporting the interior. The roof is framed with two (2x) members for a sloped roof or later dated dwellings may be constructed with trusses. It usually has a low chimney with a metal flue that extends upward. The roof over the front porch is supported by slender wood posts or masonry piers.

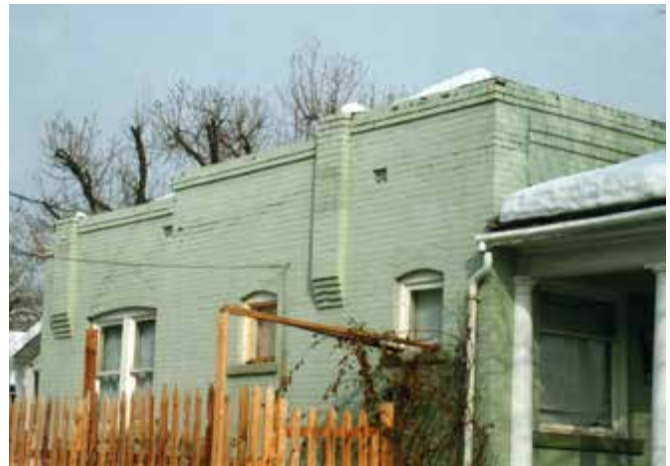
Figure 39. URM parapet walls.

A parapet is the portion of a wall that projects above the roofline and the top of a typical parapet is usually not braced (figure 39). When an earthquake occurs, the parapet can break off near the roofline from seismic forces. The bottom of the parapet near the roofline is normally weak zone because roof joists and other framing members are pocketed into the wall at this location. Failure of parapets can create a falling hazard that is a serious life safety concern, especially over doorways and walkways. As a general rule, the higher the parapet, the more serious the

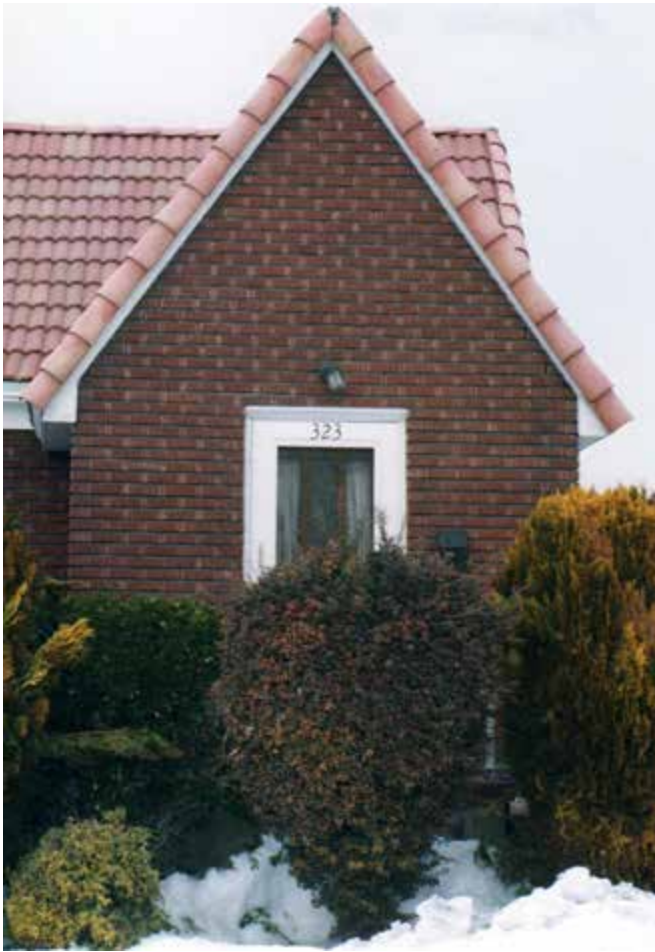
Figure 40. URM gable end walls.

A gable end wall is the triangle section of an exterior wall under the roof plane and above the eaves line (figure 40). This portion of a typical URM wall is not normally braced and supports the roof ridge. The height of this wall and the unbraced condition make it less stable than other elements to resist out-of-plane forces. Out-of-plane failure of a gable end wall is similar to that described for URM walls. The size of the gable end wall and the intensity and direction of seismic forces will have a direct effect on the stability of the wall. A wide gable generally supports a large portion of the roof. Failure of this type of gable end wall is likely to also result in at least partial collapse of the roof. The roof

rafters adjacent to a tall narrow gable are usually designed to bear on the main walls below. Failure of this type of gable end wall could create a falling hazard similar to parapets, but collapse of the roof is not likely unless the main walls below also fail. See detail 21 to help strengthen this deficiency.

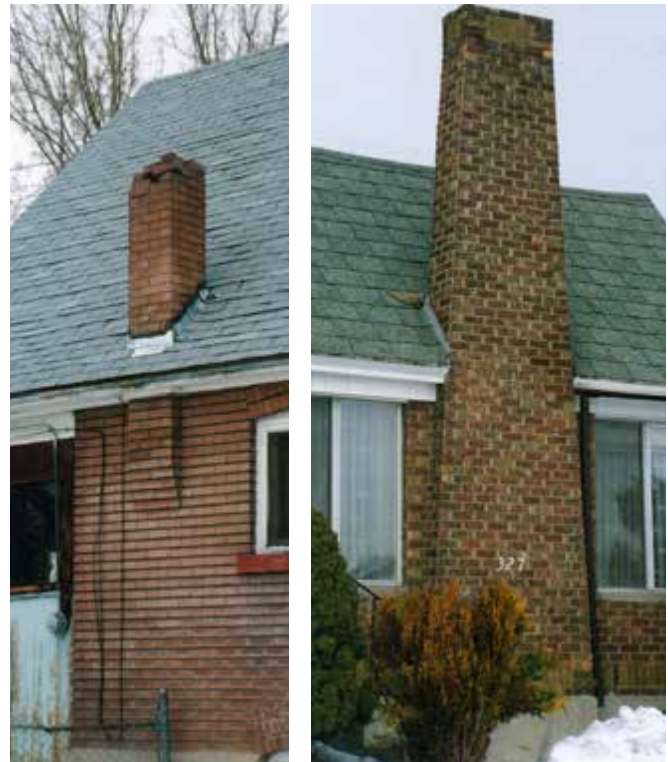
Figure 41. Typical URM chimneys.

Almost every URM home has one or more chimneys. A chimney can be located on an exterior wall or within the interior of a dwelling (figure 41). The roof joists may be pocketed into the side of the chimney or headered off around it. Often, chimneys are corbelled out of the top of a wall for a flue connection to a stove or furnace. The failure of chimneys is very similar to that of parapets. See details 22 through 25 to help strengthen these deficiencies.

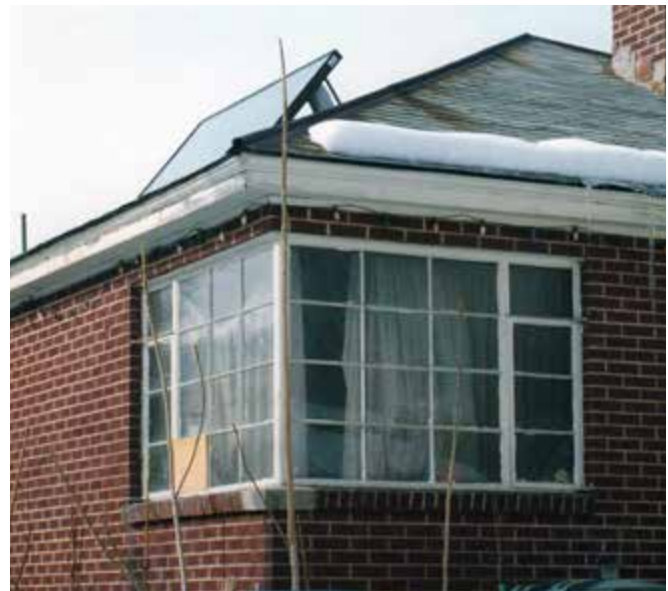
Figure 42. Typical corner window.

A corner window usually has a steel pipe at the outside corner of the window under a steel lintel to support the

masonry wall above or the wall above may be on a cantilevered steel angle to avoid a corner post (figure 42). When used, the steel pipe may or may not be connected to the steel lintel. This feature may create a weakness in the shear wall. If the steel pipe was to become displaced, partial collapse of the dwelling could take place. See details 26 and 26a to help strengthen this deficiency.
