THE UTAH GUIDE FOR THE SEISMIC IMPROVEMENT OF UNREINFORCED MASONRY DWELLINGS

**Utah Seismic Safety Commission
Existing Buildings Committee
Second Edition
2016**

THE UTAH GUIDE FOR THE SEISMIC IMPROVEMENT OF **UNREINFORCED MASONRY DWELLINGS**

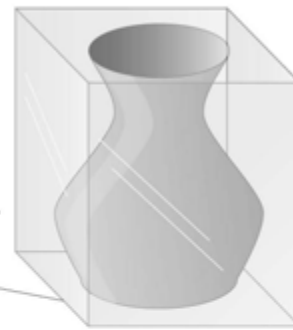
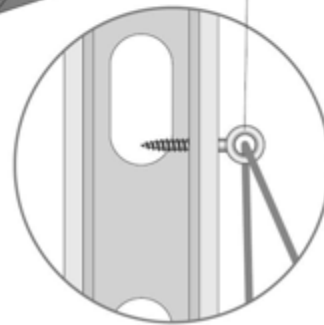
Fragile artwork restraints: Detail 114

Use museum wax to restrain small lightweight objects. (Remove with care - wax may leave small stain on base of object). Alternative: use patches of hook and loop material. [Caution - glue may affect finish on base of object].

Place object in close-fitting glass or plexiglass display case. Pedestal must be anchored.

Wire attached to frame with closed hook or closed wire loop

Eyebolt to wood metal stud

Hanging framed item

Note: Specialty hardware such as base isolated display platforms are available for especially fragile or valuable items. Seek professional guidance for expensive or irreplaceable items.

Seismic Improvement Non-Structural Detail	HOME TYPE: VARIES	Fragile Artwork Restraints	DETAIL: 114
--	----------------------	-------------------------------	----------------
