Staff Report

Re: PLNHLC2020-00940 – Minor Alterations @ 229 N Almond Street

Minor Alteration

REQUEST: Maeli Merrill, property owner, is requesting approval of a Certificate of Appropriateness for the installation of a new dormer and replacement of windows, siding on the rear of the house, front door, and fascia in the front façade. The property is currently under enforcement, as all the requested items have already been installed. The property is located at 229 N Almond Street and is a contributing structure within the Capitol Hill Local Historic District. The property is located within the RMF-35 and RMF-45 zoning districts.

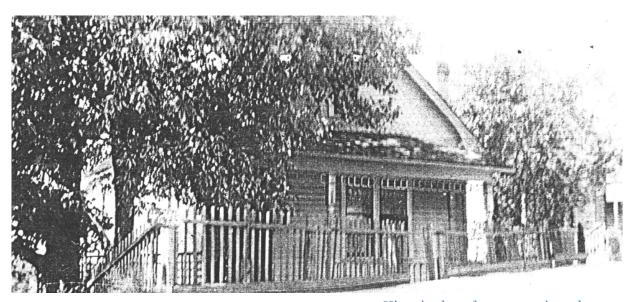
Historic photo from approximately 1935

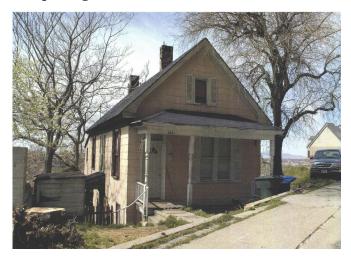
Before and after the renovation. Looking northeast, south and east façades

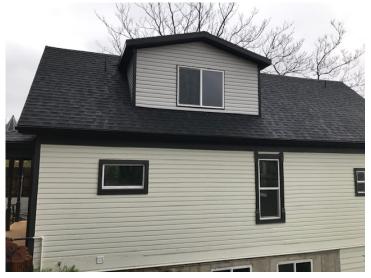
North façade showing windows to be replaced.

- 1. Replace three vinyl windows in the East elevation, front façade, with wood double hung windows.
- 2. Replace three vinyl windows on the main level of the North elevation with wood windows.
- 3. Replace one vinyl window on the dormer with two wood windows (North elevation).
- 4. Replace windows in the South and West elevations with vinyl windows.

Findings: Deteriorated architectural features shall be repaired rather than replaced wherever feasible. In the event replacement is necessary, the new material should match the material being replaced in composition, design, texture and other visual qualities. The proposed wood windows will match the material being replaced.

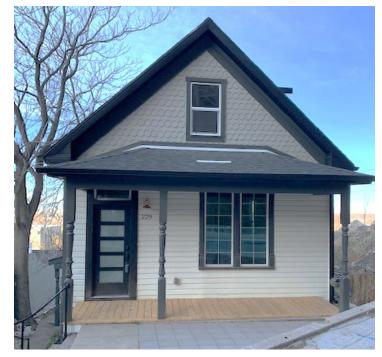
Front façade showing windows and door to be replaced.

The front door was replaced with an out of period door, however, the transom above the door was kept intact. The frame for the door was partially replaced.

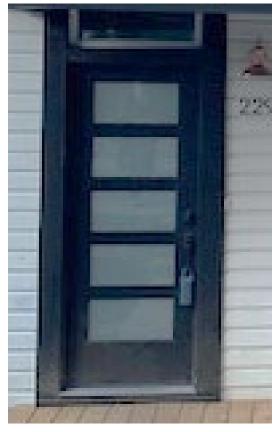
Front door installed as part of the renovation.

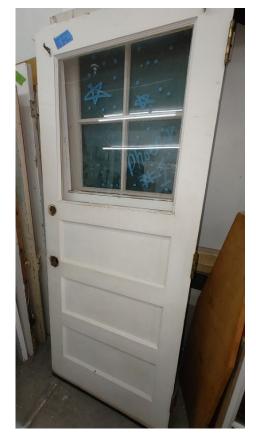
Proposed new front door.

- The front door that the applicant is proposing correspond to the architectural style and period of significance of the historic home. The proposed salvaged front door reflects the architectural style and period of significance of the home.
- 2. Approve basement door as is.

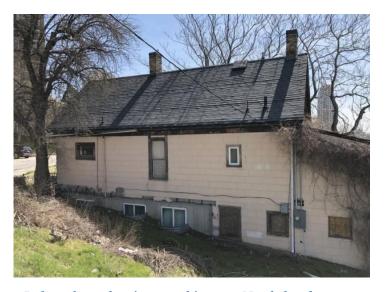
Before photo showing two chimneys. North façade.

Findings: Chimneys are considered significant features of historic properties. Removal of chimneys is not typically recommended for approval by staff. In this case, staff is not recommending that the chimneys are reinstalled because the new dormer was built where the front

chimney was located, and the rear chimney would be a replica since the actual chimney is gone. Standards for renovation of a contributing structure do not recommend reconstruction of nonexistent features.

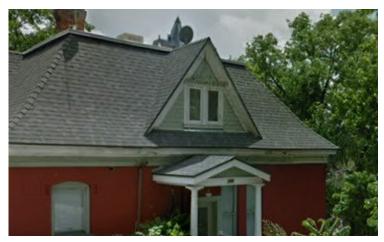
Dormer on the same block face as the subject property.

Staff asked the applicant to consider changing the dormer to better fit the architectural style and the scale of the home. Staff suggested a dormer like the property located just south of this property. Please see photo (left). The applicant responded that they would not be able to reduce the width or height of the dormer because the width and the height are necessary for the landing of the new stairs to meet current IBC standards. The width of the dormer corresponds to the width of the staircase and to the access to the

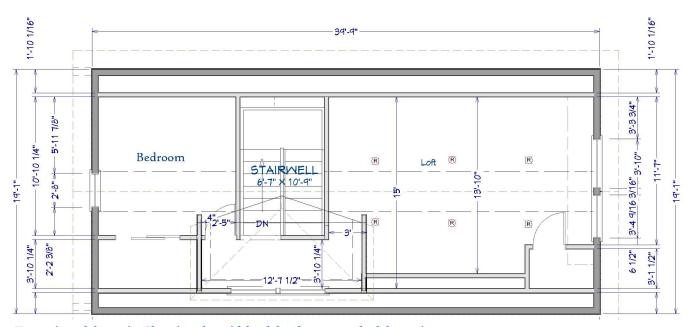
Footprint of the attic. Showing the width of the dormer and of the staircase.

different spaces in the attic. Staff suggested changing the landing of the staircase. The applicant responded that the staircase is 3 stories high and could not be rotated without the entire substructure needing to be re-engineered.

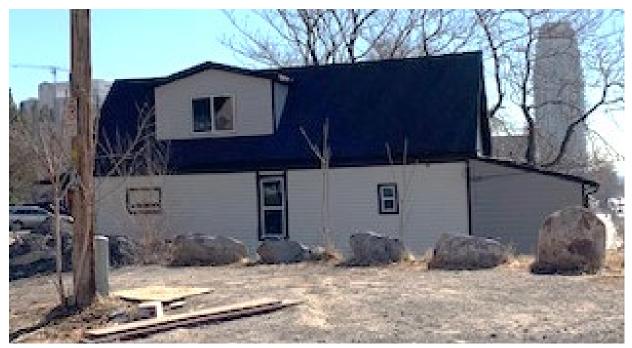
Showing the new dormer on the North elevation.

The dormer was built with a pitched roof that does not match the pitch of the house, the pitch on the dormer is a lot flatter in comparison with the pitch of the house. The dormer is very wide and has a horizontal orientation. The roof ridge of the dormer is of the same height as the roof ridge of the house. The siding of the dormer is vinyl and the window on the dormer is a sliding vinyl window.

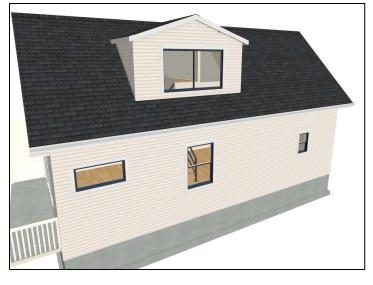
Existing dormer with gable roof and sliding windows

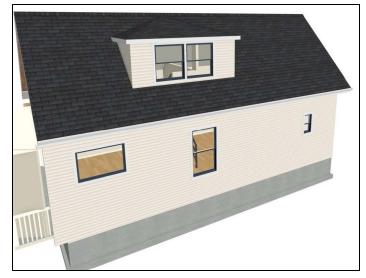
Proposed dormer with hip roof and two windows

- 1. Change the roof shape from a pitch roof to a hip roof, to echo the hip roof at the front of the house. That would be in keeping with some of the roofline and would reduce some of the height of the dormer.
- 2. Change the siding of the dormer from vinyl to wood lap siding.3. Change the one vinyl/slider window of the dormer with two double hung wood windows side by side.

The proposed hip roof is a positive change because it relates to the roof on the porch of the house and it lowers the height. The proposed changes to the siding and window are also positive. However, staff finds that this dormer, even with the proposed changes, would not be subordinate to the roof and the scale of the home.

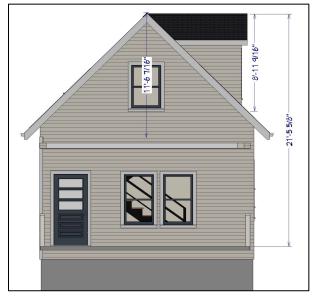
Pitch roof, approximately 9 feet tall to the ridge of the dormer roof

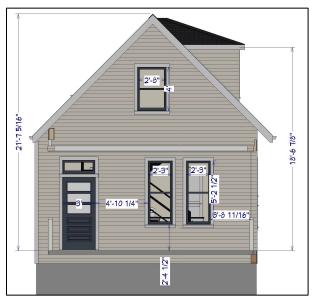
Hip roof, approximately 6 feet tall to the eave of the dormer roof

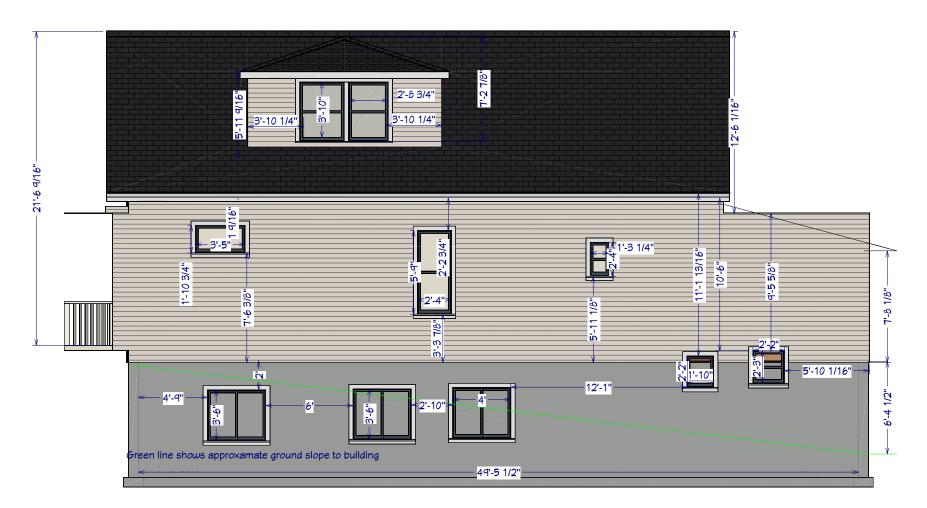
Upper elevation is 15'7" above grade

The terrain slops from the front of the house at the top of the foundation to completely exposing the foundation wall just before the addition

Addition has shed roof , because of sotware limitations I cannot render the roof in this drawing.

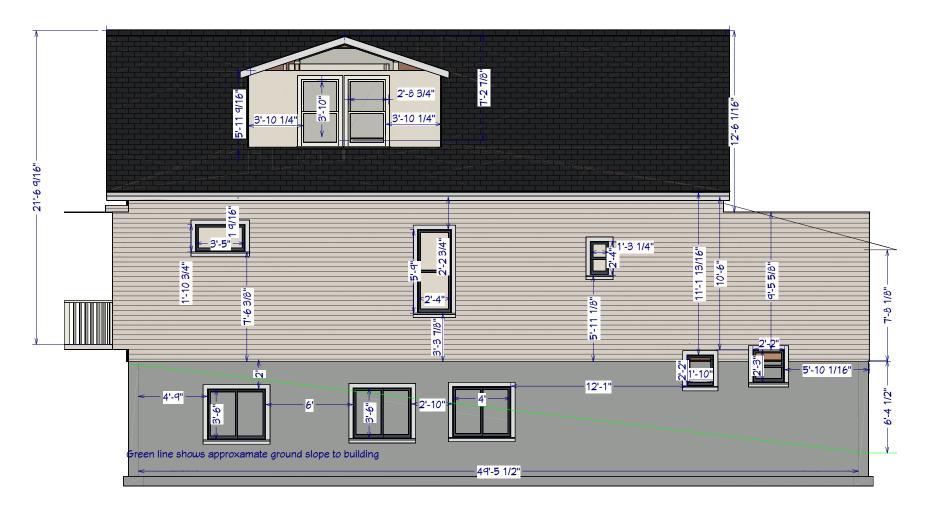
Lower elevation is 14' above grade

Upper elevation is 15'7" above grade

The terrain slops from the front of the house at the top of the foundation to completely exposing the foundation wall just before the addition

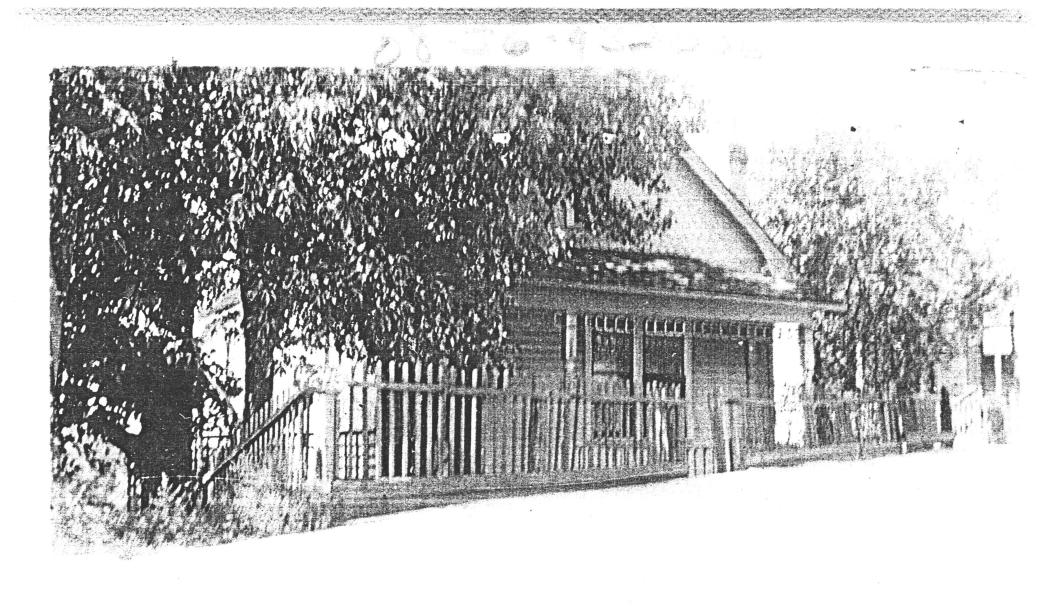
229 N. Almond Street, Salt Lake City, Utah Salt Lake County tax cards & photo, 1936
