Staff Report

To: Salt Lake City Historic Landmark Commission
From: Katia Pace, Principal Planner (801)-535-6354, katia.pace@slcgov.com
Date: November 3, 2022
Re: PLNHLC2022-00242 – Minor Alterations for an addition and window openings

PROPERTY ADDRESS: 365 N Quince Street
PARCEL ID: 08-36-282-015-0000
MASTER PLAN: Capitol Hill Master Plan
ZONING DISTRICT: SR-1A, Historic Preservation Overlay (Capitol Hill)
DESIGN GUIDELINES: Residential Design Guidelines

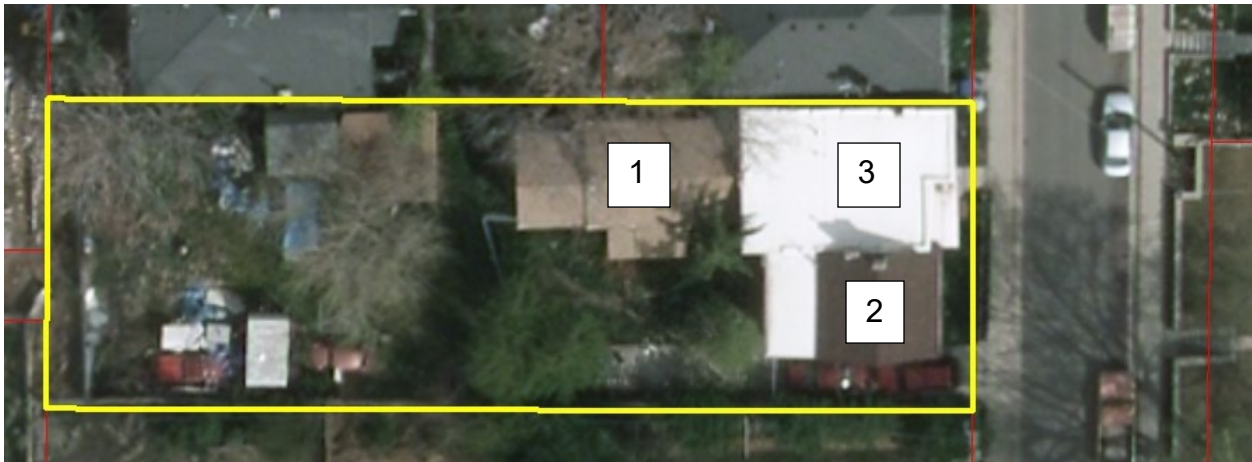
Aerial View – aerial view of the property with the three structures

This property is comprised of three separate dwelling units. The three houses contribute to the architectural character of the Capitol Hill Historic District.

1. House #1, a single-family home, was established before 1870 with an early vernacular architecture style.
2. House #2 was established sometime before 1915 as a retail store and the basement was converted to a dwelling unit between 1947 and 1950.
3. House #3 is a flat roofed, brick building, built at approximately 1921.

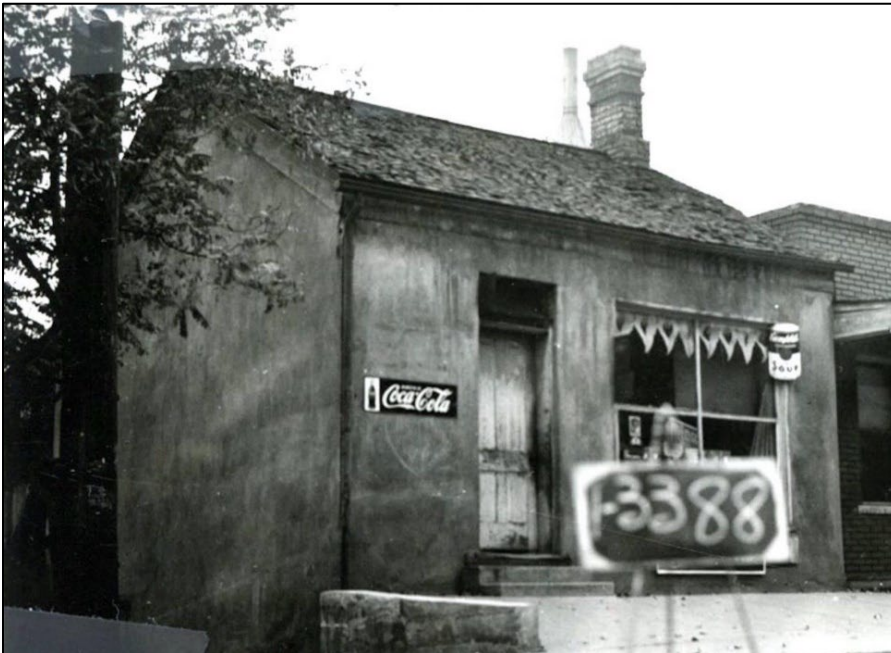
South and East elevation – front façade, historic photo from approximately 1936

The only known historic photograph of the property is a tax survey photo taken in 1936, 60 years after the store was built. The exterior details include smooth stucco finish, soffit & fascia, inset door & transom, copper gutter, and oversized store window. The original porch on the north side was removed in 1919 when House #3 was built.

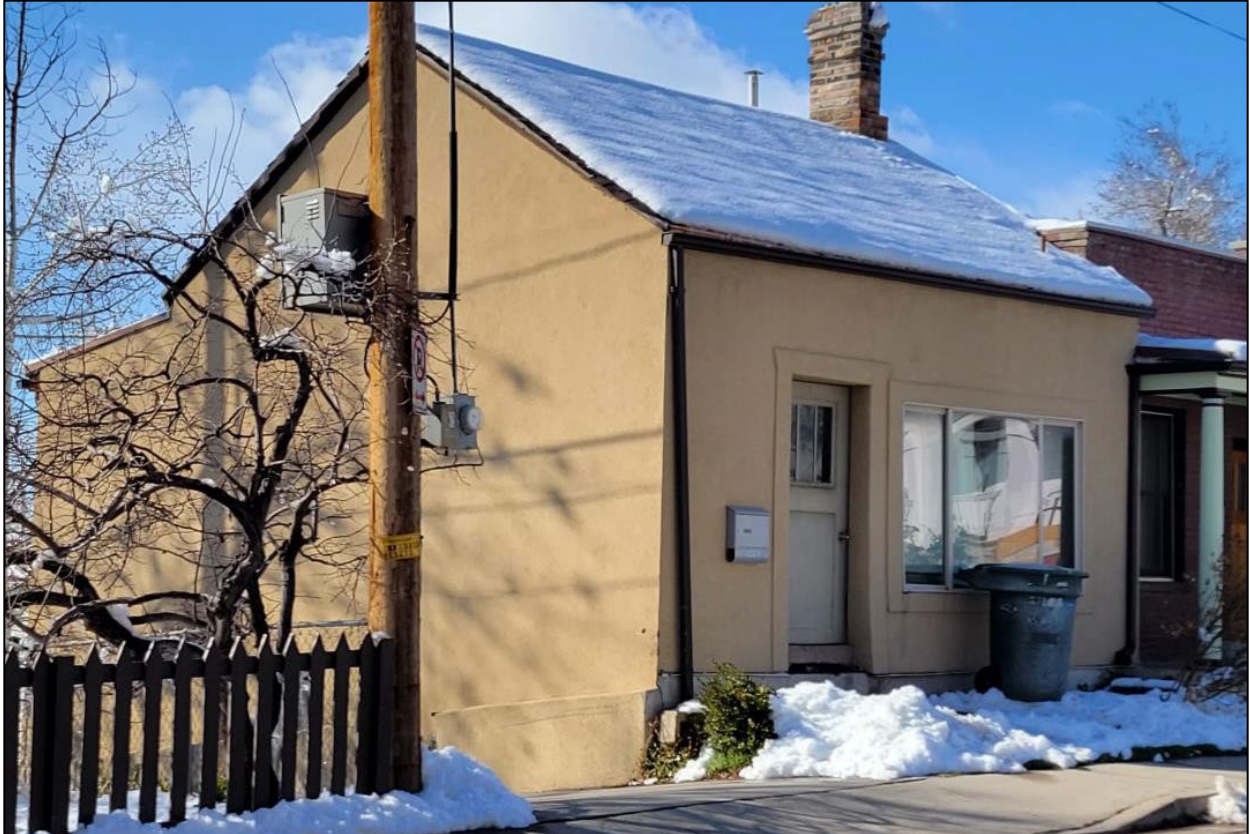
South and East elevation – front façade, current view

All historic exterior finishes have been removed and replaced with elements that are incompatible with the historic character of this structure. The proposal is to restore House #2 using historic or historic-equivalent materials supported by historic photos and written evidence.

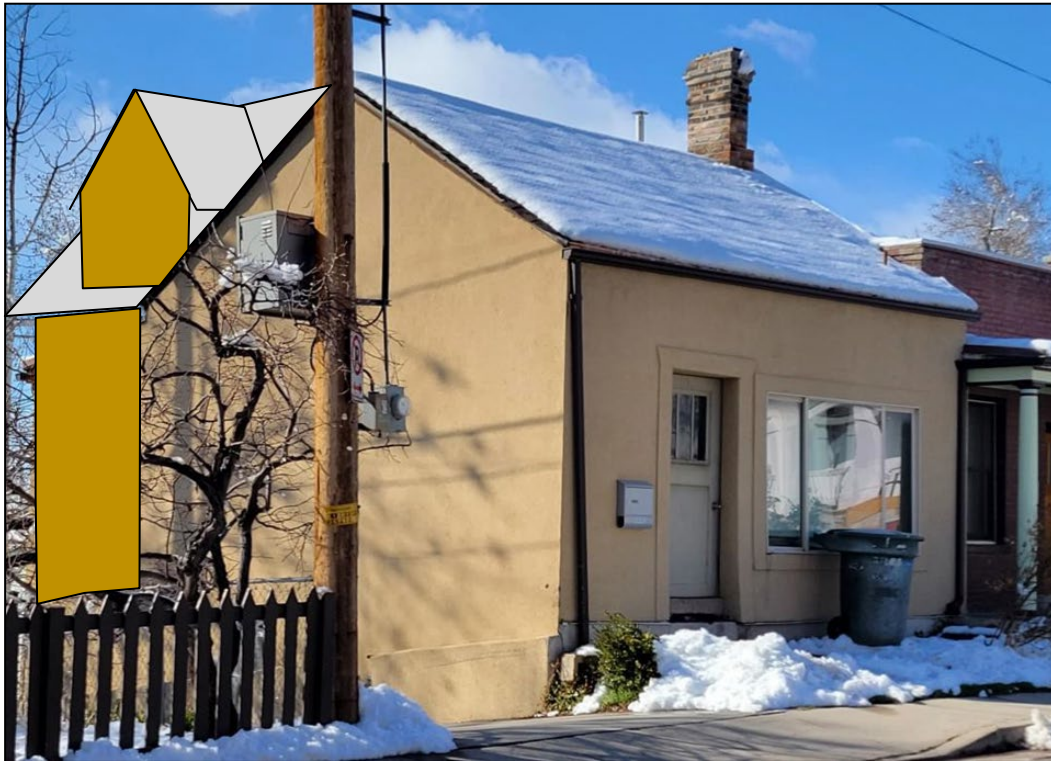
South and East elevation – showing proposed restored addition

Findings: The new west-facing, gable-end, loft roof will be located on the rear of the structure. Because of the slope of the property, the addition will start from a grade lower than the principal structure and from the street view the addition will look shorter than the principal structure. The addition will be seen from the south side of the street. The north façade is next to House #3, which blocks its view. The extension to the addition will not block any views to abutting properties.

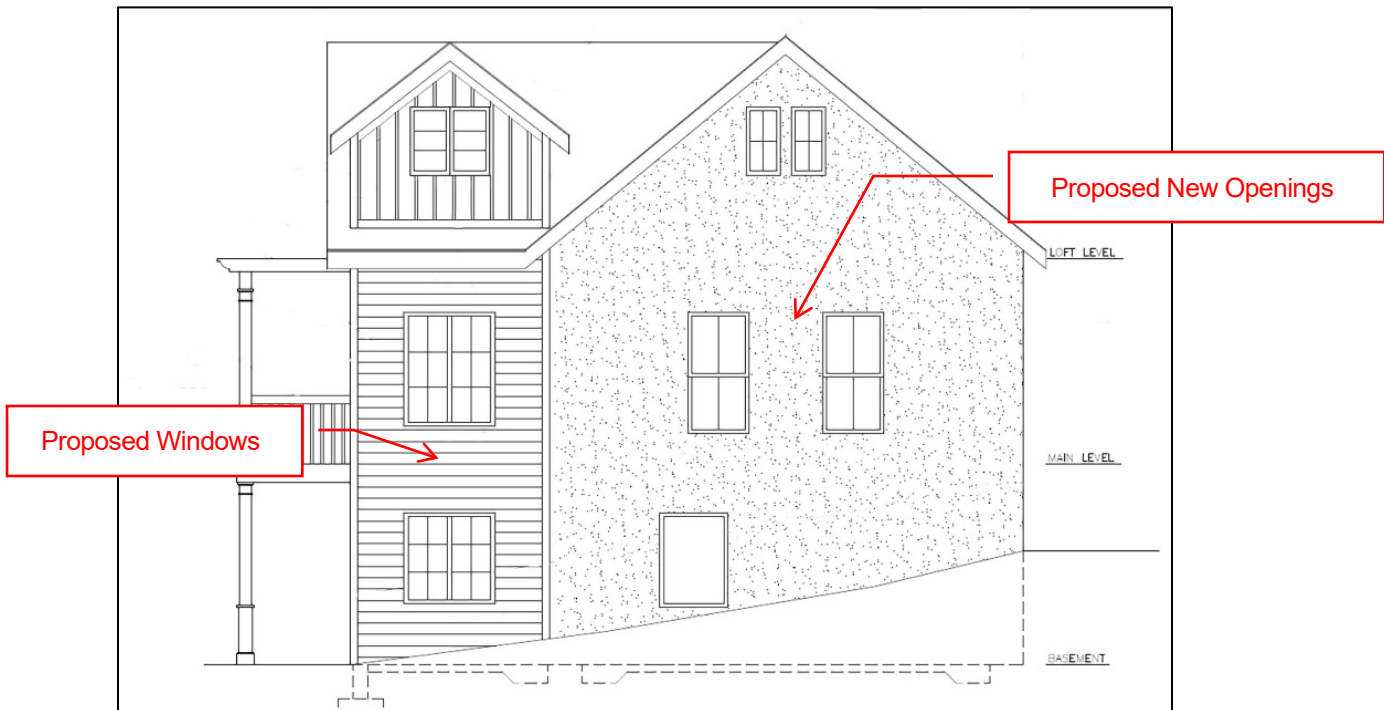
South elevation – showing proposed new openings on historic structure and proposed windows in the addition

Since House #2 was built as a store, the adobe structure had no windows on the main floor of the south side. That wall had interior shelving for the store. The basement has one small window on the south side of the adobe structure. According to Chapter 3 - Windows, of the Residential Design Guidelines, adding window openings is generally inappropriate. However, this is an adaptive reuse from a store to a residential structure. New windows would not only provide a better living environment as a residential unit, but the ventilation offered by the windows will improve the efficiency and life span of the adobe bricks.

Findings: Staff finds that the proposed window openings are important to the preservation of this building by providing ventilation to an adobe structure and to transition from commercial to residential. House # 2 has a vernacular architectural style with a simple gable roof and end chimney. As such, the proposed two-over-two, cottage-style windows are appropriate to the structure's architectural style.

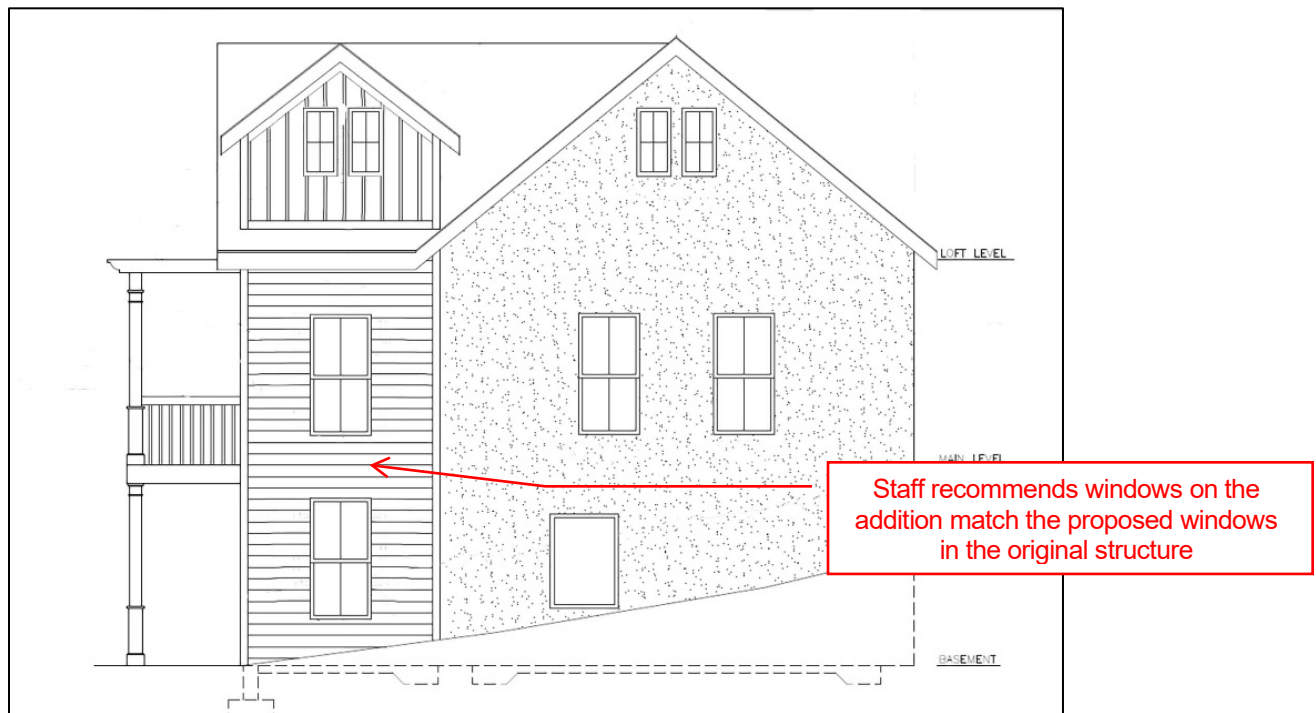
South Elevation – staff proposes similar windows on the addition and on the new openings

Findings: The proposed windows on the addition will be visible from the street. Staff recommends that the windows in the addition match the proposed new windows on the South side of the historic building as a condition of approval.

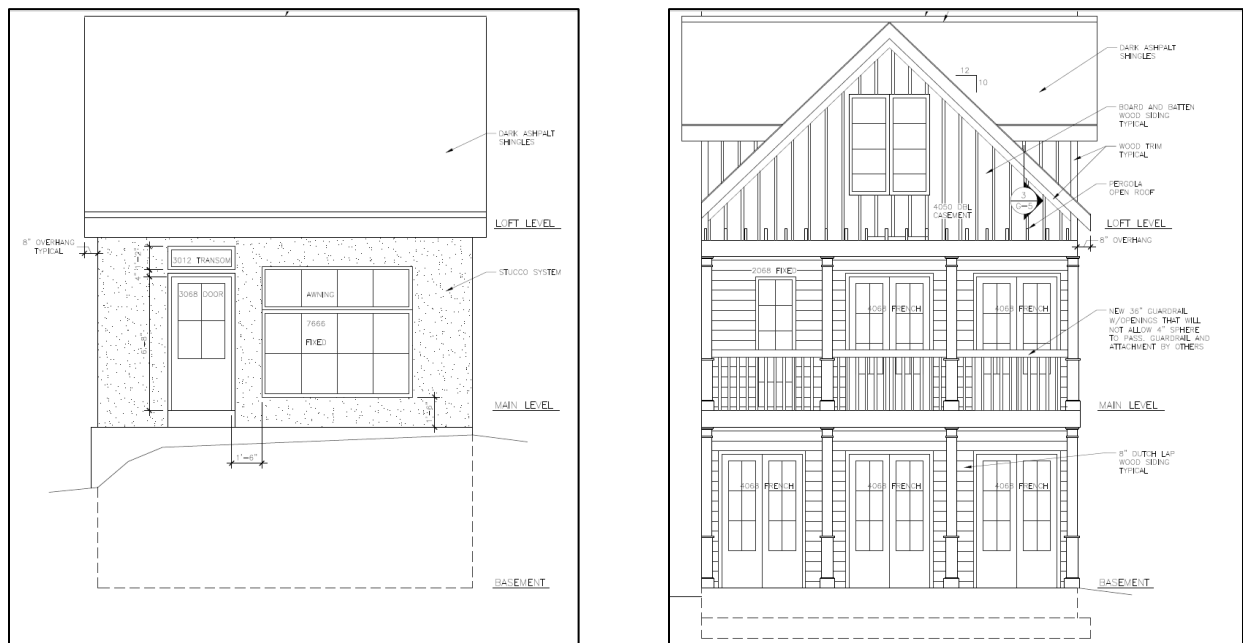
East (front) and East (rear) Elevations – appearance is inconsistent

The existing architectural style on the principal structure is simple vernacular and on the proposed addition the style is much more ornate. According to Chapter 8 – Additions, of the Residential Design Guidelines, the “appearance inconsistent with the historic character of the building is inappropriate”.

Findings: Staff finds that what makes this addition more ornate are the details on the windows, doors and columns which will be on the rear of the property, and not visible from the street. Consequently, there is more flexibility to what can be approved on the rear of the property.

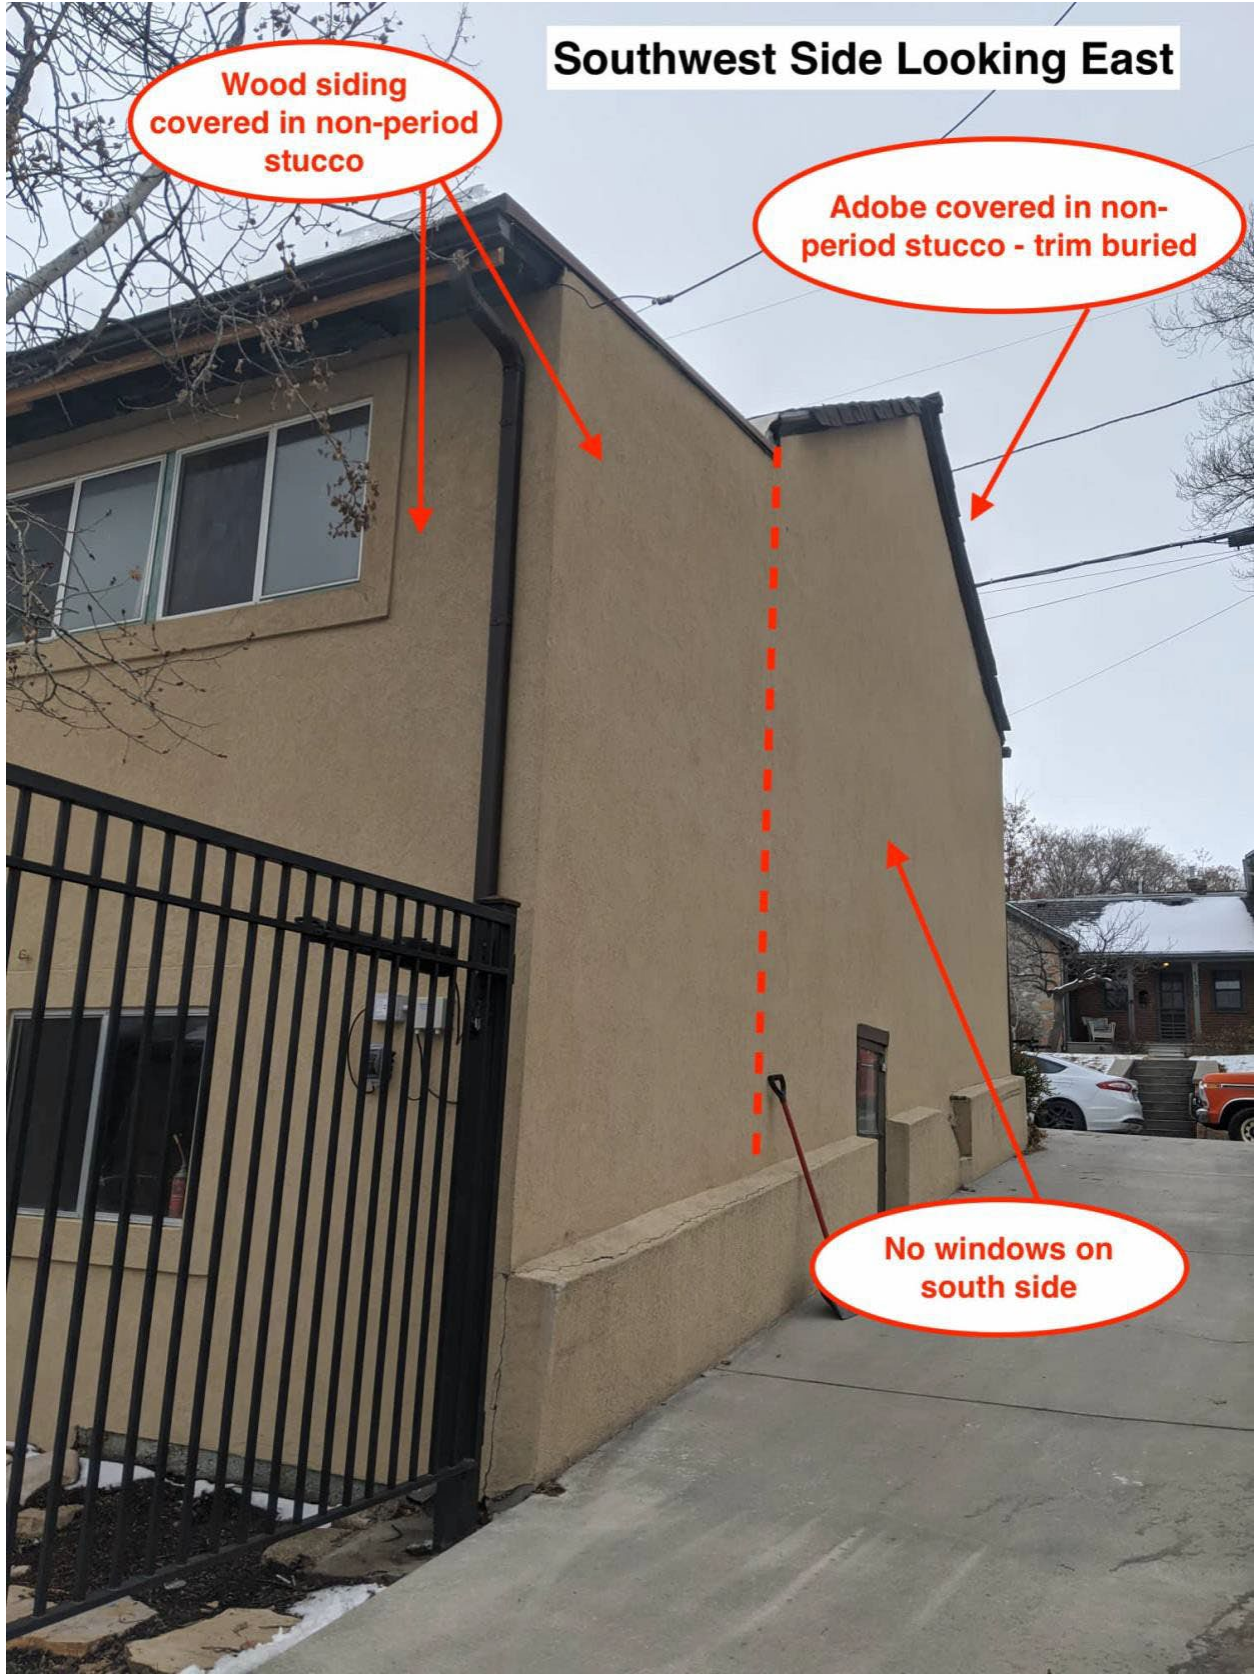
Wood siding covered in non-period stucco

Adobe covered in non-period stucco - trim buried

No windows on south side

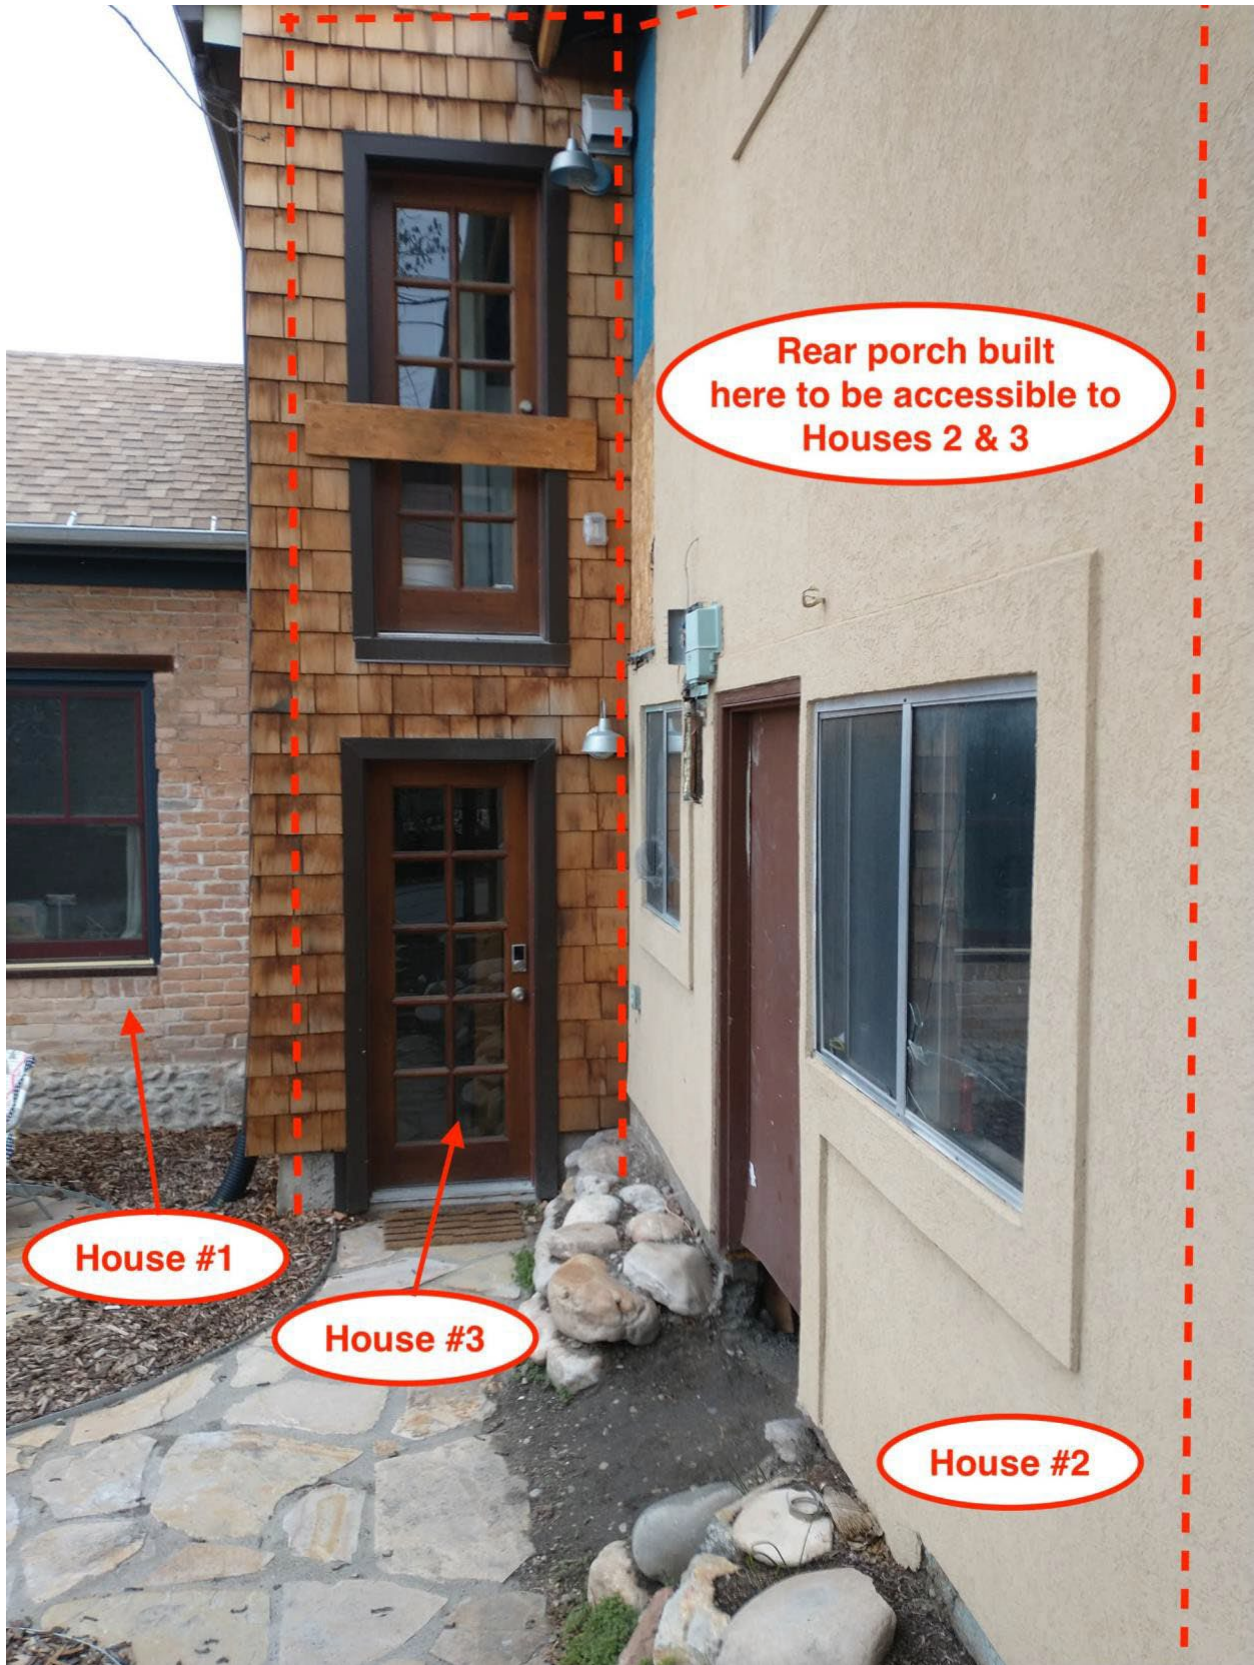
Rear porch built here to be accessible to Houses 2 & 3

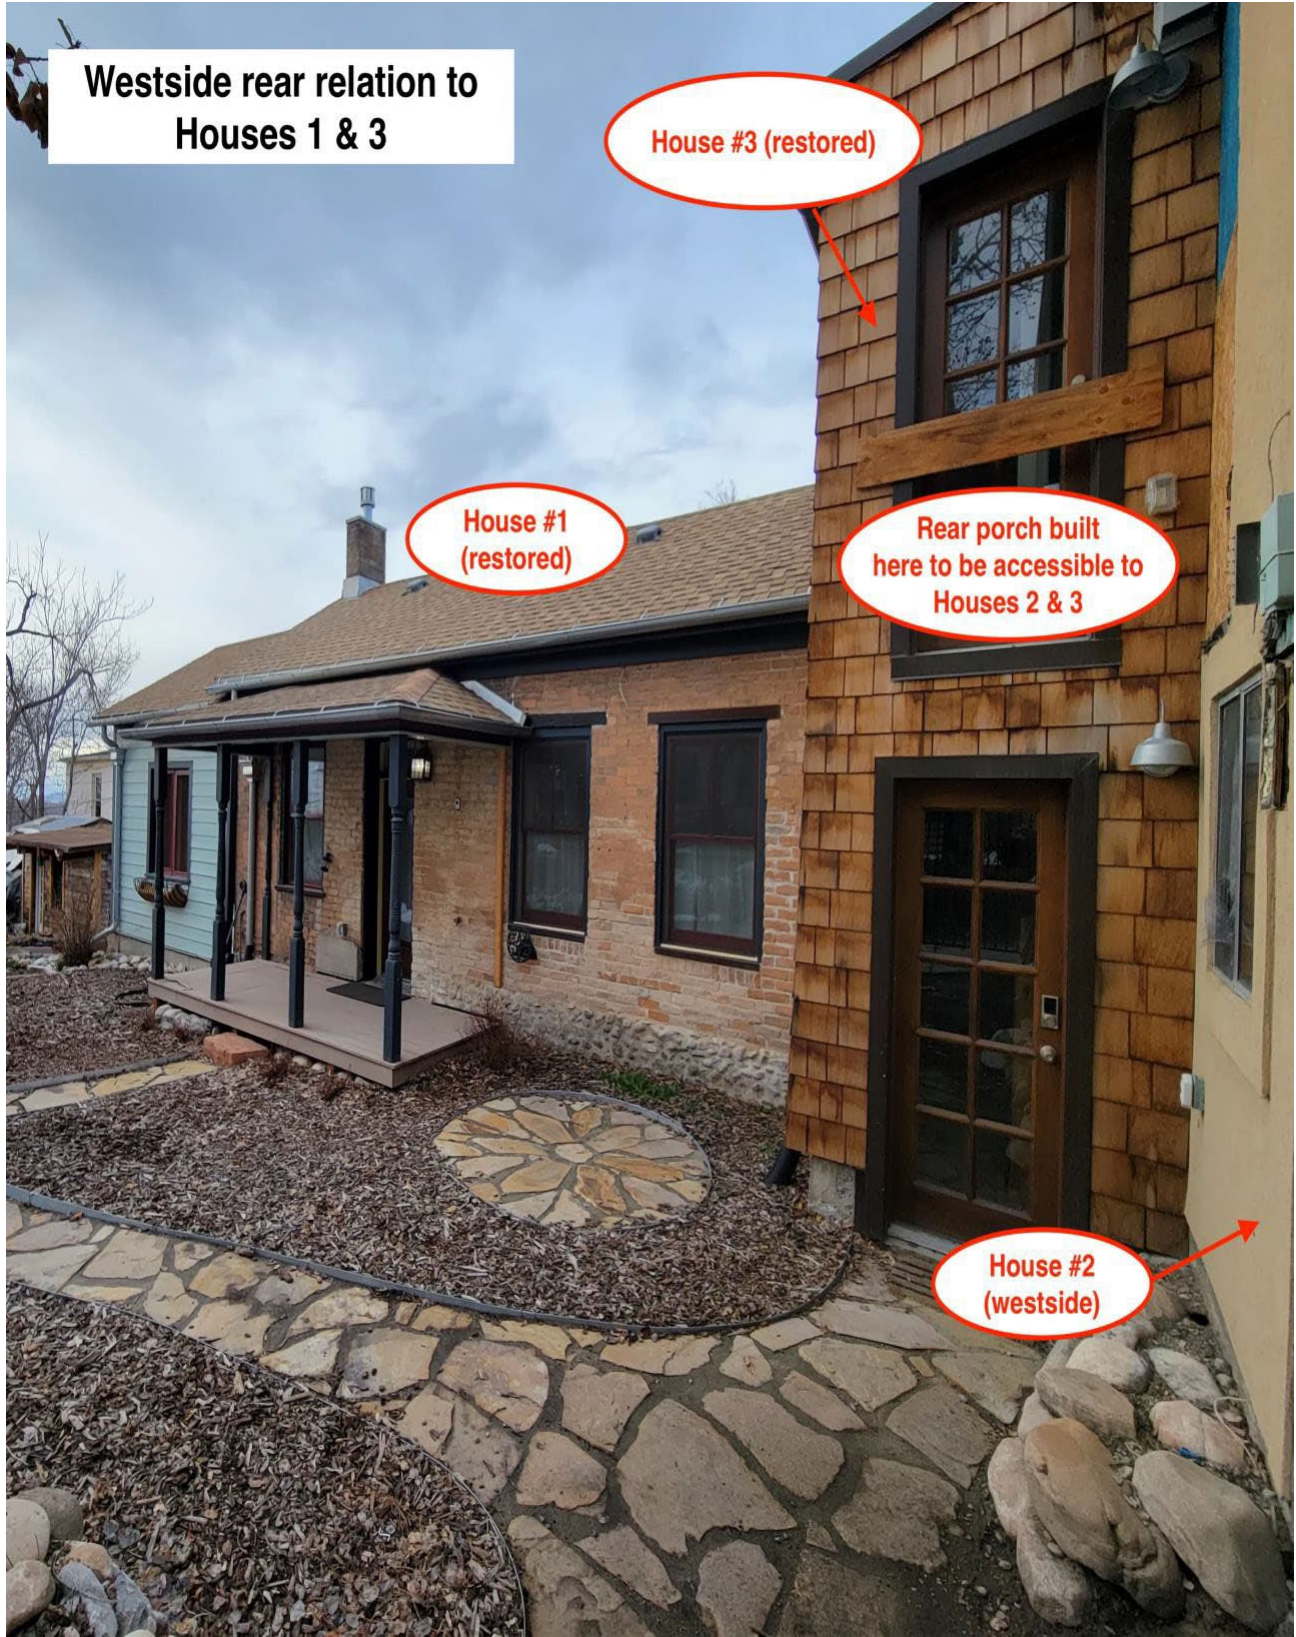
Westside rear relation to Houses 1 & 3

Rear porch built here to be accessible to Houses 2 & 3

House #2 (westside)

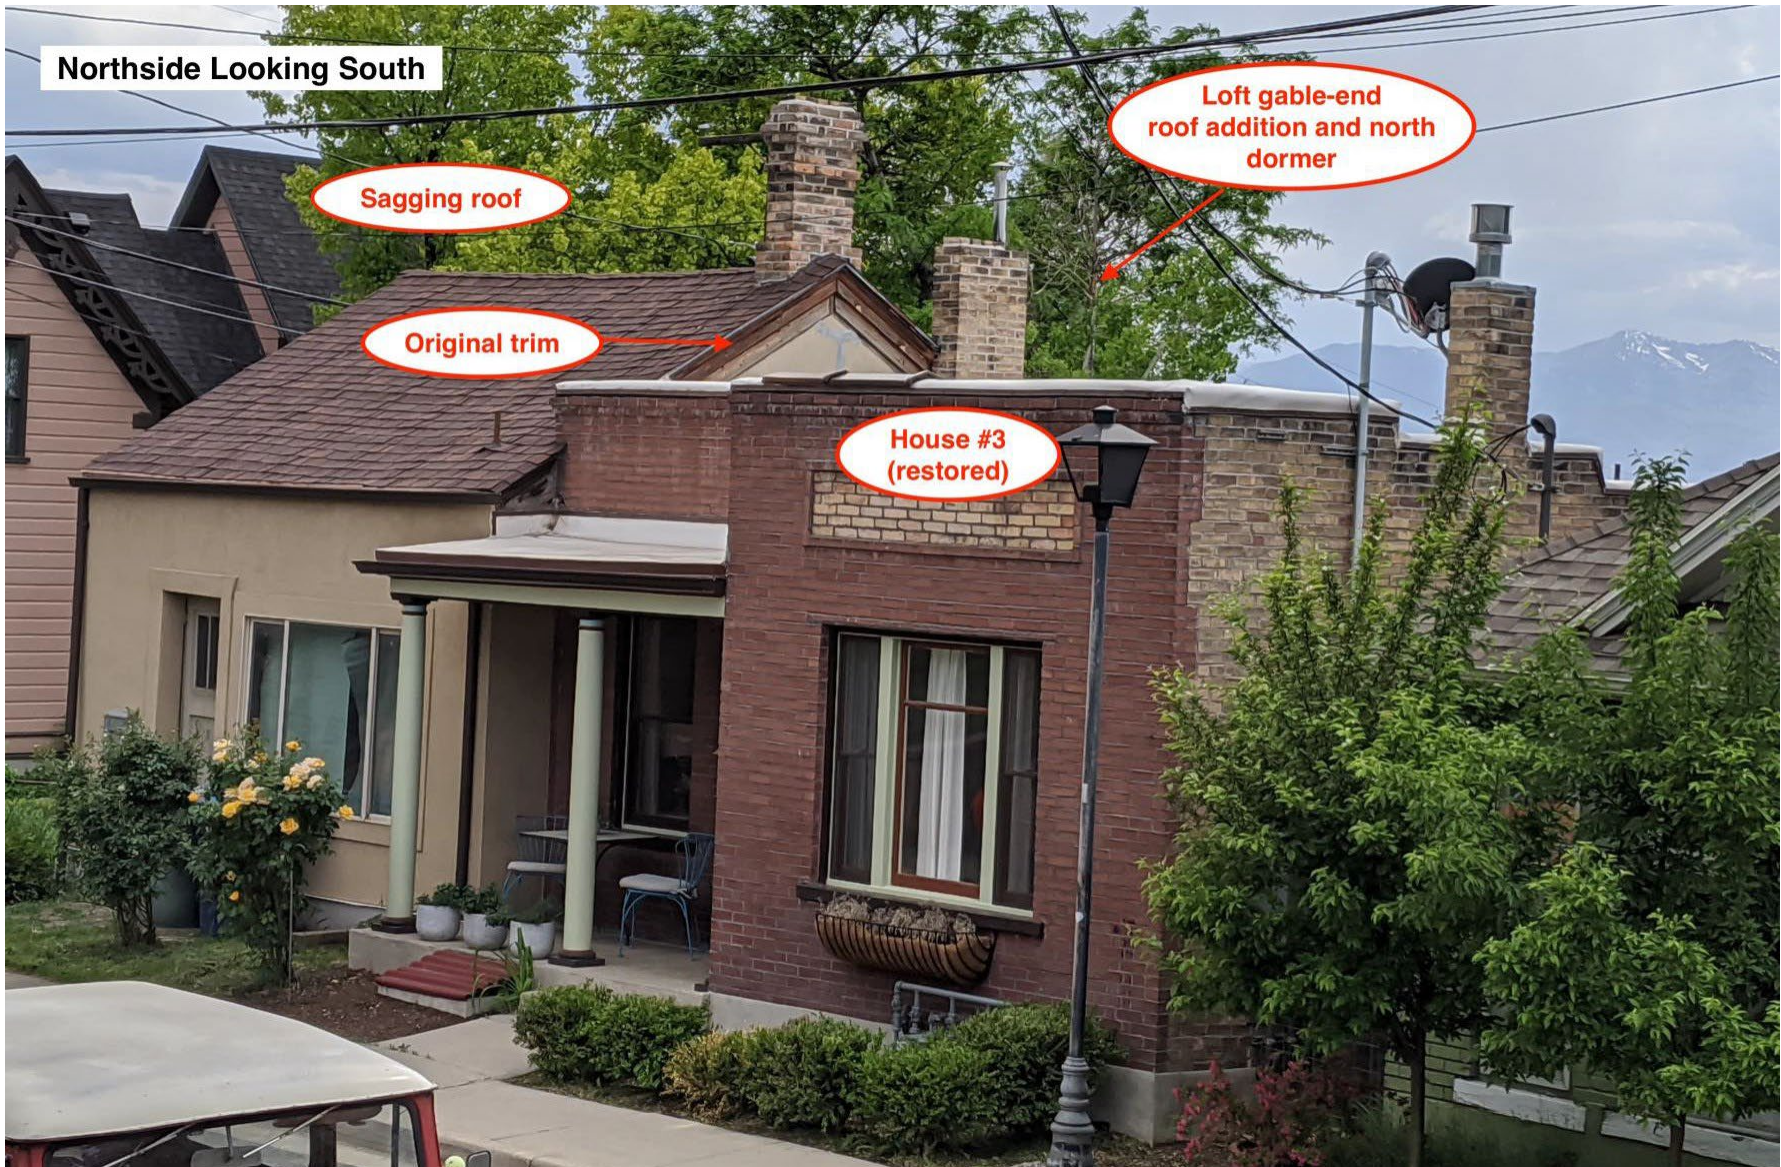
Northside Looking South

Sagging roof

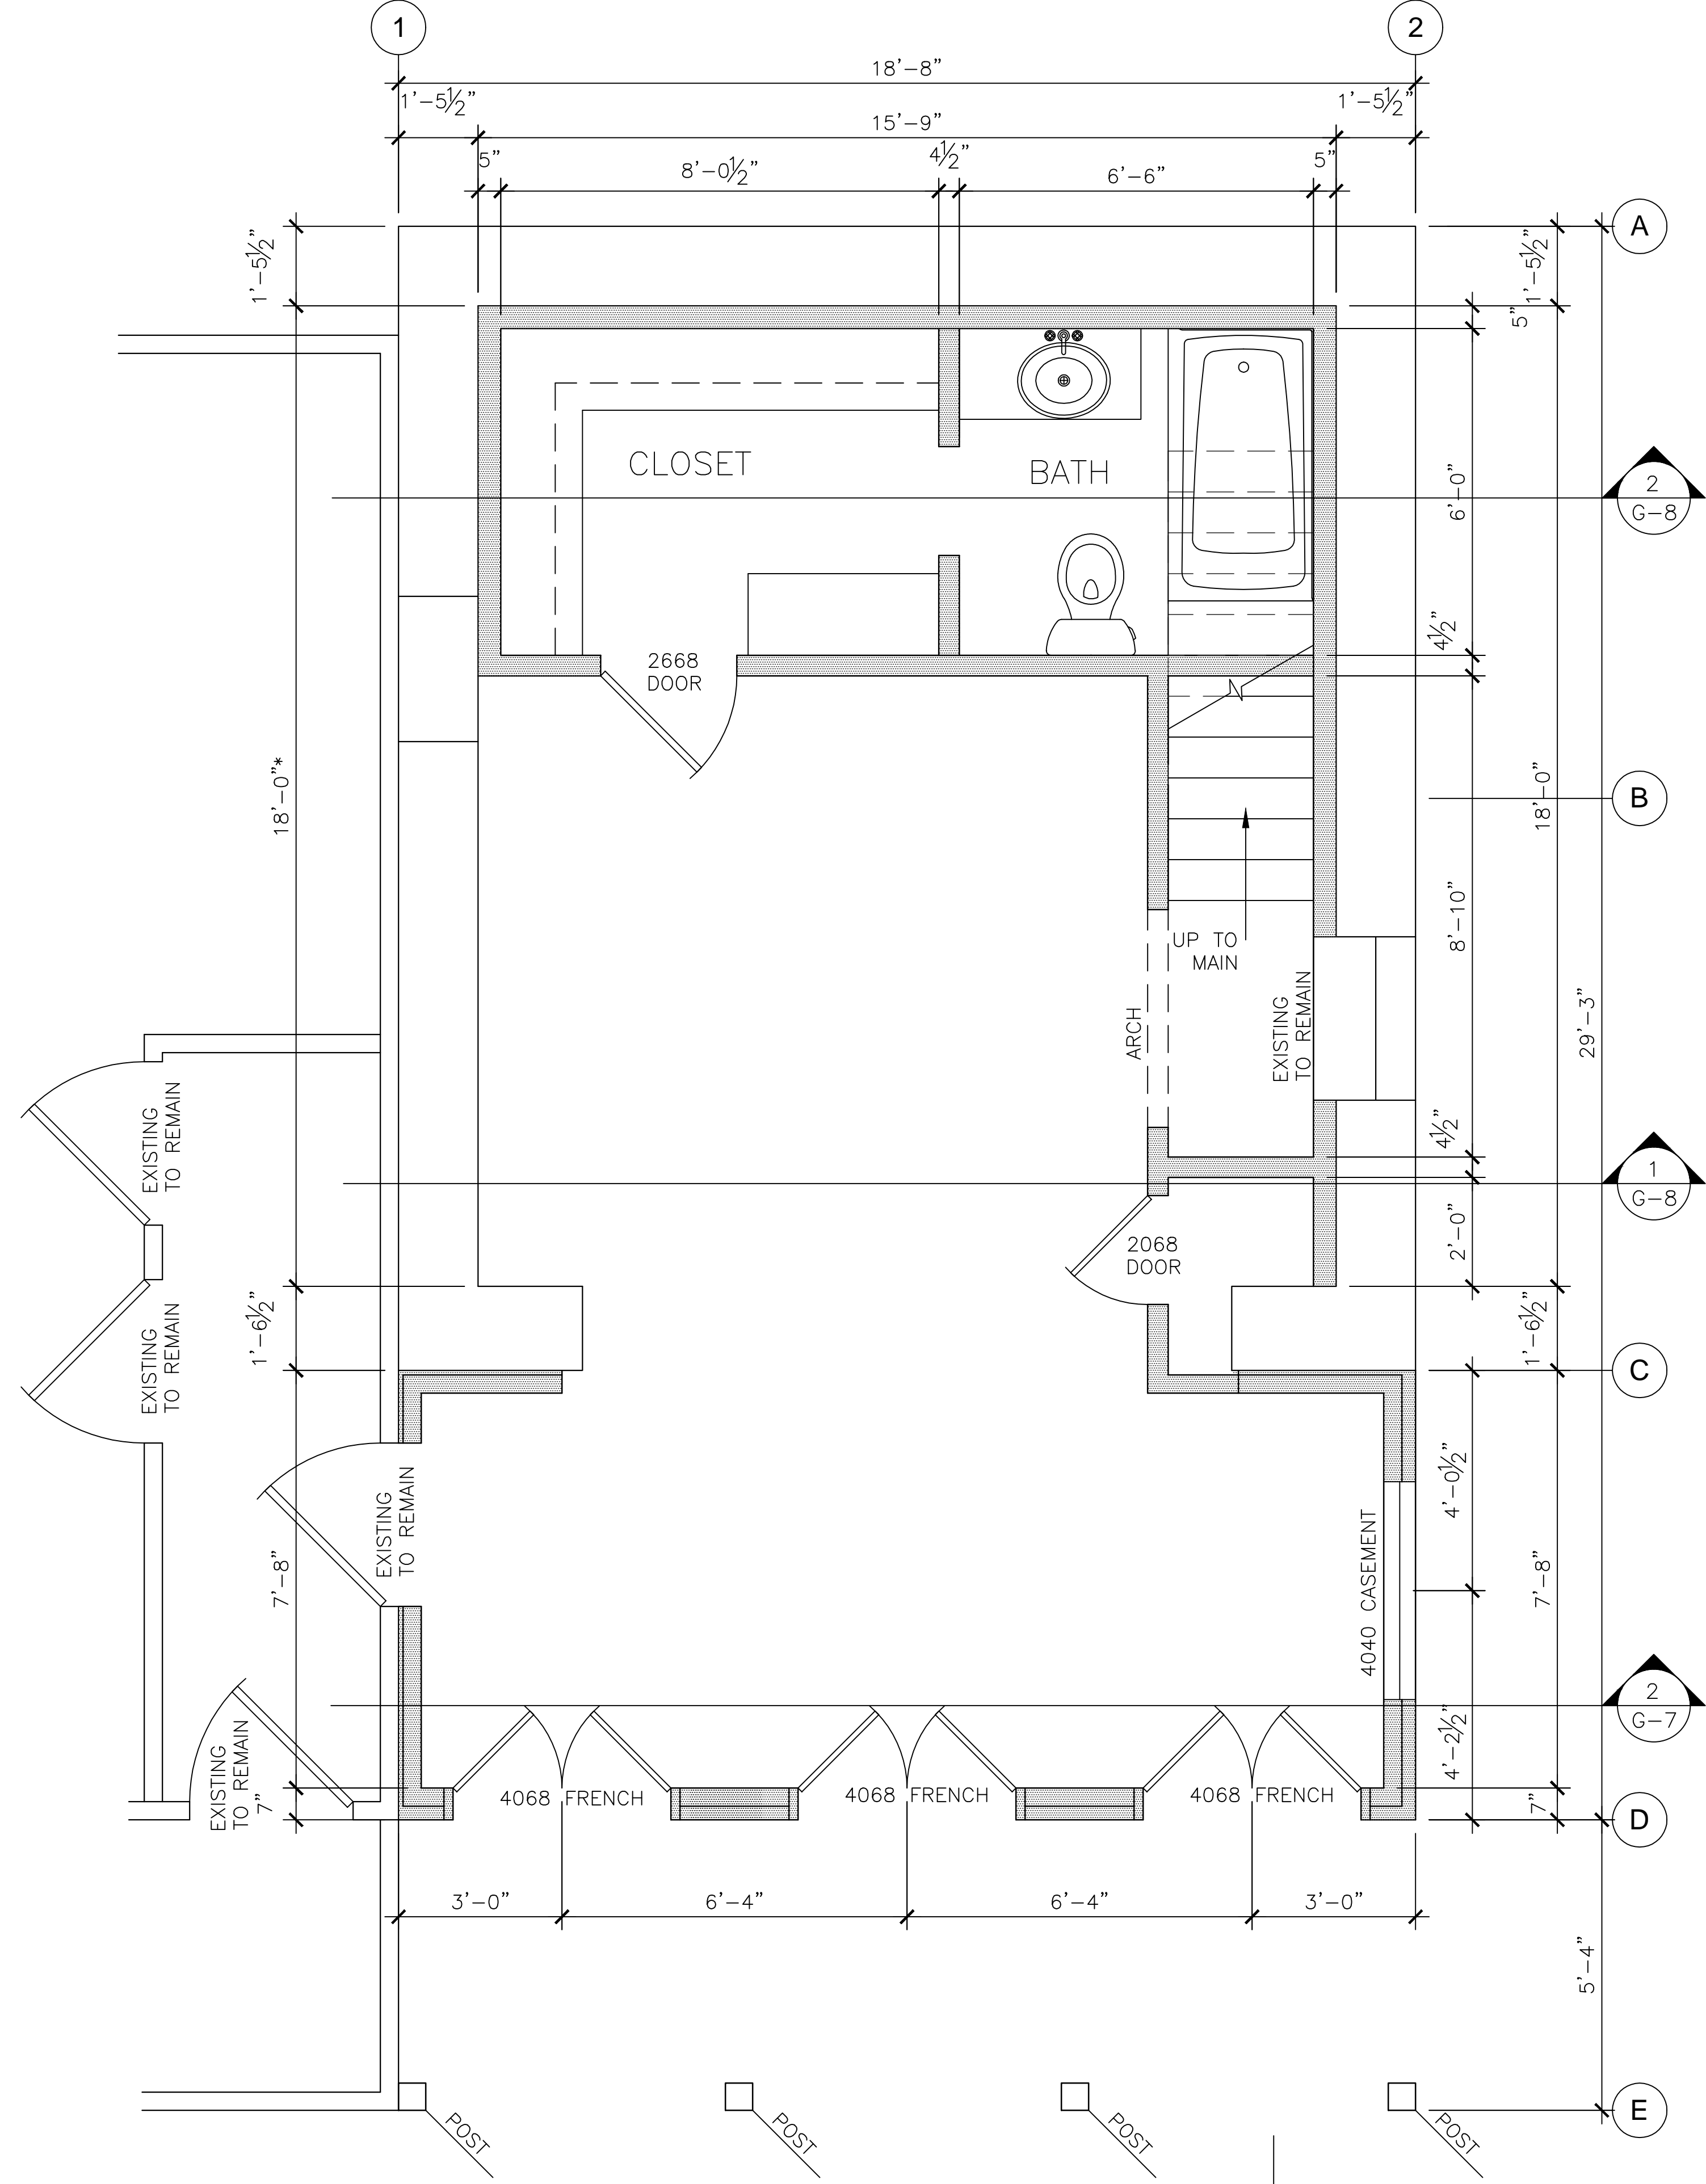
1 BASEMENT FLOOR PLAN
G-2 SCALE: 1/2" = 1'-0" ON 24"x36"
SCALE: 1/4" = 1'-0" ON 12"x18"

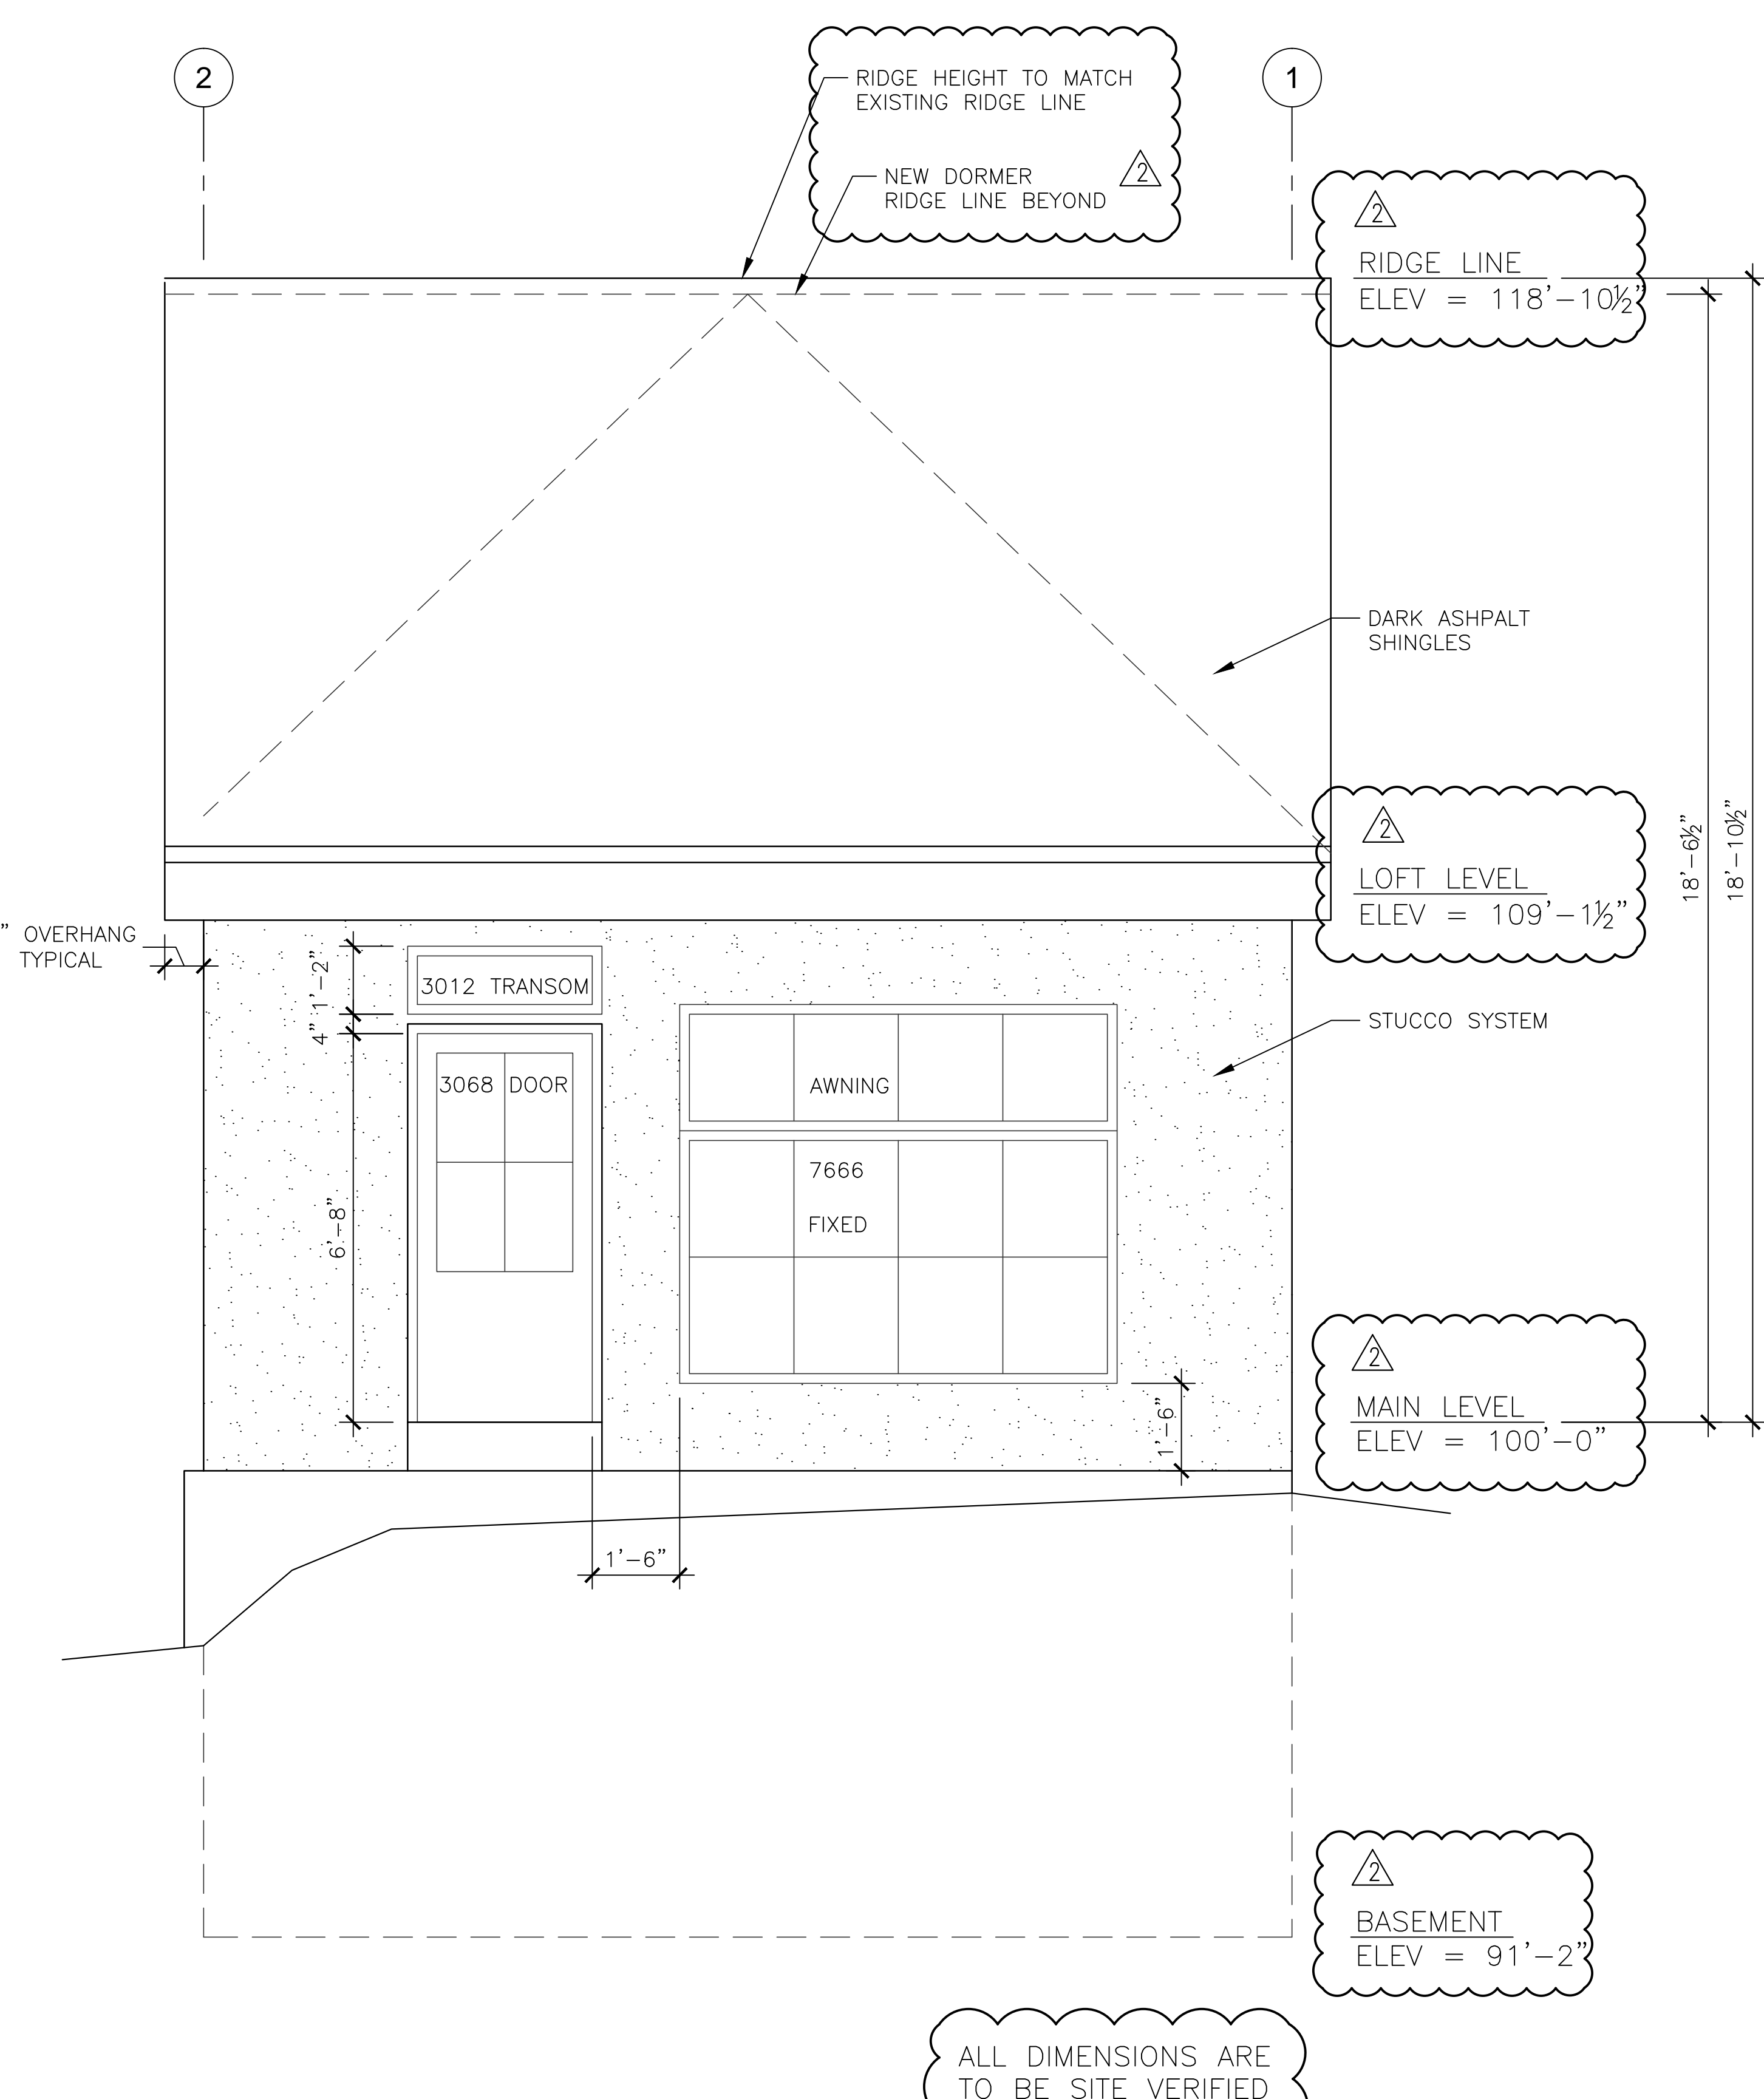
1 EAST ELEVATION
 G-4 SCALE: 1/2" = 1'-0" ON 24"x36"
 SCALE: 1/4" = 1'-0" ON 12"x18"
