Staff Report

To: Salt Lake City Historic Landmark Commission
From: Katia Pace, Principal Planner (801)-535-6354, katia.pace@slcgov.com
Date: November 3, 2022
Re: PLNHLC2022-00242 – Minor Alterations for an addition and window openings

PROPERTY ADDRESS: 365 N Quince Street
PARCEL ID: 08-36-282-015-0000
MASTER PLAN: Capitol Hill Master Plan
ZONING DISTRICT: SR-1A, Historic Preservation Overlay (Capitol Hill)
DESIGN GUIDELINES: Residential Design Guidelines

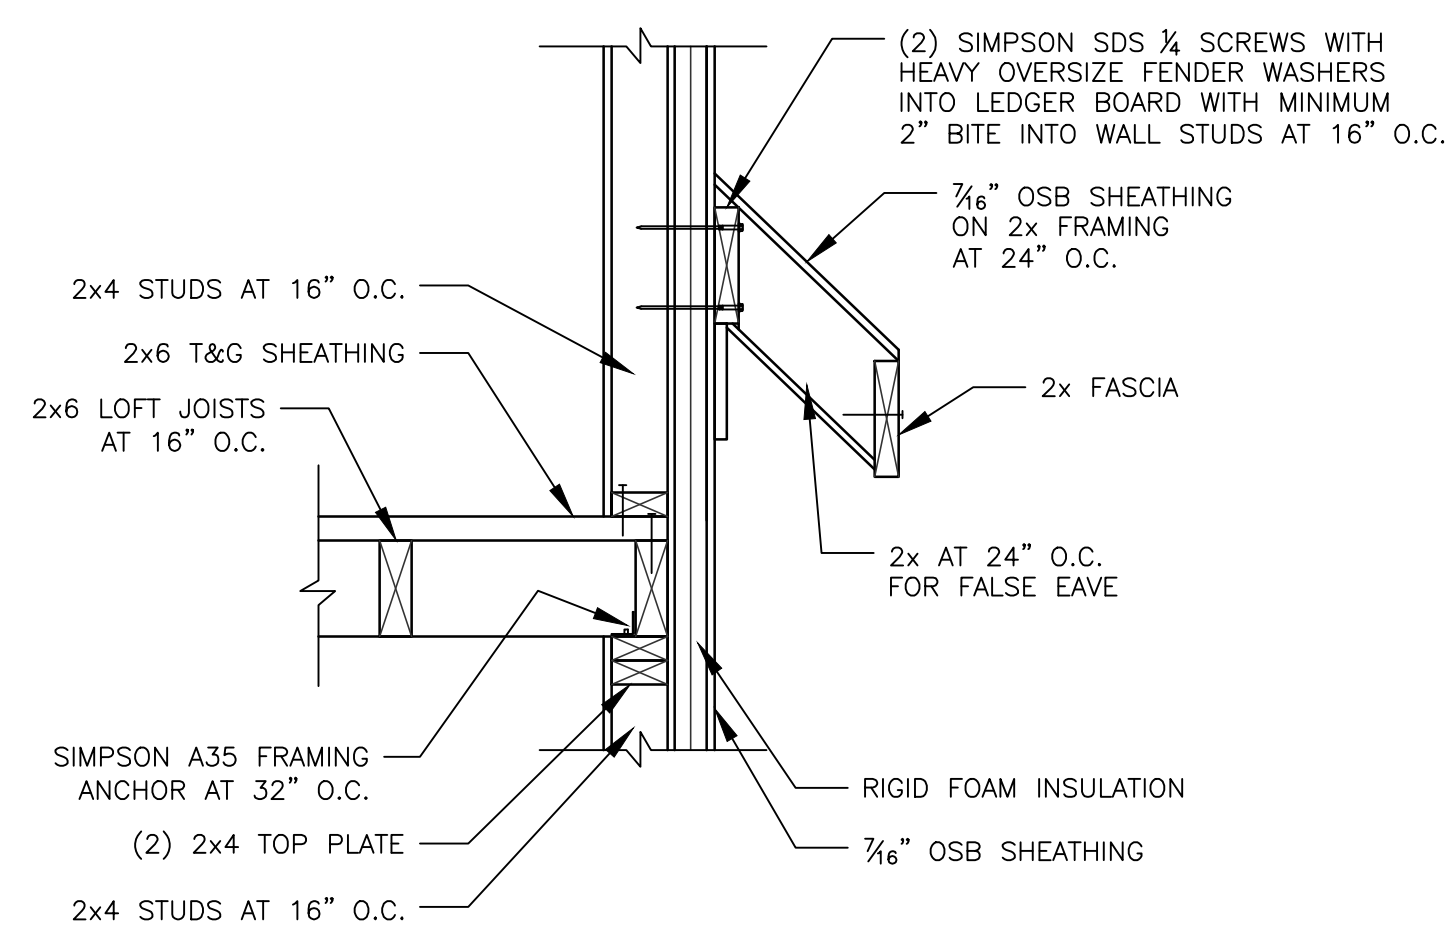
2 FALSE EAVE DETAIL
SCALE: 1" = 1'-0" ON 24"x36"
SCALE: 1/2" = 1'-0" ON 12"x18"

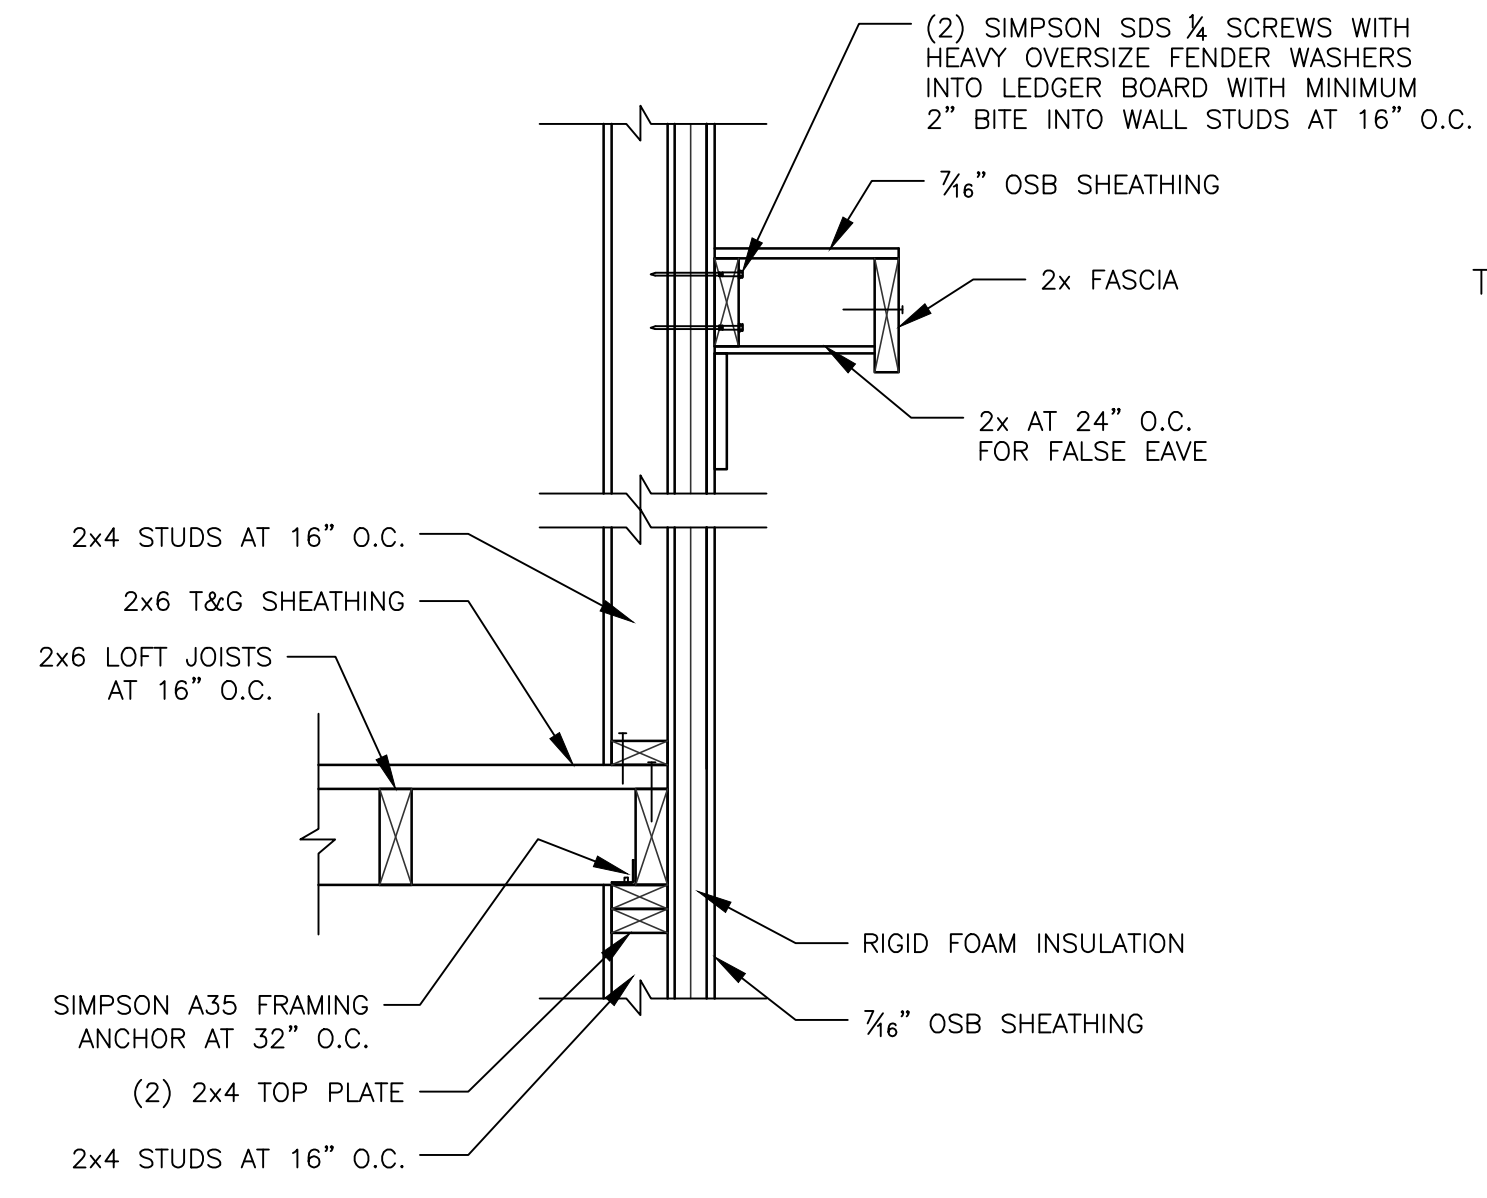
3 FALSE EAVE DETAIL
SCALE: 1" = 1'-0" ON 24"x36"
SCALE: 1/2" = 1'-0" ON 12"x18"

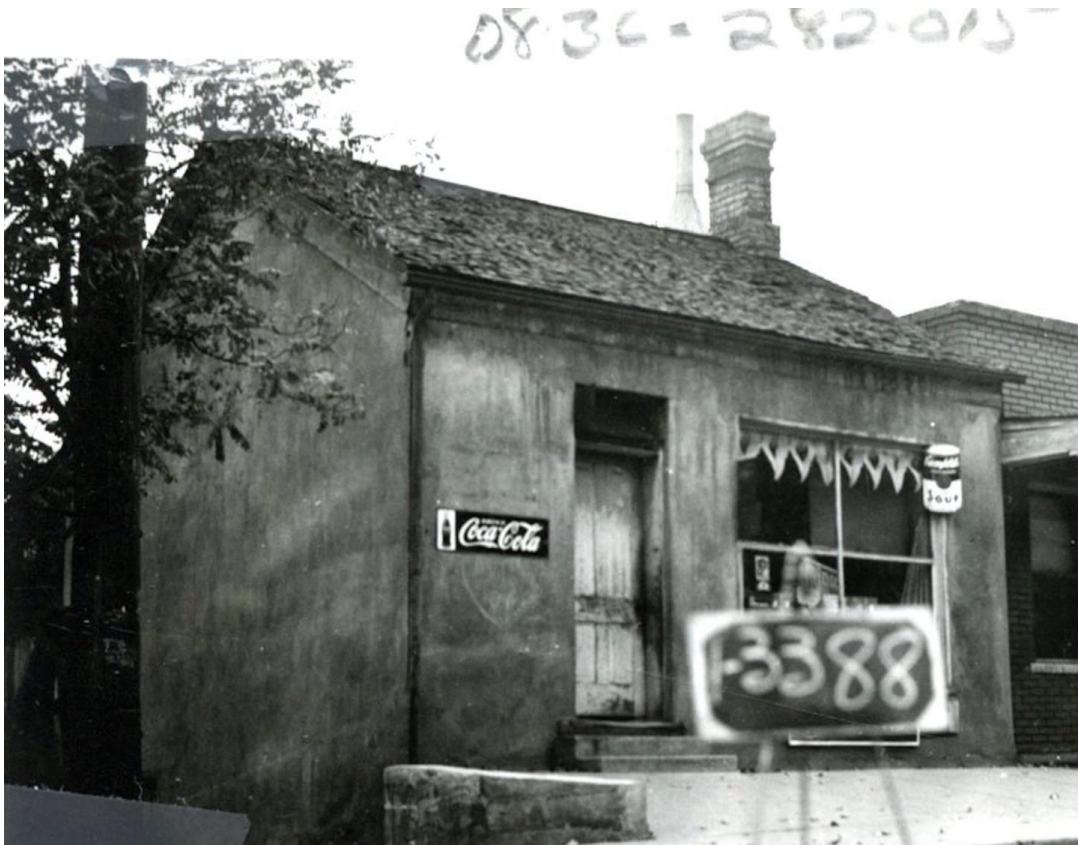
House #2 historic survey photo taken in approximately 1936.

The only known historic photograph of the property is a tax survey photo taken in 1936, 60 years after "The Store" was built. The exterior details which remained at that time include the smooth stucco finish, soffit & fascia, inset door & transom, copper gutter, and oversized store window. The original porch on the north side was removed in 1919 when House #3 was built.

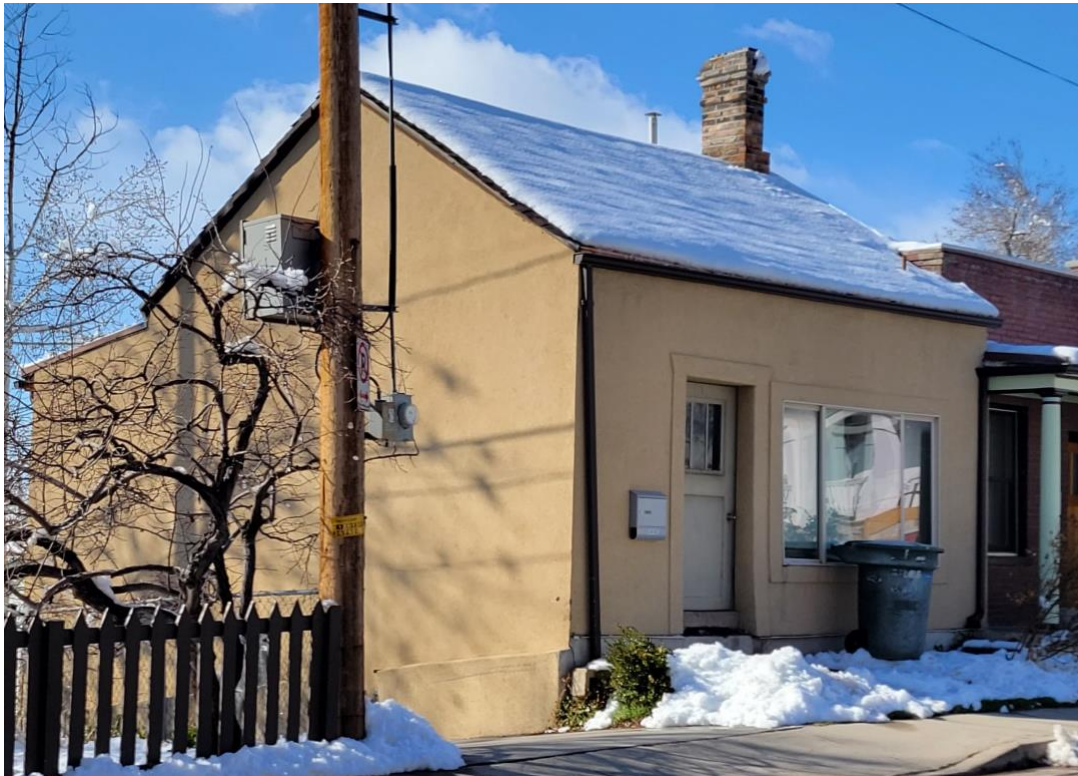
House #2 as it is today.

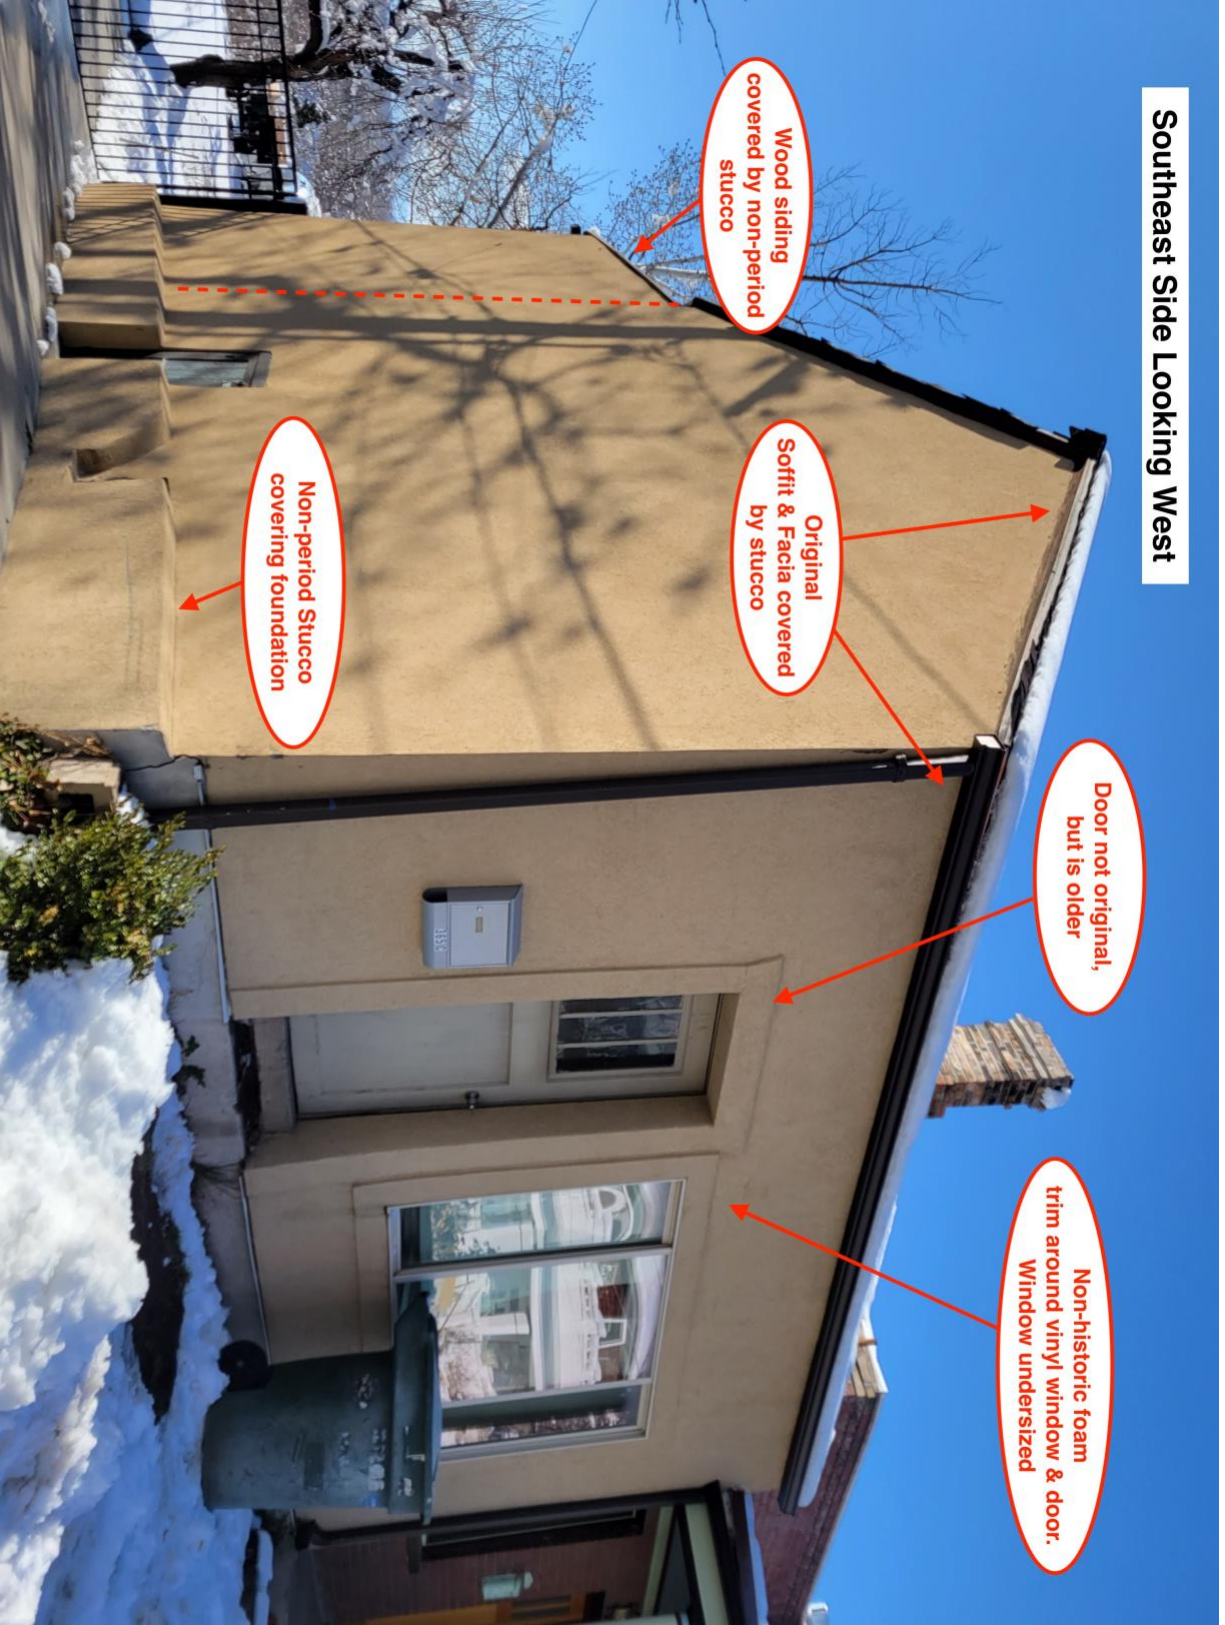
Southeast Side Looking West

Wood siding covered by non-period stucco

Original Soffit & Fascia covered by stucco

Non-period Stucco covering foundation

Non-historic foam trim around vinyl window & door. Window undersized

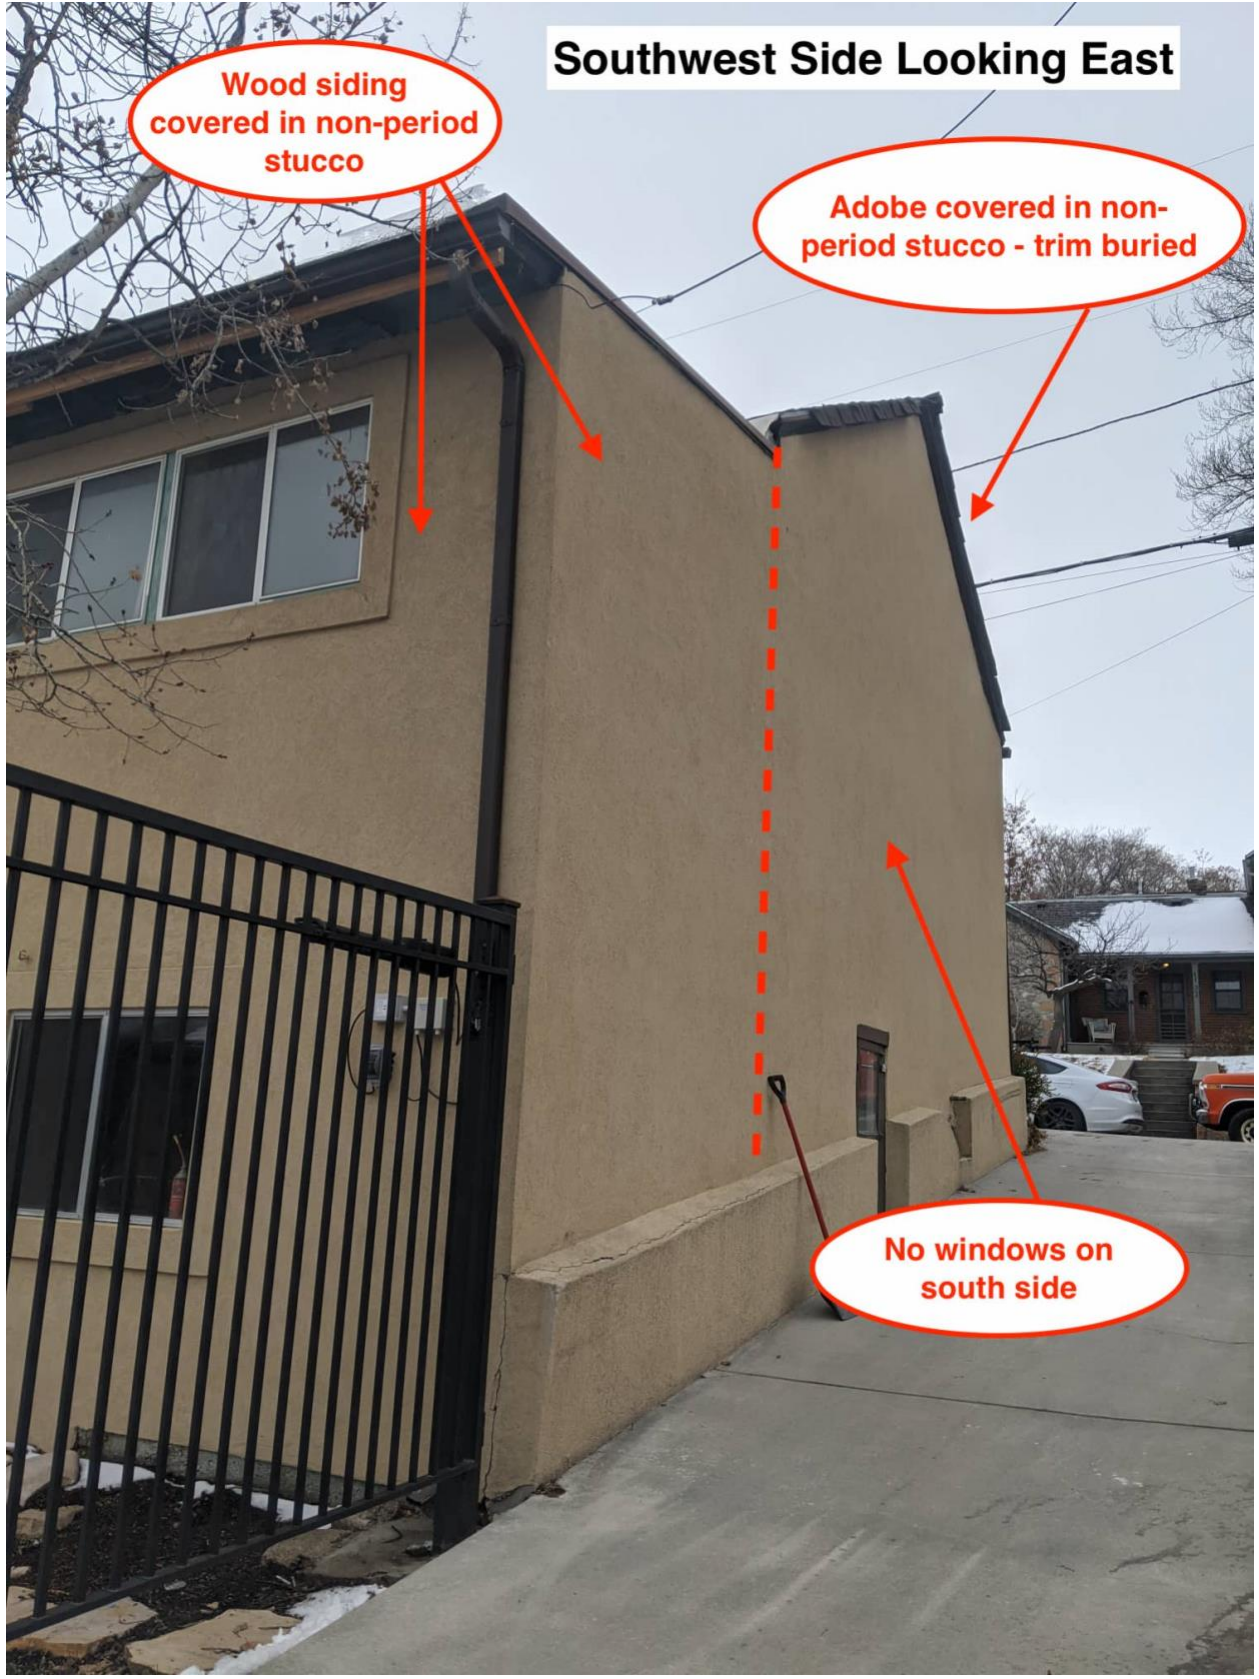
Southwest Side Looking East

Wood siding covered in non-period stucco

Adobe covered in non-period stucco - trim buried

No windows on south side

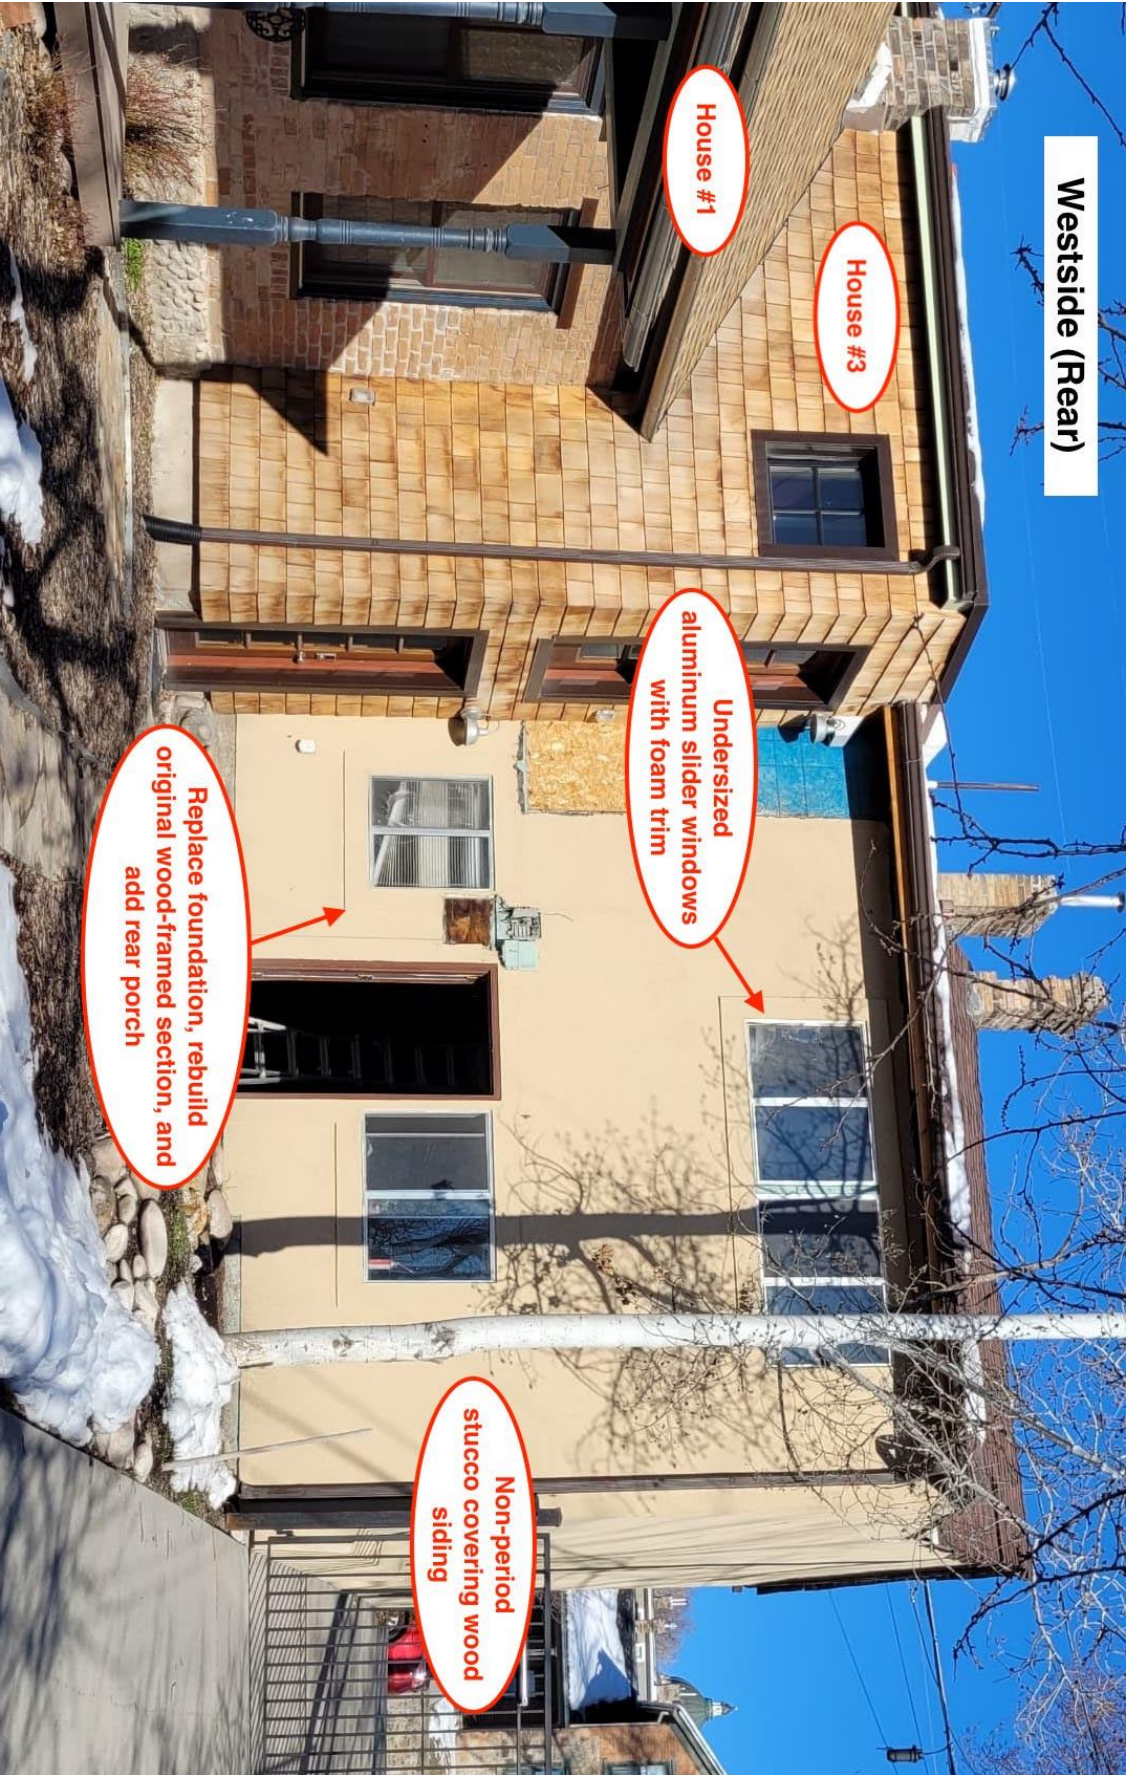
Westside (Rear)

**Replace foundation, rebuild
original wood-framed section, and
add rear porch**

**Non-period
stucco covering wood
siding**

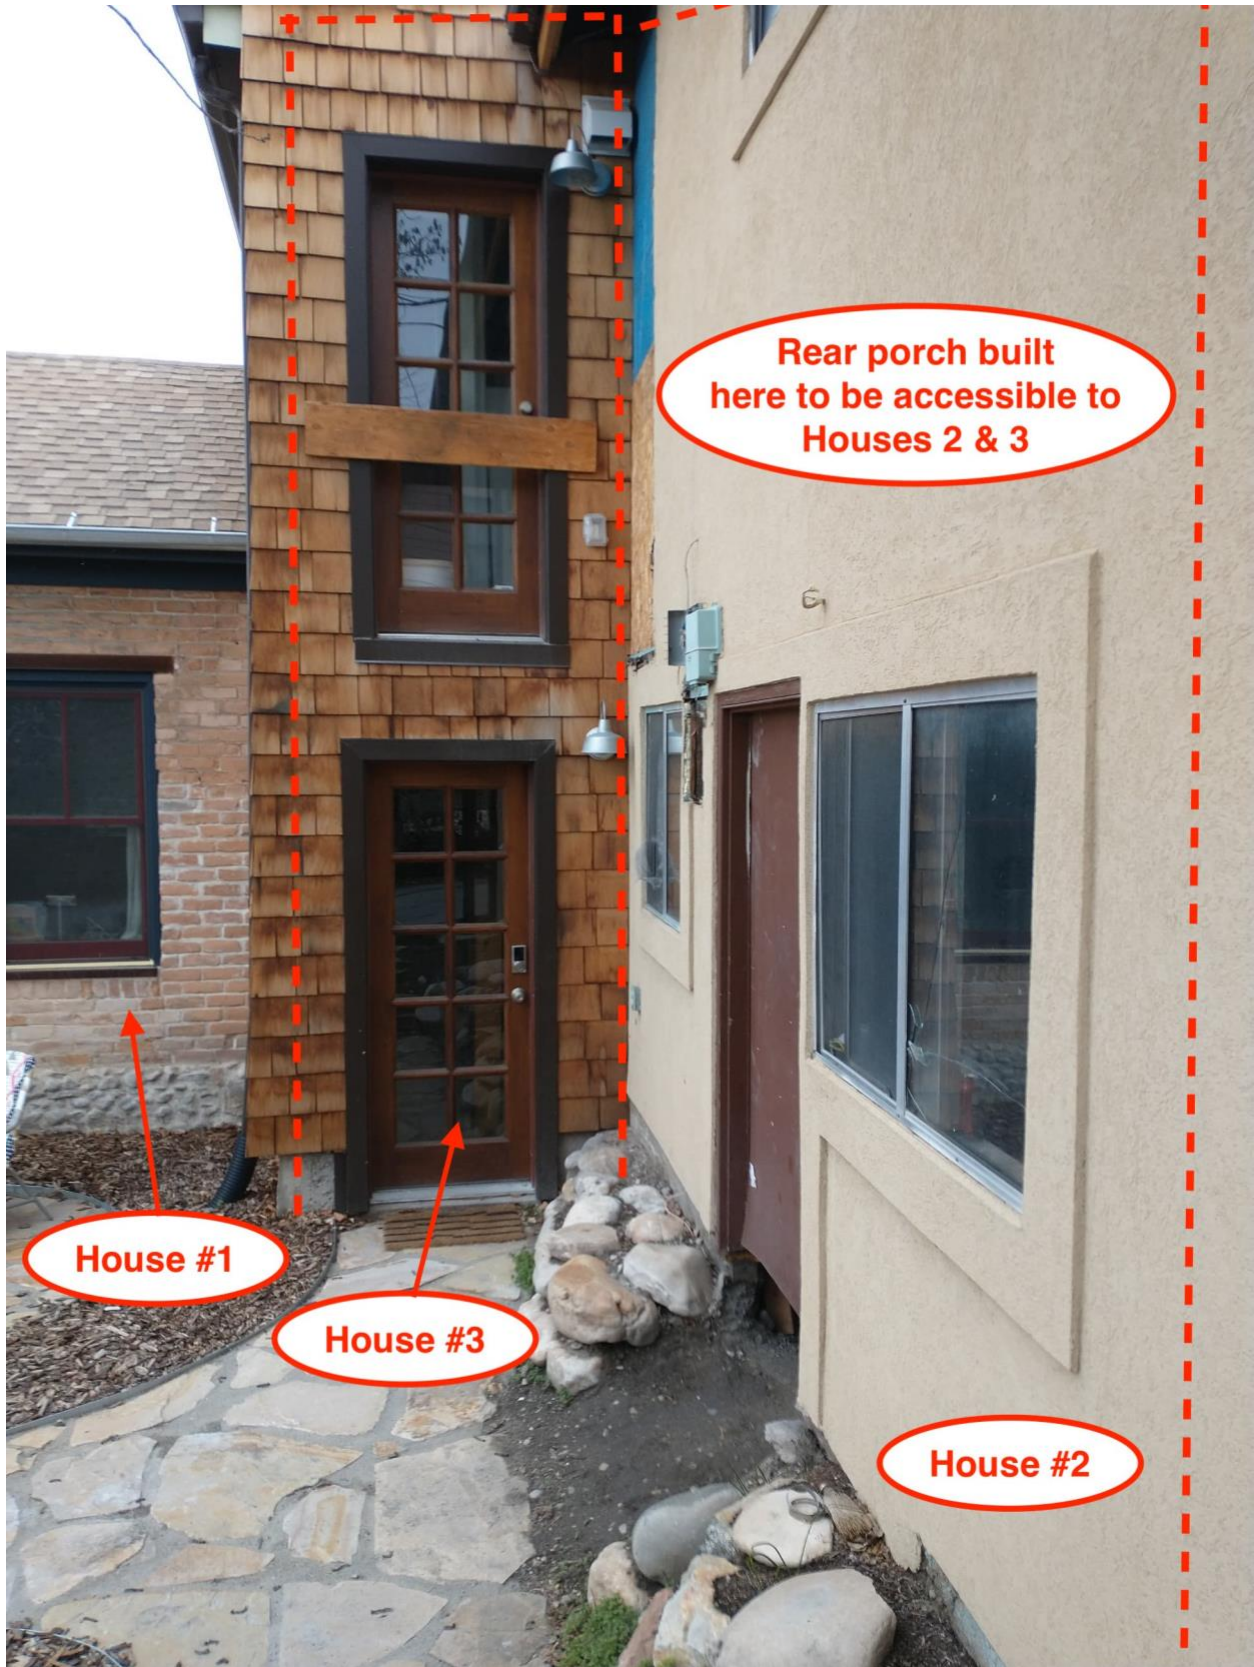
Rear porch built here to be accessible to Houses 2 & 3

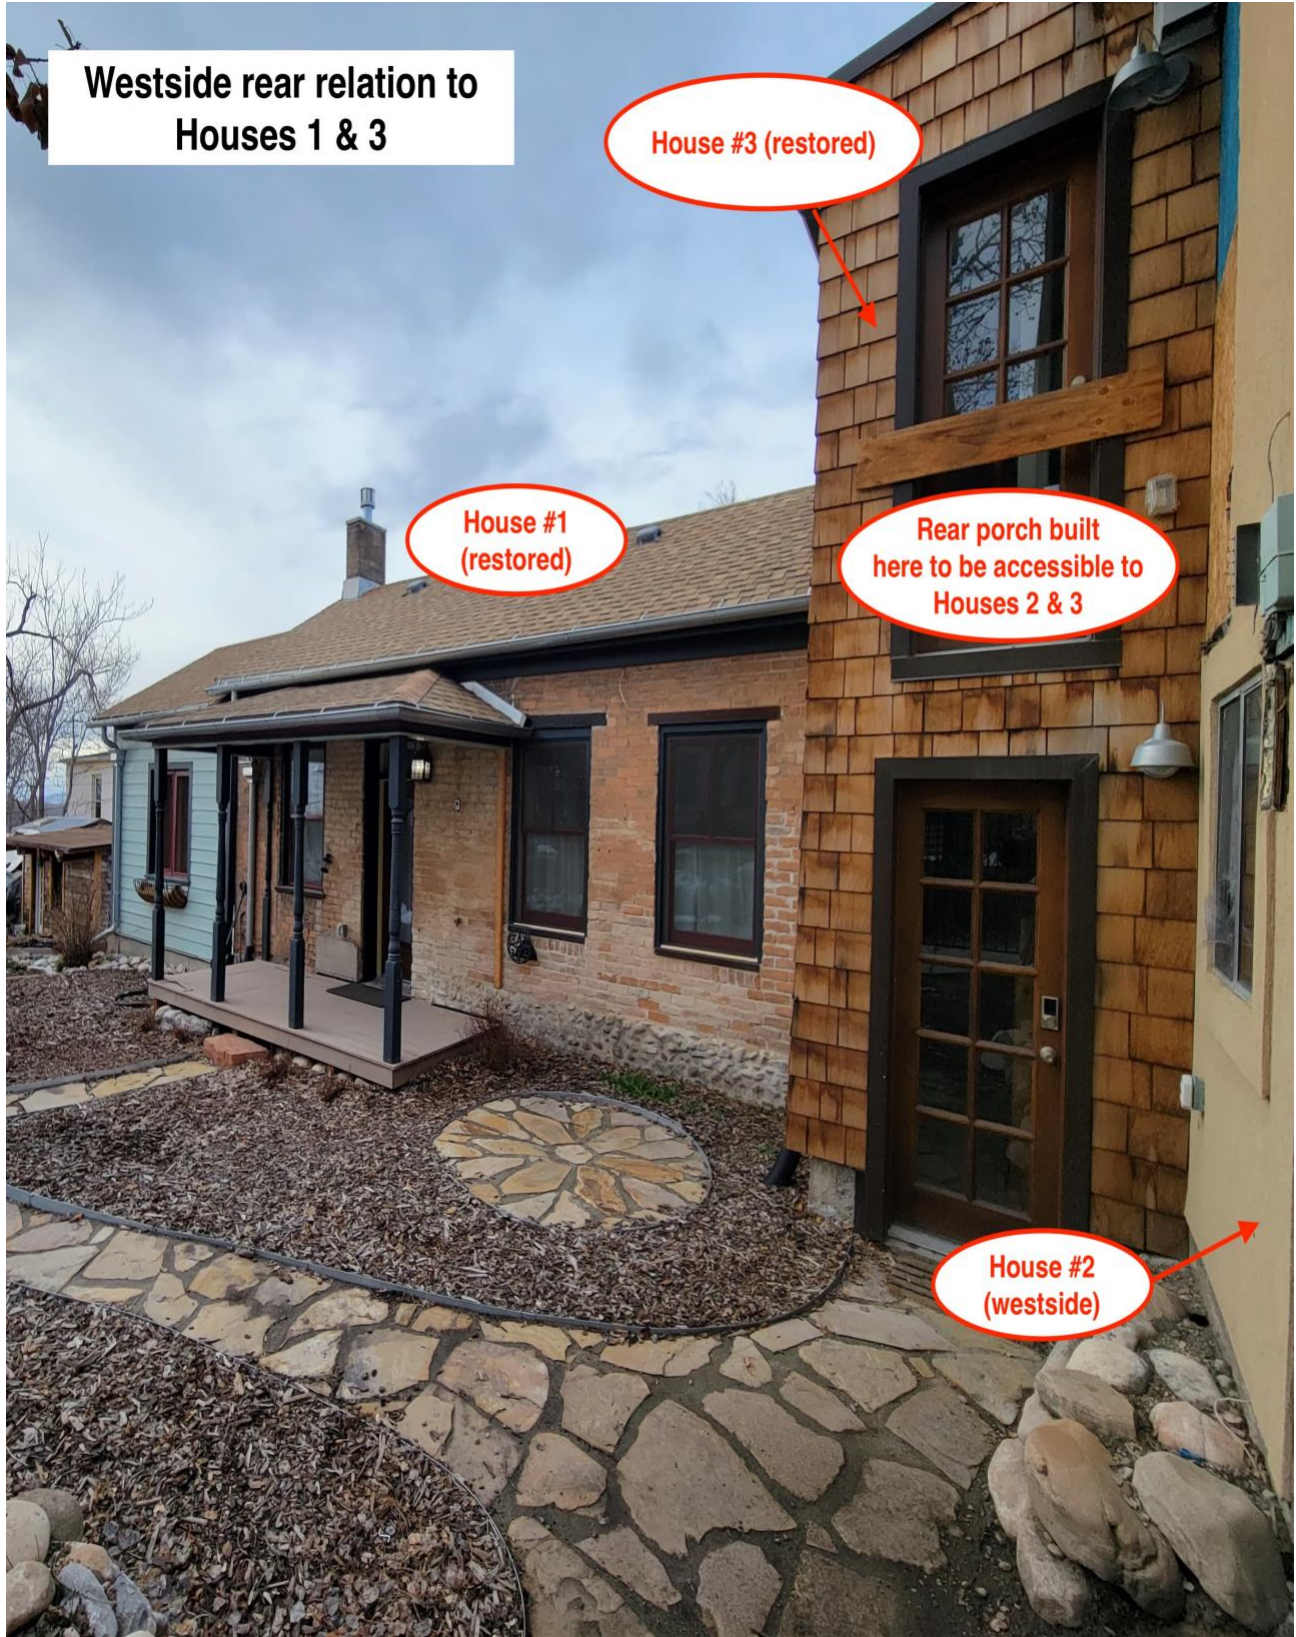
Westside rear relation to Houses 1 & 3

Rear porch built here to be accessible to Houses 2 & 3

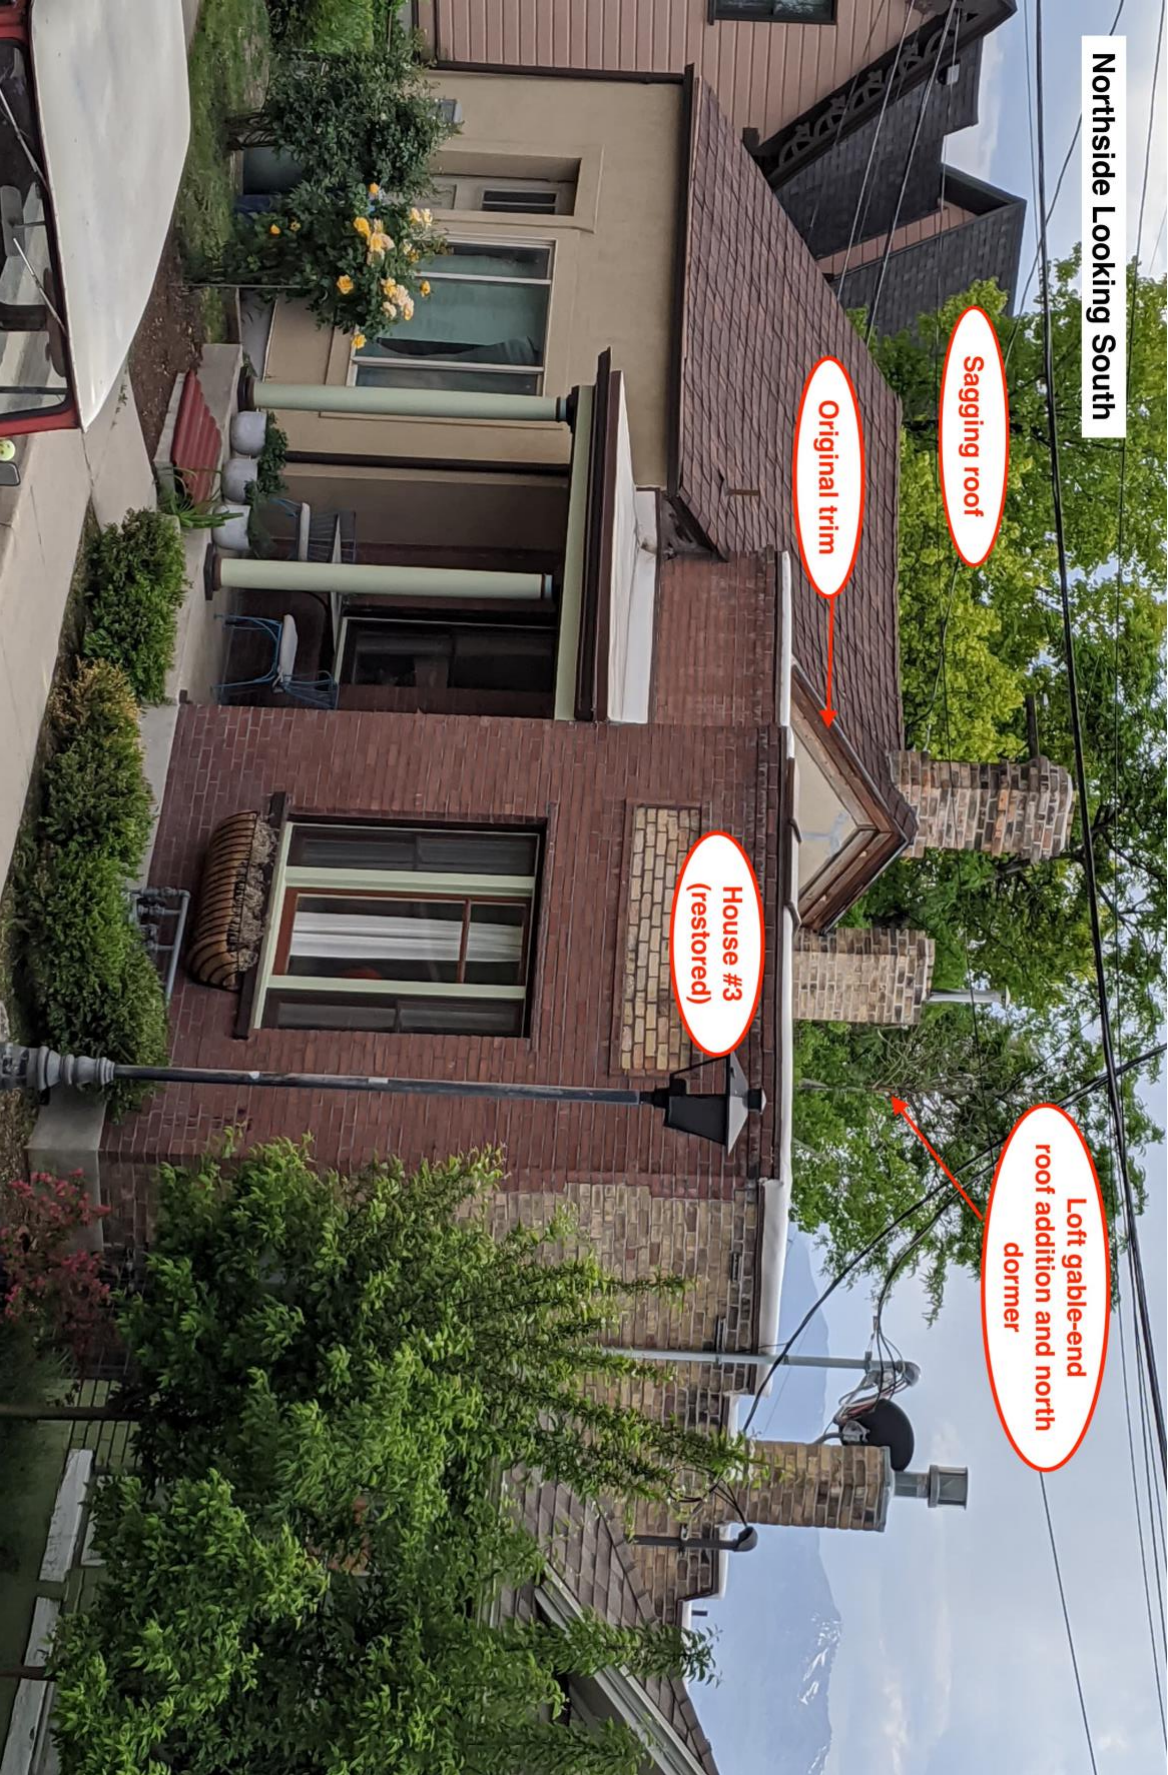
Northside Looking South

Sagging roof

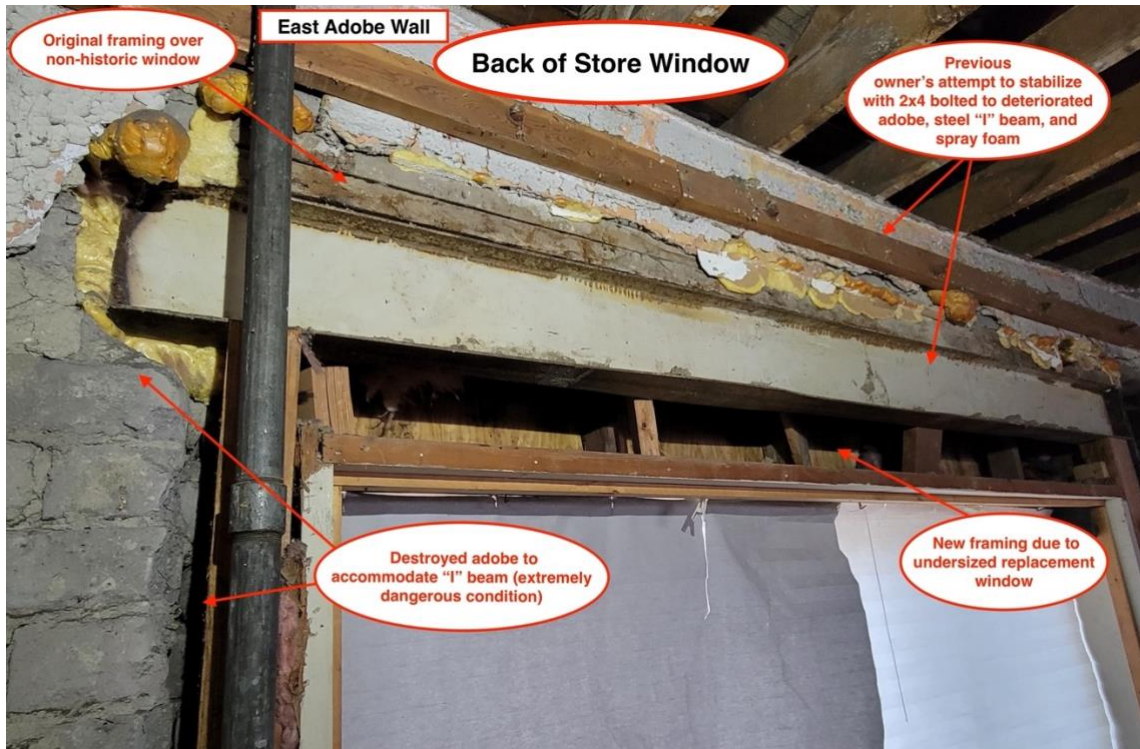
Main floor - east wall deterioration of adobe around missing transom window

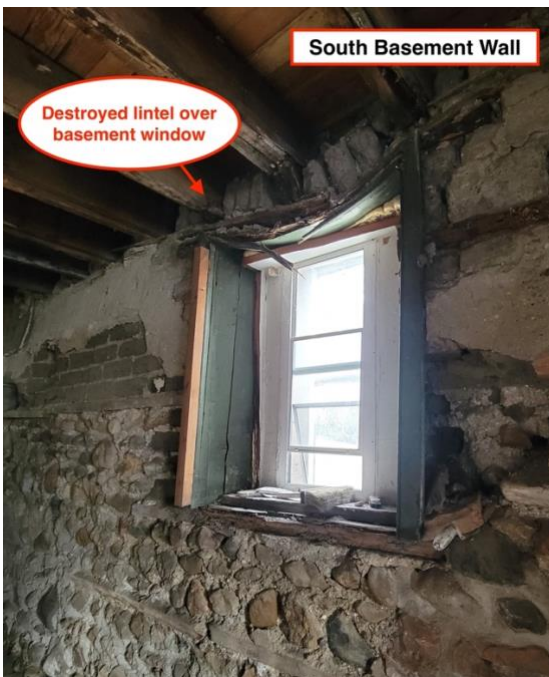
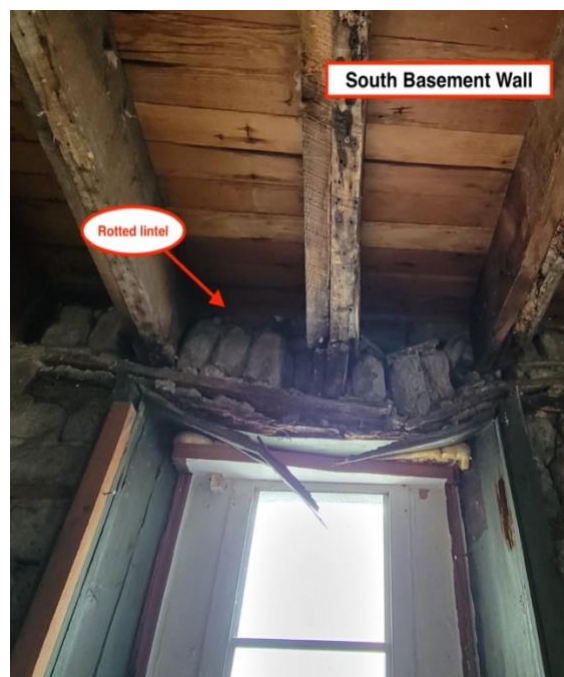
Basement – south and east walls

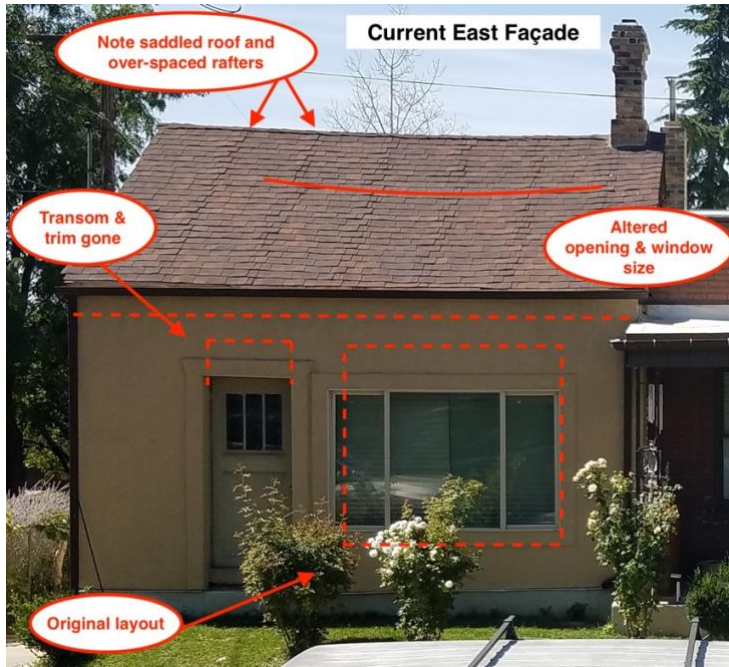
Existing: East elevation

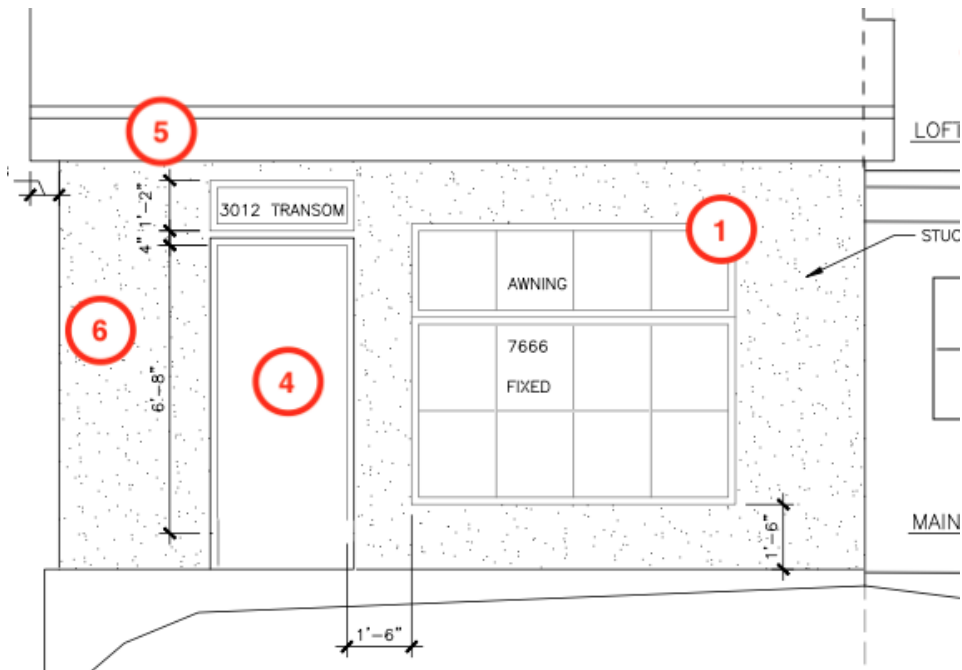
Proposed: 90"x78" (7666), 12-grid, awning top window. Size and position to match original while allowing required sheer & ventilation. Will be deep set on wall with proper historic profile, sash depth, true divided lights, etc.

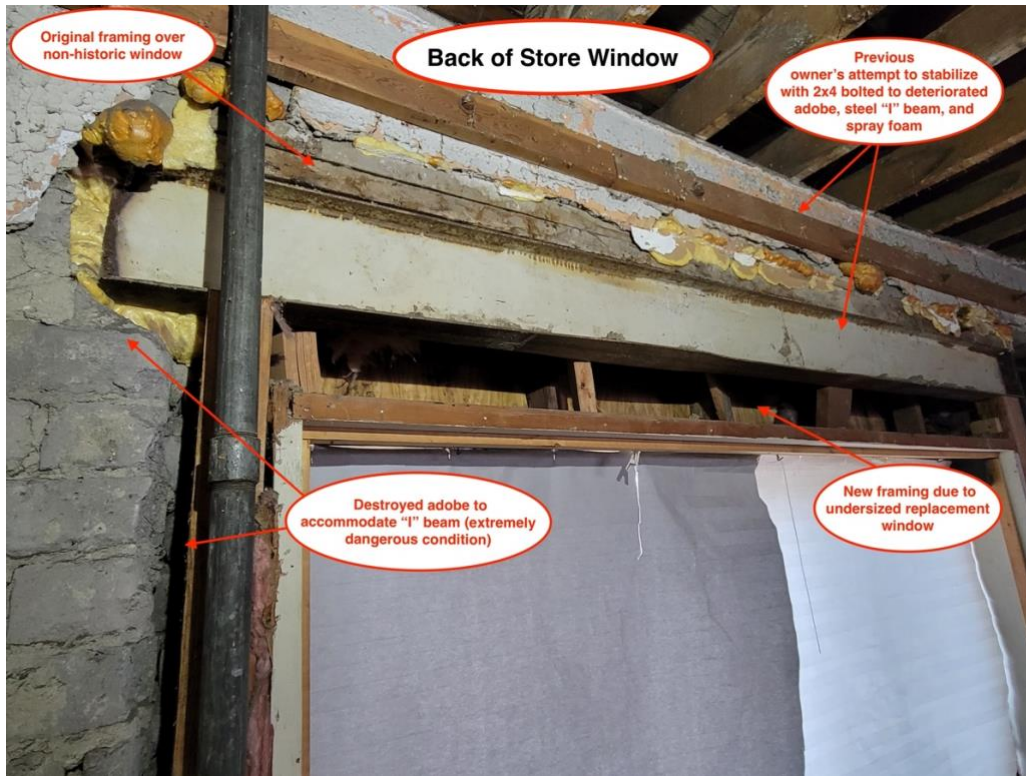
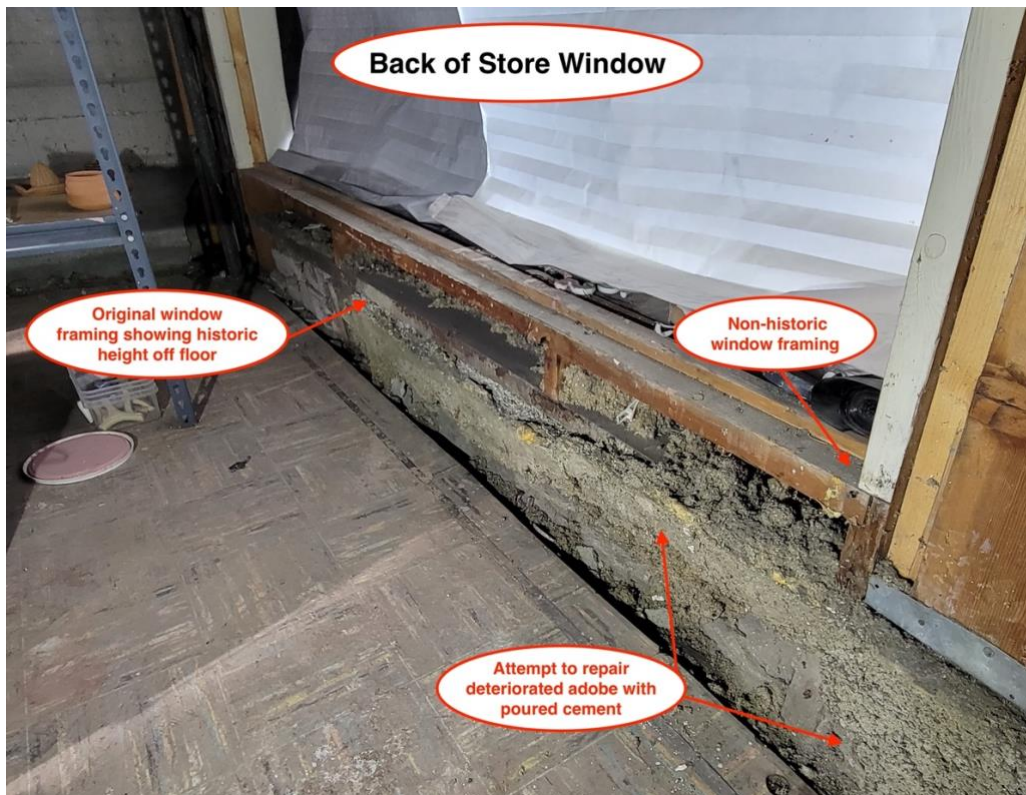
Challenge: Deteriorated condition of interior east wall around front window.
