Staff Report

To: Salt Lake City Historic Landmark Commission
From: Katia Pace, Principal Planner (801)-535-6354, katia.pace@slcgov.com
Date: November 3, 2022
Re: PLNHLC2022-00242 – Minor Alterations for an addition and window openings

PROPERTY ADDRESS: 365 N Quince Street
PARCEL ID: 08-36-282-015-0000
MASTER PLAN: Capitol Hill Master Plan
ZONING DISTRICT: SR-1A, Historic Preservation Overlay (Capitol Hill)
DESIGN GUIDELINES: Residential Design Guidelines

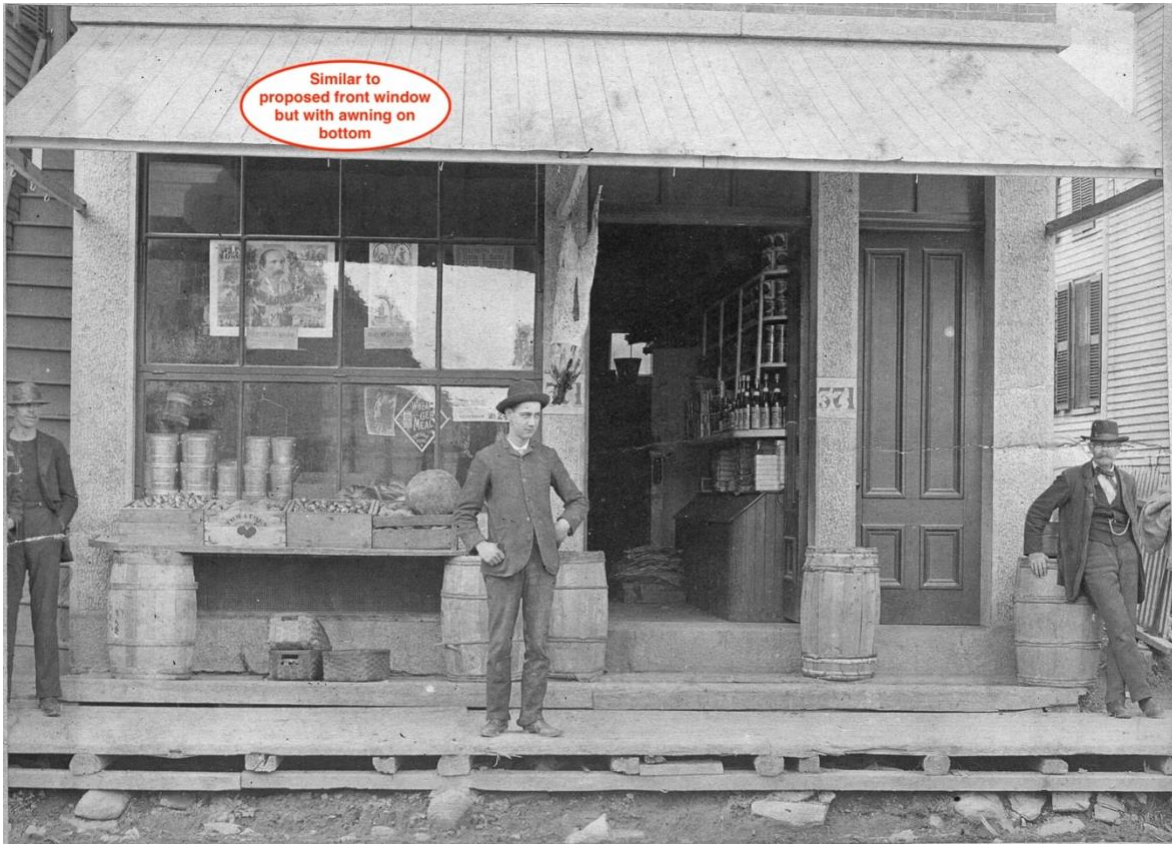
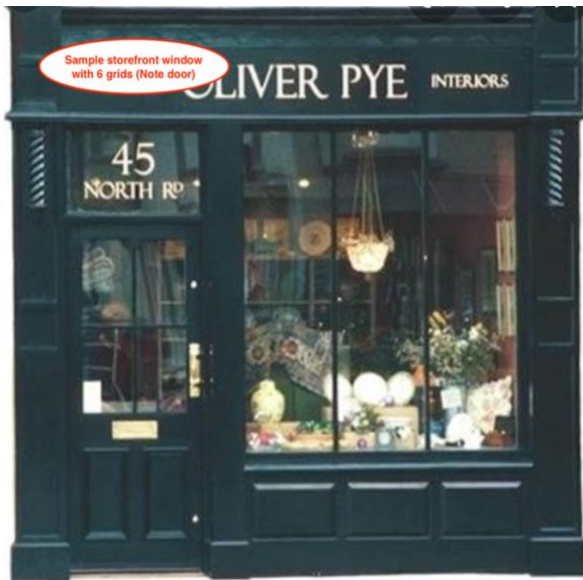
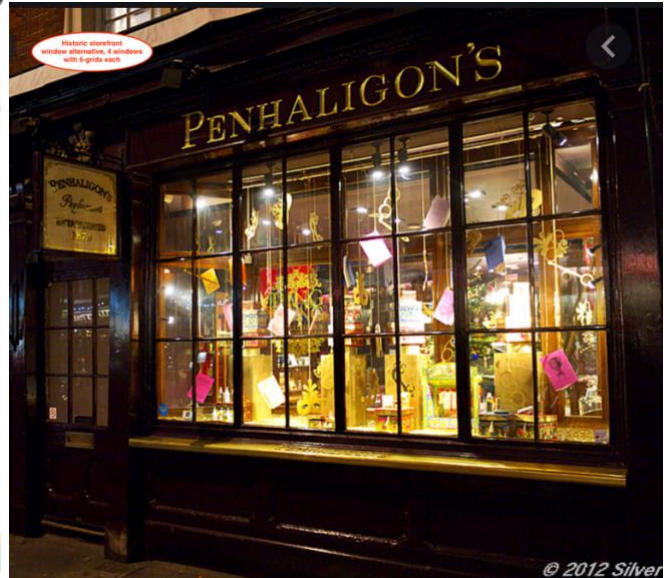
Sample historic storefront windows with similar and alternate fenestrations.

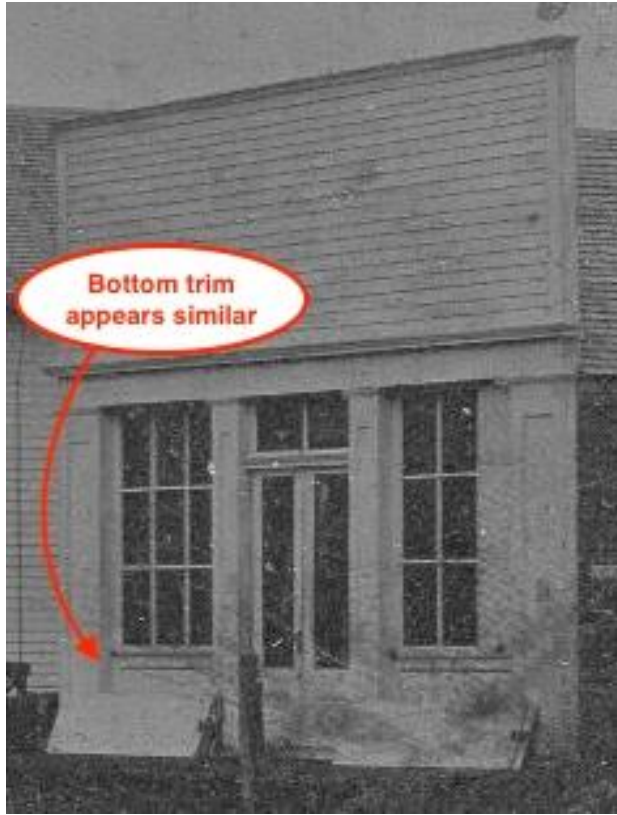
Similar new 12-grid window (also shown digitally turned to approximate proposed window).

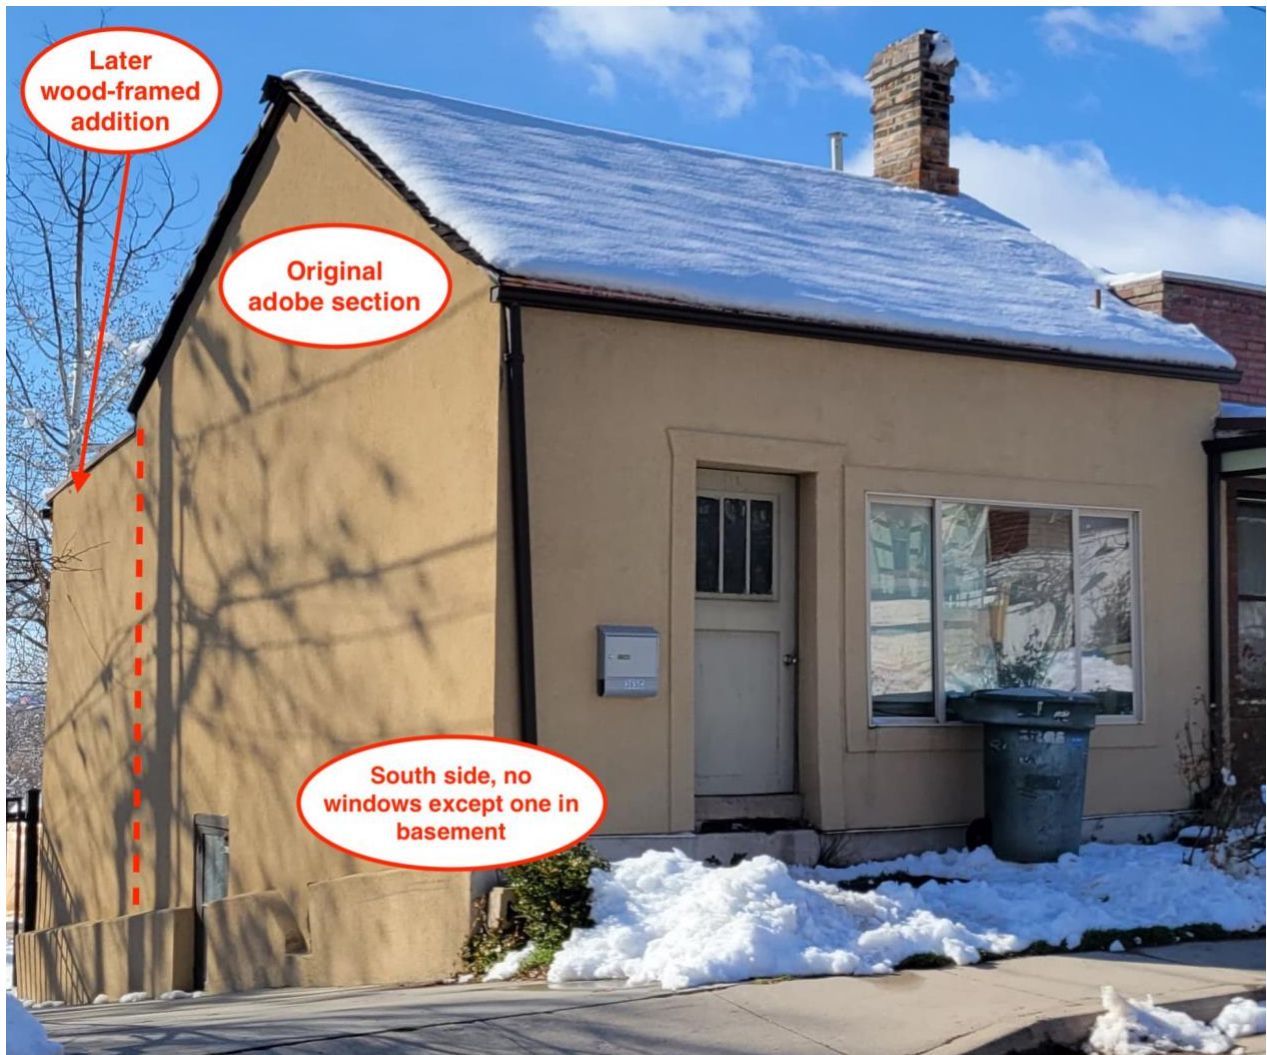
Existing: South elevation

Neighboring vernacular-style homes support the use of 2-over-2 cottage windows in the adobe section and divided-light casement windows on the wood-framed section. The south elevation shows the windows' massing and void-to-solid ratio on the wall. Note that other exterior elements such as roof/wall trim, stucco finish, and porch posts can also be seen in the photos of neighboring homes.

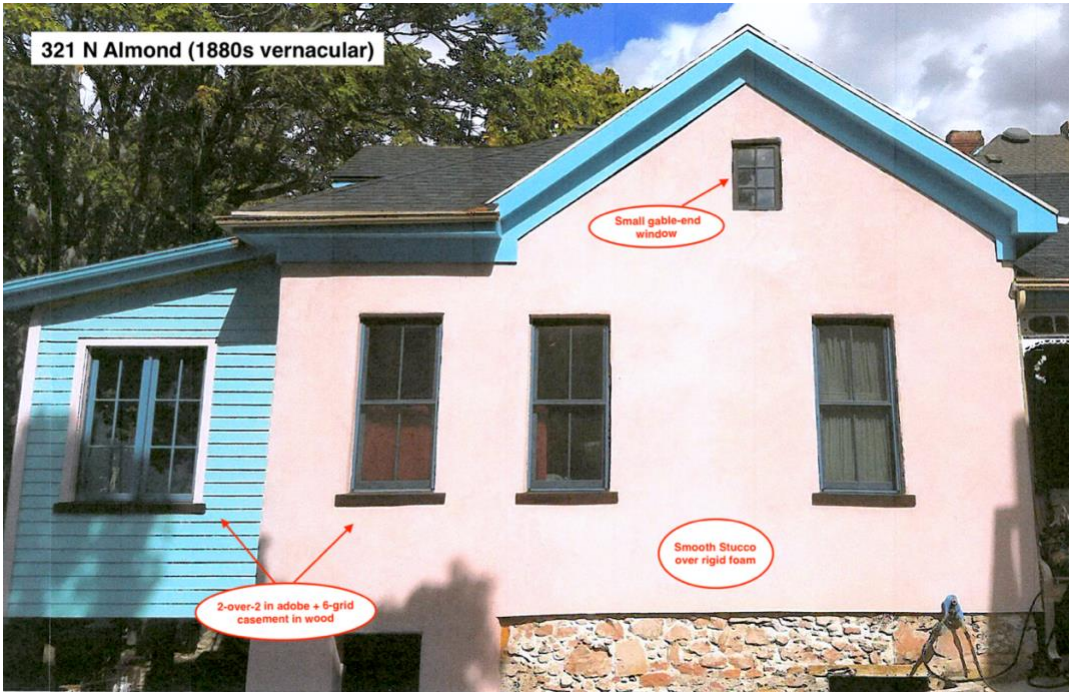
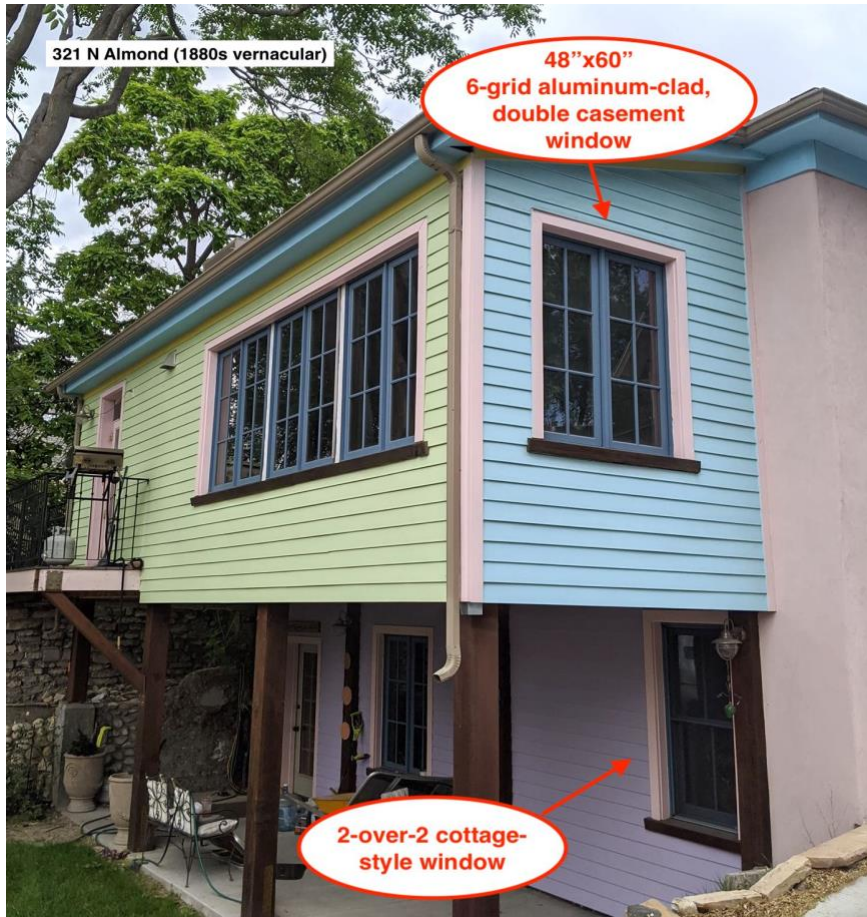
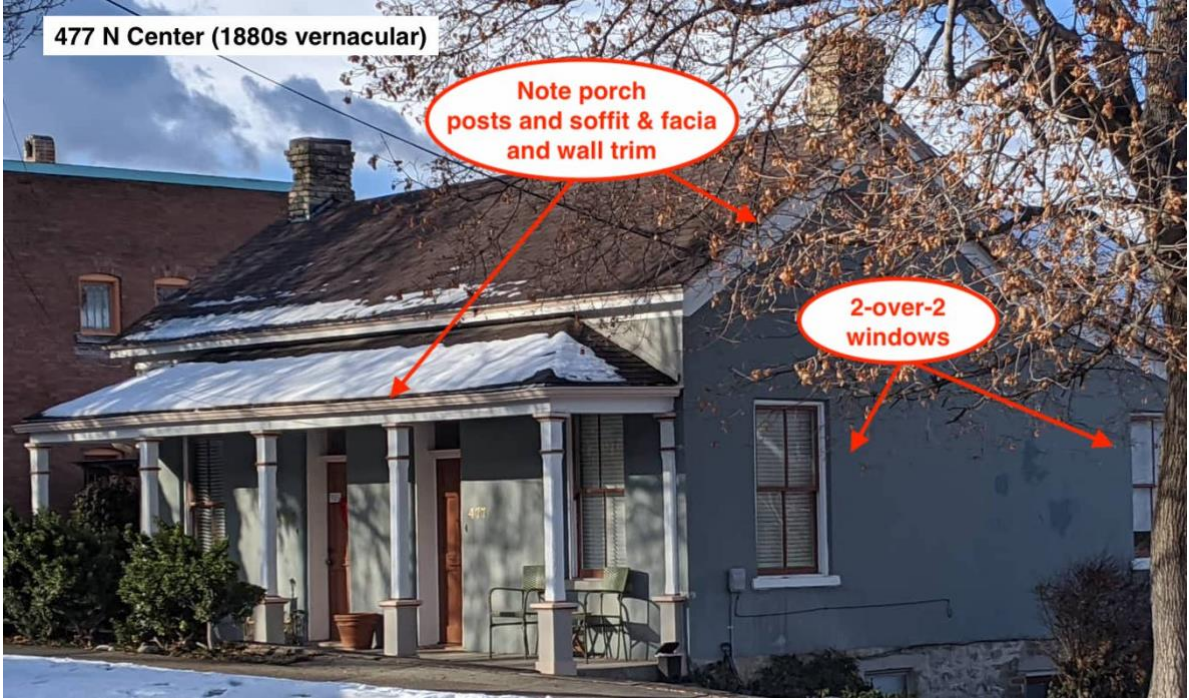
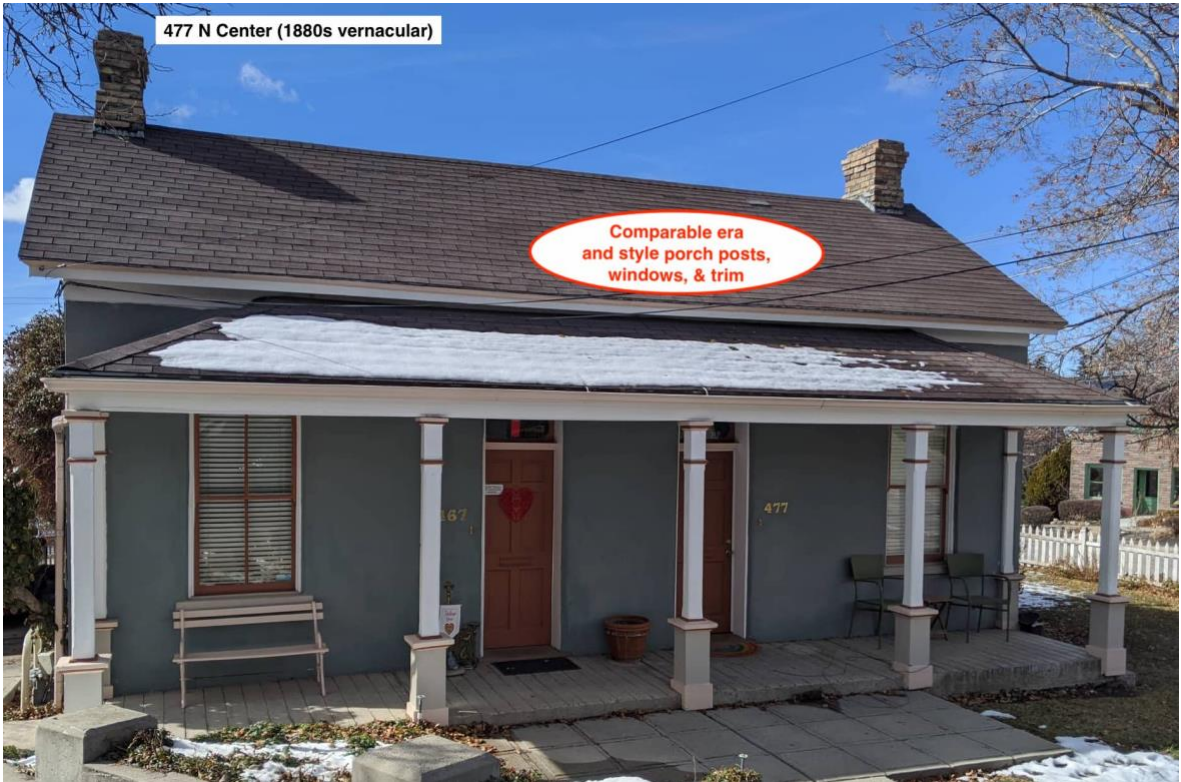
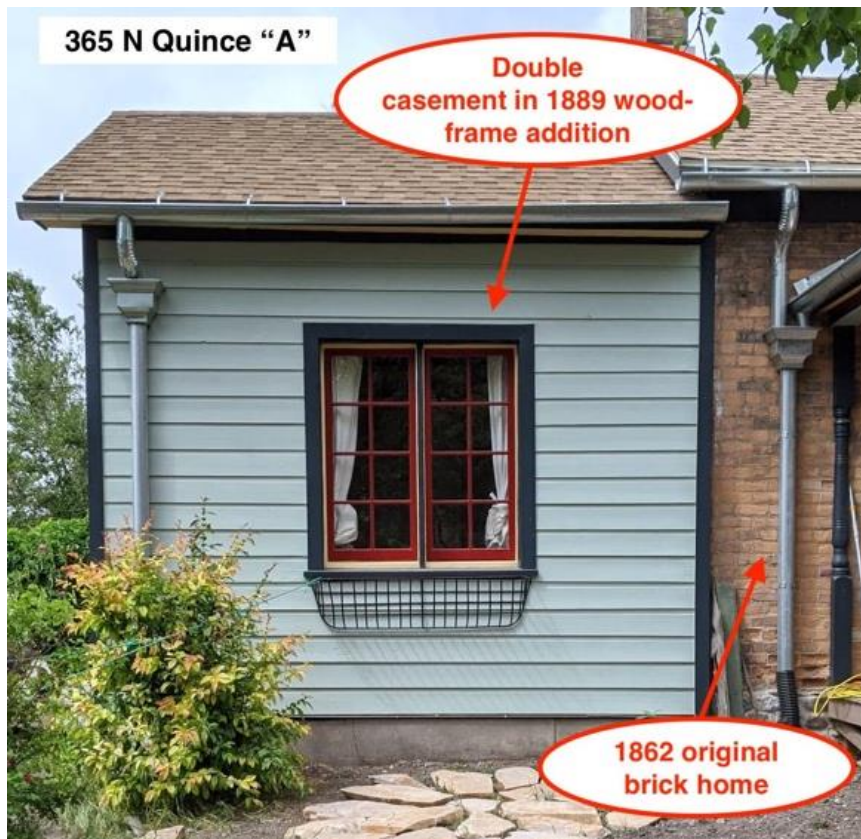
Samples: 1880s Marmalade vernacular homes with 2-over-2, cottage-style windows in original masonry sections, and divided-light casement windows on (typically) later wood sections.

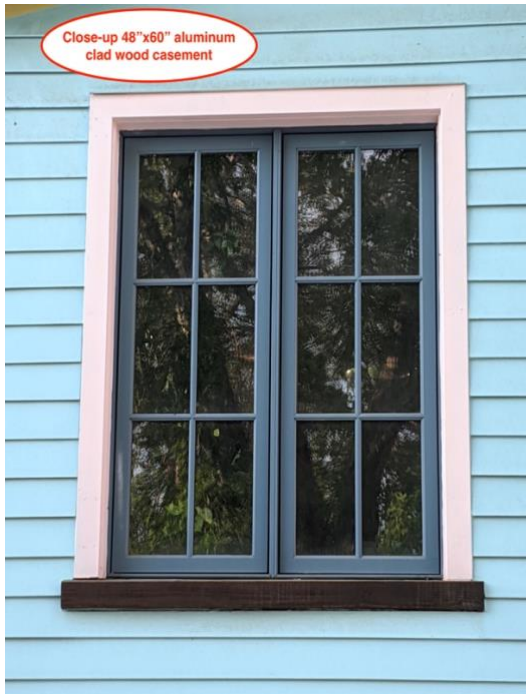
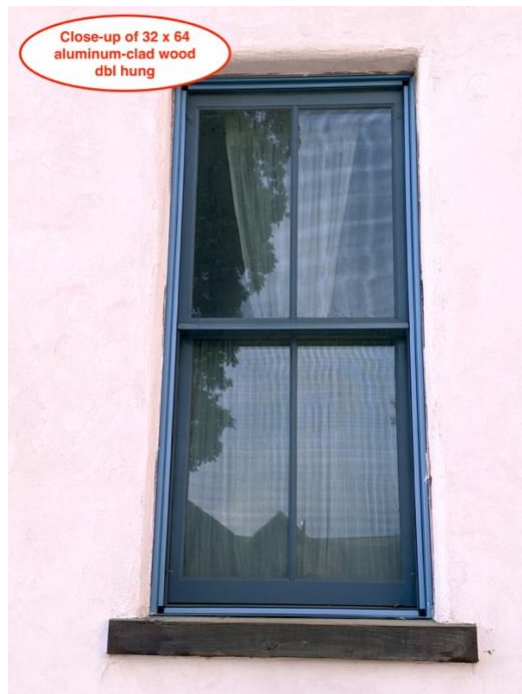
Closeup of windows approved for use in the restoration of a historic Marmalade home (shown above) which was built in 1882. (Sierra Pacific brand.)

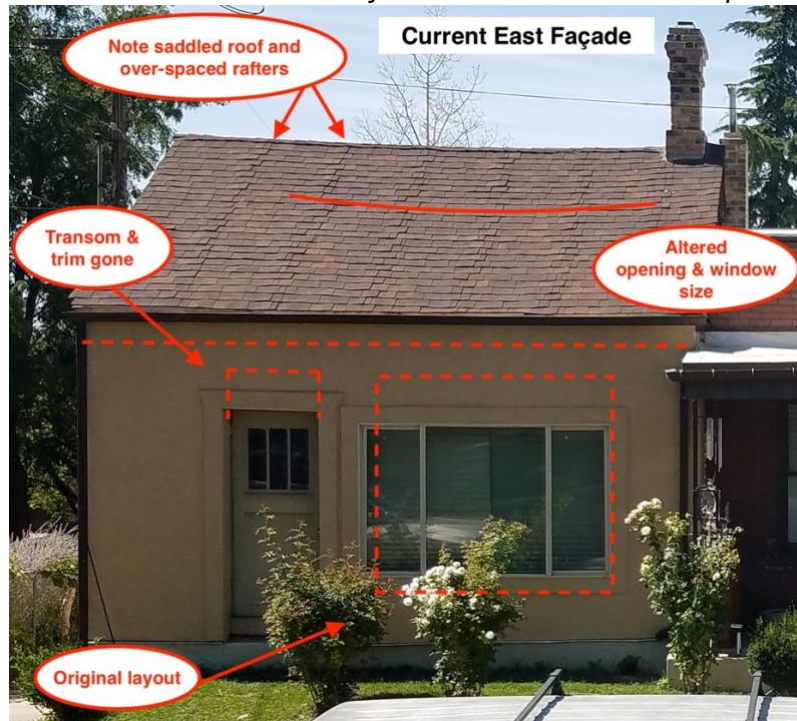
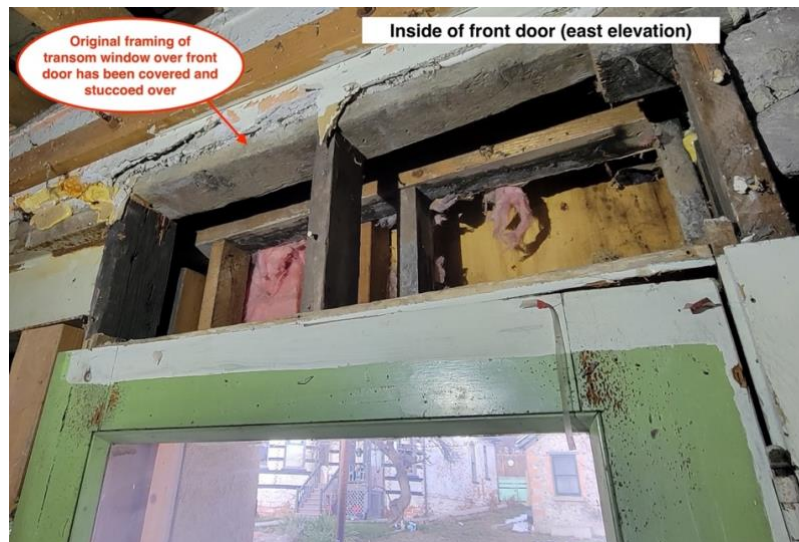
Existing: Historic transom window has been framed in and covered an operational transom.

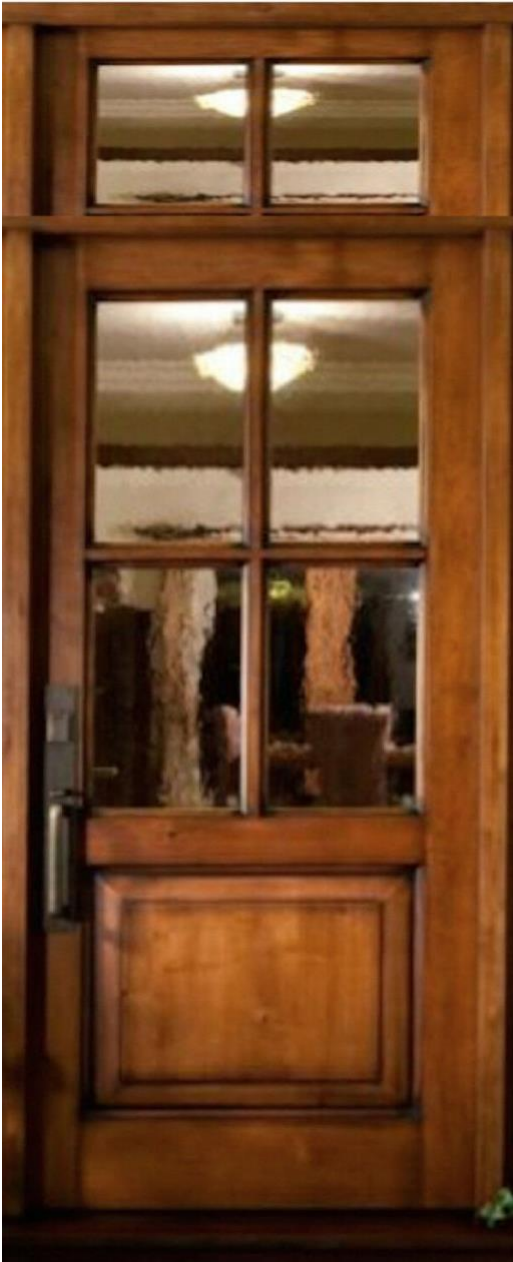
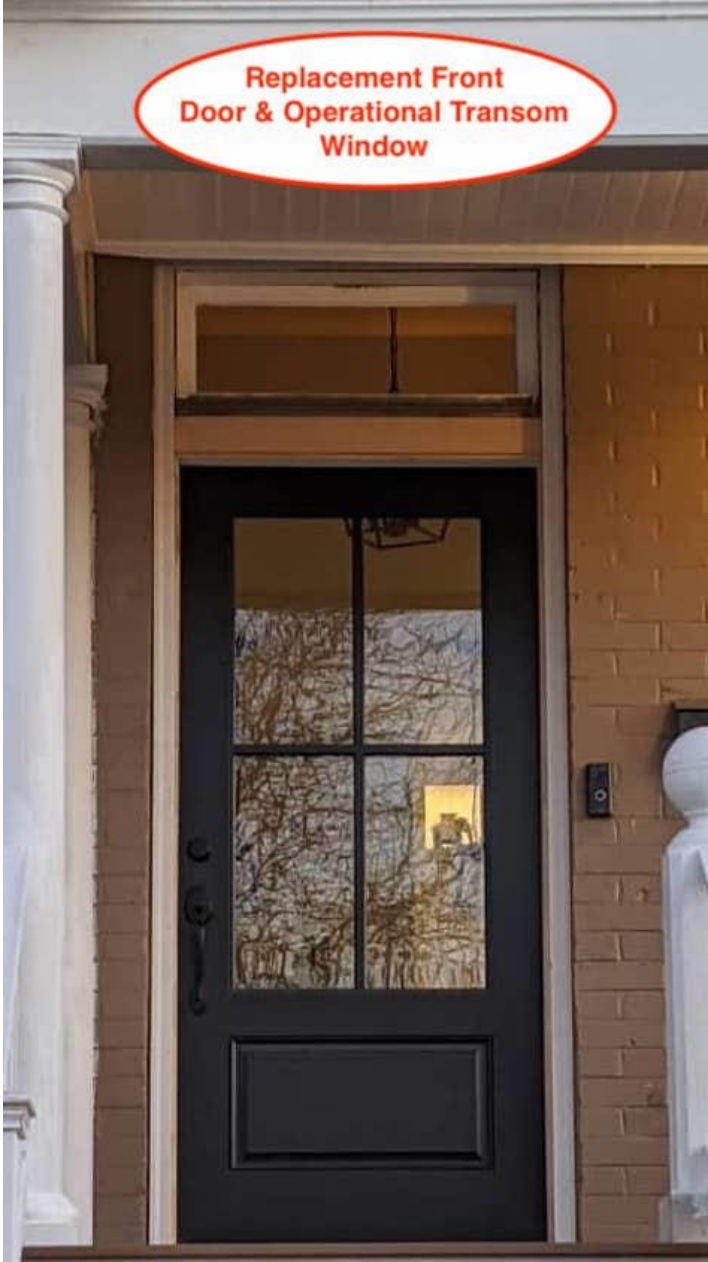
Proposed Front Door: Antique divided-light door with operational transom, or equivalent reproduction. Door on right is at 112 W. Girard Street in the Marmalade neighborhood.

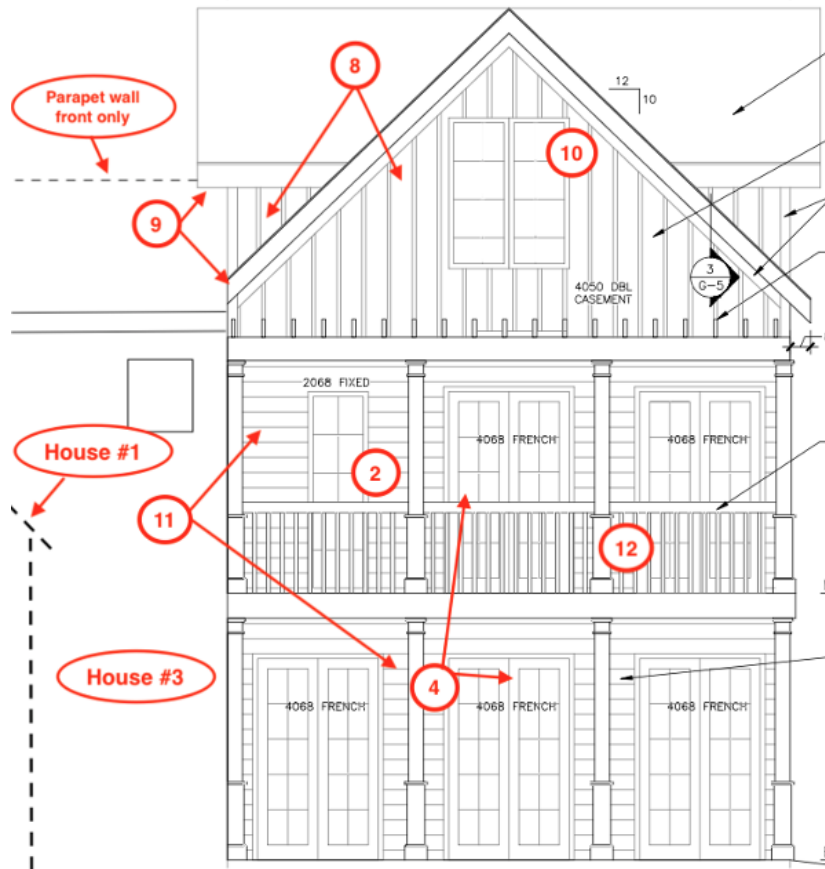
Proposed: West elevation showing proposed doors on both floors.

Support for Doors: Original framing and foundation indicate a double door may have been originally installed at the basement level. In accordance with the guidelines for a tertiary rear façade, and following adaptive use principles, replacing the small rear windows with 48"x80" double French doors would be allowed. The doors on plans are given in feet/inches width x feet/inches height.

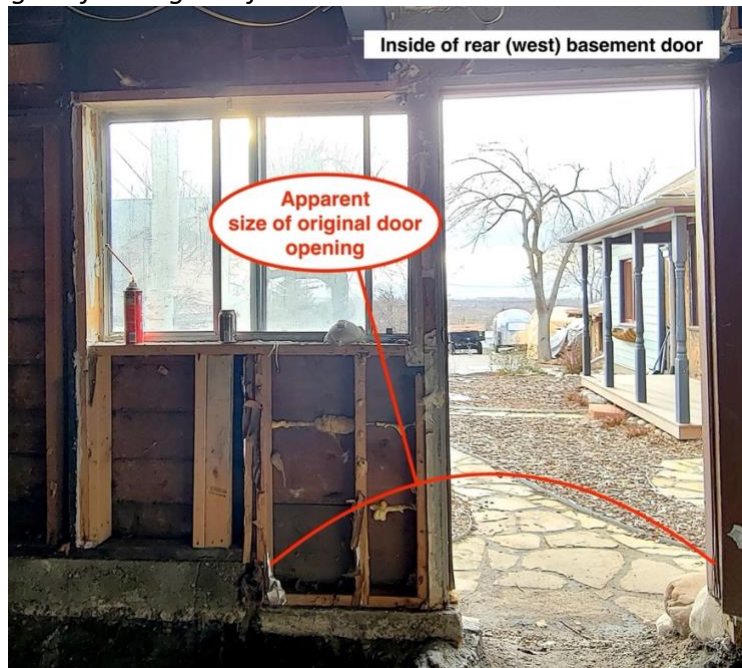
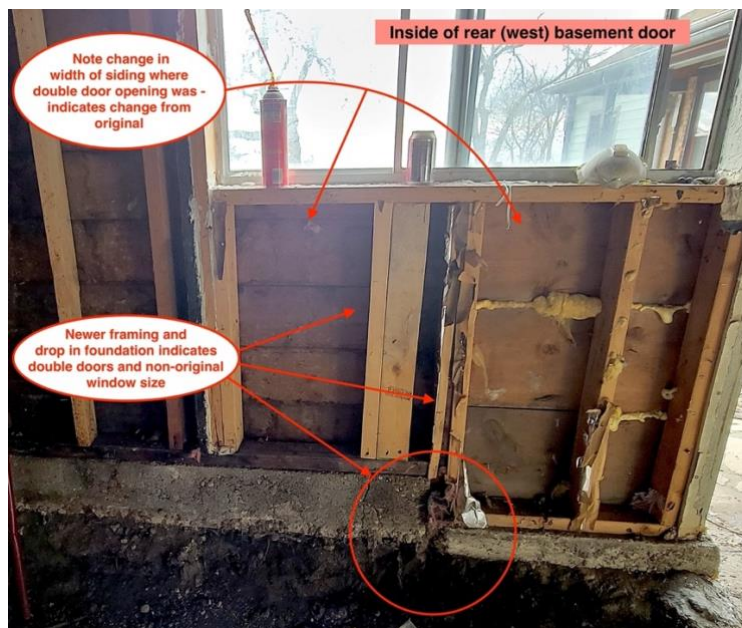
Existing: Original framing and foundation.

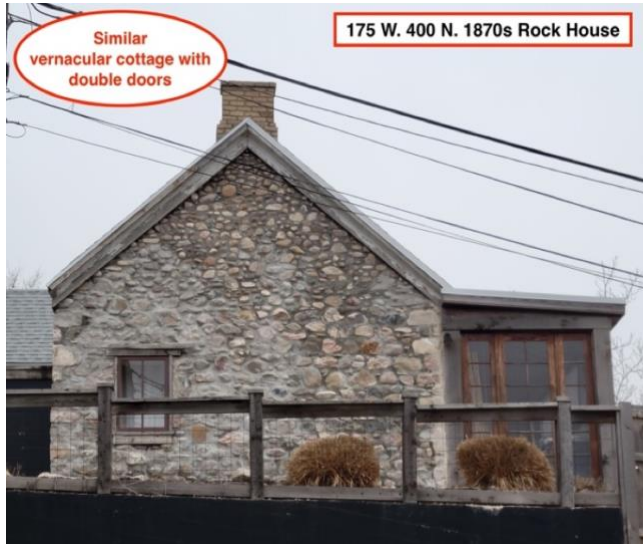
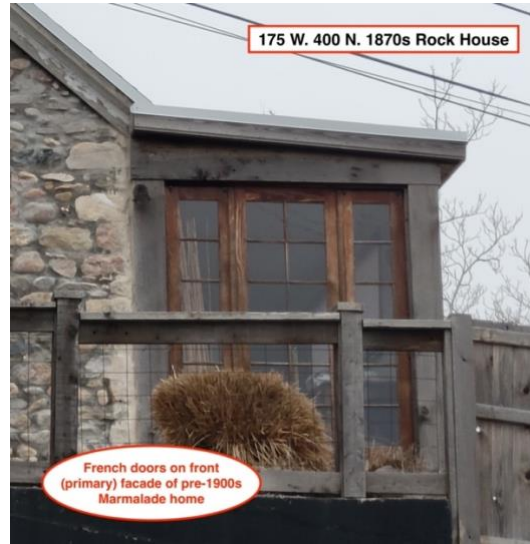
Sample: 1880s Marmalade vernacular home with French doors.

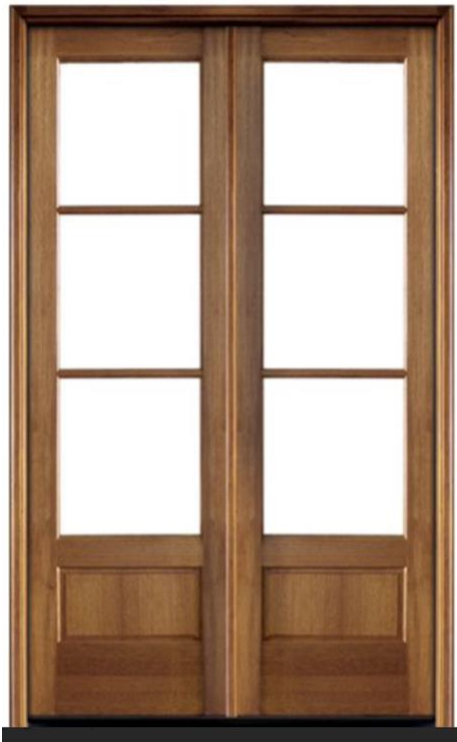
Door style we want to use (interior view – exterior will be painted aluminum-clad wood)

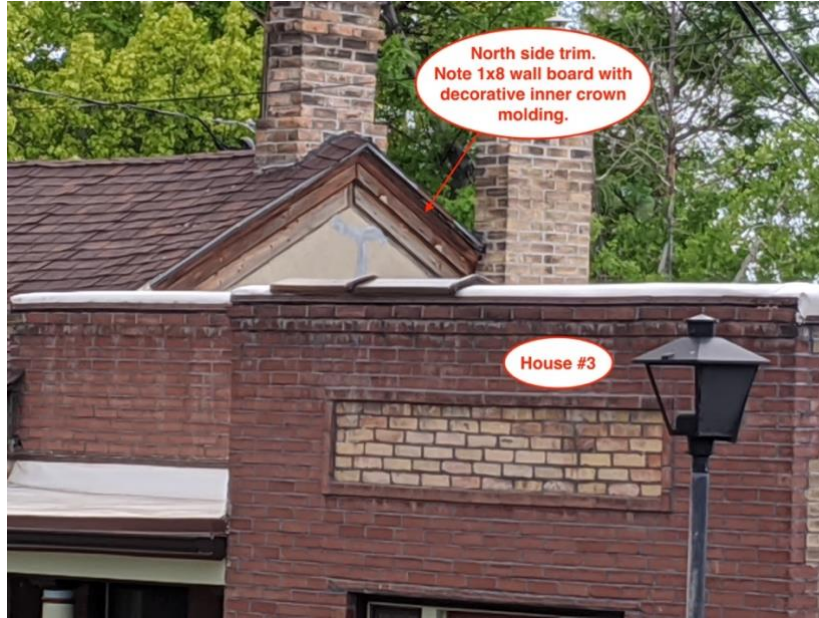
Existing: Some original trim remains on the upper north side. It is damaged, but still provides some evidence of prior materials.

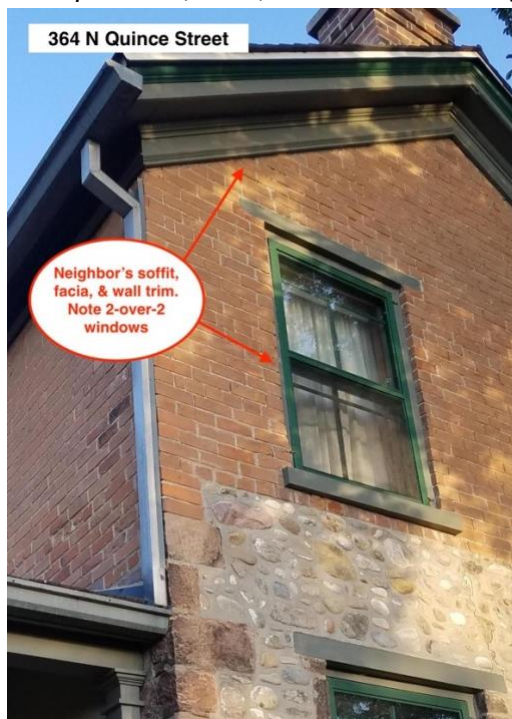
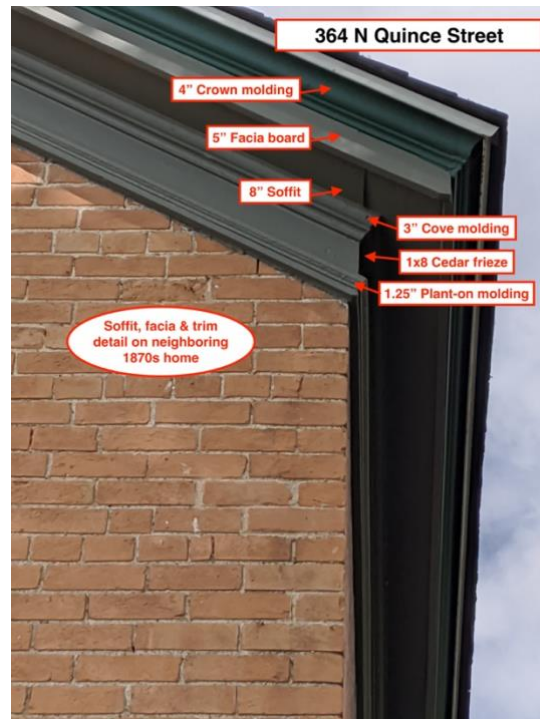
Sample: 1880s trim on neighboring house. Replace soffit, fascia, and wall trim with 1x8 cedar trim with plant-on, cove, and crown molding.

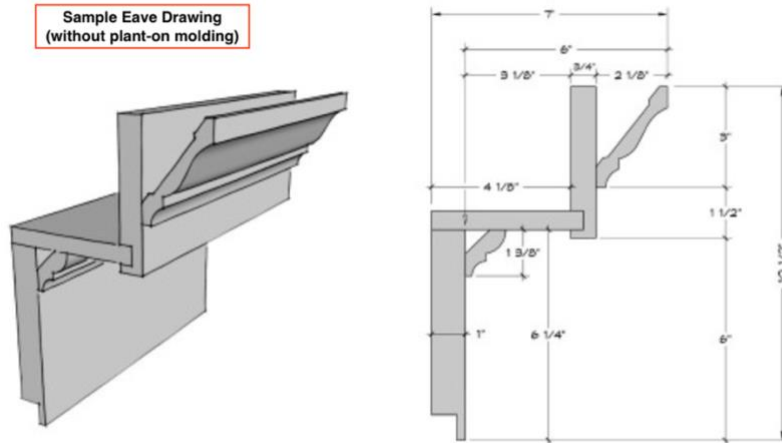
Mockup scale drawing

1 BOX EAVE
SCALE: 1" = 2"

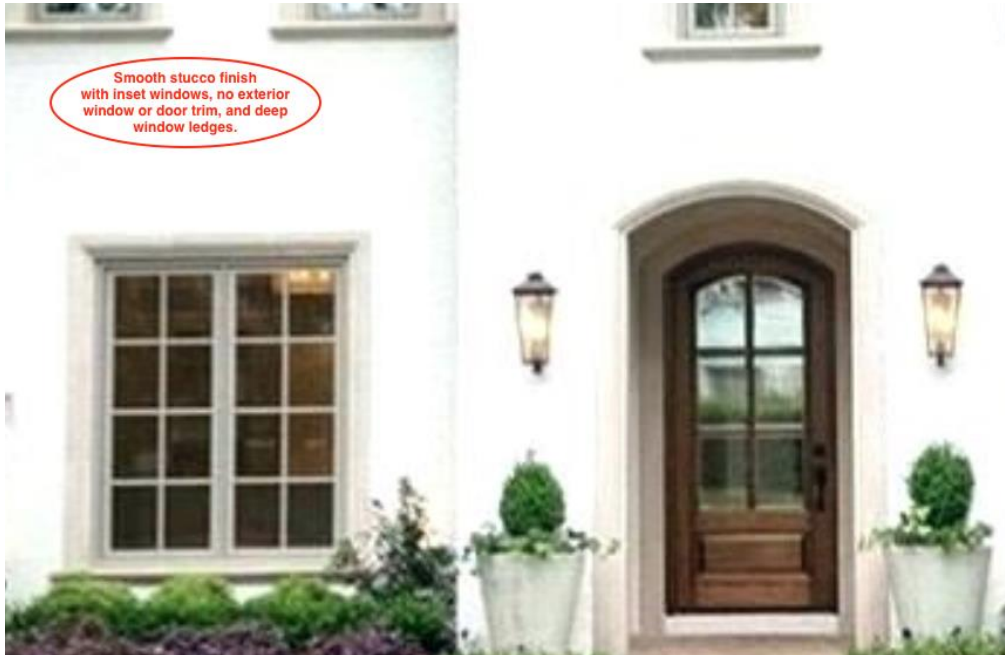
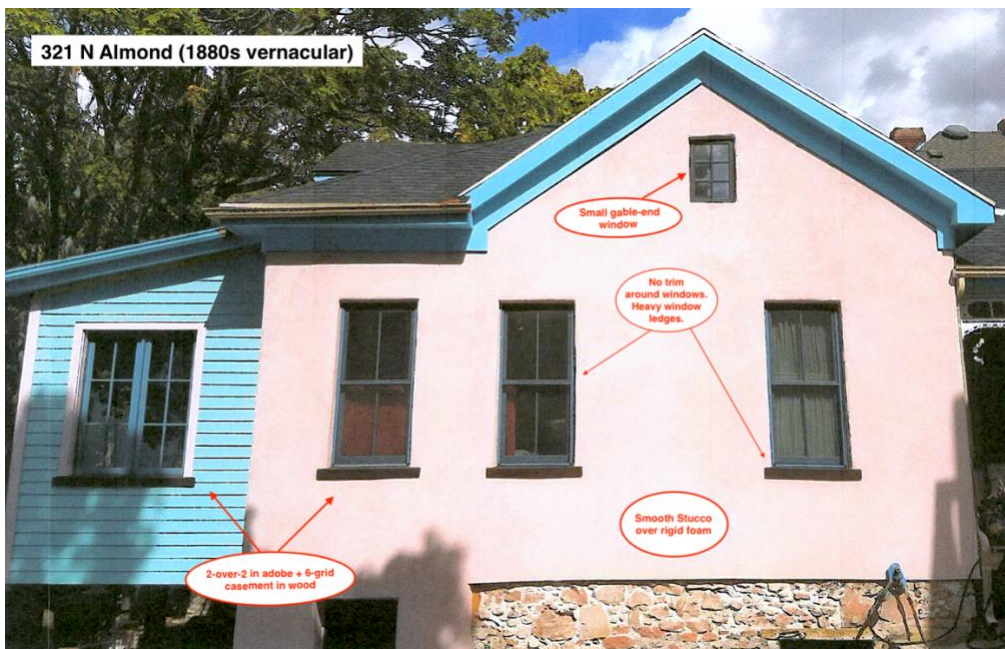
Existing: The current stucco is a modern “worm” finish with bump-outs around the windows and door. (See page 12 above.)

Proposed: Insulate exterior walls with rigid foam insulation and install ventilated stucco system. Stucco to be a smooth troweled finish as seen on the historic photo on page 11 above and similar to the following photos.. Detail of insulation discussed in Item 11 below.

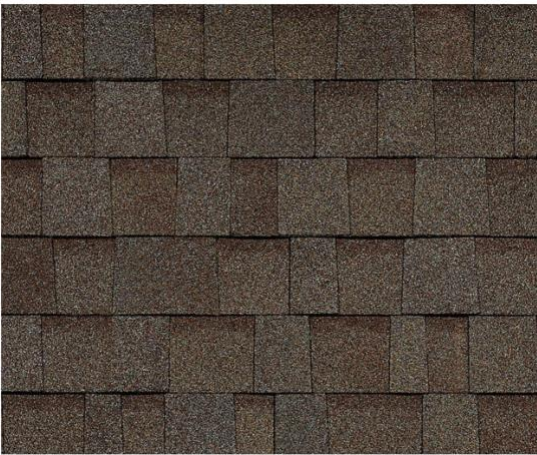
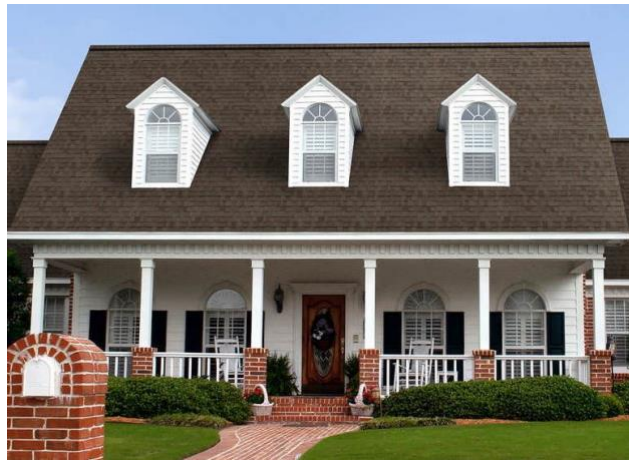
Sample: <https://www.owenscorning.com/en-us/roofing/shingles/oakridge?color=teak>

Proposed: Reinforce and re-sheet the roof. Rebuild as needed. Since the interior walls will be framed on the inside, we will tie new roofing components to the interior framing for a seismic retrofit. Insulate the old and new roof decks and seal to the exterior wall insulation. (See details for Item 11 below.) Shingle the entire roof with Owens Corning Oakridge Teak shingles.

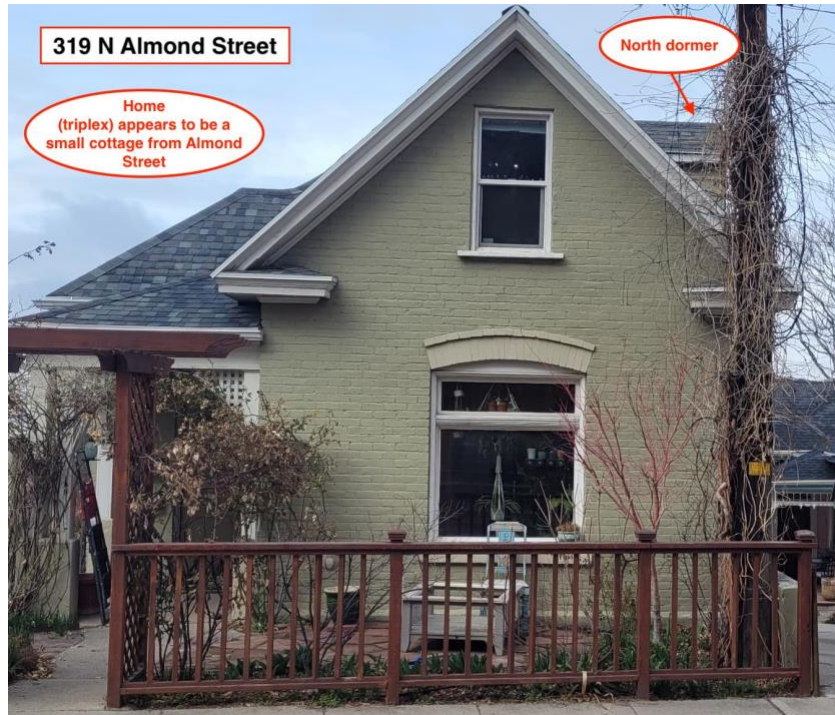
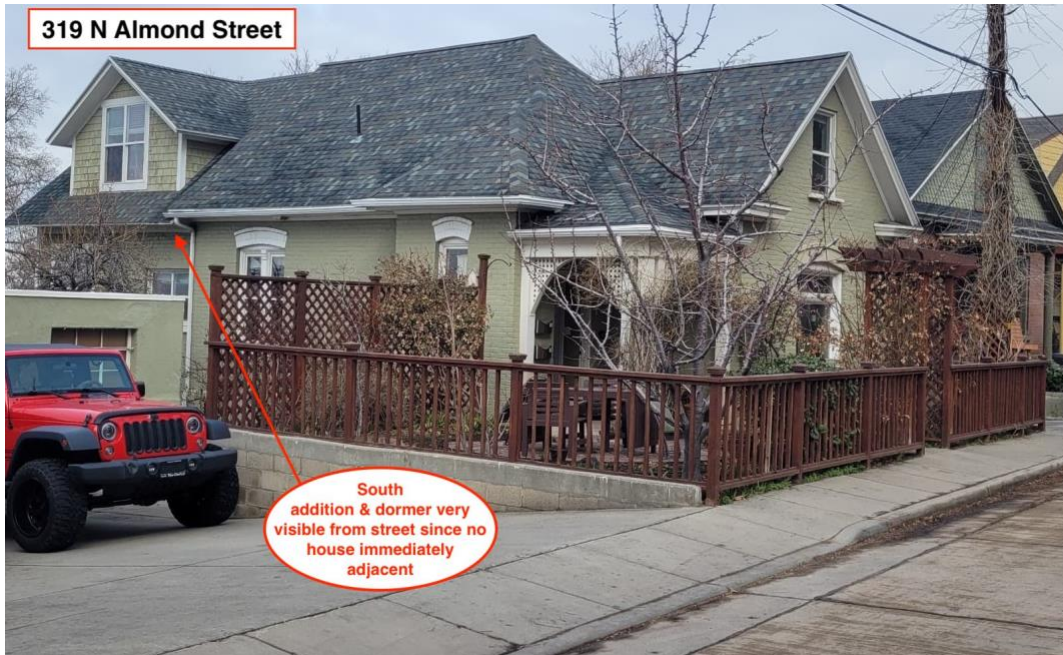
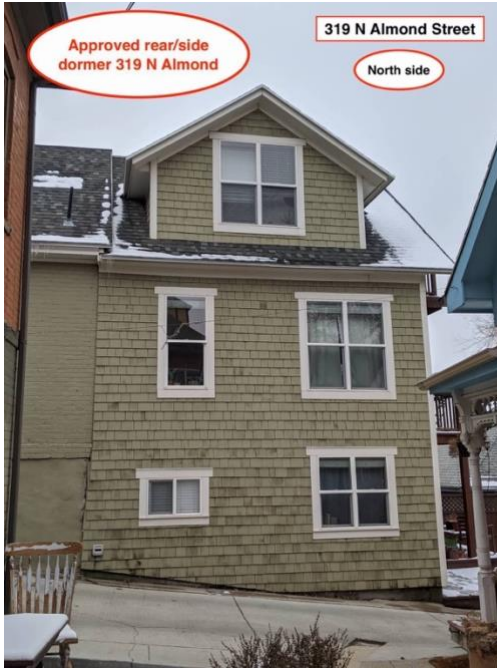
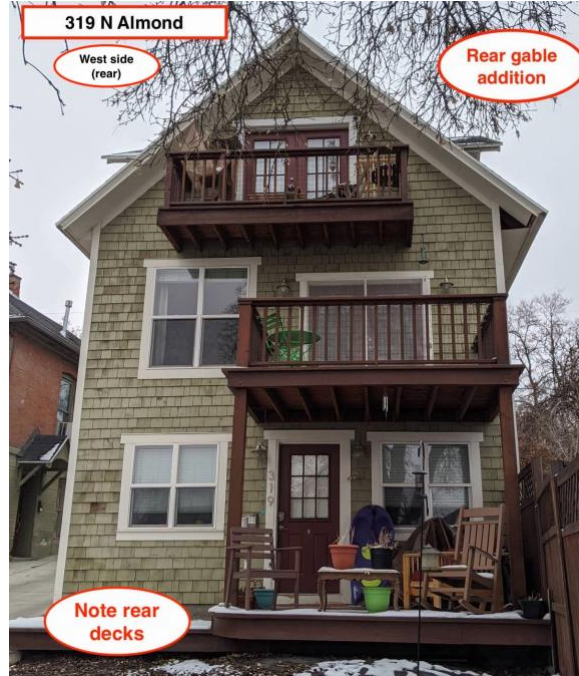
Sample: Early 1900s rear addition with dormers one block over on Almond Street. Note that like House #2, this home sits very close to the street and appears to be a small cottage from the front. Like ours, it has a south-facing secondary façade that is very visible from Almond Street – its neighboring house is also not immediately adjacent and sits farther back exposing this triplex’s entire south side to passersby. Despite its addition being visible, it does not disrupt the beauty of the structure or the neighborhood.

Even though this is a 3-story rear addition with two large dormers, the city approved it, and rightly so. Our plans are less ambitious and don’t enlarge House #2’s footprint; we’re only expanding into the attic – though that does require changing the rear roof line. As noted in Item

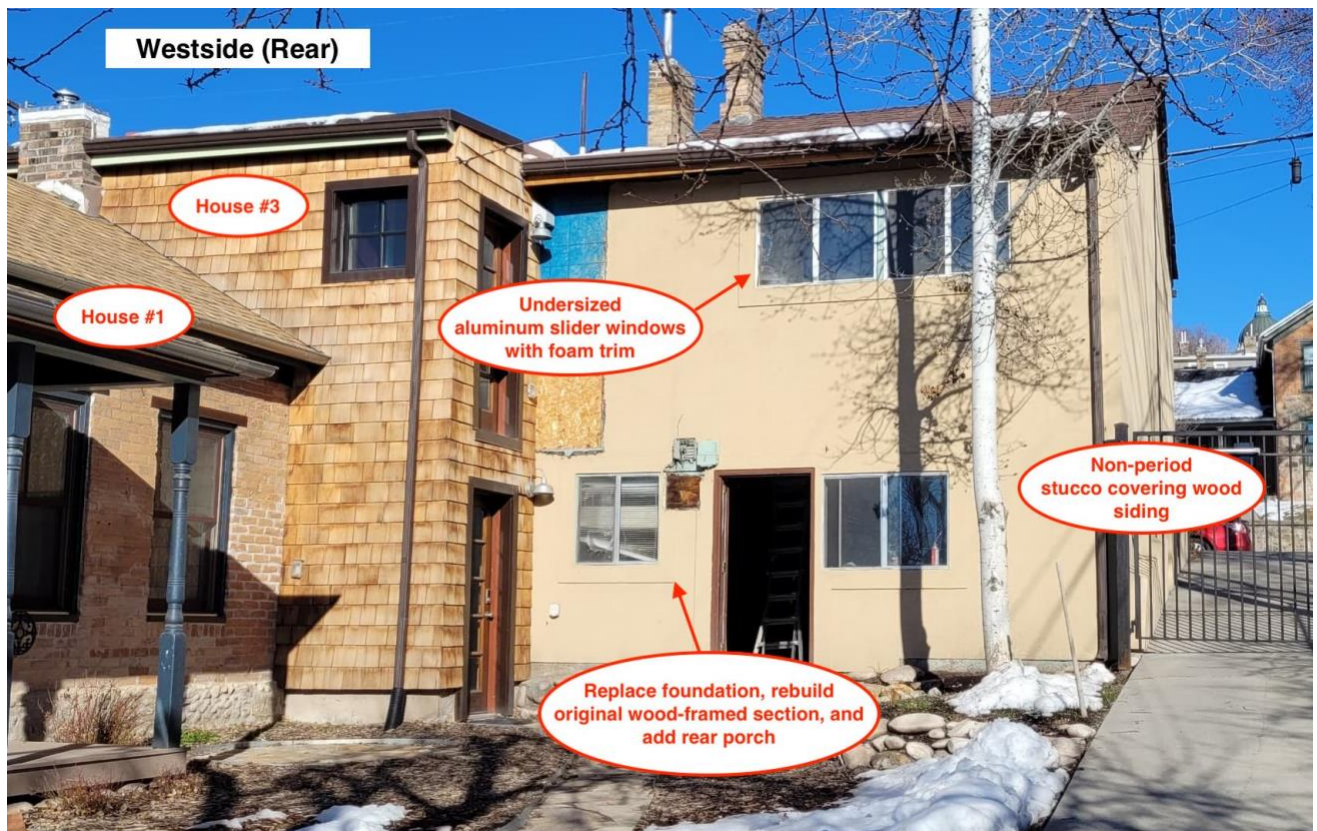
Quince houses currently. Houses #1 & #3 have been restored.

Note: Houses #1 and #3 were in equally rough shape when we first began these renovations. They too suffered from the prior owner's misguided repairs. They are now beautiful examples of both an early 1860s pioneer cottage – one of the few still standing in Salt Lake – and an early 1900s parapet/flat roof cottage. Following are photos showing the properties as purchased and current. These show the backs of Houses #2 and #3, and the front of House #1.

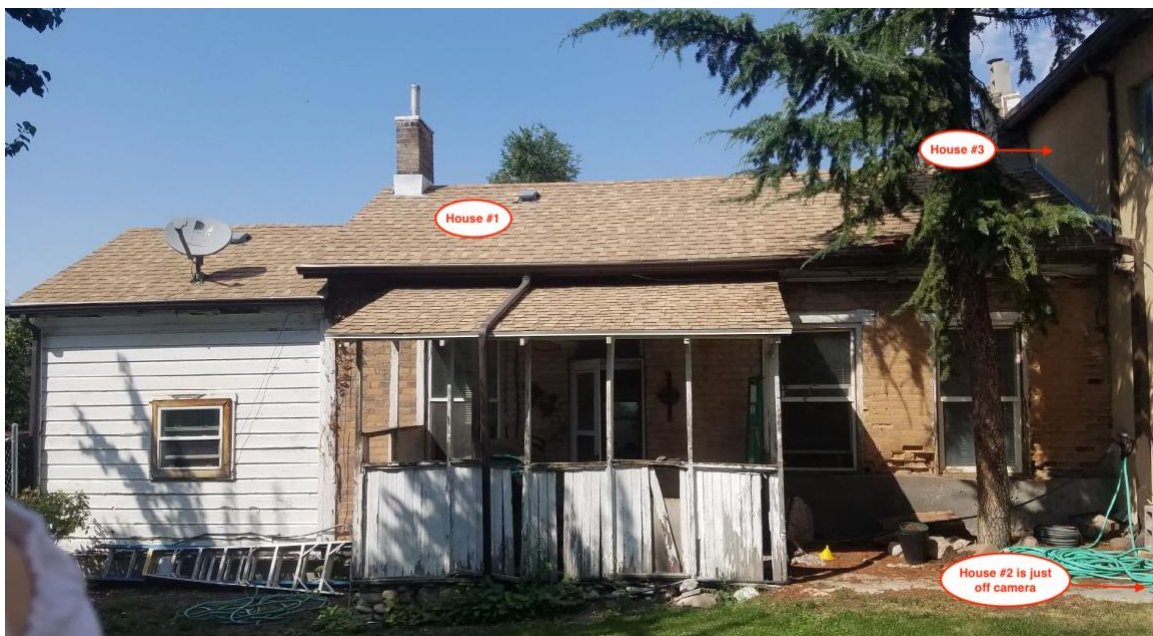
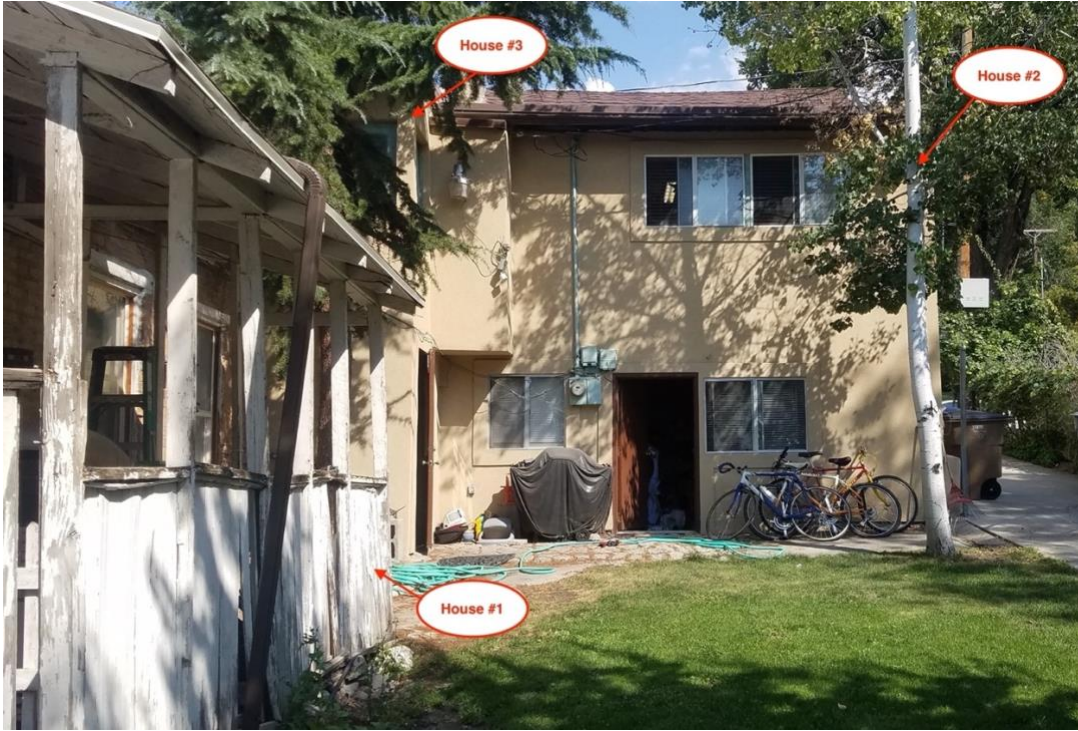
Quince houses as purchased before any renovation.
