Staff Report

To: Salt Lake City Historic Landmark Commission
From: Katia Pace, Principal Planner (801)-535-6354, katia.pace@slcgov.com
Date: November 3, 2022
Re: PLNHLC2022-00242 – Minor Alterations for an addition and window openings

PROPERTY ADDRESS: 365 N Quince Street
PARCEL ID: 08-36-282-015-0000
MASTER PLAN: Capitol Hill Master Plan
ZONING DISTRICT: SR-1A, Historic Preservation Overlay (Capitol Hill)
DESIGN GUIDELINES: Residential Design Guidelines

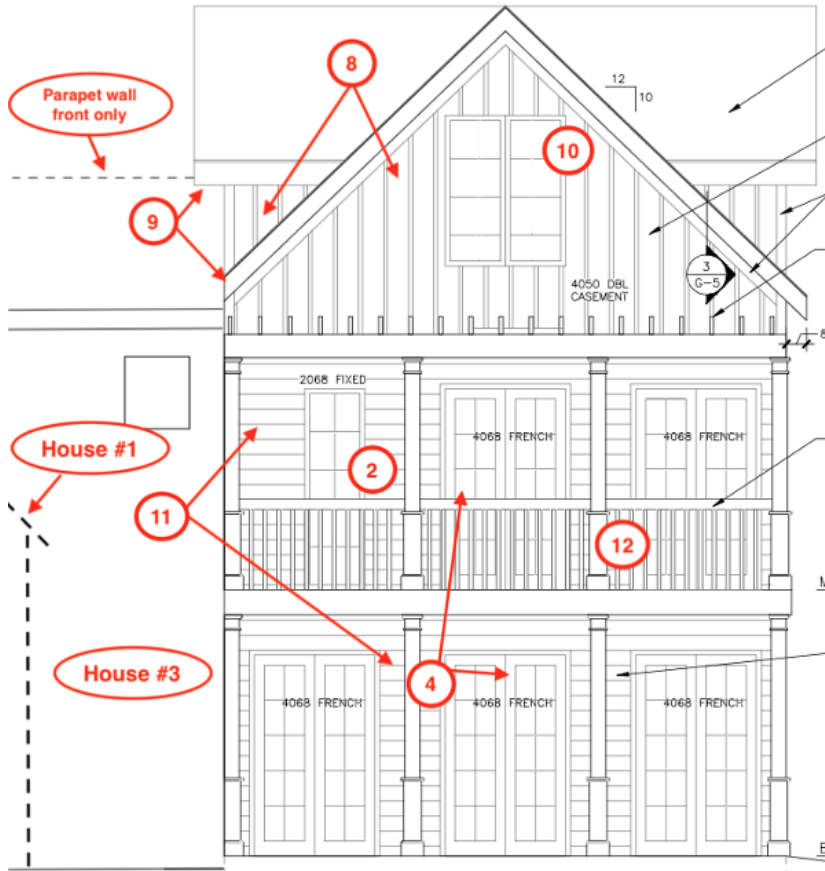
Proposed: Reconstruct rear wood-frame section and foundation per plans. The size will not change.

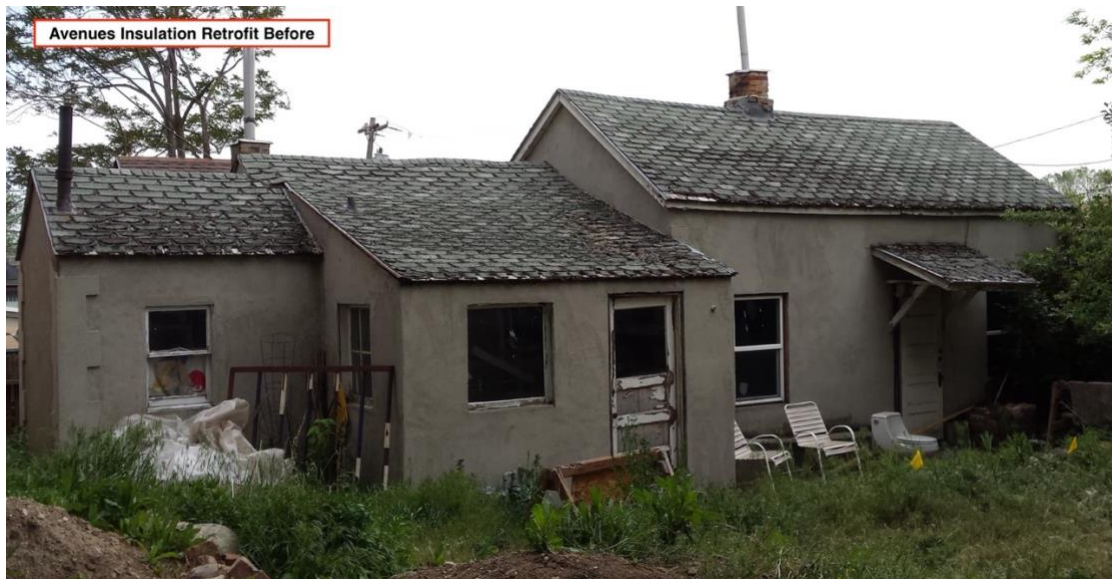
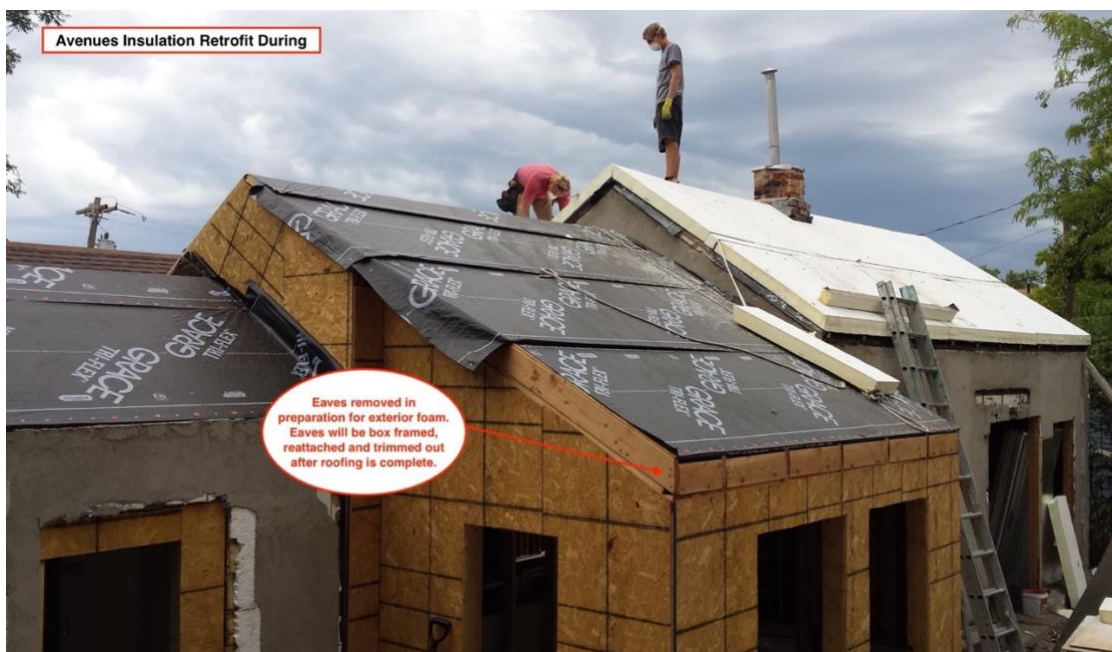
Samples: Deep energy retrofit of 1890s house in the Avenues, before, during, & after.

Eaves removed, 3" rigid foam applied on walls, 8" on roof, then taped and air sealed.

Insulation – Deep Energy Retrofit: As with the wood-framed sections we rebuilt on Houses #1 and #3, we will be installing the insulation on the exterior envelope of the roof and walls. House #2 is especially suited for this deep energy retrofit, since it has no original exterior wall finishes or trim which would otherwise be displaced. It requires close attention to detail but results in a highly efficient and well-insulated structure. This will be our 5th time using this system.

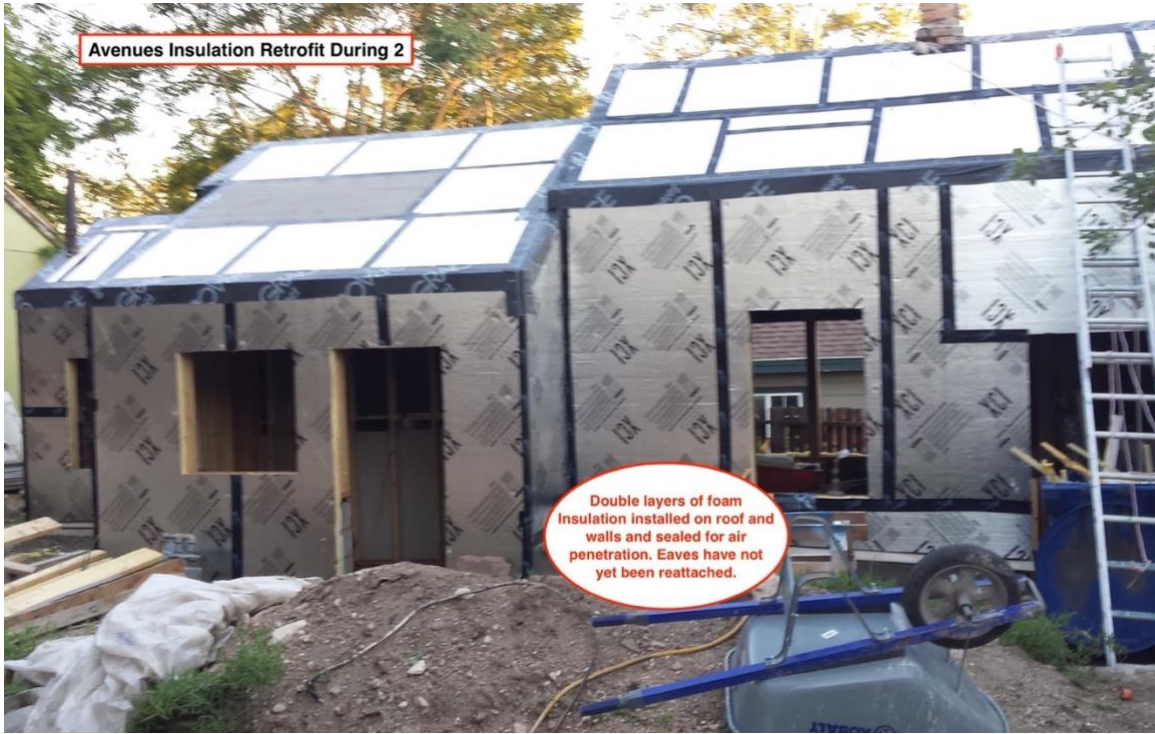
Box eaves reinstalled, 1x3 furring strips installed for drainage plane, trim installed.

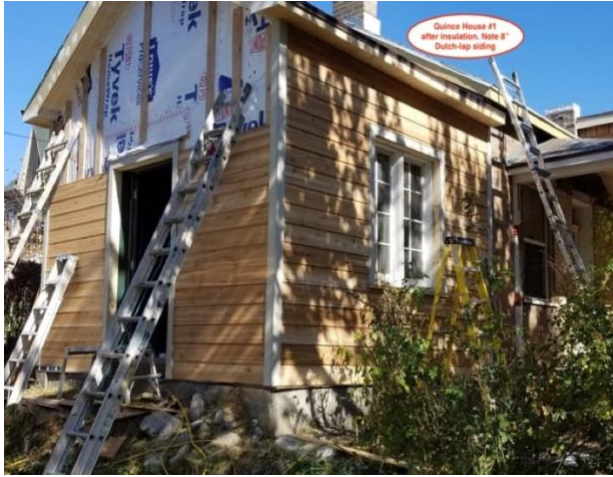
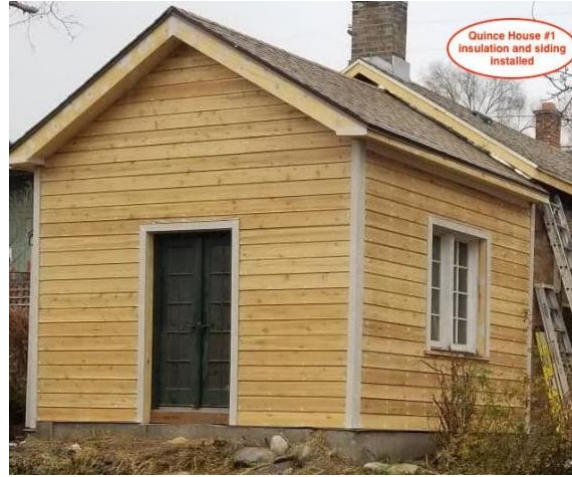
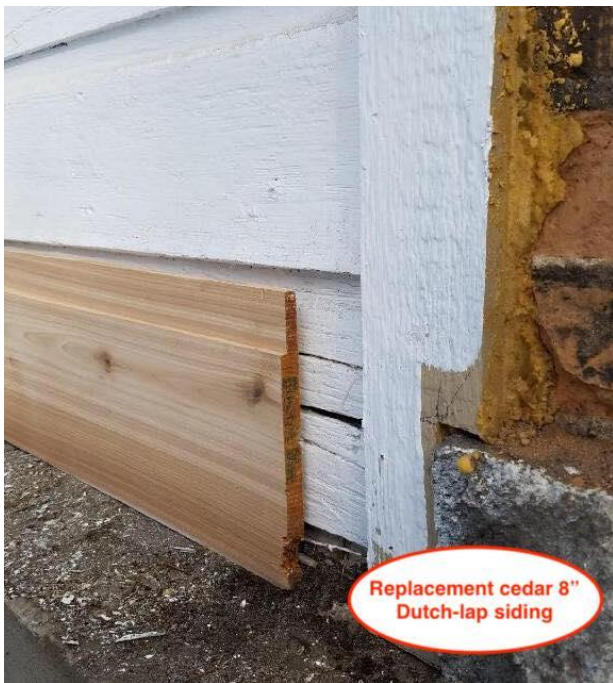
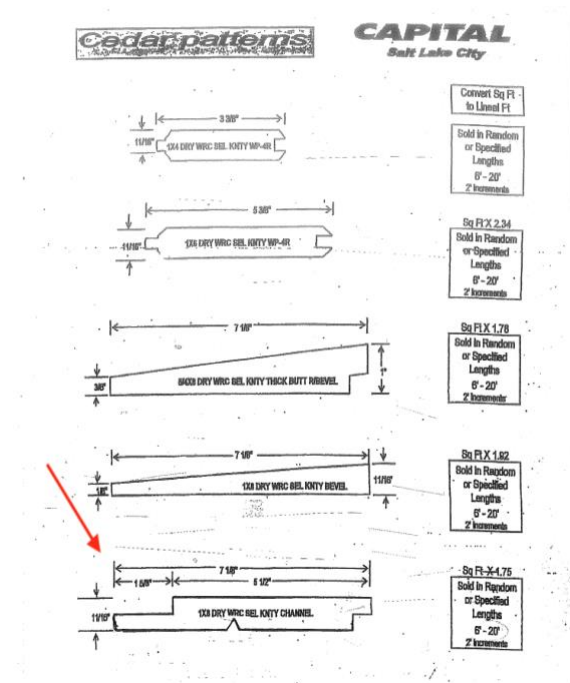
Siding on wood-framed section: 8" cedar Dutch-lap siding, which was the same used on the Flowers' own home (House #1), will be used to restore the rear, 1936 addition. Below are images of the last project we used this siding on. It was installed over 3" of exterior rigid foam.

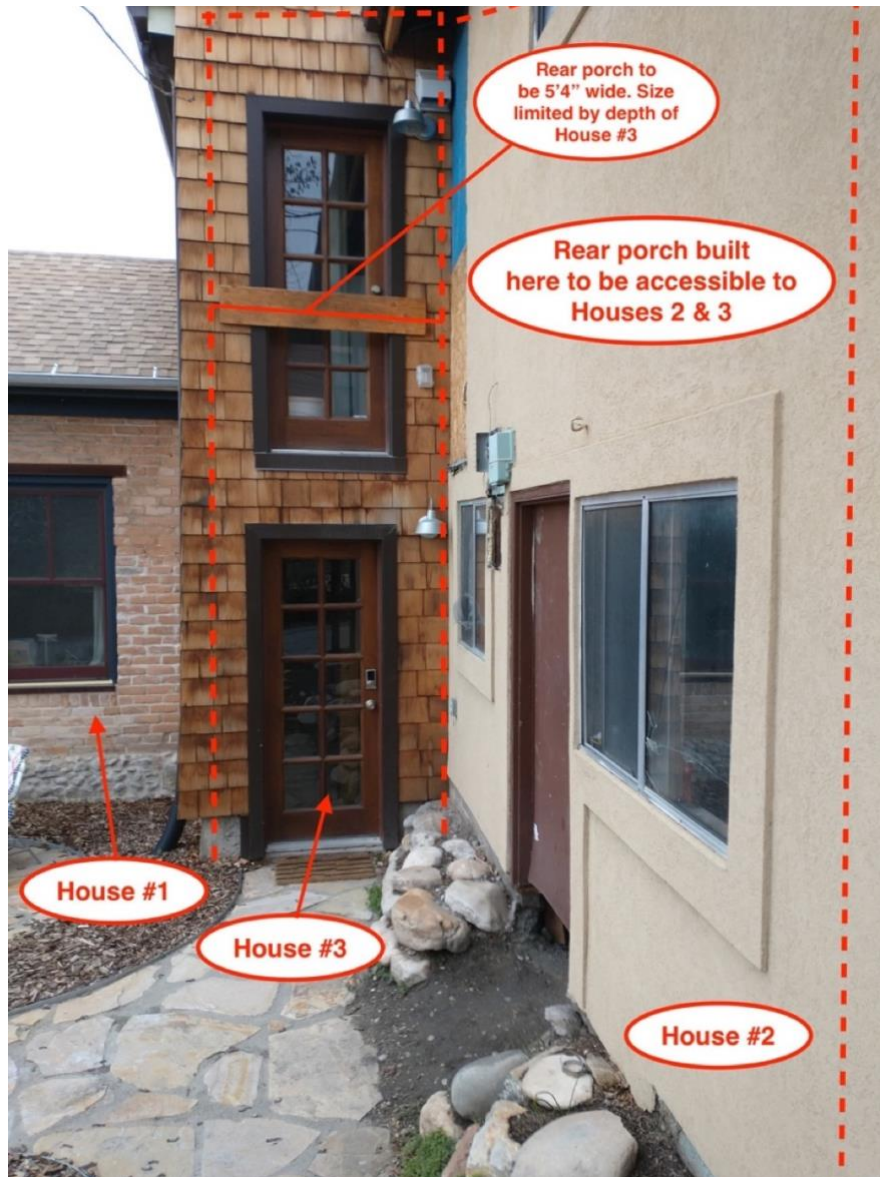
Dimensions: The new porch/deck is limited in depth by the rear entry access of House #3 and the front façade of House #1 as shown below. It will be 5'4" depth. The porch is also limited in width by the width of House #2 and the driveway. As such, it will be 18'8" wide.

Proposed: Construct a small, 5'4" x 18'8," two-level rear porch on the rear of House #2. See Section A.3.a. for the guidelines and arguments in favor of the porch.

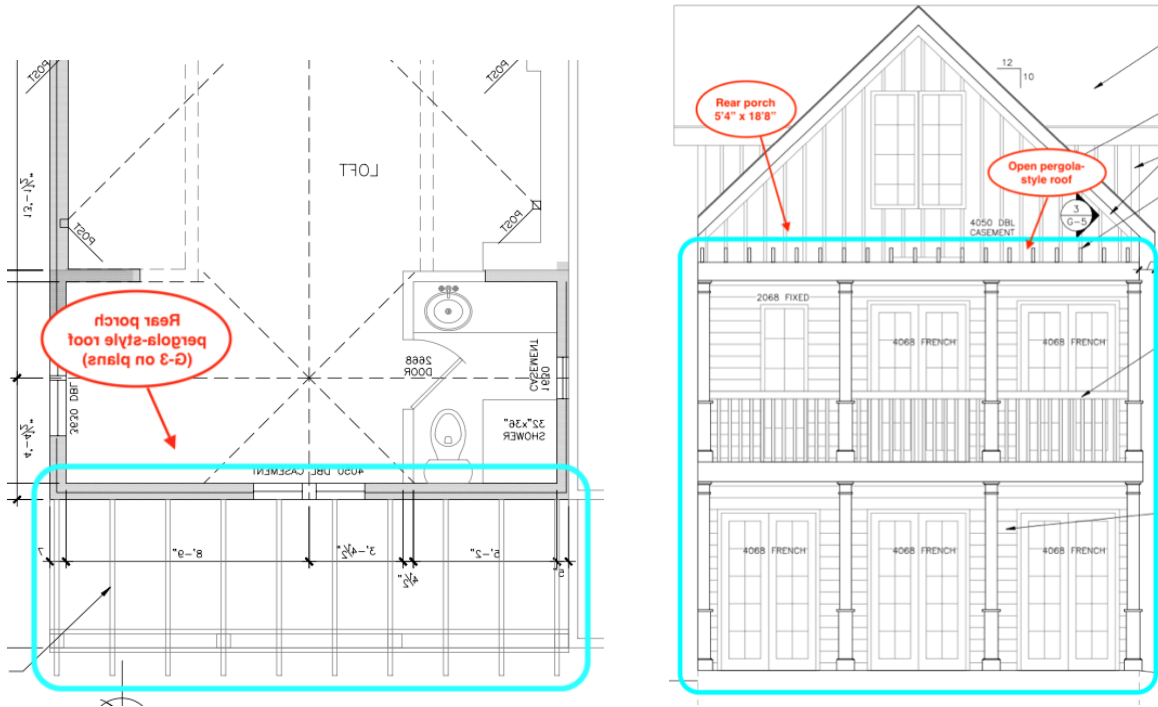
Roof: The loft addition will not extend over the porch; it will end at the same plane as the west, wood-framed section. The porch roof will be built in an open, pergola style with 3"x 6" rough sawn lumber.

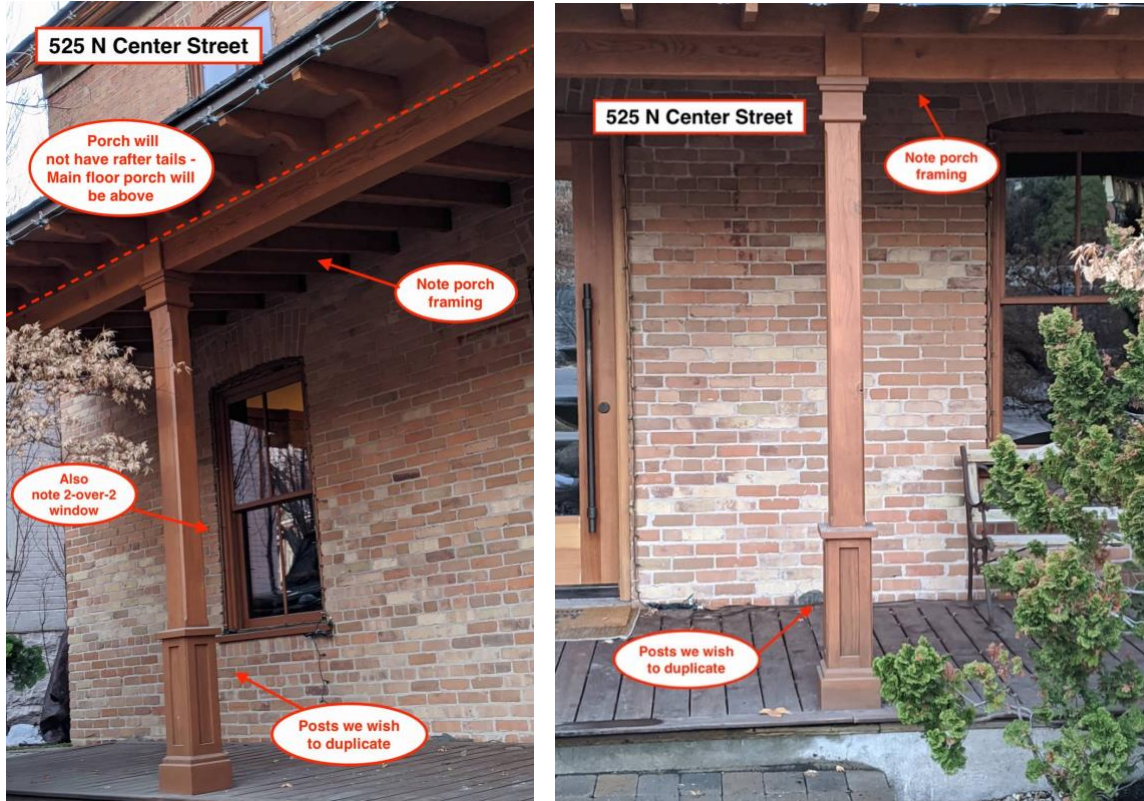
Samples: Posts & construction style we will duplicate from similar era home in the Marmalade.

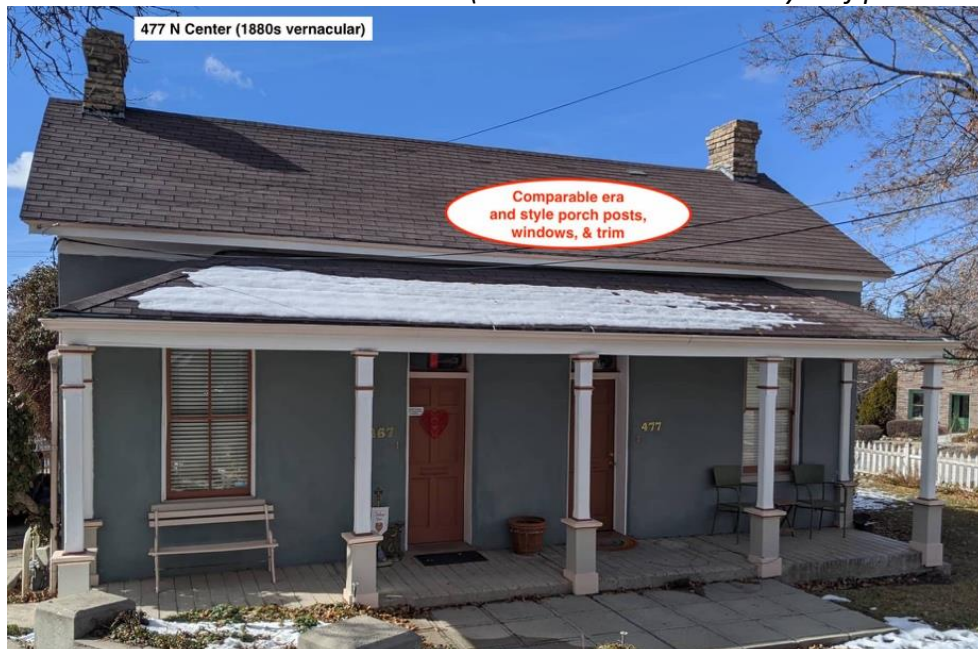
Posts from a similar home in the Marmalade (we will use lower box style of posts above).

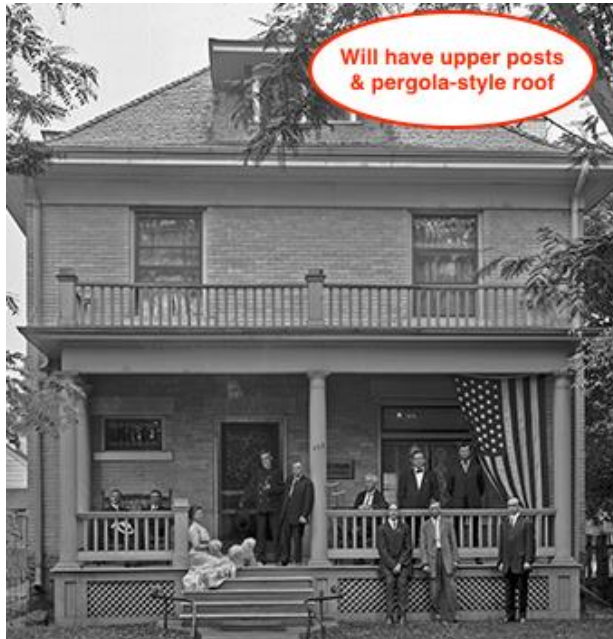
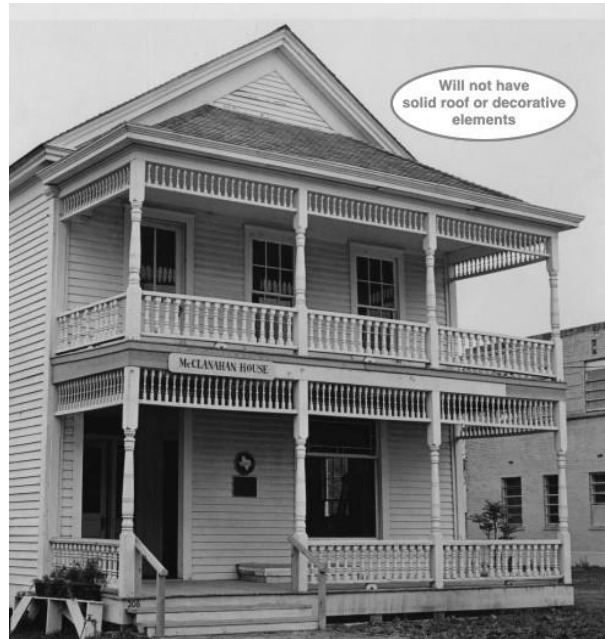
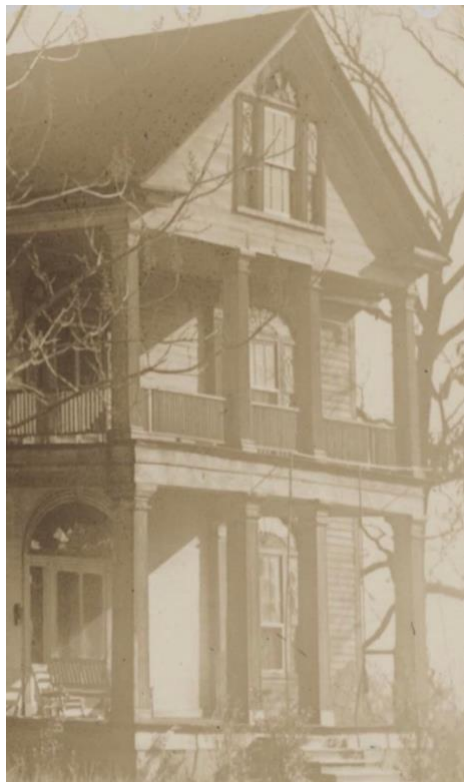
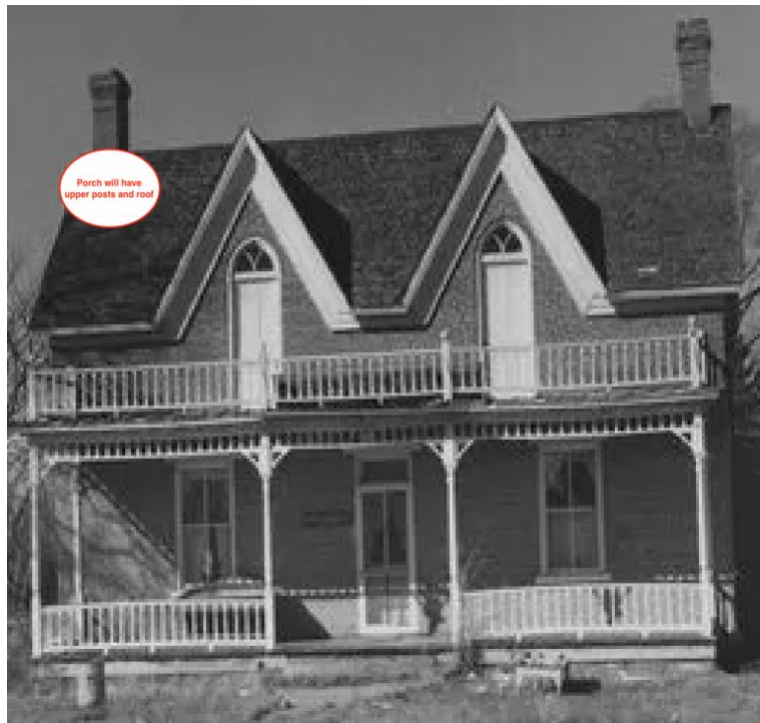
Sample historic two-level porches
