THE UTAH GUIDE FOR THE SEISMIC IMPROVEMENT OF **UNREINFORCED MASONRY DWELLINGS**

**Utah Seismic Safety Commission
Existing Buildings Committee
Second Edition
2016**

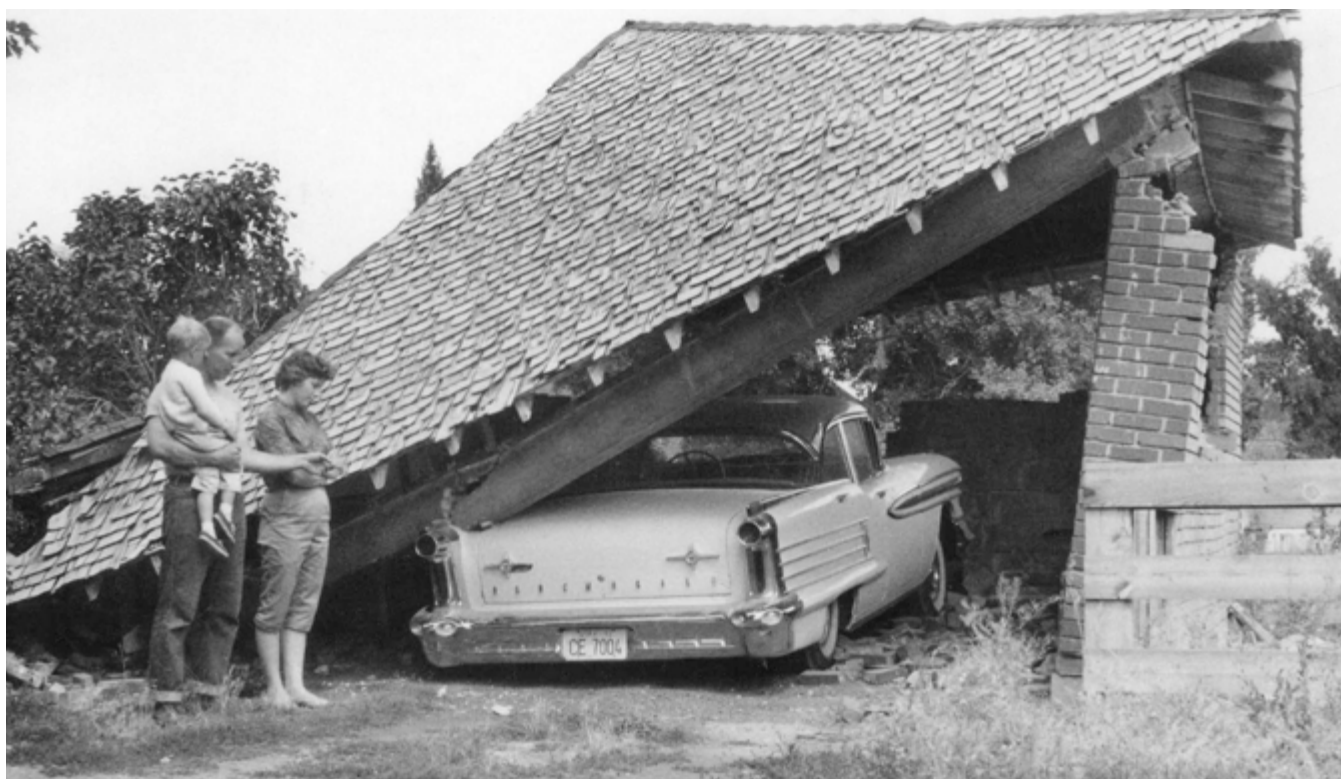
Figure 9. URM pier failure. Photo: Ariel Benson

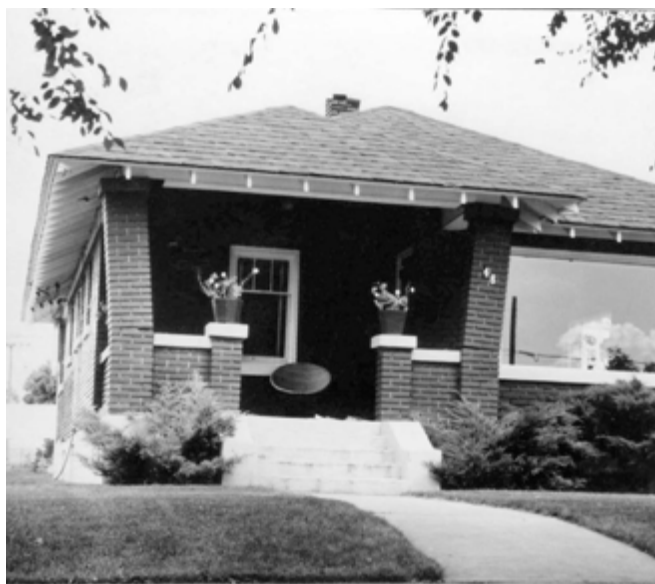
Figure 10. URM pier failure. Photo: Ariel Benson

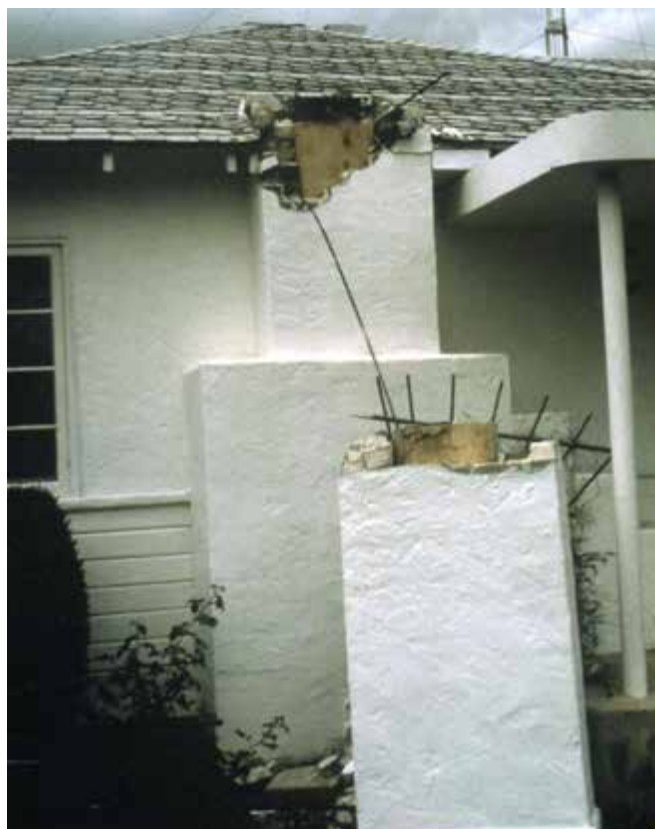
Figure 11. Chimney failure due to inadequate reinforcement.

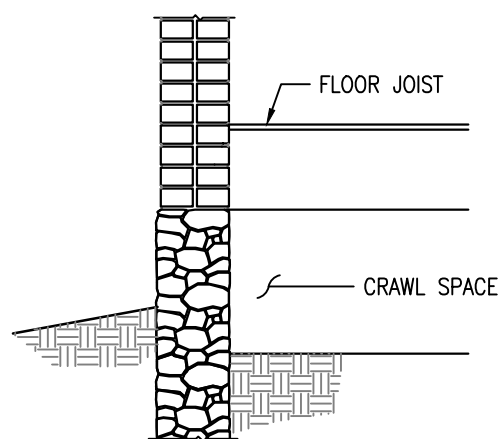
Figure 18. URM bearing wall.

A bearing wall is defined as a wall that supports any vertical load in a dwelling as well as its own weight (figure 18). In this case, the vertical loads come from the floor and roof systems in a dwelling. The floor(s) and roof are normally composed of wood joists (parallel horizontal wood members) and a diaphragm (plywood or wood

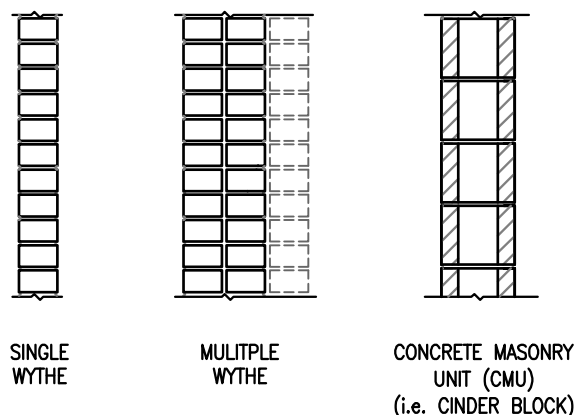
Figure 19. Vertical section through URM walls.

Figure 19 illustrates three types of URM walls described in this guide. Failure of these walls can happen in several different ways. In-plane failure occurs when seismic forces from an earthquake are introduced parallel to the wall causing the wall to be displaced horizontally within the plane of the wall (figure 20). Out-of-plane failure occurs when seismic forces are introduced perpendicular to the wall and the wall either falls away from the floor(s) and/or roof, or buckles between the floor(s) and roof (figure

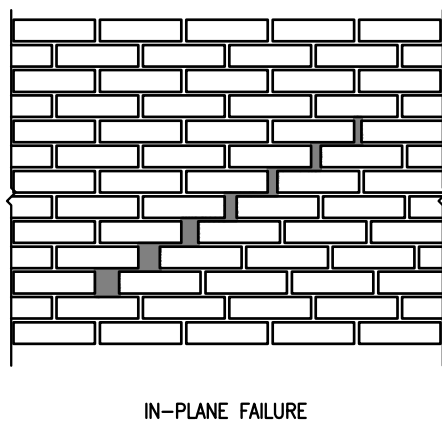
Figure 20. In-plane failure.

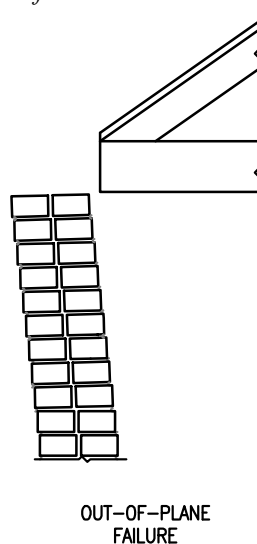
Figure 21. Out-of-plane failure.

21). The floor joists usually pocket into the masonry and the roof joists normally bear on top of wall. In both cases, there may or may not be a wood plate to which these joists are nailed. Failure of these connections can cause the joists to slide off their bearing support, resulting in full or partial collapse of a floor or roof. Another common failure in multiple wythe (or vertical layer) construction where one or more of the outer wythes of brick may fall away from the rest of the wall, as they are not connected together.

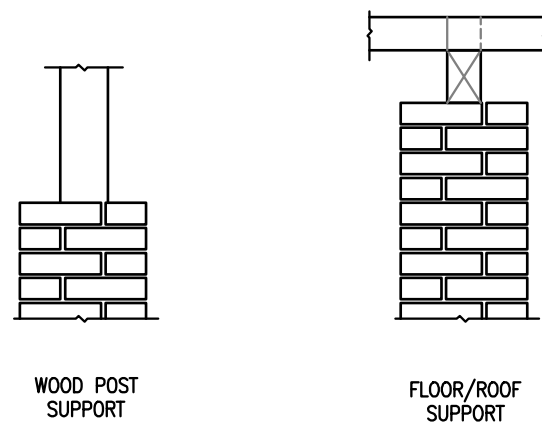
Figure 22. Wood post support and floor/roof support.

Masonry piers can be located within the dwelling under the main beam line that supports the first floor or at the exterior to support the roof over a porch (figure 22). In both cases, the pier either continues to the floor or roof, or supports a wood post that then continues to the floor or roof. These piers are subject to the same type of failure as the masonry foundation wall. Taller piers will have tendency to topple or buckle during an earthquake.

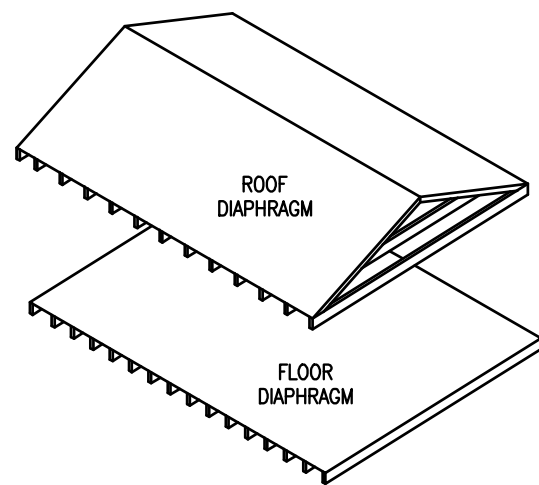
Figure 23. Example of roof and floor diaphragms.

The diaphragm is the structural element that consists of sheathing fastened to the underlying joists, creating a flat floor/roof or a sloping roof, which distributes forces throughout a particular level of the dwelling (figure 23). Horizontal forces generated in the masonry walls are transferred to the diaphragms. The diaphragms in URM construction generally fail due to the large forces generated from the weight of the surrounding masonry and/or the poor connections tying the diaphragms and walls together.

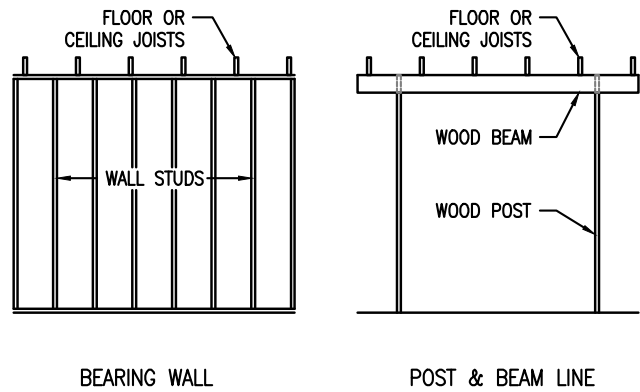
Figure 24. Bearing wall and post and beam line.

The interior-bearing element may be an URM wall, a wood stud wall, a post and beam line, or any combination (figure 24). This intermediate support is required because the floor and roof joists generally cannot span between exterior walls. These elements will normally fail from inadequate connections or lack of any connections to each other.

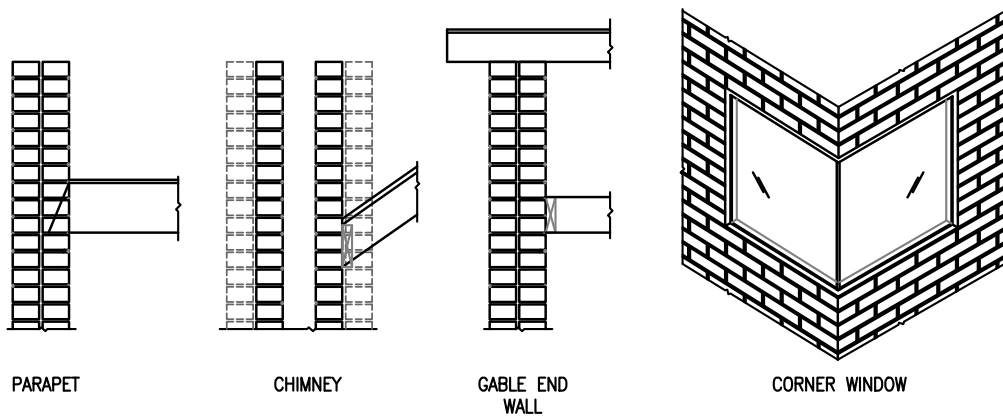
Figure 25. Examples of a parapet, chimney gable end wall, and corner window.

The special features covered in this guide include URM parapets, masonry gable end walls, chimneys, and corner windows (figure 25). There are other special features found on URM dwellings, however these are the most common. A description of each of these items, their deficiencies, and references to the appropriate corrective measures are included at the end of Chapter 5.

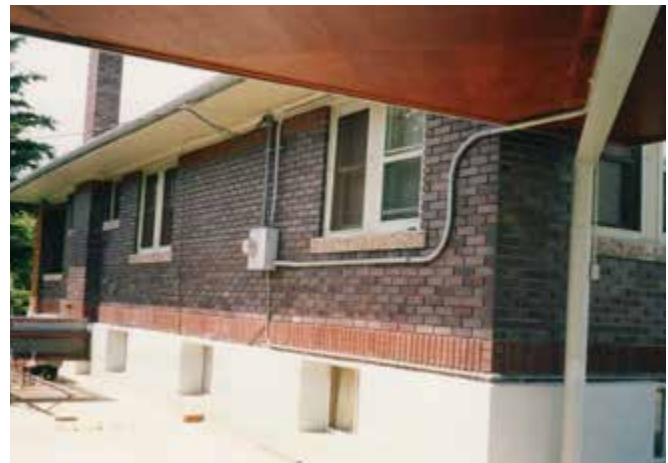
Figure 28. Model A rear view.

Model A was built in approximately 1906 and is a single-story dwelling with a full basement (figures 27 and 28). The construction consist of double wythe URM exterior walls, concrete foundation walls supporting a wood floor and roof/ceiling joists around the exterior, and wood stud bearing walls within the dwelling. It has two chimneys, one exterior and one interior, and a porch with tall masonry piers supporting the roof.

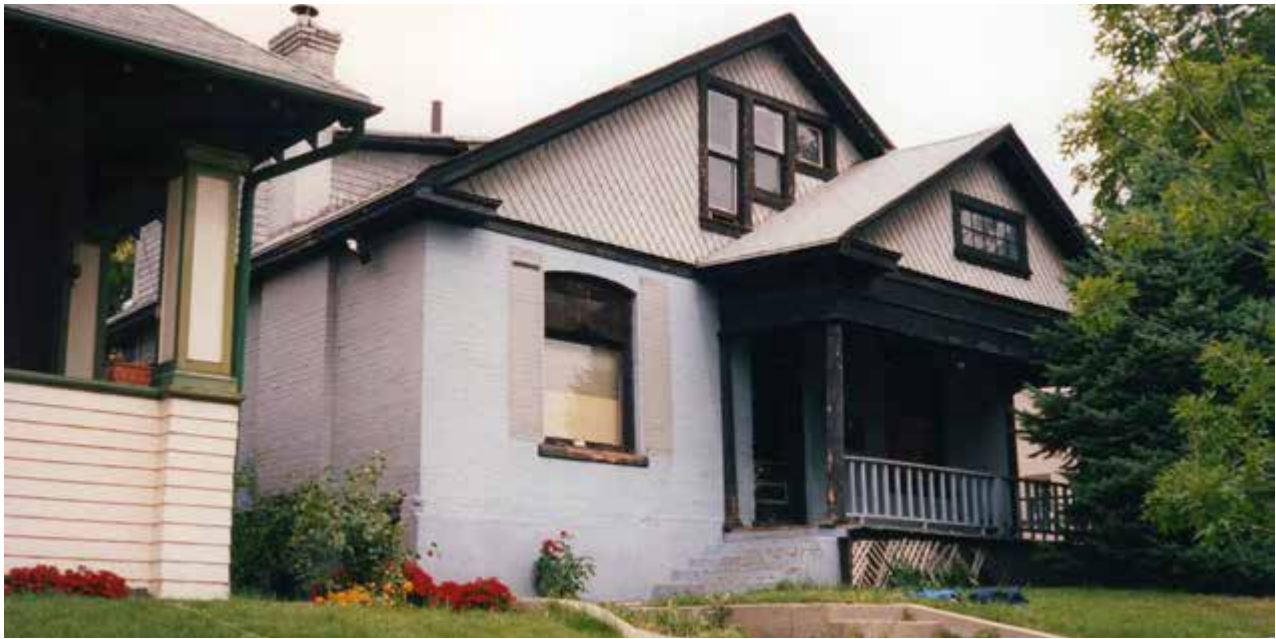
Figure 29. *Model B front view.*

Model B was built in the late 1890s, and is a single-story home with an attic area used for living space, with a concrete shelf type basement (figures 29 and 30). The construction consists of double wythe URM exterior walls, concrete foundation walls supporting a wood floor, roof/ceiling joists around the exterior, wood post and beams inside the dwelling, the front and back porch roofs are supported by wood posts, and it has one exterior chimney. Some of the posts are bearing on masonry piers.

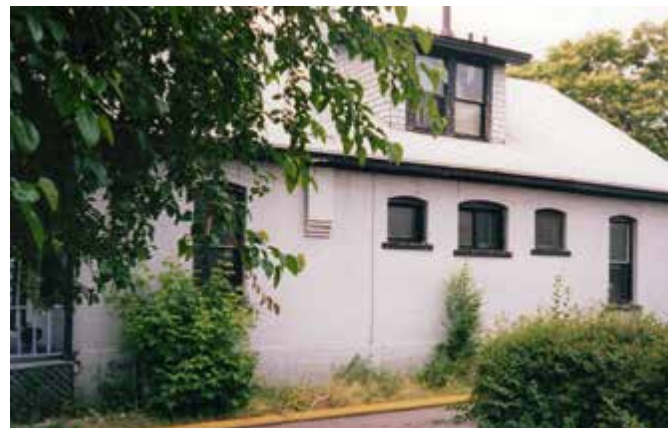
Figure 30. *Model B rear view.*

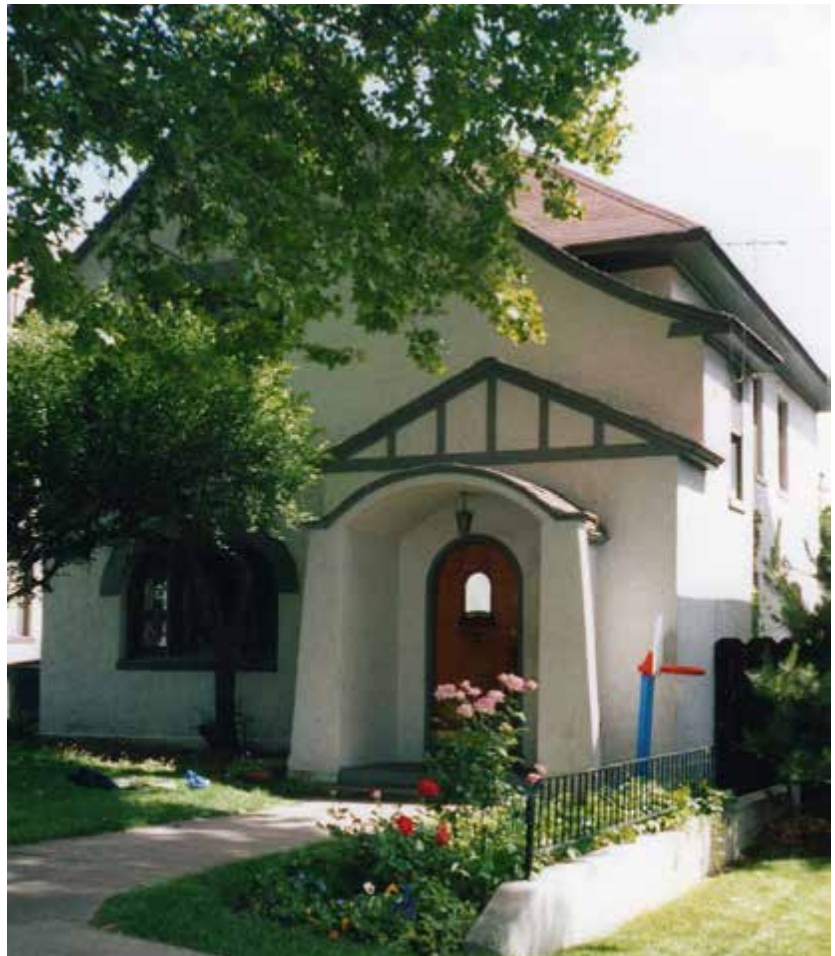
Figure 31. *Model C front view.*

Model C was built in the 1900s, and is a two-story home with a concrete shelf basement (figures 31 and 32). The construction consists of double wythe URM exterior walls covered with stucco, masonry/rock foundation walls supporting a wood floor and roof/ceiling joists around the exterior. A wood beam on masonry piers or wood posts supports the floor, while a wood stud wall supports the roof. It has two exterior chimneys and several small roof areas built into the dwelling.

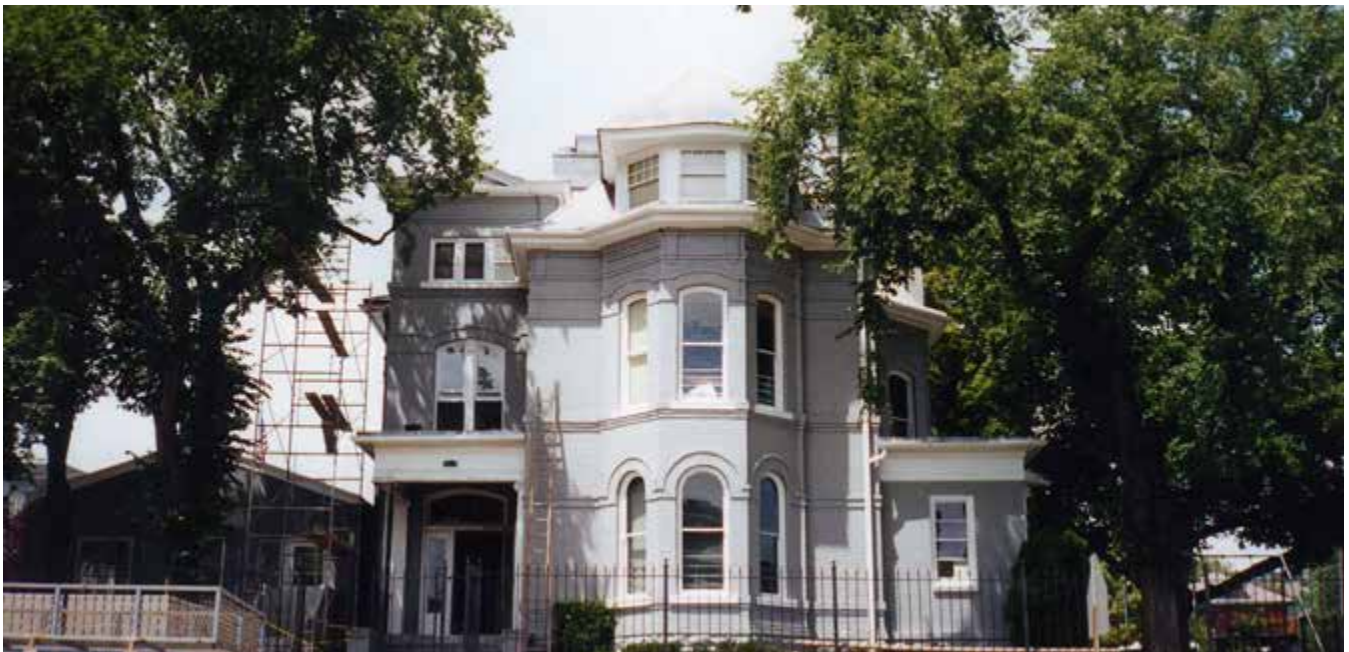
Figure 33. Model D front view.

Model D was built in the early 1900s and is a two-story home with living space built into the attic area and a partial shelf basement (figures 33 and 34). The construction consists of double wythe URM exterior walls and masonry/rock foundation walls supporting a wood floor and roof/ceiling joists around the exterior. A wood beam supported by masonry piers support the floor, while an interior wood stud wall supports the ceiling/floor joists. It usually has one exterior chimney and may have low roof areas at any elevated the floor levels.

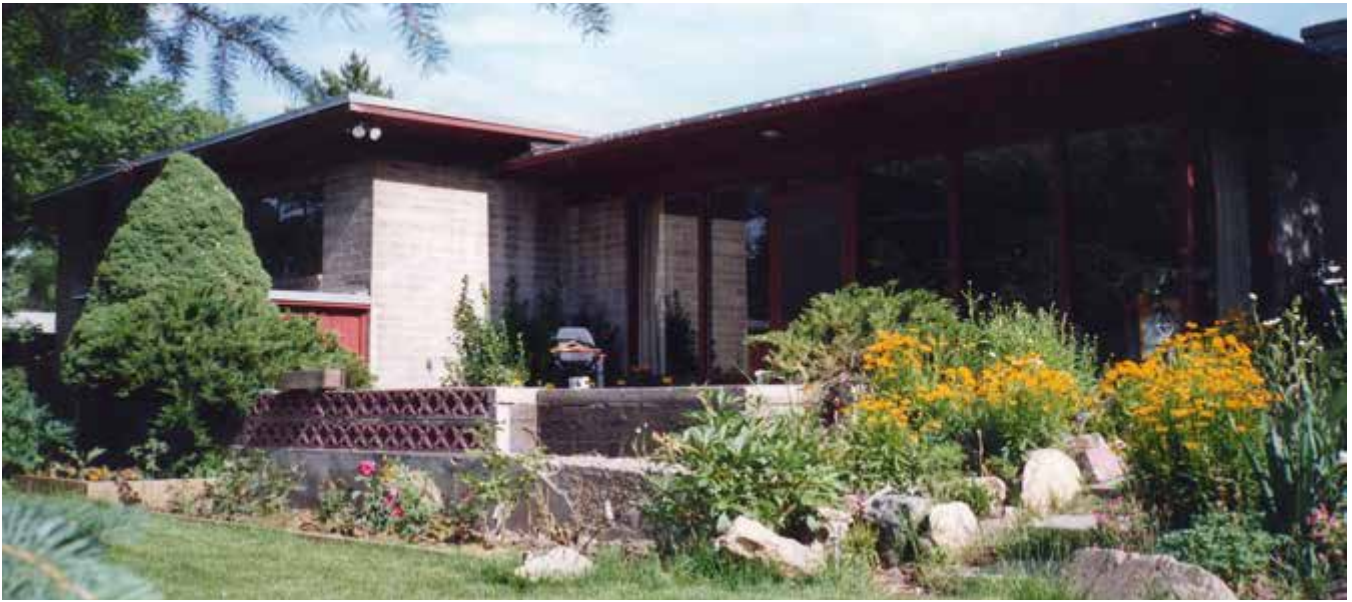
Figure 37. *Model F front view.*

Model F was built in 1954, and is a single-story home with a partial basement and flat roof (figure 37). The construction consists of a concrete/cinder block walls, referred as concrete masonry units (CMU), and concrete foundation walls supporting wood floor and roof/ceiling joists around the exterior with wood stud bearing walls supporting the interior. It has one low chimney with a metal flue that extends up. The roof over the front porch is supported by slender wood posts.

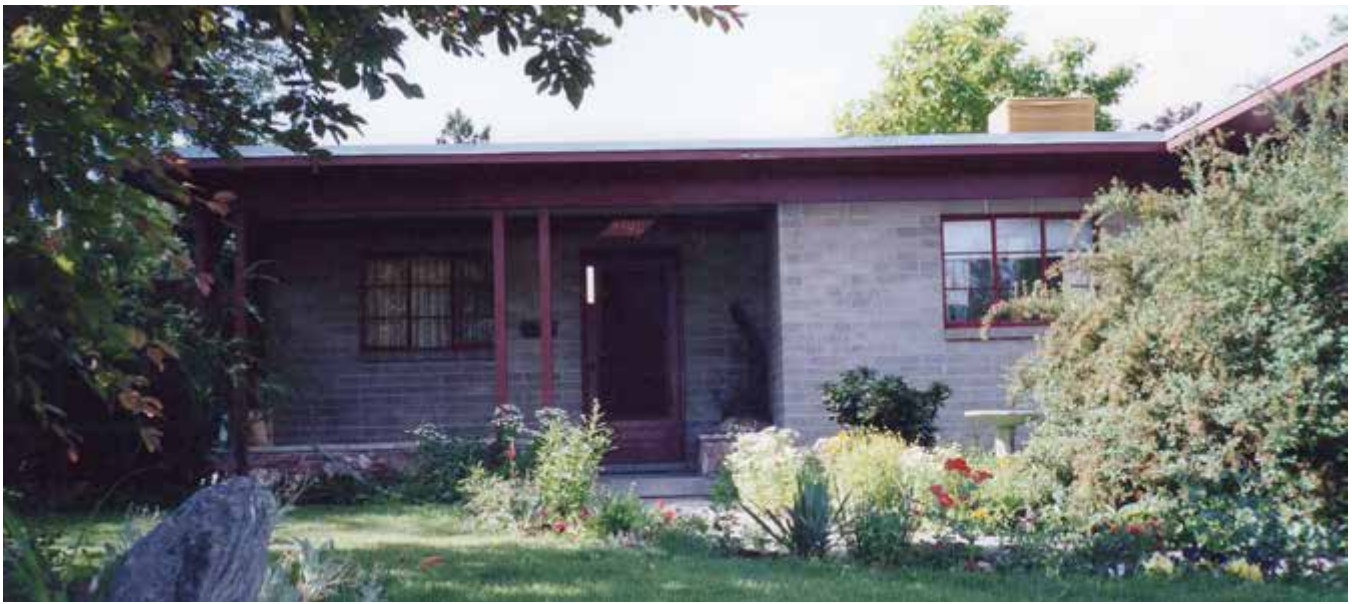
Figure 38. Model G front view.

Model G is a single-story home with a basement and was a common building type constructed in the 1940s and 1950s (figure 38). The construction consists of CMU walls with exterior brick veneer and concrete foundation walls with the concrete/cinder block portion of the exterior walls supporting wood floor and roof/ceiling joists around the exterior with wood stud bearing walls supporting the interior. The roof is framed with two (2x) members for a sloped roof or later dated dwellings may be constructed with trusses. It usually has a low chimney with a metal flue that extends upward. The roof over the front porch is supported by slender wood posts or masonry piers.

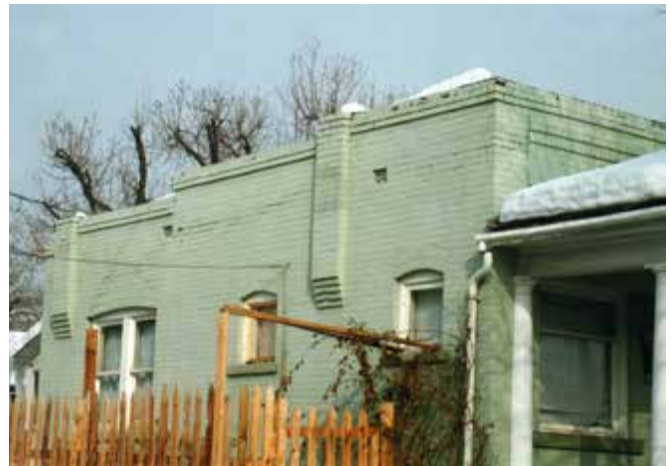
Figure 39. URM parapet walls.

A parapet is the portion of a wall that projects above the roofline and the top of a typical parapet is usually not braced (figure 39). When an earthquake occurs, the parapet can break off near the roofline from seismic forces. The bottom of the parapet near the roofline is normally weak zone because roof joists and other framing members are pocketed into the wall at this location. Failure of parapets can create a falling hazard that is a serious life safety concern, especially over doorways and walkways. As a general rule, the higher the parapet, the more serious the

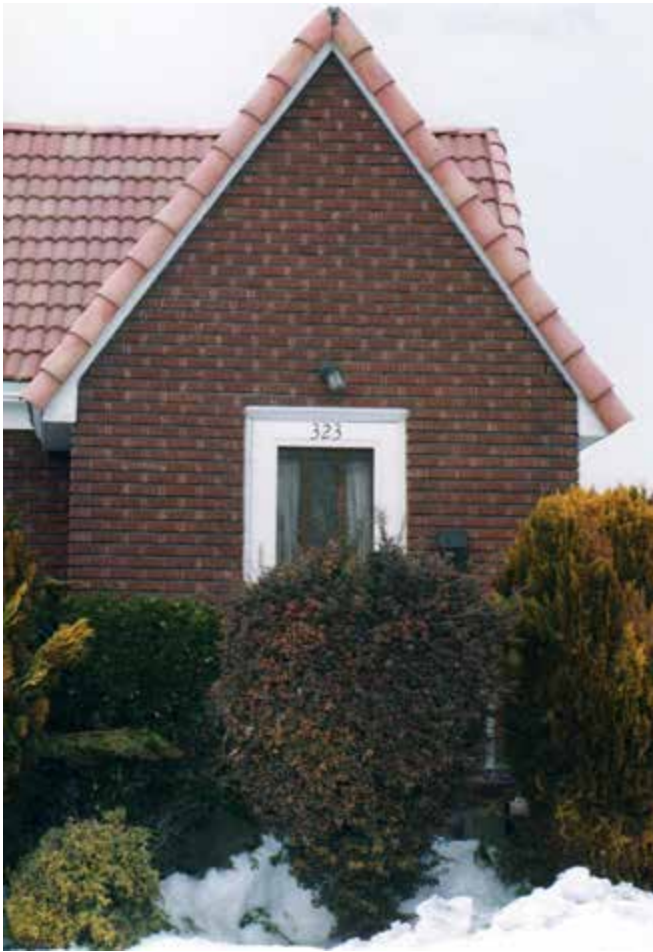
Figure 40. URM gable end walls.

A gable end wall is the triangle section of an exterior wall under the roof plane and above the eaves line (figure 40). This portion of a typical URM wall is not normally braced and supports the roof ridge. The height of this wall and the unbraced condition make it less stable than other elements to resist out-of-plane forces. Out-of-plane failure of a gable end wall is similar to that described for URM walls. The size of the gable end wall and the intensity and direction of seismic forces will have a direct effect on the stability of the wall. A wide gable generally supports a large portion of the roof. Failure of this type of gable end wall is likely to also result in at least partial collapse of the roof. The roof

rafters adjacent to a tall narrow gable are usually designed to bear on the main walls below. Failure of this type of gable end wall could create a falling hazard similar to parapets, but collapse of the roof is not likely unless the main walls below also fail. See detail 21 to help strengthen this deficiency.

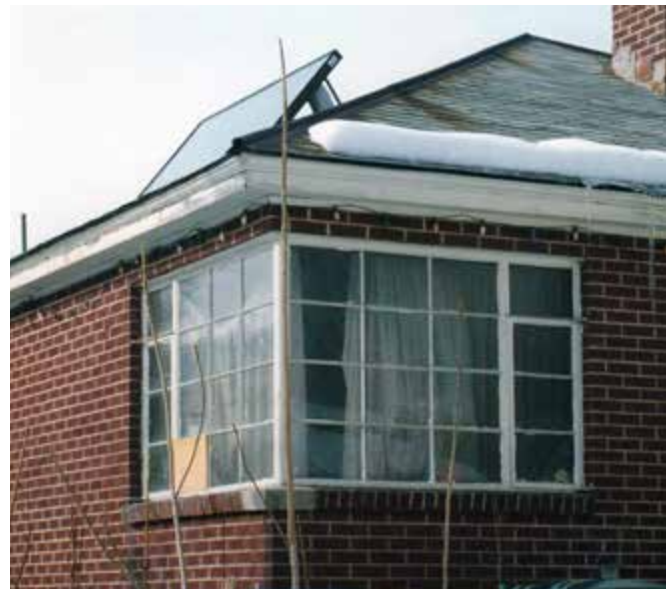
Figure 42. Typical corner window.

masonry wall above or the wall above may be on a cantilevered steel angle to avoid a corner post (figure 42). When used, the steel pipe may or may not be connected to the steel lintel. This feature may create a weakness in the shear wall. If the steel pipe was to become displaced, partial collapse of the dwelling could take place. See details 26 and 26a to help strengthen this deficiency.

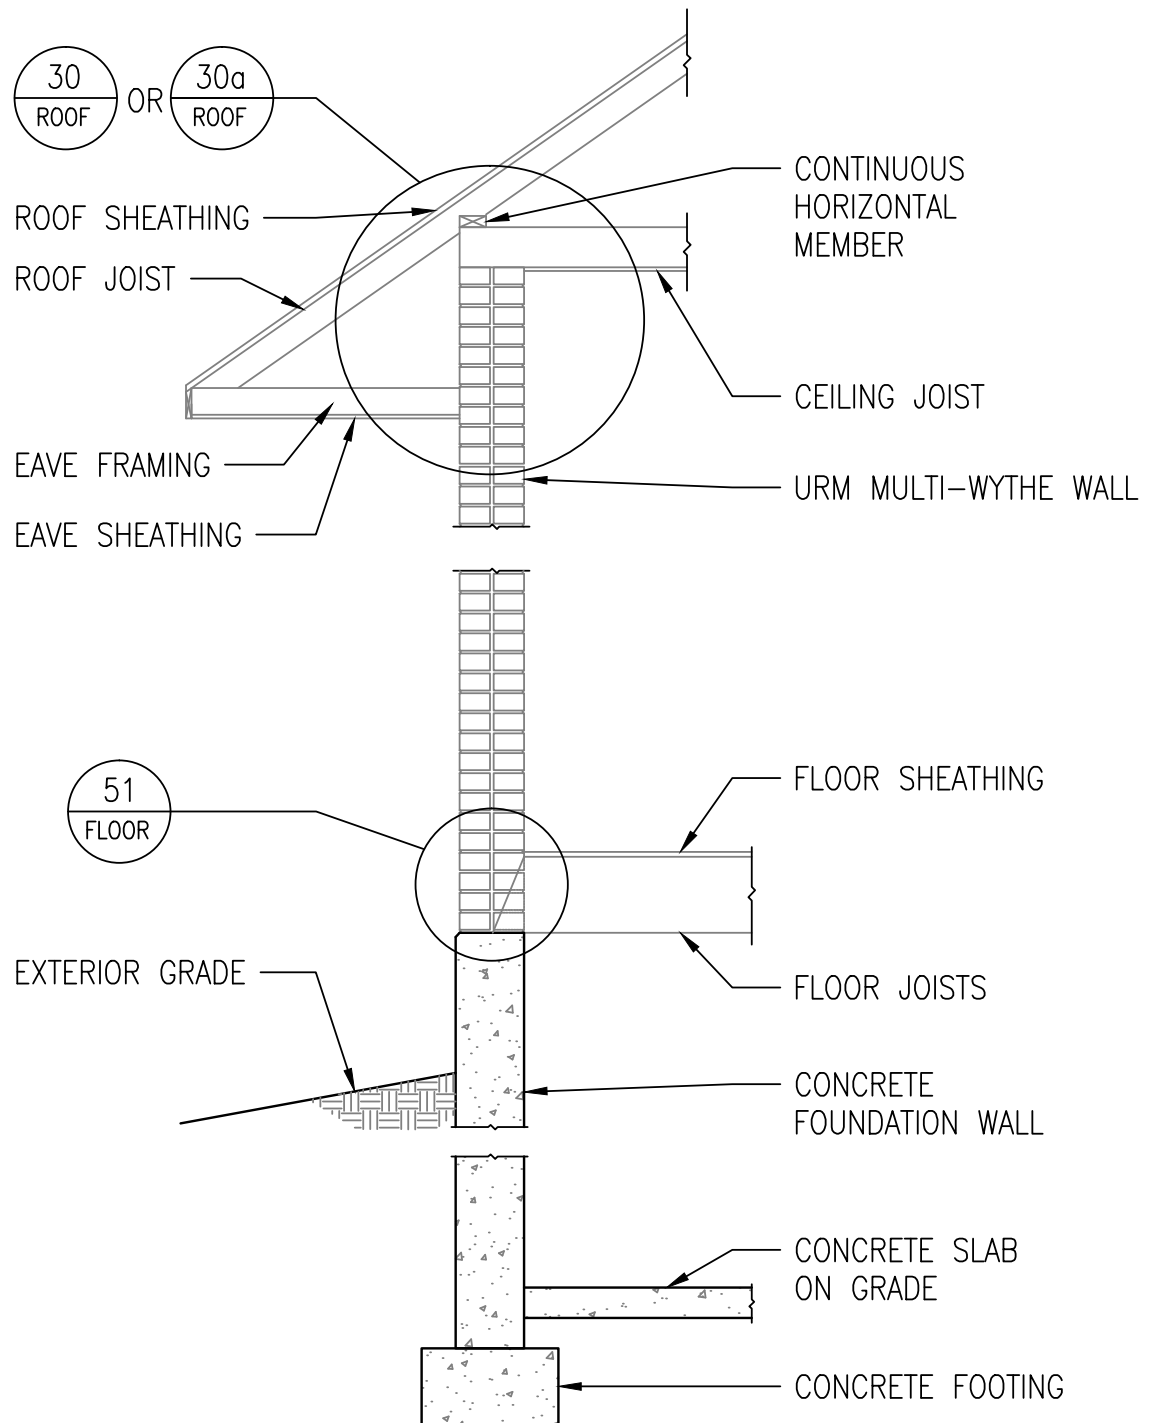
Model Home Seismic Deficiencies	HOME TYPE: MODEL A	Exterior Wall Sections	DETAIL: 1
------------------------------------	-----------------------	---------------------------	--------------

SECTION W/ JOIST FRAMING
PERPENDICULAR TO WALL

Details 1 and 2 show two different existing exterior wall details for a Model A dwelling. Reference circles have been superimposed onto these details showing the area of the wall where seismic deficiencies normally occur. The details for improvements to strengthen these deficiencies are found in Chapter 6. Table 1 and the additional details in Chapters 6 and 7 also recommend other improvements, although not illustrated in these exterior wall details.

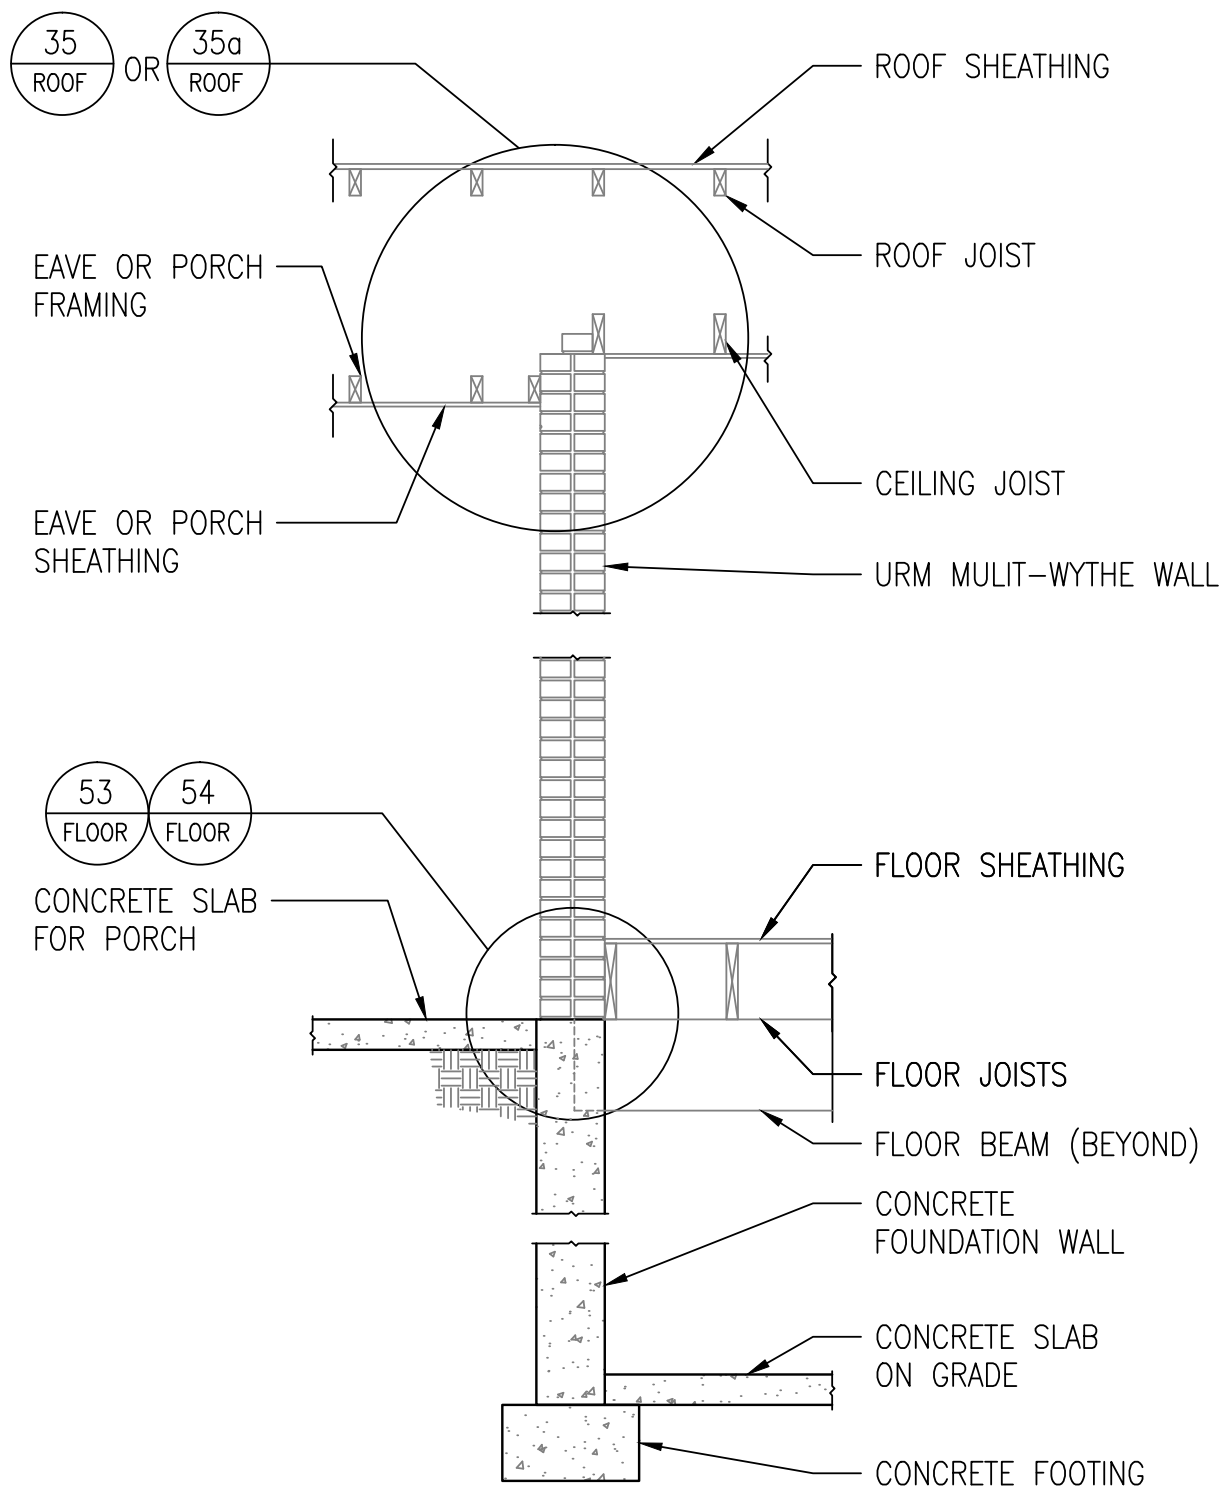
Model Home Seismic Deficiencies	HOME TYPE: MODEL A	Exterior Wall Sections	DETAIL: 2
------------------------------------	-----------------------	---------------------------	--------------

SECTION W/ JOIST FRAMING PARALLEL TO WALL

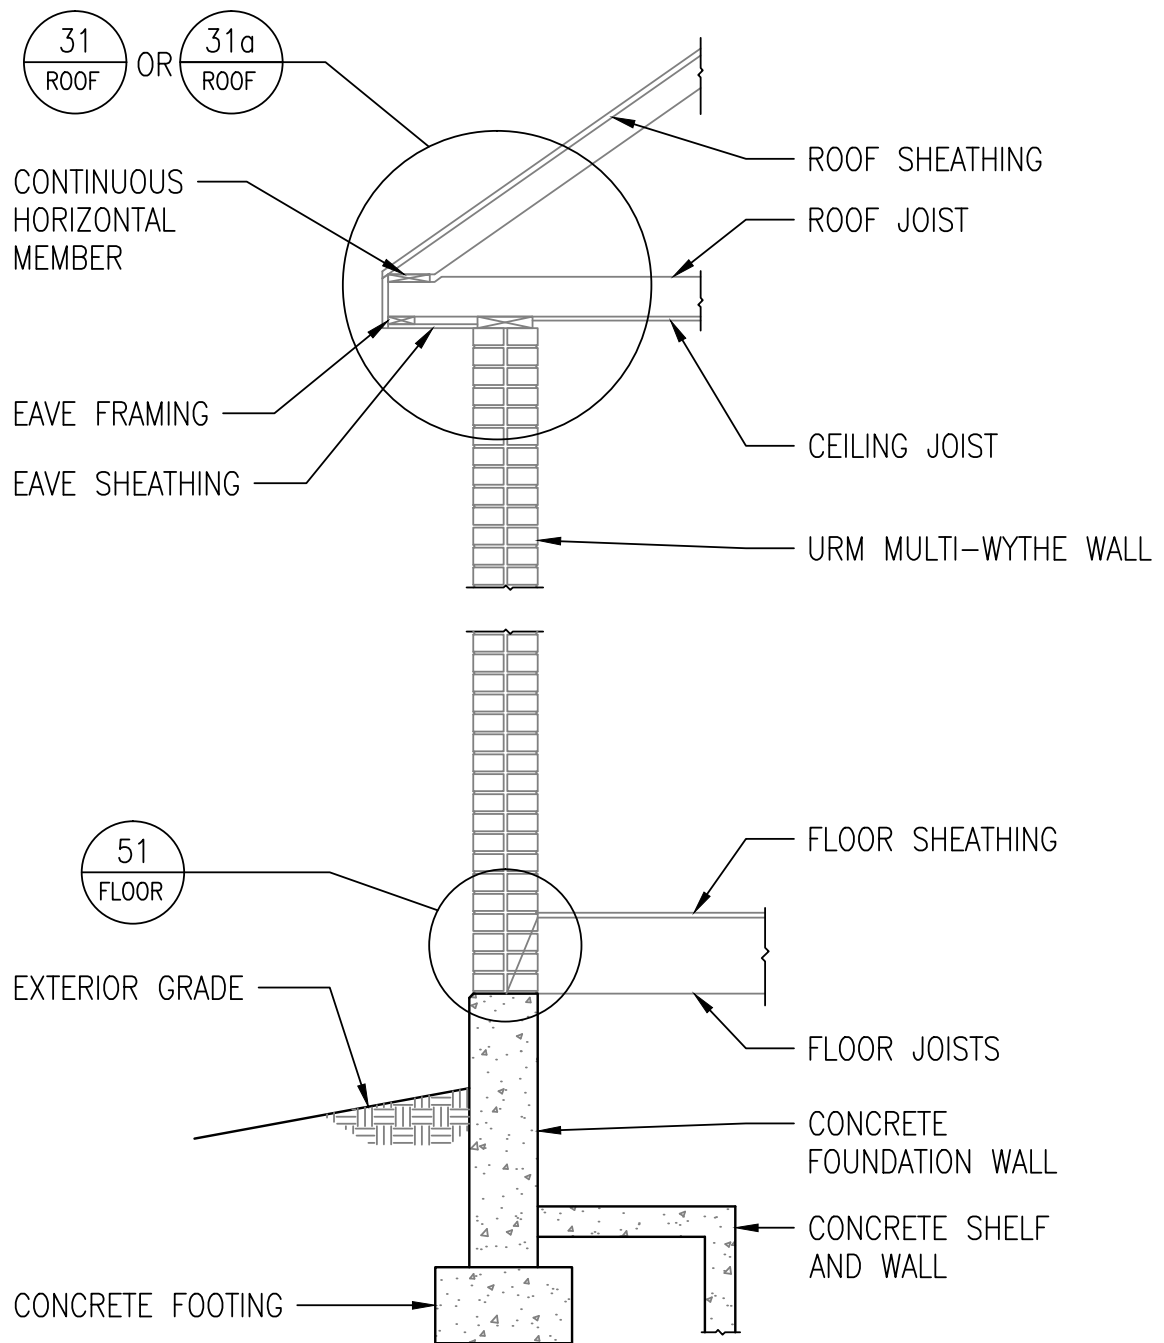
Model Home Seismic Deficiencies	HOME TYPE: MODEL B	Exterior Wall Sections	DETAIL: 3
------------------------------------	-----------------------	---------------------------	--------------

SECTION W/ JOIST FRAMING
PERPENDICULAR TO WALL

Details 3 and 4 show two different existing wall details for Model B. Reference circles have been superimposed onto these details showing the area of the wall where seismic deficiencies normally occur. The details for improvements to strengthen these deficiencies are found in Chapter 6. Table 1 and the additional details in Chapters 6 and 7 also recommend other improvements, although not illustrated in these exterior wall details.

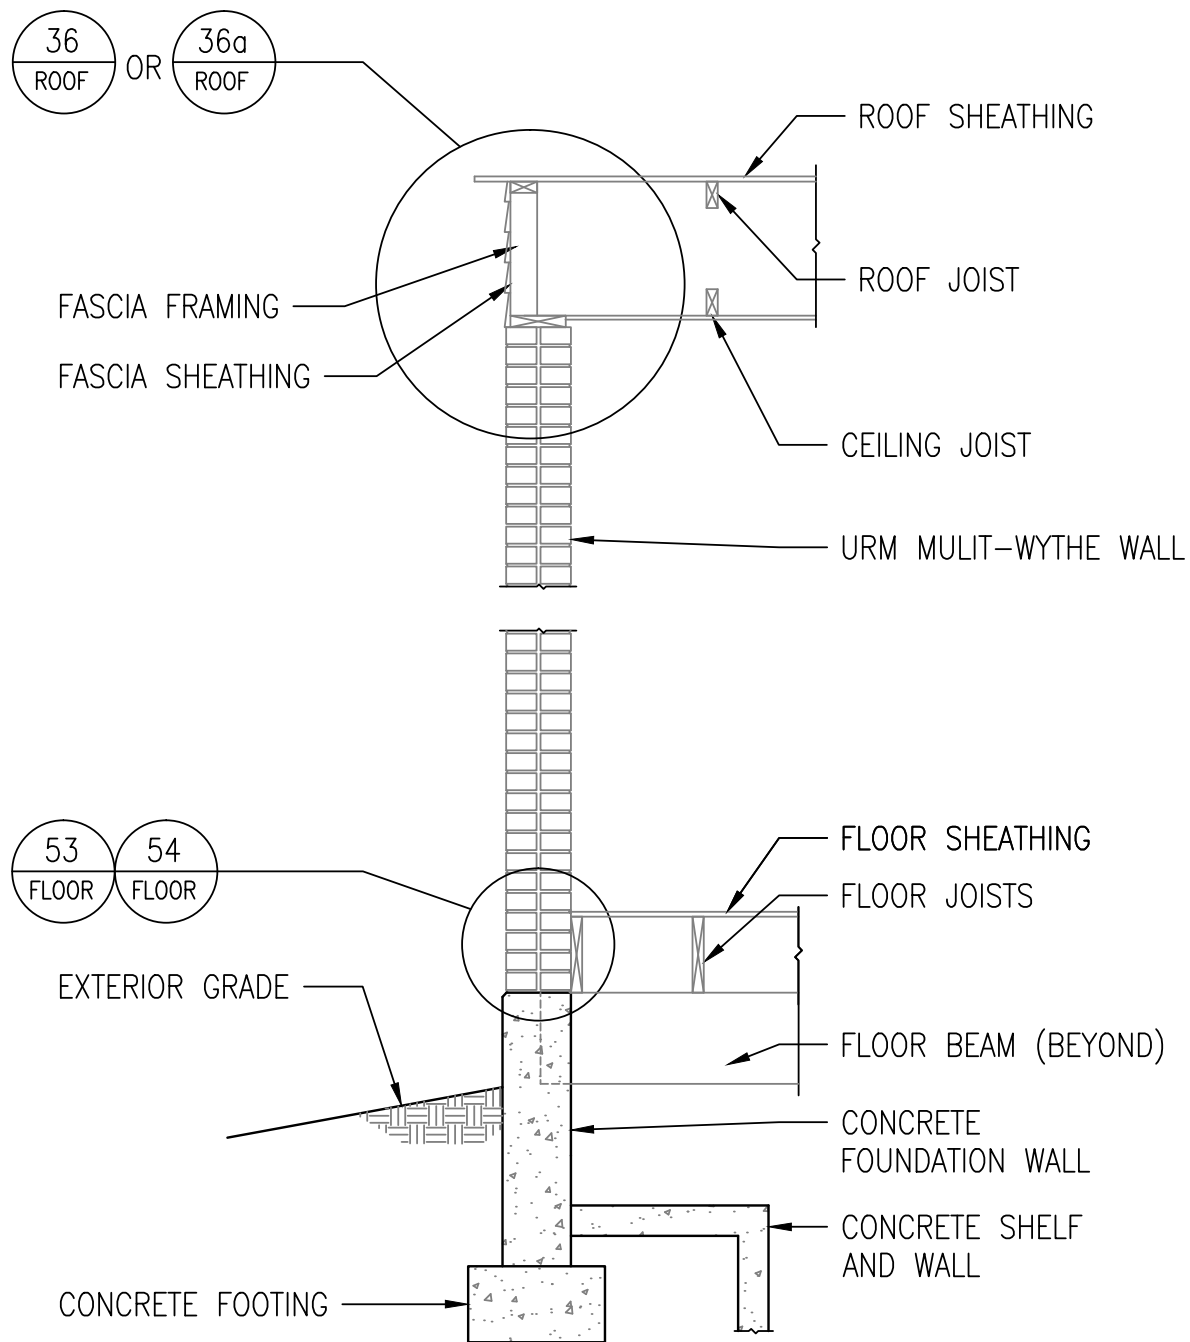
Model Home Seismic Deficiencies	HOME TYPE: MODEL B	Exterior Wall Sections	DETAIL: 4
------------------------------------	-----------------------	---------------------------	--------------

SECTION W/ JOIST FRAMING
PARALLEL TO WALL

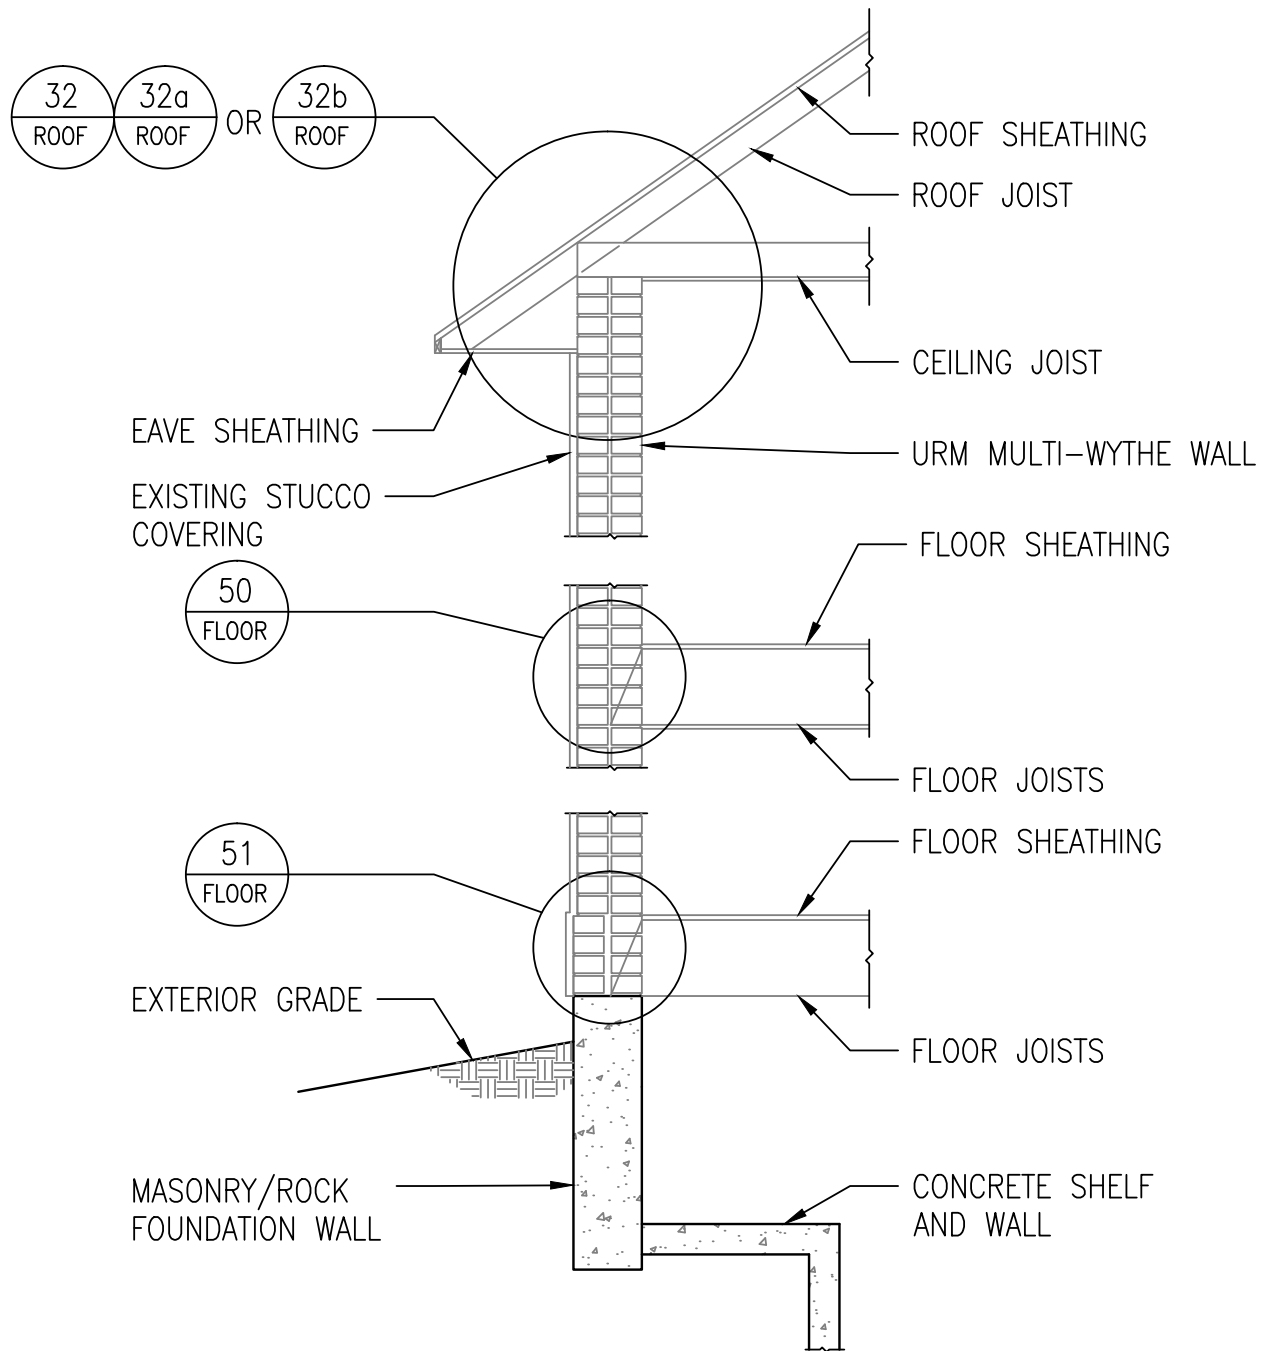
Model Home Seismic Deficiencies	HOME TYPE: MODEL C	Exterior Wall Sections	DETAIL: 5
------------------------------------	-----------------------	---------------------------	--------------

SECTION W/ JOIST FRAMING
PERPENDICULAR TO WALL

Details 5 and 6 show two different existing exterior walls sections for Model C. Reference circles have been superimposed onto the details showing the area of the wall where seismic deficiencies normally occur. The details for improvements to strengthen these deficiencies are found in Chapter 6. Table 1 and the additional details in Chapters 6 and 7 also recommend other improvements, although not illustrated in these exterior wall details.
